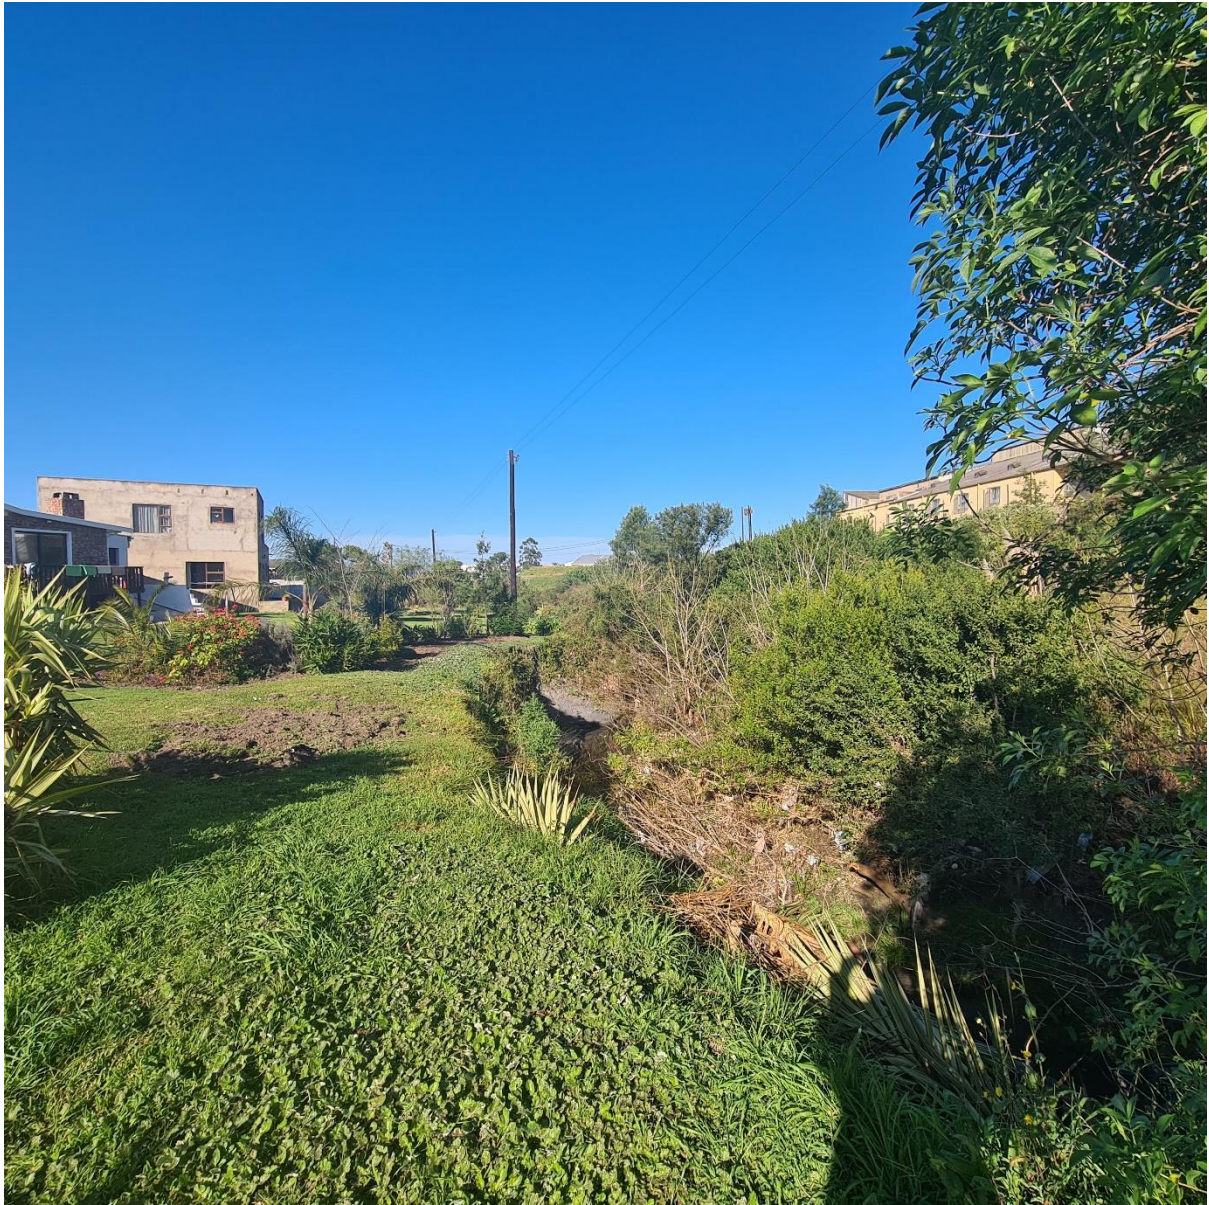
Figure 1: Mowed lawn on river embankment (Kikuyu grass).

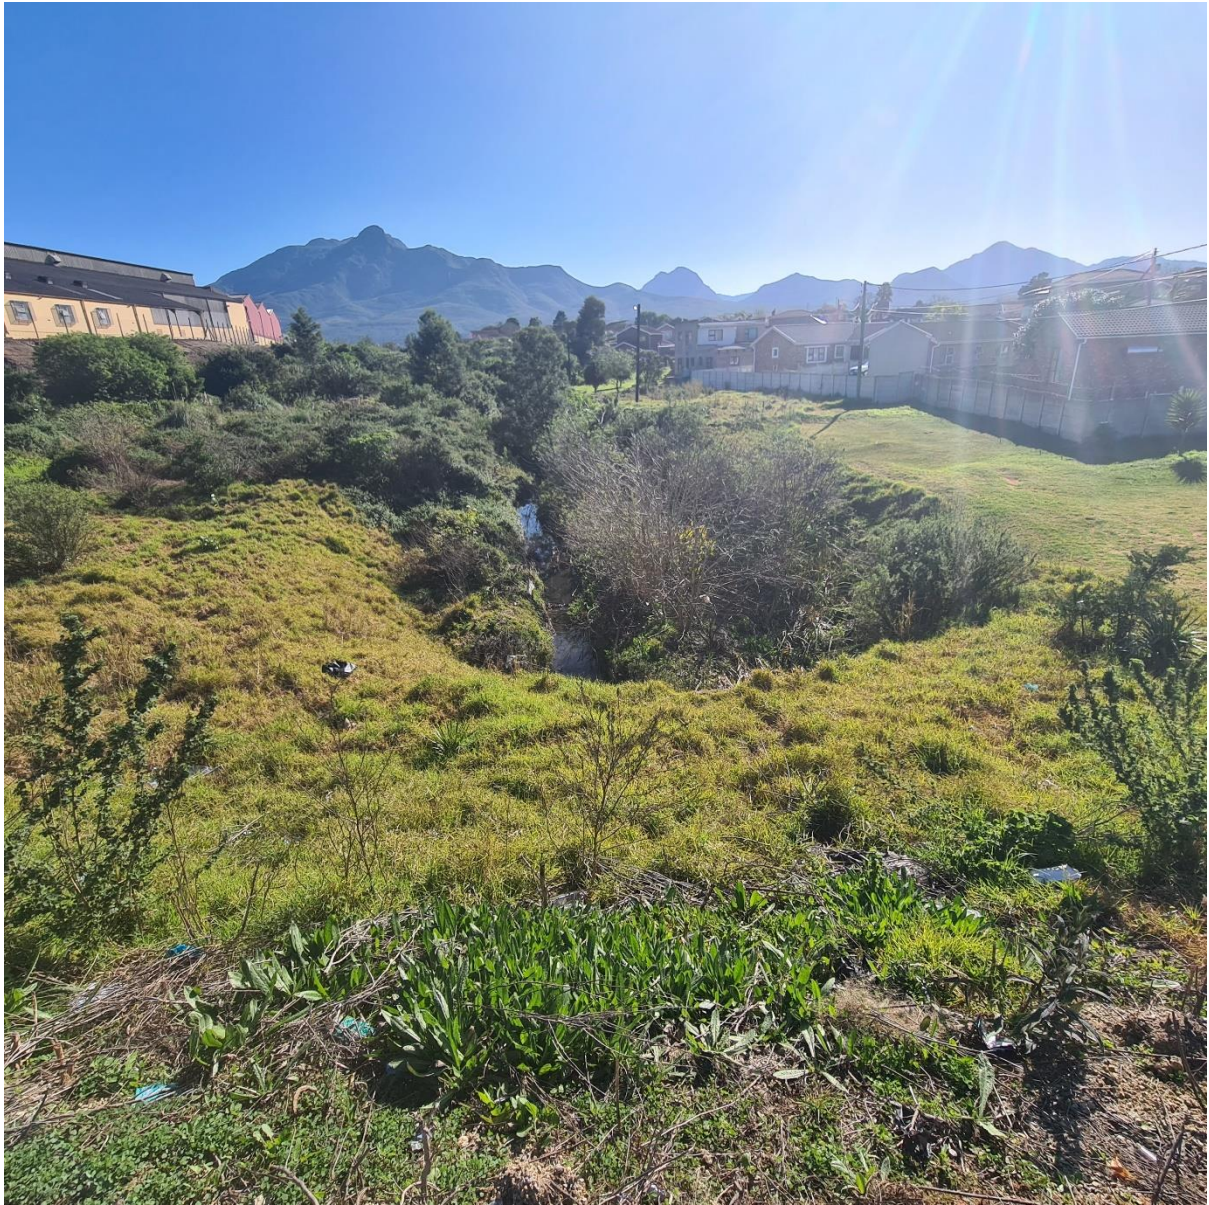
Figure 2: Properties of Molen Close Street (right hand side of watercourse). Note the mowed lawn up to the watercourse.

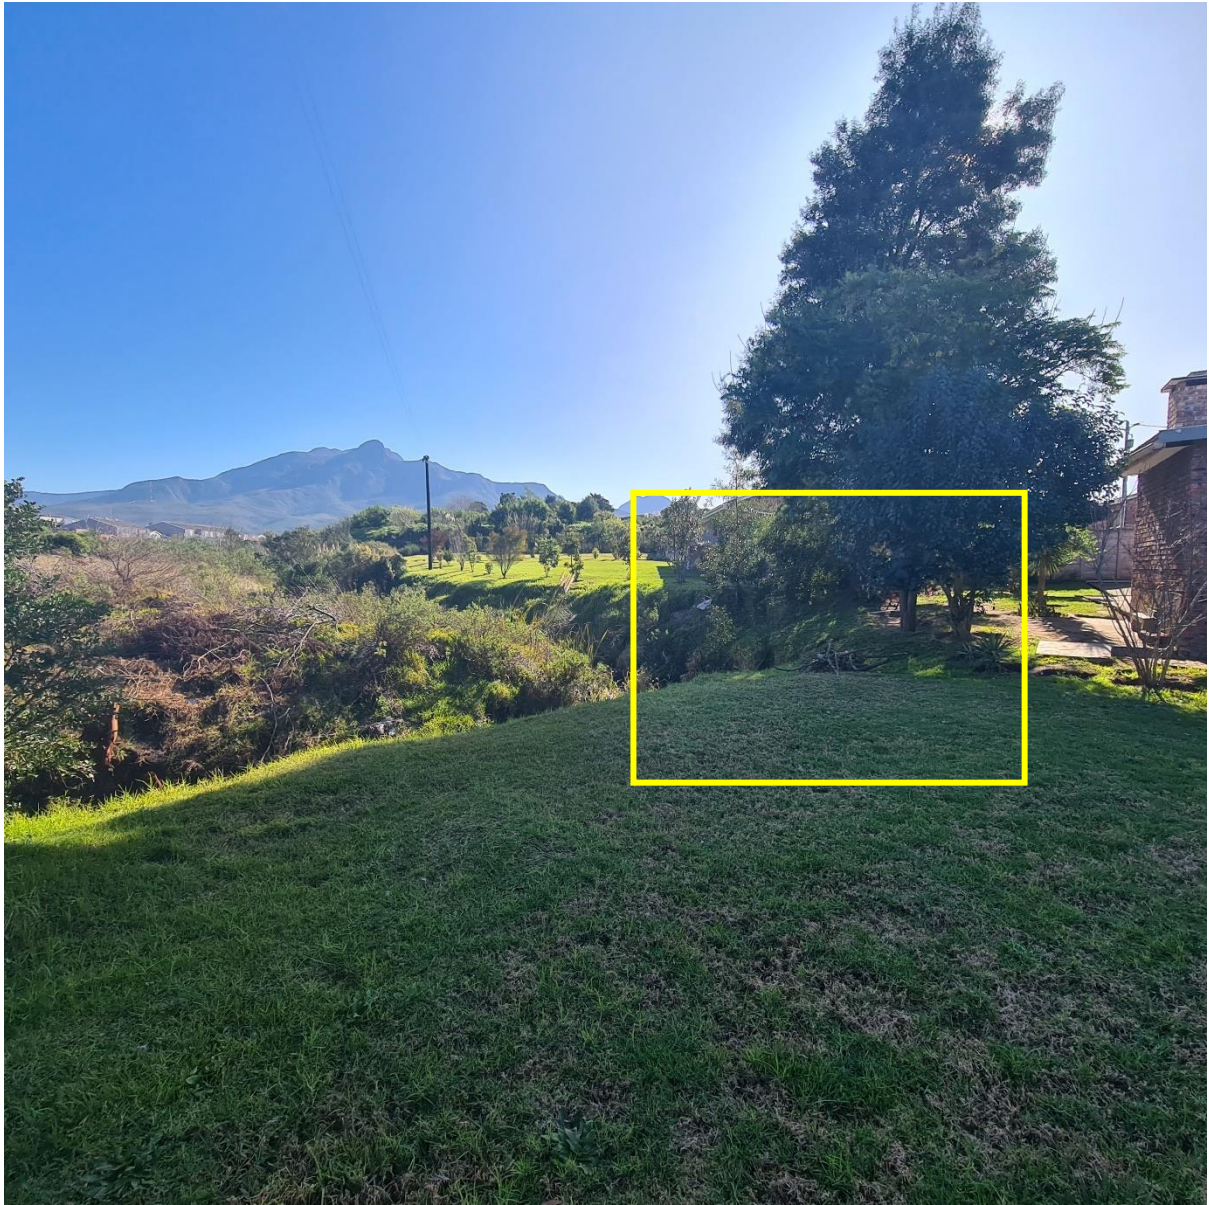
Figure 3: Main problem area along Erf 21150 & 21151.

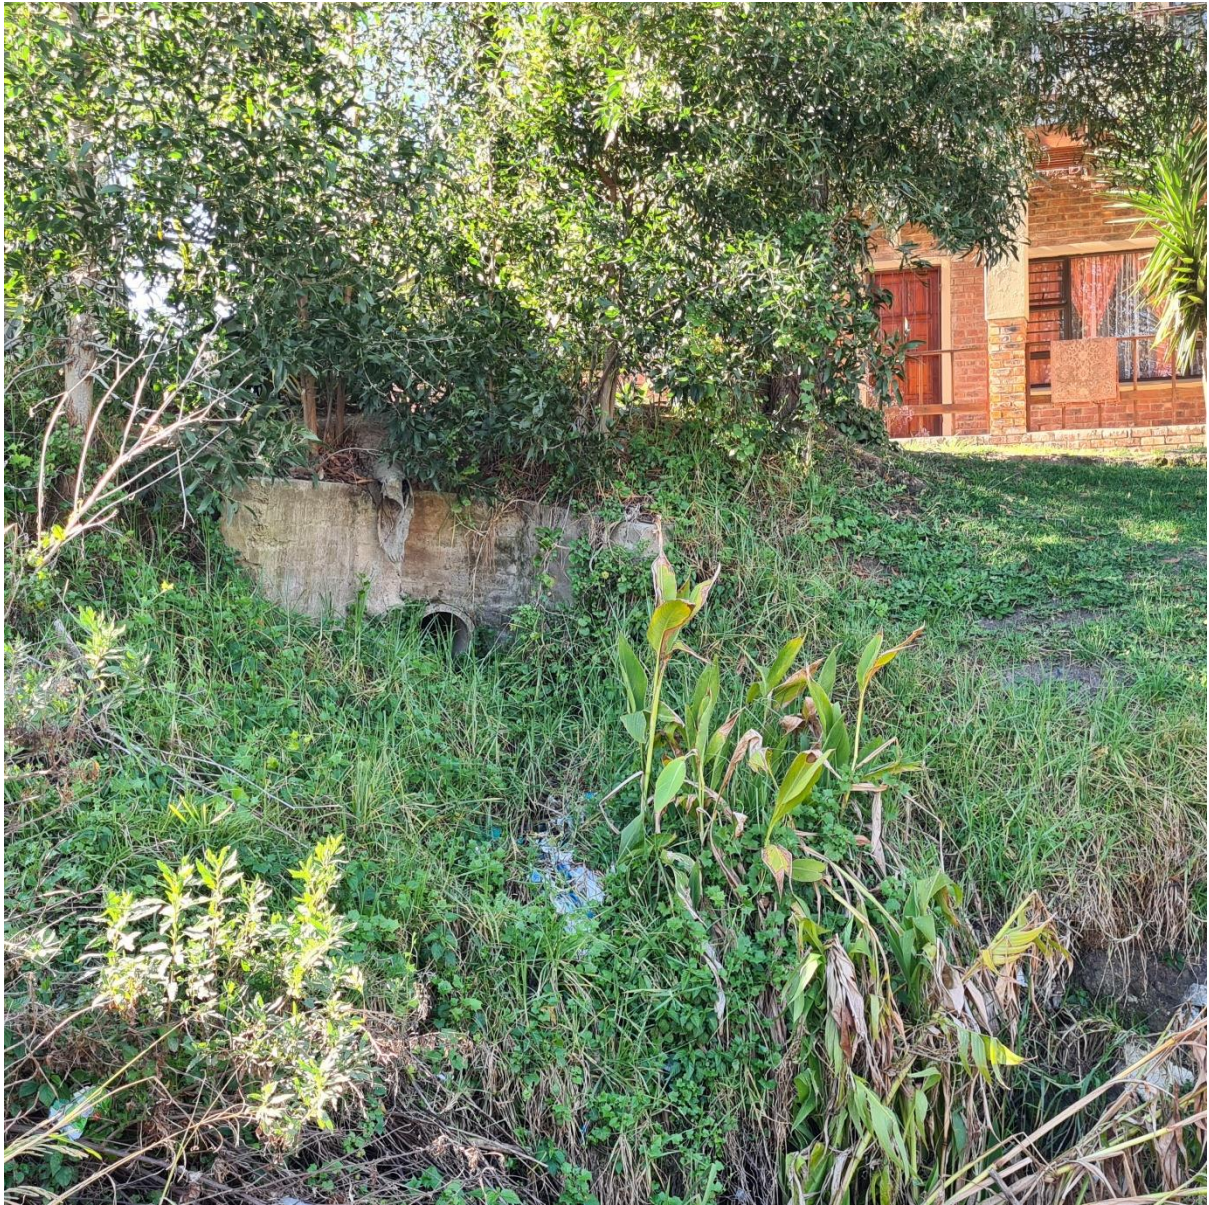
Figure 4: Stormwater outlet along Erf 21150.

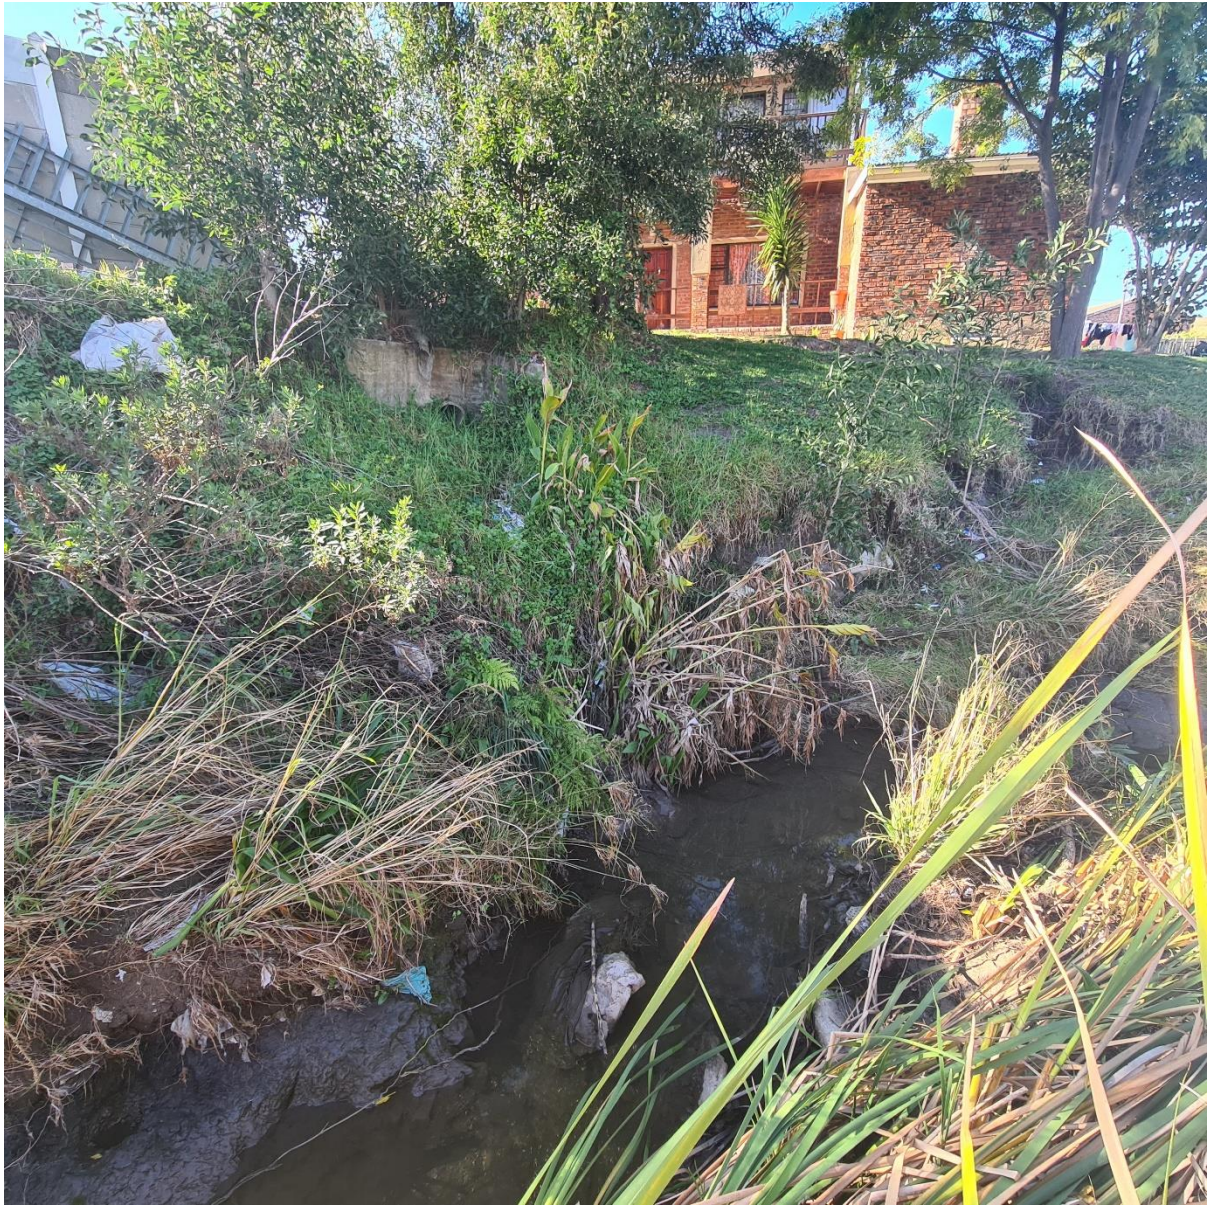
Figure 5: Area of main concern.

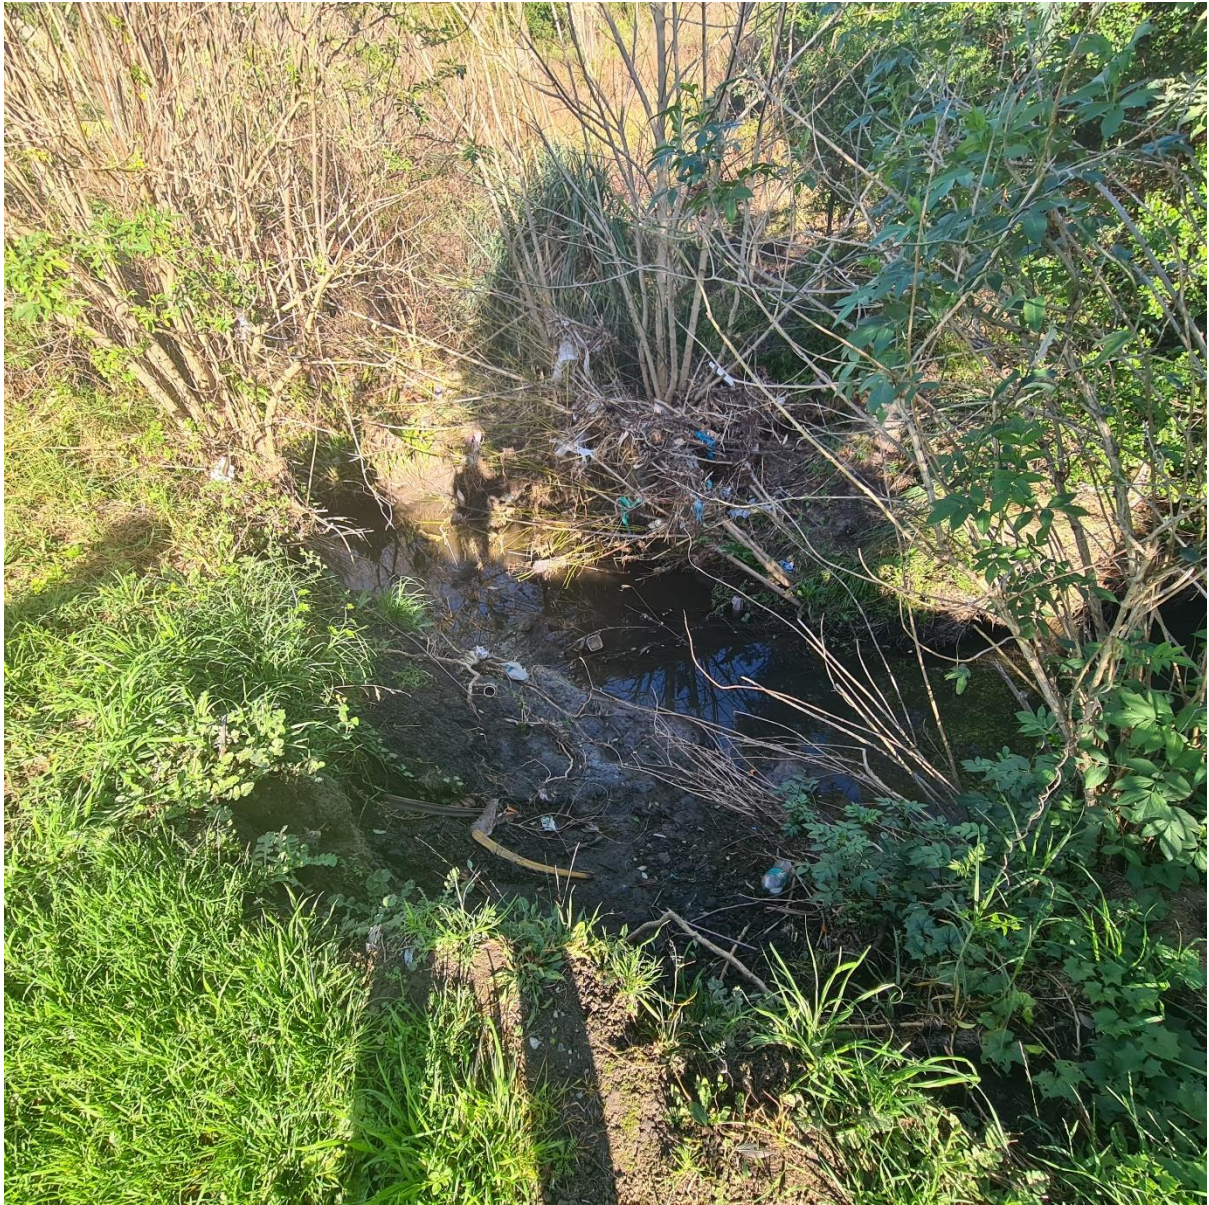
Figure 6: Degraded watercourse full of rubble.

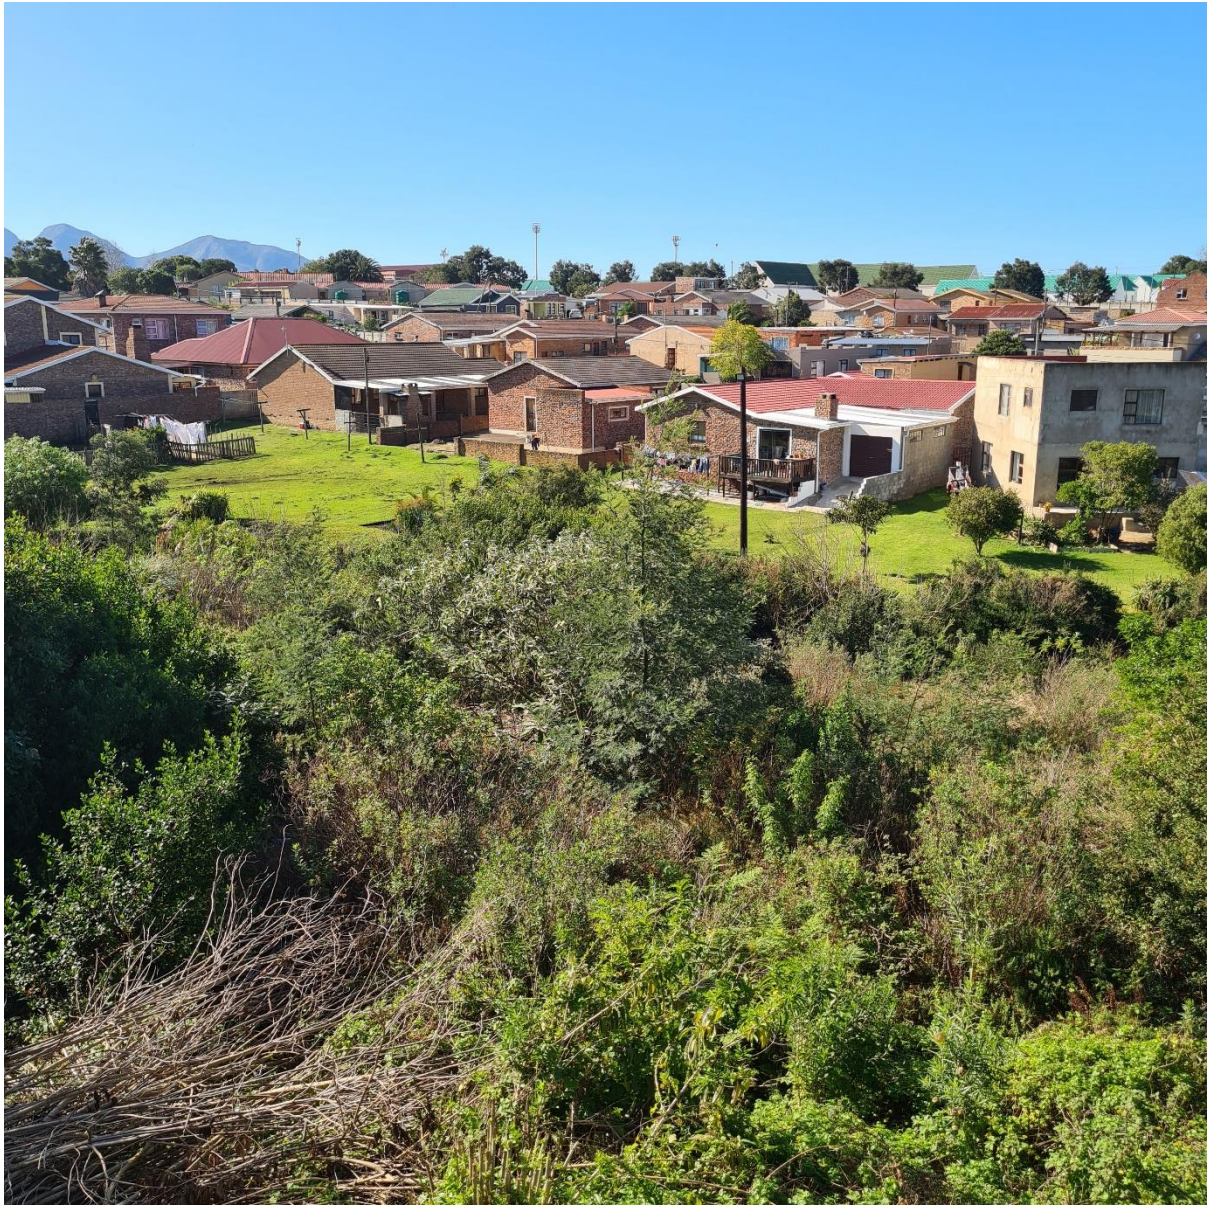
Figure 7: Properties of Molen Close street with mowed Kikuyu lawns encroaching RE/464.
