# ANYSBERG MANAGEMENT ROADS

## CONDITION ASSESSMENT - STORMWATER DAMAGE

**PROJECT REF NO: 11755000**

*10 July 2025*

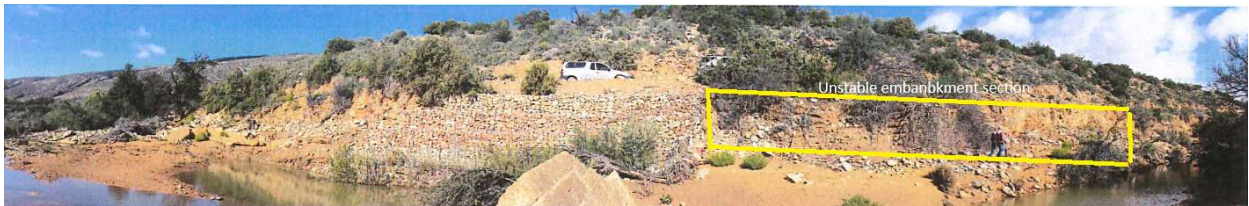
Figure 1: Vrede Goedehoop Road - Extend of Eroded embankment

This is the main access road from Laingsburg to the nature reserve offices. One specific section was identified that was being problematic and which is 670m in length. The specific problem section is located next to the portion adjacent to the Prinsriver, an order 2 stream. A minor wash away is located at ch. 60. The main concern is the section between ch. 200 and ch. 300 where extensive erosion is caused to the riverbank. Based on site assessments, extensive retaining structures has high as 8m will have to be constructed to prevent the complete washaway of the road. Two options are available:

- Construction using gabion structure as per the existing embankment protection, and
- Construction of a concrete retaining wall.

The report by SKC Masakhizwe Consulting Engineers provides extensive details on remedial measures (see Annexure B).

An alternative here is to divert the road to a completely new position (see Figure 1).

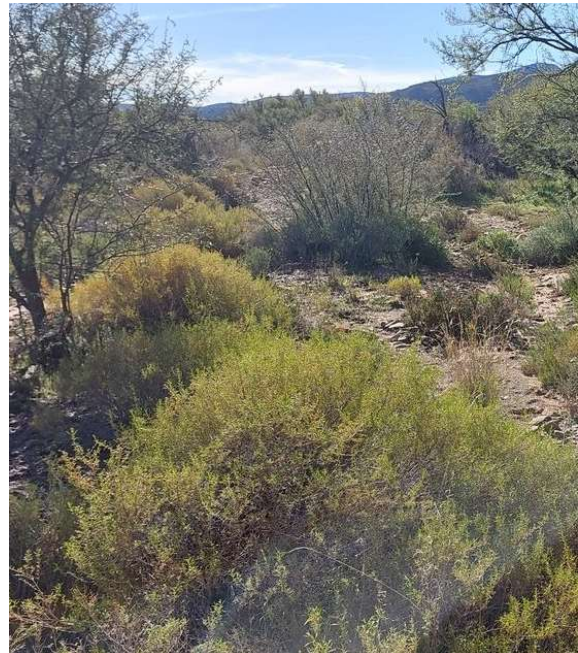
Several major stream crossings are encountered (ch. 1750, 2340, 3260, 3600, 4120, 5540 and ch. 5800 that warrants the construction of major low low-level or culverts structures to divert stormwater runoff though or over the roadway.

Photo 4: Taken at Ch 1740 at stream crossing.

130137	1740	20		Stream crossing	Reno Matressed 12m long x 3m wide
130239	1820	80	Road washed out	Start grassblocks	
130348	1910	90	End grassblocks		
130510	2000	90	Heavy grading/water bars ch 2000 to ch 2300		
151822	2300	300	Heavy grading/water bars ch 2000 to ch 2300		
151748	2340	40	Stream crossing	Reno Matressed 12m long x 3m wide	
151723	2380	40	3. Average	Heavy grading/water bars ch 2380 to ch 2700	
132119	2480	100	Heavy grading/water bars ch 2380 to ch 2700		
132400	2700	220	Fair condition ch 2700 to ch 2900	Light grade/do nothing	
133507	2900	200	2. Good	Fair condition ch 2700 to ch 3240	Light grade/do nothing
133754	3100	200	Fair condition ch 2700 to ch 3240	Light grade/do nothing	
134048	3240	140	4. Poor	Stream crossing	Provide low level drift (concrete)
134136	3300	60	Road washed out	Heavy grading/water bars for 20m	
134237	3320	20			
134448	3410	90	2. Good	Good condition ch 3410 to ch 3550	Nil

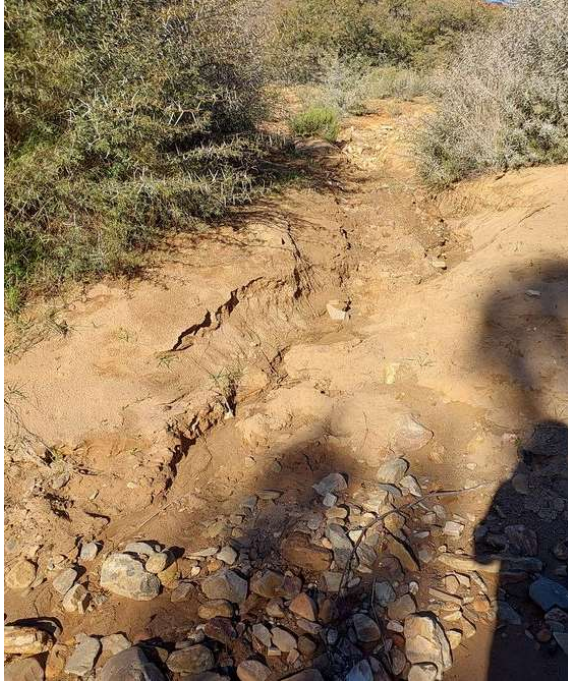
Photo 5: Taken at Ch 2340 (stream crossing)

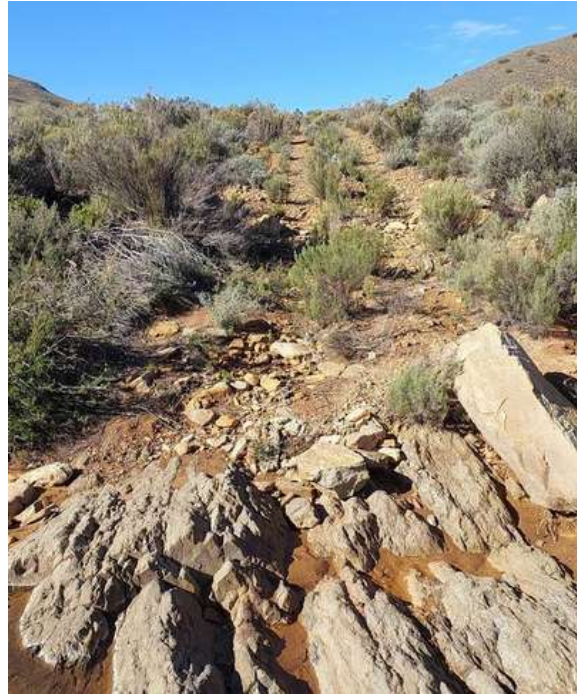
**Figure 14: Taken at ch. 6000**

142343	5800	0	3. Average	Fair condition ch 5800 to 6000	Heavy grading/water bars	
142645	6000	200		Fair condition ch 5800 to 6000	Heavy grading/water bars	
	7640	1640		Heavy grading ch 6000 to 7640	Heavy grading/water bars	
	7640	0	4	Stream crossing	New grassblock drift	
	7640	0	3. Average	Heavy grading ch 7640 to 7930	Heavy grading/water bars	
	7930	290	4. Poor	Stream crossing	New grassblock drift	
	7930	0	3. Average	Heavy grading ch 7930 to 9080	Heavy grading/water bars	
	9080	1150	4. Poor	Stream crossing	New grassblock drift	
	9930	850	3. Average	Heavy grading ch 9090 to 12600	Heavy grading/water bars	
	12600	2670	4. Poor	Stream crossing	New grassblock drift	
	15300	2700	3. Average	Heavy grading ch 12600 to 15300	Heavy grading/water bars	
Misc. works						
81306			4	Poor condition		
82954			4	Poor condition		
83606			4	Water crossing	18m x 3m drift gabions	
92739			4	Water crossing	18m x 3m drift gabions

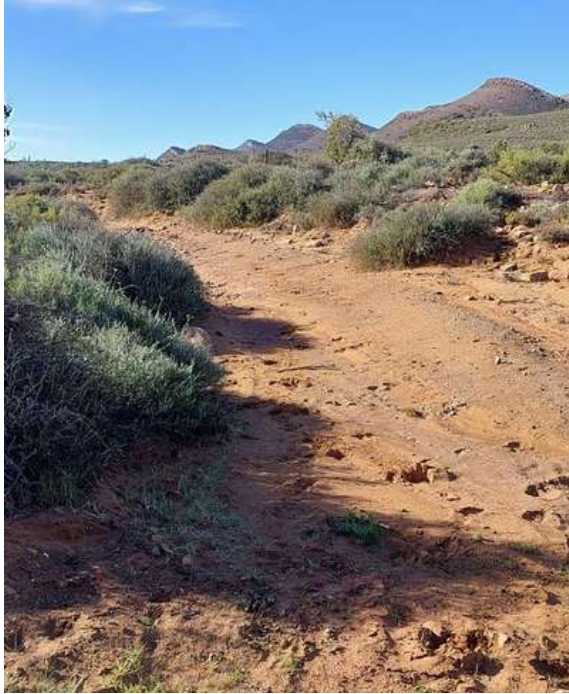
**Photo 1: Taken at ch. 140**

At ch. 140 a major stream crossing is encountered with no structure in place. After ch. 140 the roadway is in fair condition up to ch. 700. After ch. 700 the roadway is on top of exposed shale (no gravel wearing course) and although driveable, can lead to tyre damage. Heavy blading/dozing will be required up to ch. 1000. After ch. 1000 a major stream crossing is encountered that will require a stormwater culvert structure. Further main crossings are encountered at ch. 1340 and 1650. After ch. 1650 the road is in a passable condition for a vehicle with a high ground clearance. Heavy grading will be required here.

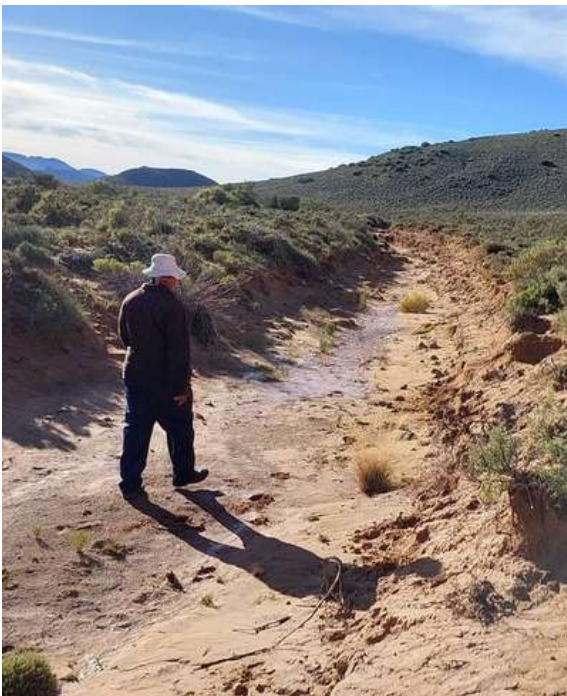
**Photo 7: Taken at ch. 3220**

At ch. 3000, the road is located adjacent to a major stream crossing and a section of the roadway has washed away up to ch. 3400. It is recommended that the roadway be relocated out of the stream crossing

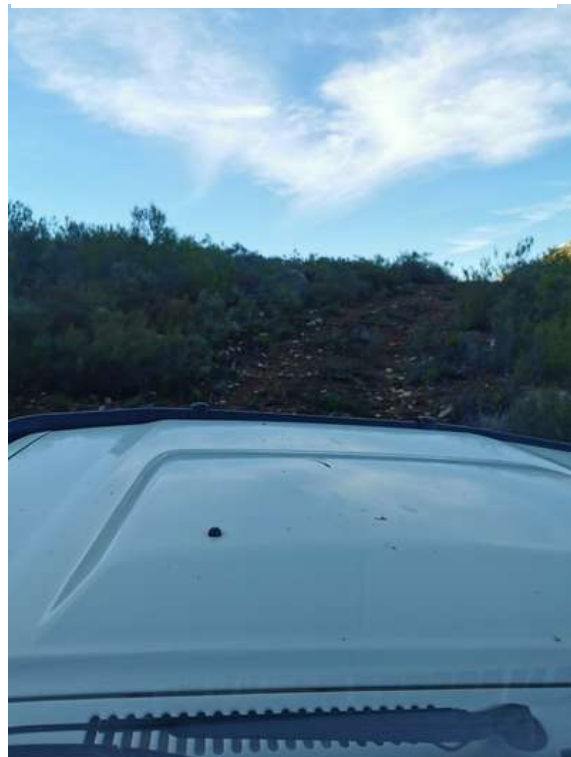
**Photo 4: Taken at ch. 4300 (steep incline)**
