# GAMKABERG NATURE RESERVE

## ROADS CONDITION ASSESSMENT - STORM DAMAGED ROADS

**PROJECT REF NO:  
EM-GI000103 (DOI), 11755010 (V3)**

***30 July 2025***

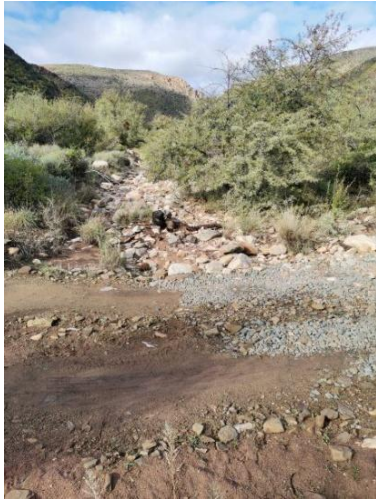
Figure 9: photo 28, a seasonal watercourse area intersecting the road. The road edge is strewn with boulders, cobbles, and sediment.

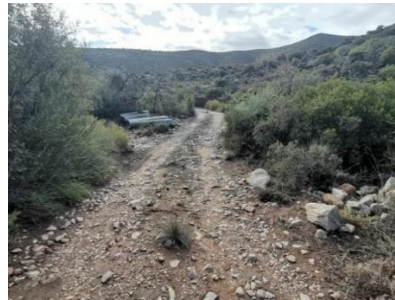
Figure 10: photo 29, there's a seasonal watercourse intersecting the road. The road edge is strewn with boulders, cobbles, and sediment. There are concrete stormwater pipes.

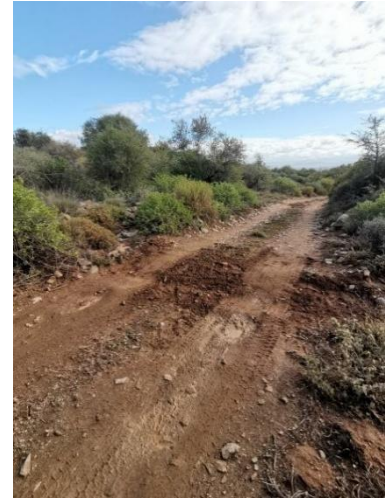
Figure 11: photo 35, The road exhibits natural firmness and is in moderate condition.

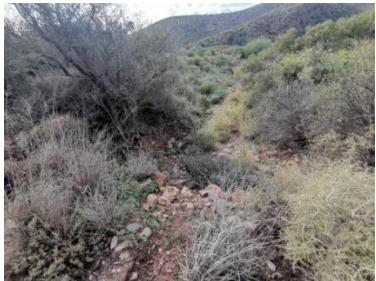
Figure 12: photo 40 a watercourse area with boulders, cobbles and debris.

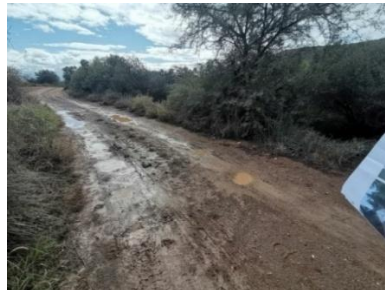
Figure 13: photo 43, filled watercourse culverts needed.

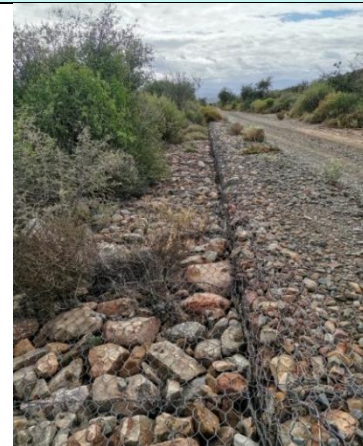
Figure 14: photo 51, watercourse area with gabion mattresses.

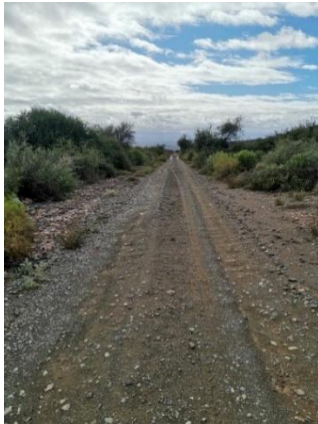
Figure 15: photo 53, watercourse area, with gabion mattresses.

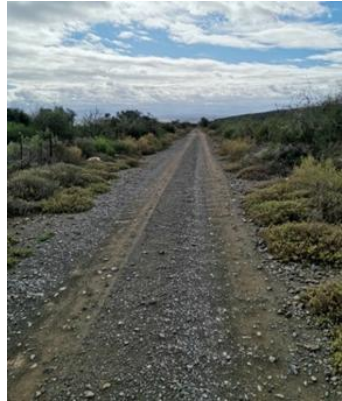
Figure 16: photo, 56 The road exhibits natural firmness and is in moderate condition.

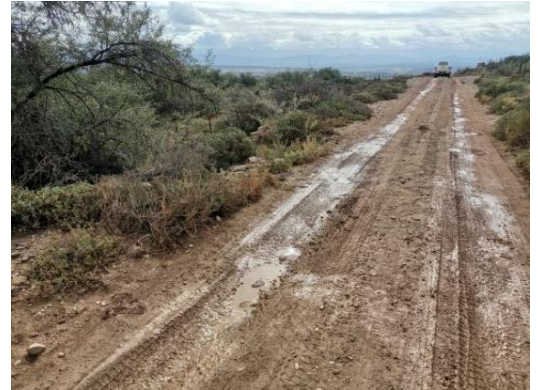
Figure 17: photo 59, muddy, saturated conditions. And standing water in depressions.

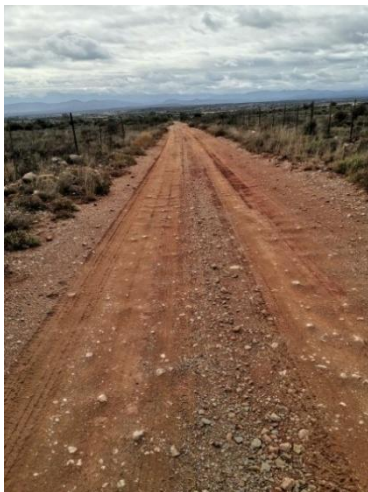
Figure 18: photo 67, The road exhibits natural firmness and is in moderate condition.

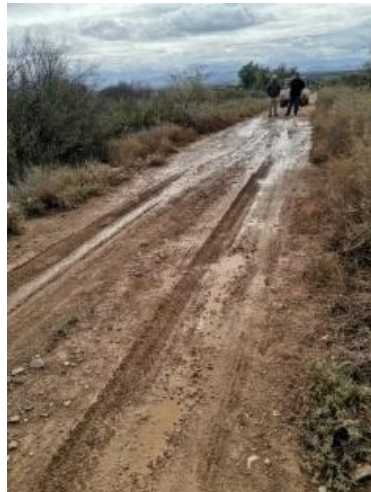
Figure 19: photo 68 muddy, saturated conditions. And standing water in depressions.

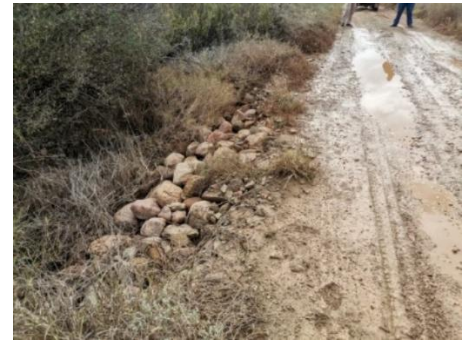
Figure 20: photo 70, a seasonal watercourse area with boulders, cobbles and debris. Standing water.

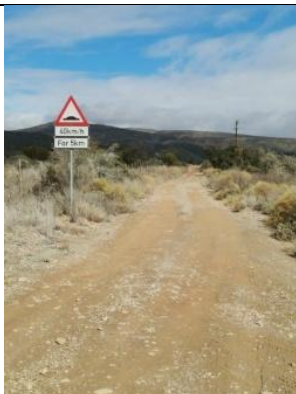
Figure 21: photo 72, the road exhibits natural firmness and is in moderate condition.

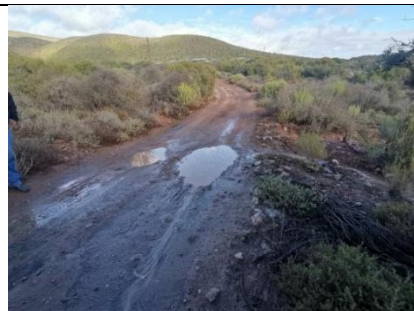
Figure 22: photo 3, The watercourse that was backfilled after the last rain.

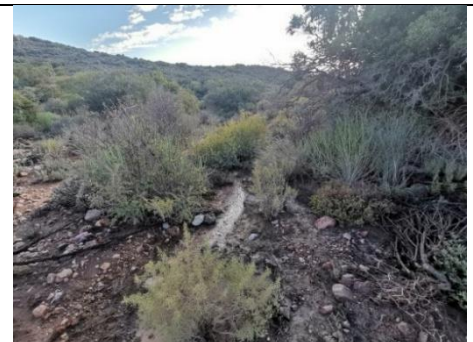
Figure 23: photo 4, a watercourse high volume surface runoff zone.
