SWARTBERG MANAGEMENT ROAD

CONDITION ASSESSMENT - STORMWATER DAMAGE

PROJECT REF NO: 11755011

30 July 2025

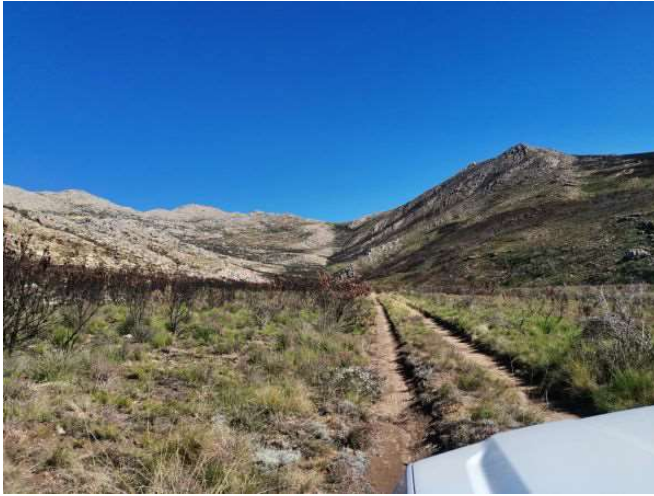
Figure 3: Photo 1, road path is in good condition, no remedial work required.

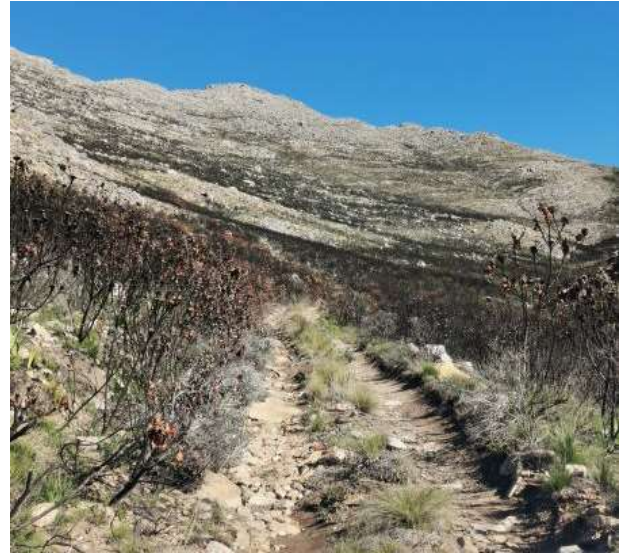
Figure 4: Photo 3, the road is in average condition with erosion along wheel tracks. Imported material required.

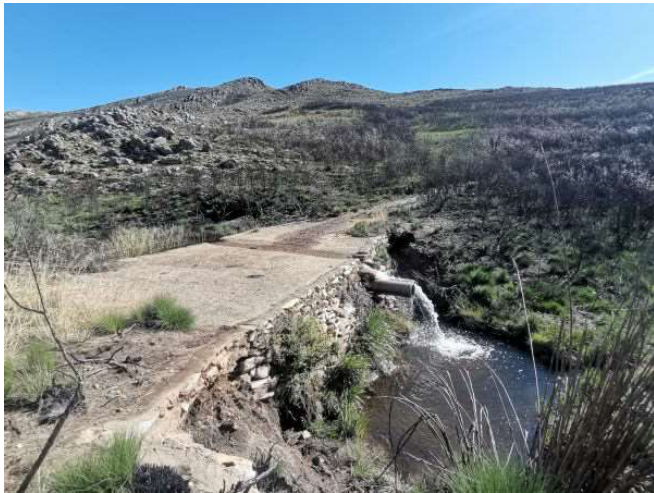
Figure 5: Photo 4, concrete slab bridge in good condition. No remedial action required at the bridge.

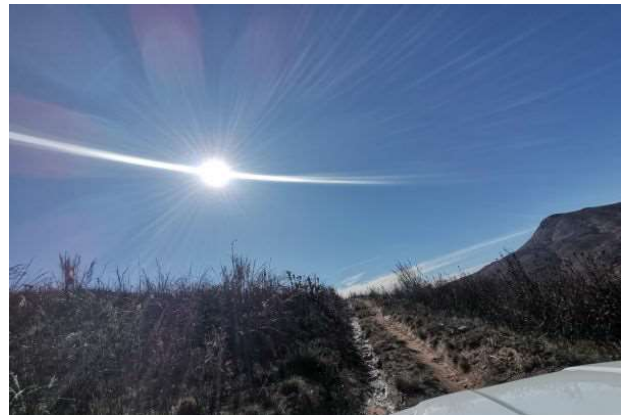
Figure 6: Photo 6, road eroded. Imported fill material along wheel tracks required.

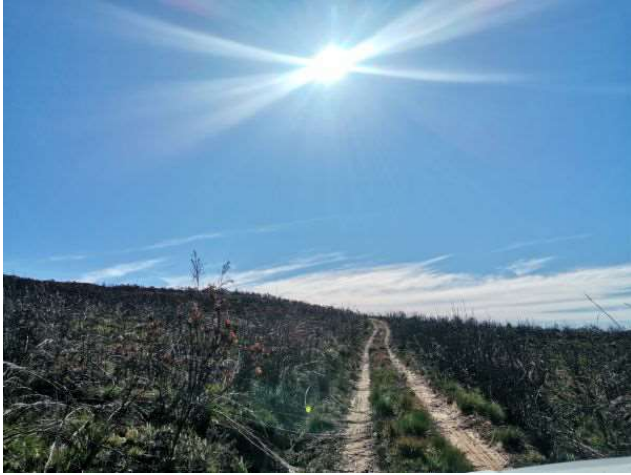
Figure 7: Photo 7, road path is in excellent condition, no remedial work required.

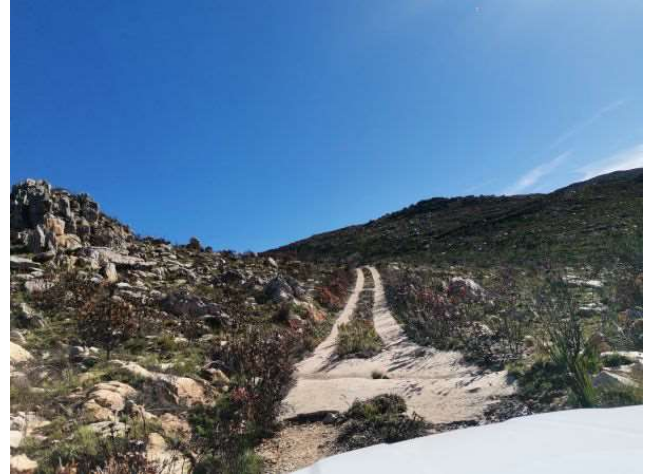
Figure 8: Photo 11, the road is in average condition, some erosion evident.

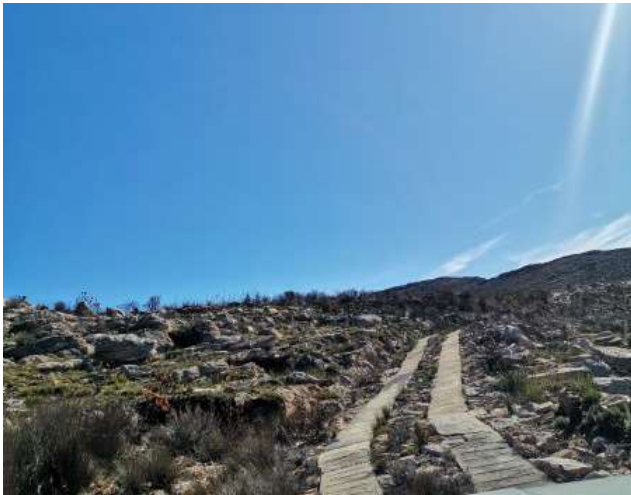
Figure 9: Photo 17, road in good condition. Concrete strips are still in good condition.

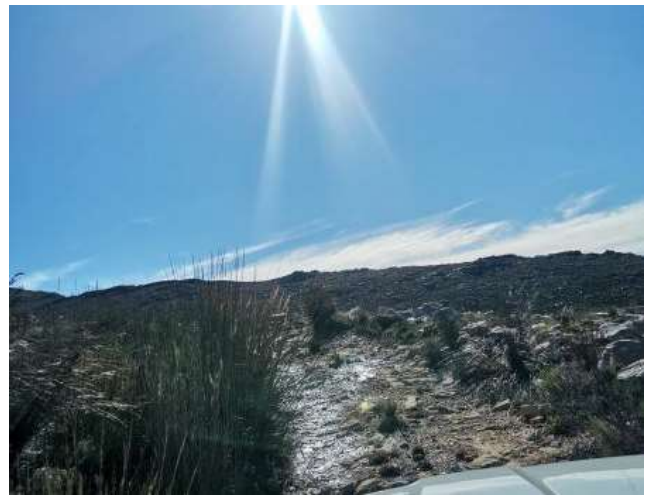
Figure 10: Photo 18, road in average condition. Weathered wheel tracks with a lot of exposed rocks.

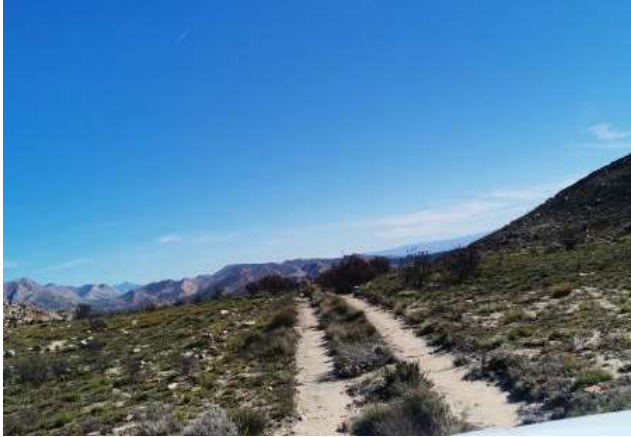
Figure 11: Photo 23, road in good condition. Bumps need reshaping.

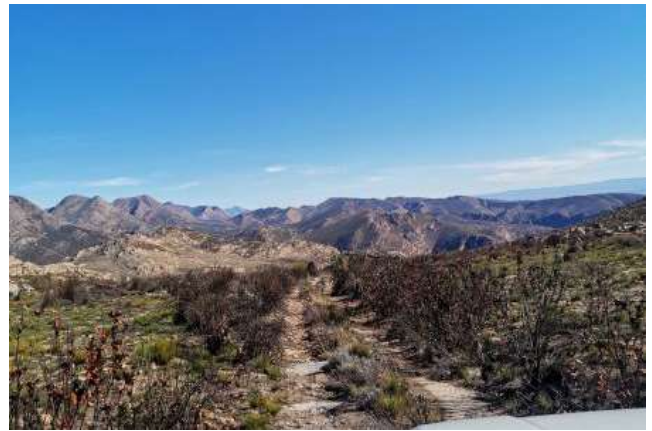
Figure 12: Photo 24, the road is in average condition, slightly eroded

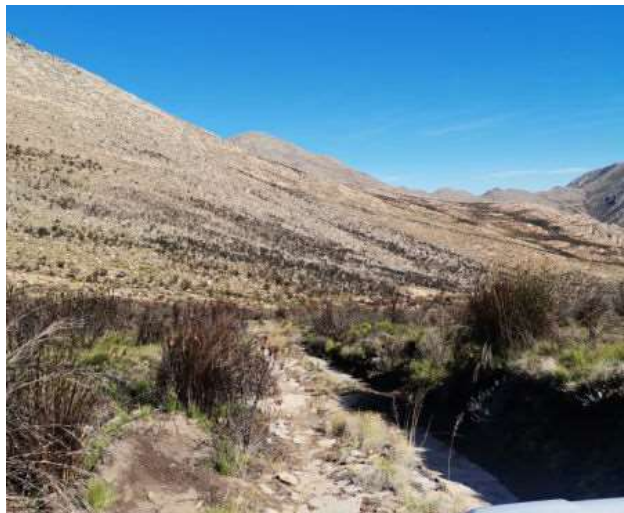
Figure 13: Photo 26, soil is eroded, a lot of rocks exposed.

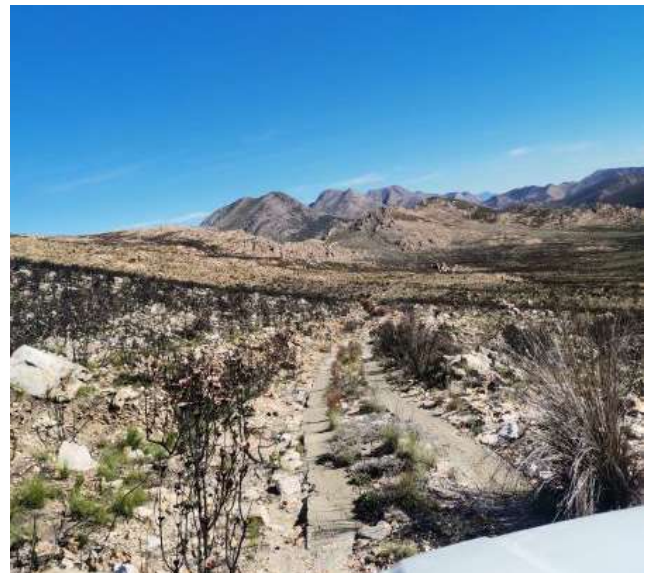
Figure 14: Photo 32, concrete strips in average condition. Cracking and some movement visible.

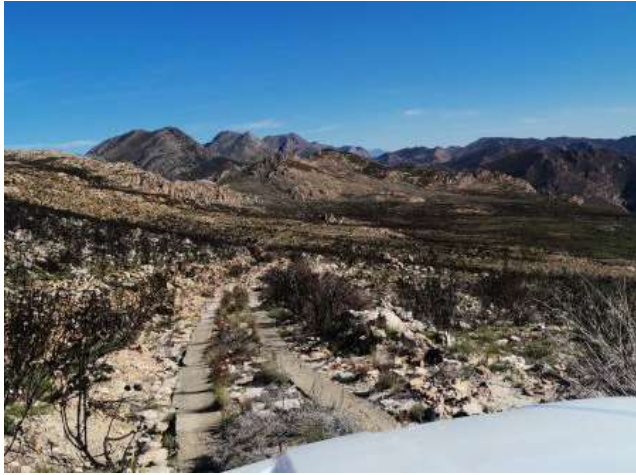
Figure 15: Photo 33, concrete strips in average condition. Cracking and some movement visible.

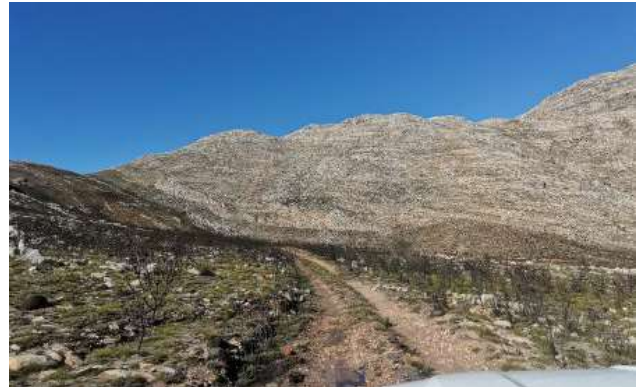
Figure 16: Photo 48, the road is in good condition. No remedial work required

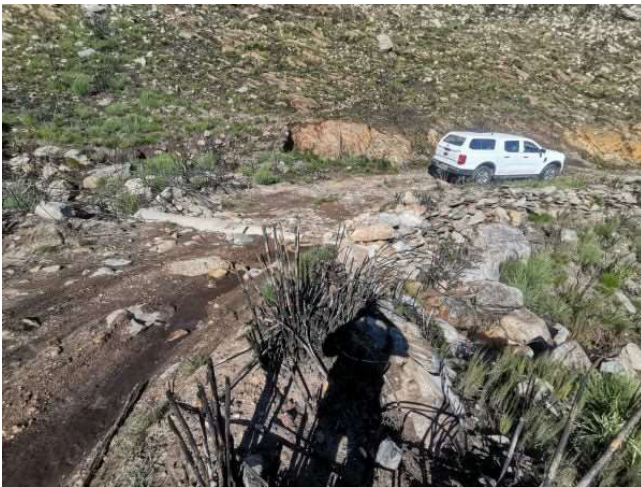
Figure 17: Photo 52, road is in poor condition. Eroded with large rocks exposed.

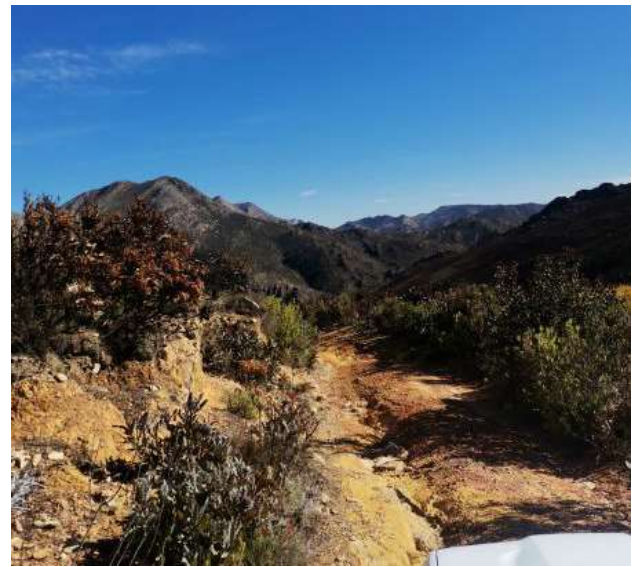
Figure 18: Photo 57, rock in poor condition. Evidence of stormwater running along road and soil washed away. Humps required to direct water away from road

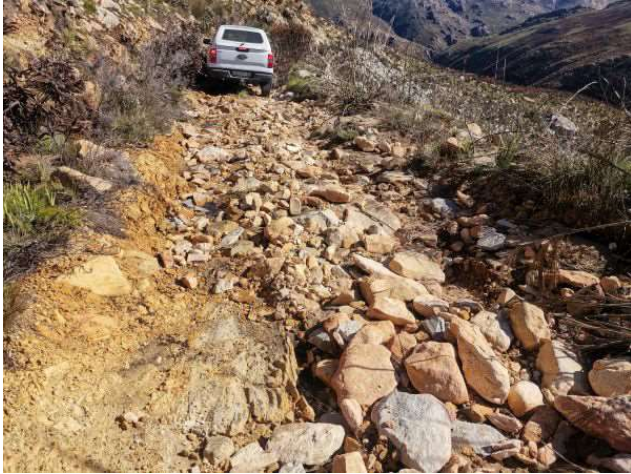
Figure 19: Photo 65, road is in critical condition. All fines eroded. Large rocks exposed.

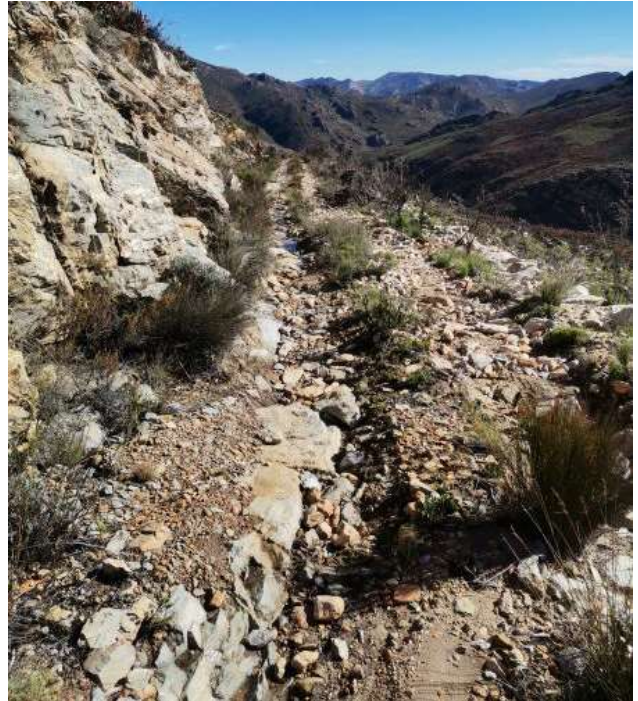
Figure 20: Photo 67, road in poor condition. All fines eroded. Large rocks exposed.

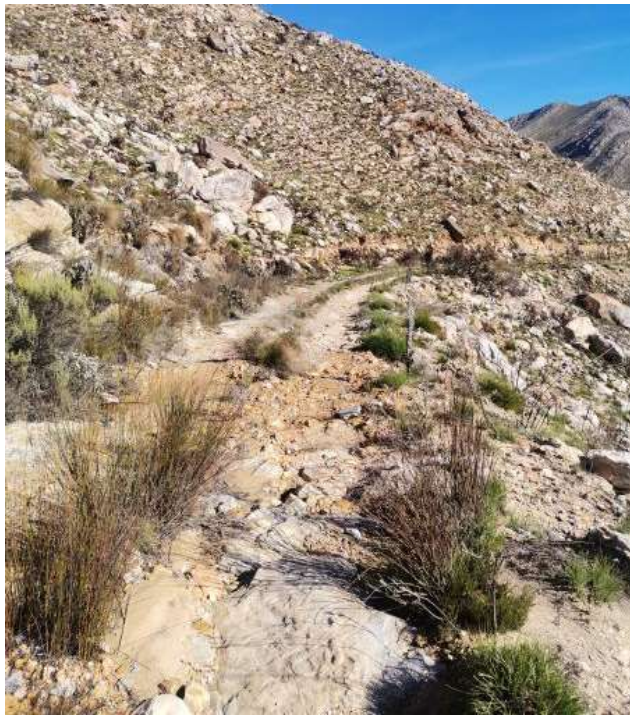
Figure 21: Photo 72, road path is in poor condition. Wheel tracks eroded.

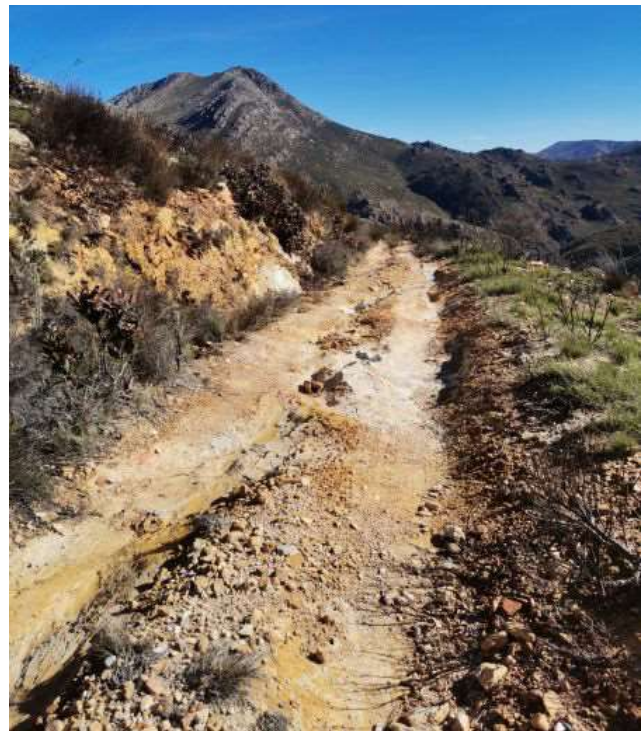
Figure 22: Photo 78, the road in average condition. Reshaping of humps required.

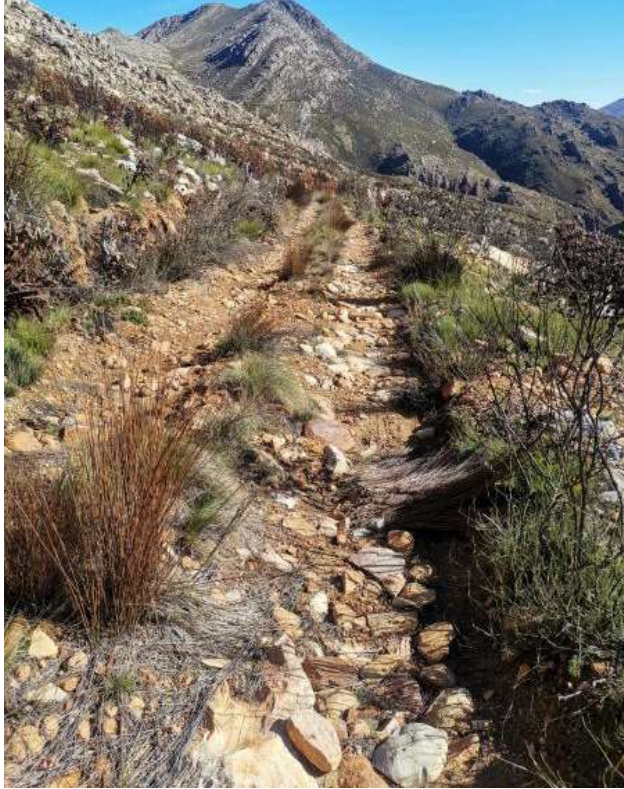
Figure 23: Photo 80, soil eroded, humps required to channel the water out of the road path.

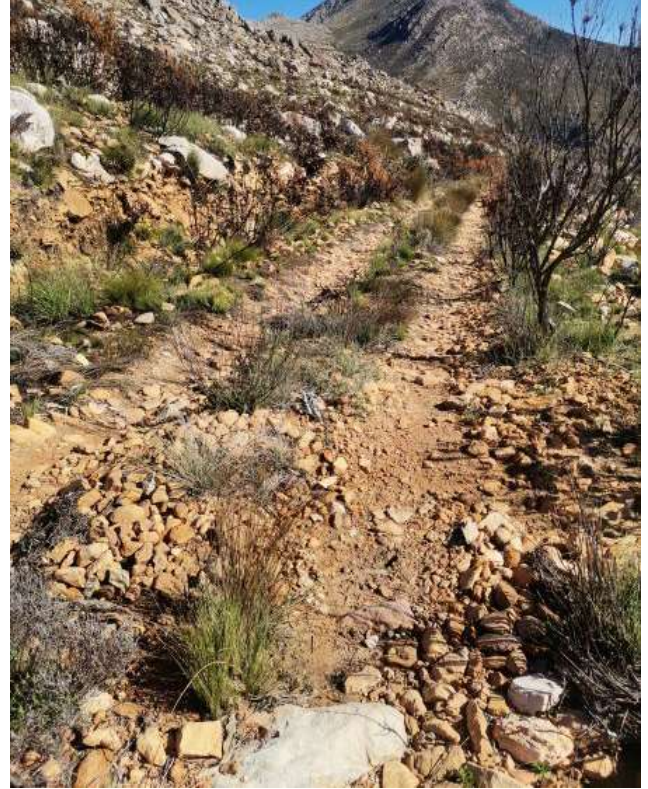
Figure 24: Photo 81, roadway eroded with exposed rocks, no adequate stormwater drainage.

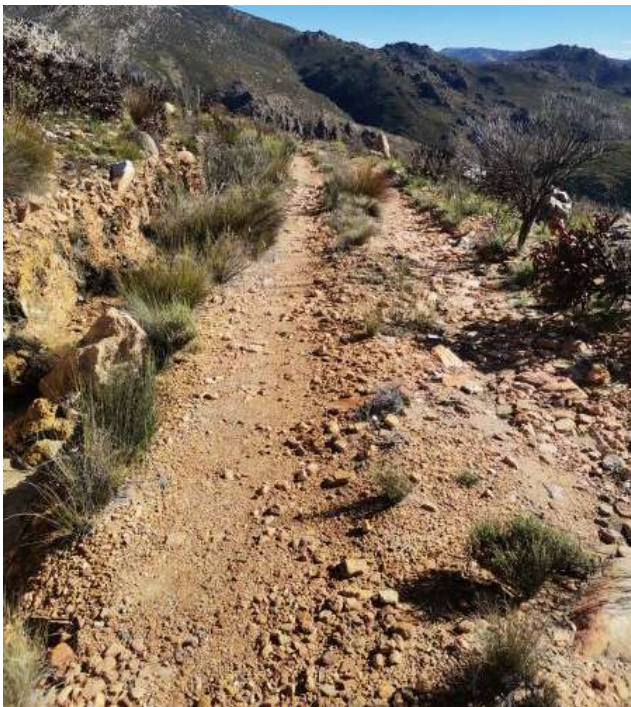
Figure 25: Photo 84, road in good condition.
Reshaping of humps required.

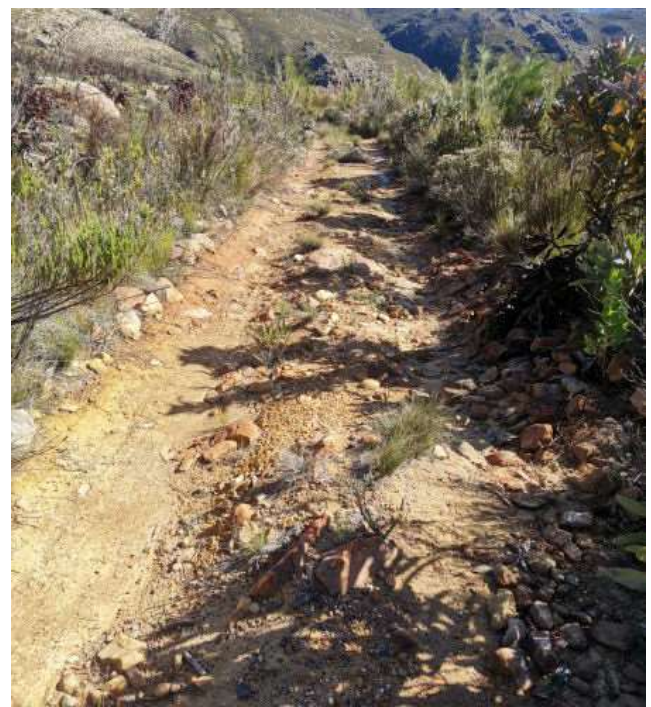
Figure 26: Photo 87, road in average condition.
Reshaping of humps required.

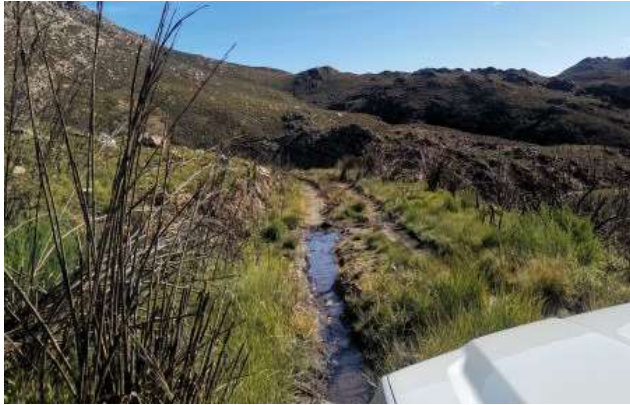
Figure 27: Photo 90, road is in average condition. There's standing water on wheel tracks due to poor stormwater drainage.

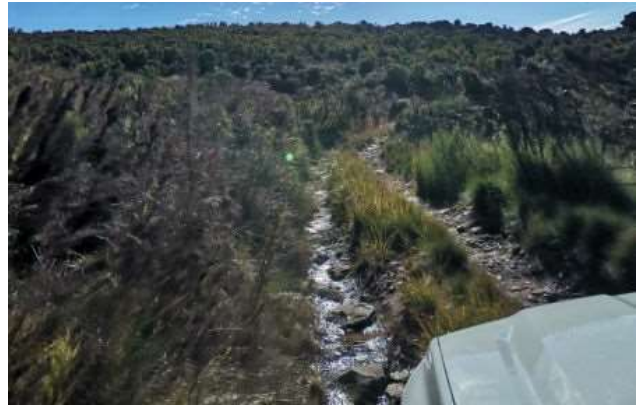
Figure 28: Photo 91, the road is in poor condition. Wheel tracks eroded, rocks exposed and water standing in wheel tracks.

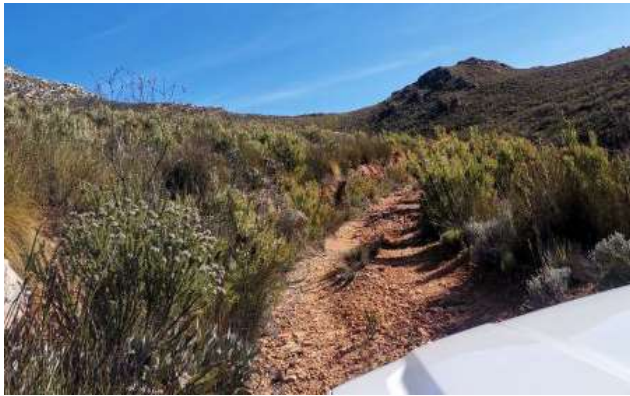
Figure 29: Photo 98, road in average condition. Reshaping of humps required.

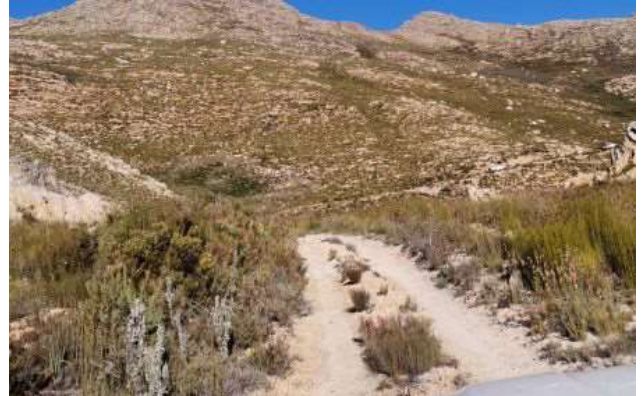
Figure 30: Photo 114, road in excellent condition. No remedial action needed.

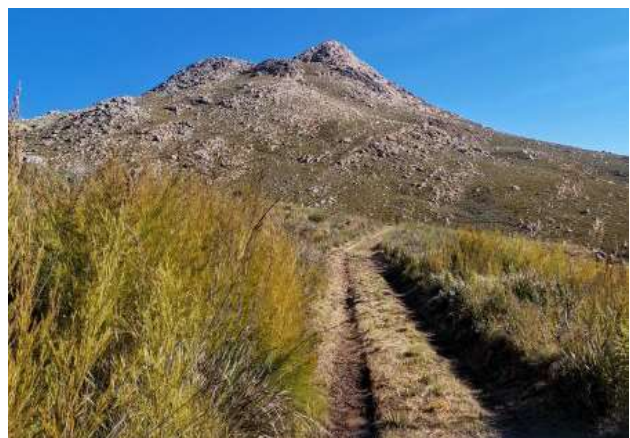
Figure 31: Photo 126, Road in excellent condition.
