Maintenance Management Plan for the Bigai River Floodplain, Knysna, Western Cape.

Prepared for: Knysna Municipality

May 2023 (updated September/December 2023)

of **Confluent Environmental (Pty) Ltd**

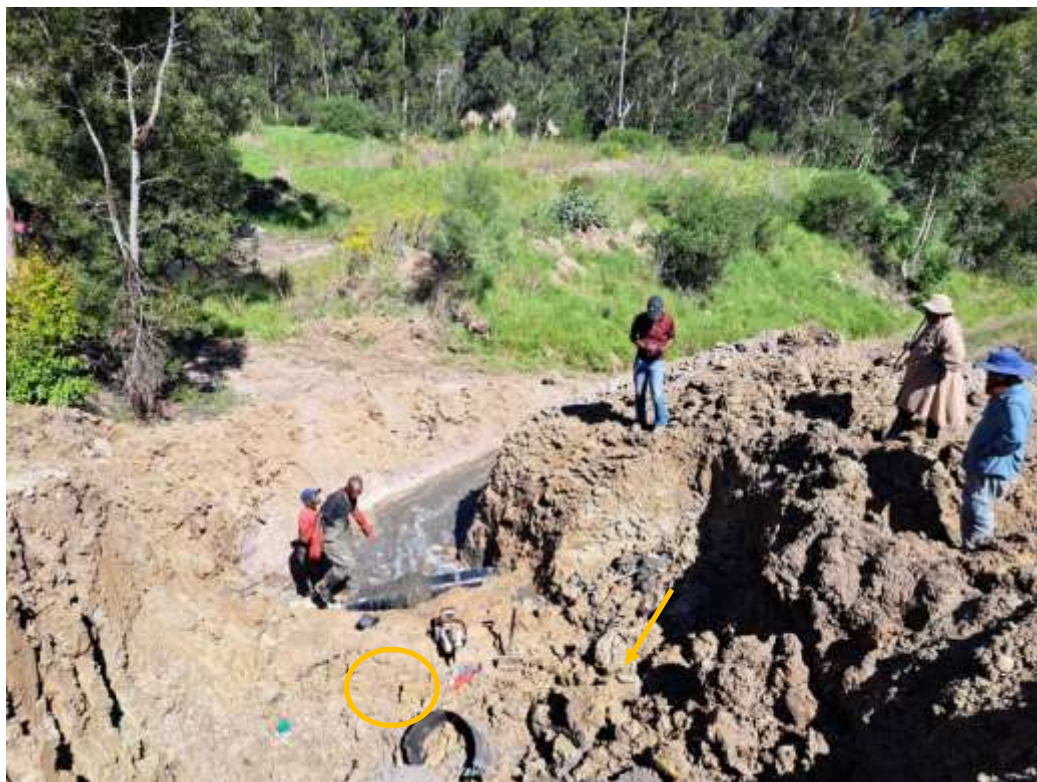
Figure 9. Photo taken on 31 March 2023 of a bulk sewerline that was opened to remove a blockage due to a walking crutch (arrow). Raw sewage and silt flowed straight downslope into the Bigai Wetland.

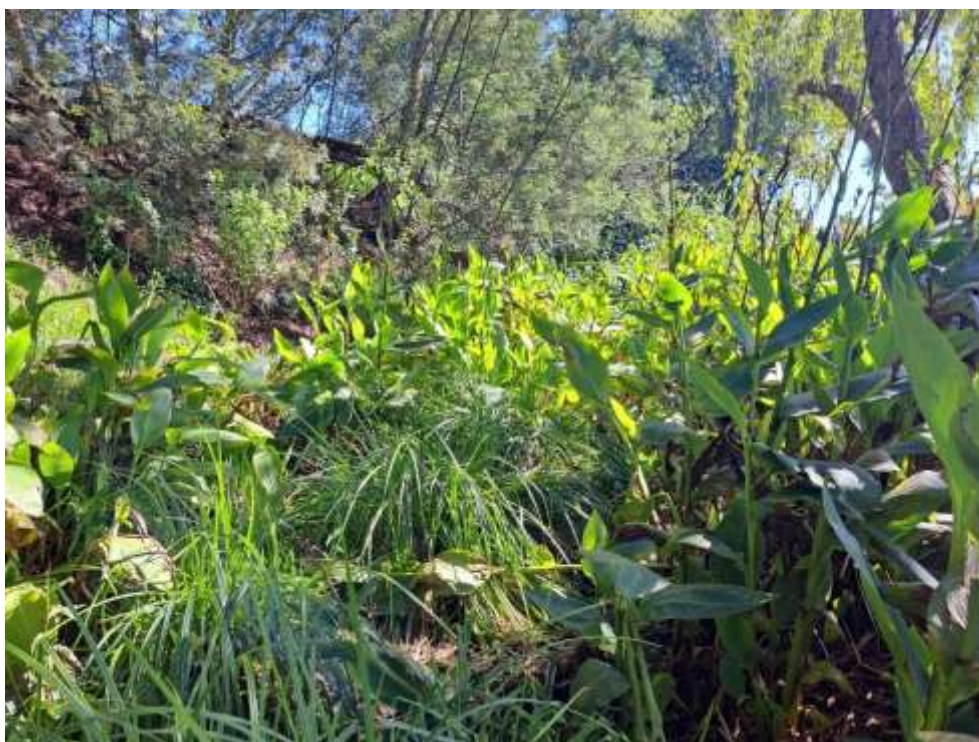
Figure 14. An example of extensive stands of alien vegetation in the drainage channel (*Canna indica*) and above on the flood berm (*Acacia mearnsii*) at the golf course.

Such trees must be cut and the stumps treated with a registered herbicide (gel type is good as it does not dribble or spread easily). Woody material must not be discarded into the Bigai River or into the artificial drainage channel.

Wherever alien plants listed in Table 2 are encountered during maintenance operations in this MMP, these **plants must be physically removed** or controlled using recognised best practice methods. However, herbicides may be used within wetland areas due to high risk of impacting aquatic life. **Ring barking is a good alternative** for larger trees in wetland areas.

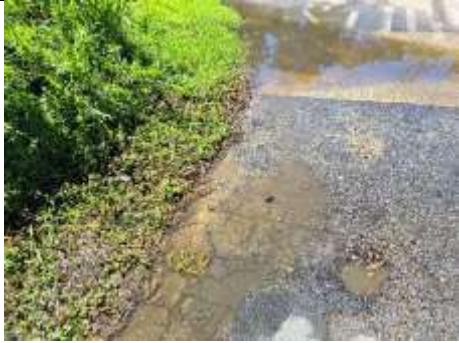
| No. | Location | Photo | GPS Coordinate | Description | Maintenance Actions |
|---|---|--|---|--|---|
| 1 | Kennet Street Street Parcel RE/2090 | | 34° 3'32.50"S, 23° 4'50.66"E | Culvert. Water pushing up (observable flow) through the road surface | <ul style="list-style-type: none"> Investigate presence of culvert either side of the road. If present, the culvert must be cleared by hand of vegetation, sediment & litter. Area of clearance is along the length of each culvert plus a metre either side, to the depth of the concrete, and 2 m into the wetland. Sediment may be used by the golf course for landscaping excluding water features. |

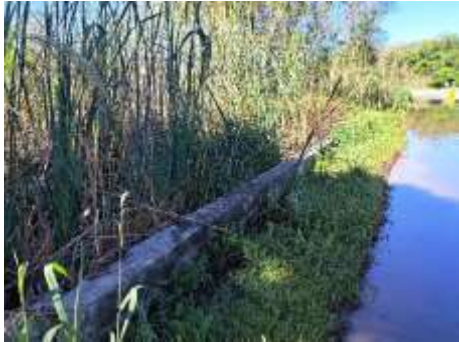
| No. | Location | Photo | GPS Coordinate | Description | Maintenance Actions |
|---|---|--|---|--|---|
| 2 | Howard Street 2 culverts up and downstream 10m and 4m in length Street Parcel RE/2090 | | 4 m culvert: 34° 3'31.13"S, 23° 4'49.43"E & 10m culvert: 34° 3'30.68"S, 23° 4'48.46"E | Culverts completely covered by vegetation and silt up and downstream of the road crossing. | <ul style="list-style-type: none"> Vegetation and sediment must be cleared by hand or using a small excavator positioned on the road. Area of clearance is along the length of each culvert plus a meter either side (12m and 6m respectively), to the depth of the concrete, and 2 m into the wetland. Sediment may be used by the golf course for landscaping excluding water features. |

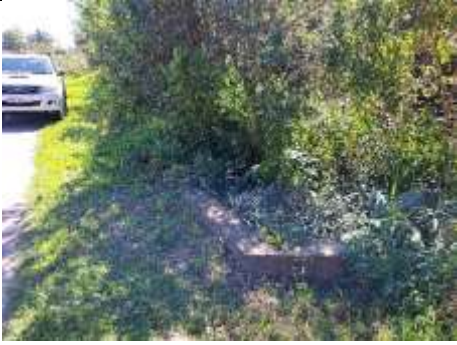
| <p>3</p> | <p>Howard Street Street Parcel RE/2090</p> | | <p>34° 3'32.28"S, 23° 4'52.47"E</p> | <p>2 m culvert blocked by vegetation and silt on both sides of the road.</p> | <ul style="list-style-type: none"> • Vegetation and sediment must be cleared by hand. • Area of clearance is along the length of each culvert plus a metre either side, to the depth of the concrete, and 2 m into the wetland. • Sediment may be used by the golf course for landscaping excluding water features. |

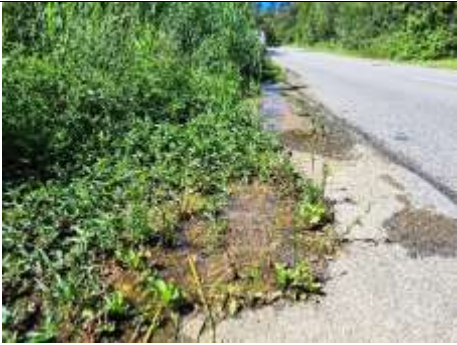
| <p>4</p> | <p>Howard Street Street Parcel RE/2090</p> | | <p>34° 3'31.59"S, 23° 5'7.39"E</p> | <p><u>Possible</u> culvert blockage. Water standing on surface and draining onto road. Vegetation growing on road.</p> | <ul style="list-style-type: none"> • Investigate presence of culvert either side of the road. • If present, the culvert must be cleared by hand of vegetation, sediment & litter. • Area of clearance is along the length of each culvert plus a metre either side, to the depth of the concrete, and 2 m into the wetland. • Sediment may be used by the golf course for landscaping excluding water features. |

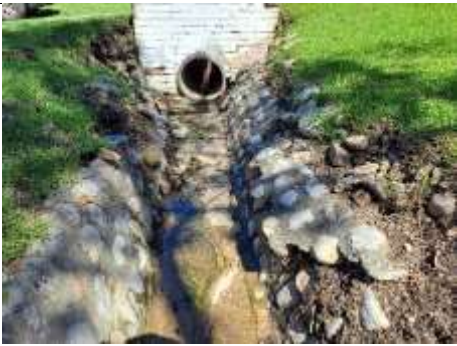
| <p>5</p> | <p>Howard Street Street Parcel RE/2090</p> | | <p>34° 3'29.99"S, 23° 5'14.82"E</p> | <p>Culvert sides breaking apart. Require repairs. Culvert partially blocked with silt further down.</p> | <ul style="list-style-type: none"> • Not in a watercourse but needs repair work as the cement sides are breaking apart and siltation has occurred in the pipe. <ul style="list-style-type: none"> • Silt must be cleared out the pipe. |

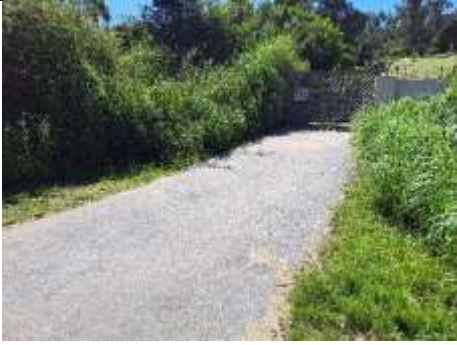
| <p>6</p> | <p>62 Howard Street Street Parcel RE/2090</p> | | <p>34° 3'29.60"S, 23° 5'12.58"E</p> | <p>Culvert beneath driveway requires vegetation and silt clearance</p> | <ul style="list-style-type: none"> • Vegetation and sediment must be cleared by hand. • Area of clearance is along the length of each culvert plus a metre either side, to the depth of the concrete, and 2 m into the wetland. |

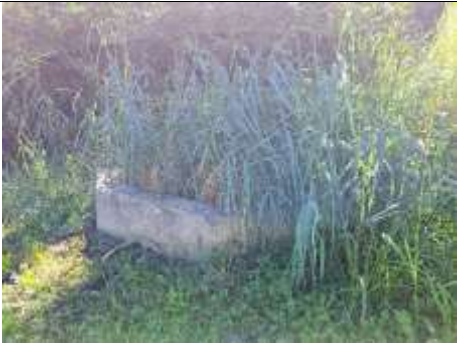
| <p>7</p> | <p>Thesen Street Street Parcel RE/2090</p> | | <p>34° 3'29.32"S 23° 5'4.79"E</p> | <p>2 m culvert blocked with vegetation and silt which must be removed.</p> | <ul style="list-style-type: none"> • Vegetation and sediment must be cleared by hand. • Area of clearance is along the length of each culvert plus a metre either side, to the depth of the concrete, and 2 m into the wetland. • Sediment may be used by the golf course for landscaping excluding water features. |

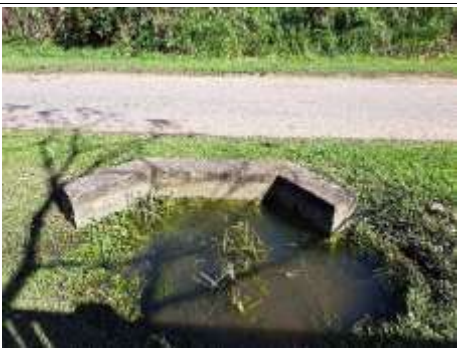
| <p>8</p> | <p>Thesen Street Street Parcel RE/2090</p> | | <p>34° 3'27.01"S, 23° 4'48.45"E</p> | <p>1 m Culvert is silted up and not draining beneath the road and into the wetland opposite. Both culvert sides to be cleared of silt and vegetation.</p> | <ul style="list-style-type: none"> • Vegetation and sediment must be cleared by hand. • Area of clearance is along the length of each culvert plus a metre either side, to the depth of the concrete, and 2 m into the wetland. • Sediment may be used by the golf course for landscaping excluding water features. |

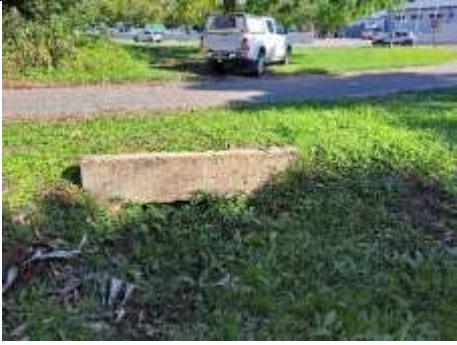
| <p>9</p> | <p>Thesen Street Street Parcel RE/2090</p> | | <p>34° 3'27.89"S, 23° 4'44.54"E</p> | <p>2 m culvert is silted up and full of vegetation which must be cleared to restore flow conveyance.</p> | <ul style="list-style-type: none"> • Vegetation and sediment must be cleared by hand. • Area of clearance is along the length of each culvert plus a metre either side, to the depth of the concrete, and 2 m into the wetland. • Sediment may be used by the golf course for landscaping excluding water features. |

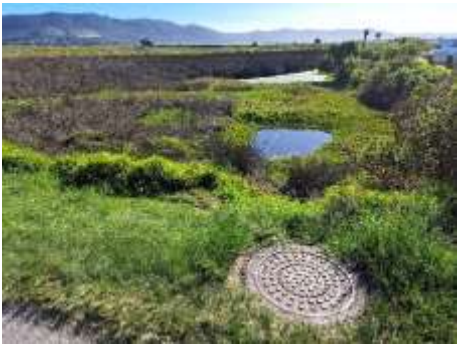
| <p>10</p> | <p>George Rex Drive Street Parcel RE/2090</p> | | <p>34° 3'12.94"S, 23° 4'11.06"E</p> | <p>Culvert must be checked for flow conveyance. The invert level may be too high and require lowering. Silt and vegetation must be cleared if necessary.</p> | <ul style="list-style-type: none"> • Vegetation and sediment must be cleared by hand. • Area of clearance is along the length of each culvert plus a metre either side, to the depth of the concrete, and 2 m into the wetland. • Sediment may be used by the golf course for landscaping excluding water features. • As soon as the culvert is cleared, a silt fence must be installed on the estuary side of the culvert to prevent excessive siltation from entering the estuary. |

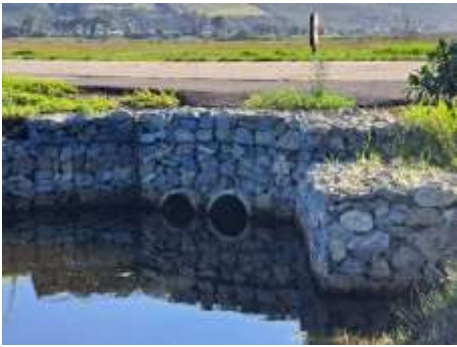
| <p>11</p> | <p>George Rex Drive Street Parcel RE/2090</p> | | <p>34° 3'20.34"S, 23° 4'10.73"E</p> | <p>Culvert recently upgraded and functioning well. May require periodic clearance of silt and vegetation reducing conveyance.</p> | <ul style="list-style-type: none"> • If flows are blocked in either direction it is necessary to clear vegetation, silt and litter from the culvert by hand. • Area of clearance is aligned with the gabions, plus a metre either side, to the depth of the gabions and 2 m into the wetland / estuary. • Sediment may be used by the golf course for landscaping including water features. • As soon as the culvert is cleared, a silt fence must be installed on the estuary side of the culvert to prevent excessive siltation from entering the estuary. |

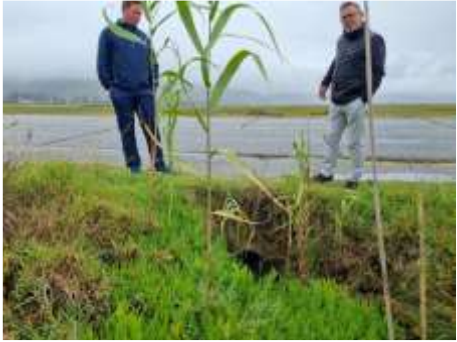
| <p>12</p> | <p>George Rex Drive Street Parcel RE/2090</p> | | <p>34° 3'30.62"S, 23° 4'10.14"E</p> | <p>Culvert currently blocked and requires periodic clearance of vegetation and silt.</p> | <ul style="list-style-type: none"> • Vegetation and sediment must be cleared by hand. • Area of clearance is along the length of each culvert plus a metre either side, to the depth of the concrete, and 2 m into the wetland/estuary. • Sediment may be used by the golf course for landscaping excluding water features. • As soon as the culvert is cleared, a silt fence must be installed on the estuary side of the culvert to prevent excessive siltation from entering the estuary. |

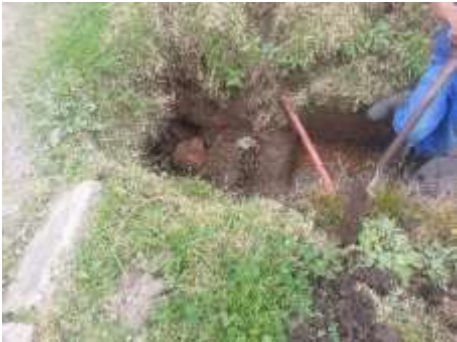
| <p>13</p> | <p>George Rex Drive Street Parcel RE/2090</p> | | <p>34° 3'11.37"S 23° 4'11.40"E</p> | <p>Culvert pictured when it was last cleared in 2015, it is now blocked and needs to be cleared of silt again. Visible pipes are fibre cables and a water pipe.</p> | <ul style="list-style-type: none"> • Vegetation and sediment must be cleared by hand. • Area of clearance is along the length of each culvert plus a metre either side, to the depth of the concrete, and 2 m into the wetland/estuary. • Sediment may be used by the golf course for landscaping excluding water features. • As soon as the culvert is cleared, a silt fence must be installed on the estuary side of the culvert to prevent excessive siltation from entering the estuary. |

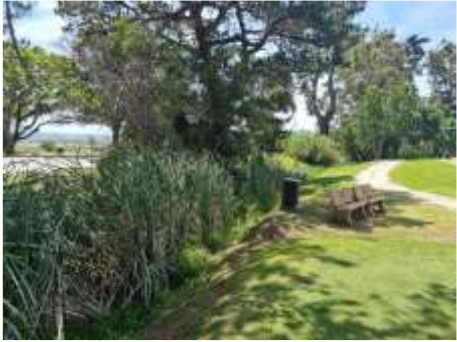
| <p>14</p> | <p>Golf course 9th hole drainage channel (artificial) Erf 2233</p> | | <p>900 m length from: 34° 3'33.03"S, 23° 4'44.66"E To 34° 3'35.83"S, 23° 4'11.96"E</p> | <p>Historical artificial channel that drains water off the 9th hole has silted up and requires sediment and vegetation removal.</p> | <ul style="list-style-type: none"> • Check the weather forecast and plan work for a dry spell lasting at least a week. • Excavate silt and vegetation in the direction from upstream to downstream. • Clearance can be by hand and/or a small excavator positioned on the adjacent fairway. • Clear silt and vegetation from the channel, measuring 2 m wide and 50-80 cm deep. • Ensure the channel is graded in a gentle slope in a downstream direction. • Clear 100m per week over 5 weeks. In this manner disturbance to wildlife will be minimised. • Alien plants should be removed during this process and include Canna lilies (<i>Canna indica</i>). <ul style="list-style-type: none"> • Cleared sediment can be used for landscaping outside of water features by the golf course. • Ensure excavator has no leaks and is in good working order. • All workers must dispose of litter or waste in bins and must not damage or pollute the drainage channel. |

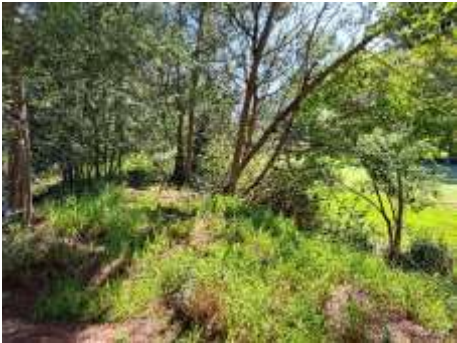
| <p>14</p> | <p>Golf course flood protection berm between 9th hole and Bigai Wetland Erf 2233</p> | | <p>500 m length from 34° 3'33.03"S, 23° 4'44.66"E To 34° 3'39.76"S, 23° 4'27.74"E</p> | <p>Historical soil berm built to reduce flooding on golf course. Has numerous black wattles which must be removed.</p> | <ul style="list-style-type: none"> • Large black wattles (<i>Acacia mearnsii</i>) and Blackwood (<i>Acacia melanoxylon</i>) must be cut down and the stumps painted with gel-type herbicide registered for use, not a foliar spray. • Smaller trees can be hand-pulled or removed including roots using a Tree Popper. • Remove all cut biomass from the site and dispose of it at an appropriate green waste site. No material must be discarded in the Bigai Wetland or the drainage channel on either side of the berm. • Aim to achieve a minimum of 80% vegetation cover on the berm. |

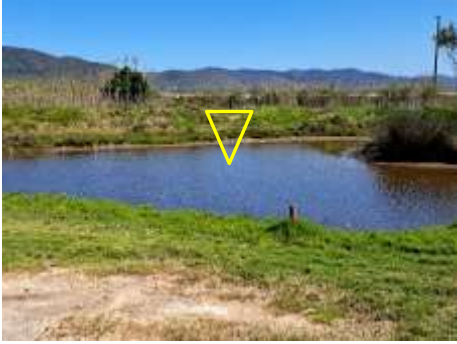
| <p>16</p> | <p>Knysna Golf Course adjacent to George Rex Drive, this channel is adjacent to the above culvert. Erf 2232</p> | | <p>34° 3'29.76"S 23° 4'11.43"E</p> | <p>A small embankment of sand and vegetation cuts off the internal from the external channel. A notch (yellow) of approximately 4m³ needs to be excavated to improve flow.</p> | <ul style="list-style-type: none"> • Dig out a section of 4 m³ of sediment in the embankment to improve through-flow between the drainage channel and the culvert leading to the estuary. <ul style="list-style-type: none"> • Digging must be done by hand. • Sediment can be used for landscaping in the golf course outside of water features. |

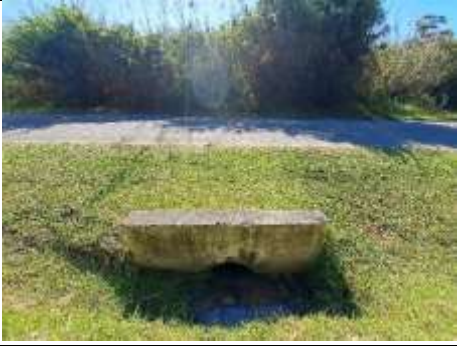
| <p>17</p> | <p>Kennet Street Street Parcel RE/2090</p> | | <p>34° 3'38.45"S, 23° 4'38.68"E</p> | <p>1 m culvert blocked with silt which must be excavated until the bottom later of concrete has been reached on both sides.</p> | <ul style="list-style-type: none"> • Vegetation and sediment must be cleared by hand. • Area of clearance is along the length of each culvert plus a metre either side, to the depth of the concrete, and 2 m into the wetland downstream. • Sediment may be used by the golf course for landscaping excluding water features. |

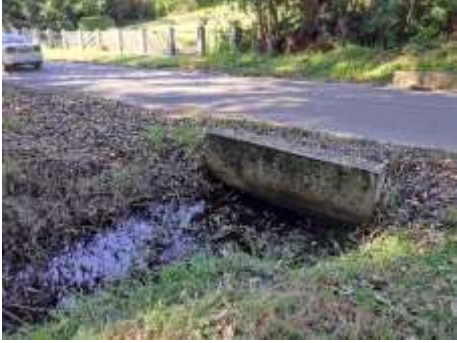
| <p>18</p> | <p>Howard Street Street Parcel RE/2090</p> | | <p>34° 3'24.40"S, 23° 4'35.94"E</p> | <p>1 m culvert leading to the golf course needs to be cleared of silt and vegetation on both sides of the road.</p> | <ul style="list-style-type: none"> • Vegetation and sediment can be cleared by hand or using a small excavator working from the road. • Area of clearance is along the length of each culvert plus a metre either side, to the depth of the concrete, clearing can follow the channel as long as necessary to reach the drainage channel on the golf course perimeter. • Cleared sediment may be used by the golf course for landscaping excluding water features. |

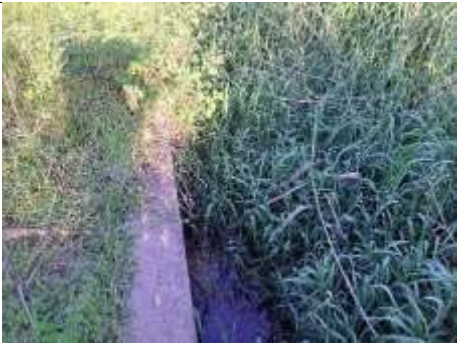
| <p>19</p> | <p>Wilson Street Street Parcel RE/2090</p> | | <p>34° 3'42.07"S, 23° 4'32.60"E</p> | <p>12m length Culvert under Wilson Street blocked with sediment and vegetation restricting flow.</p> | <ul style="list-style-type: none"> • Vegetation and sediment must be cleared by hand or using a small excavator positioned on the road. • Area of clearance is along the length of each culvert plus a meter either side (14m), to the depth of the concrete, and 2 m into the wetland. • Sediment may be used by the golf course for landscaping excluding water features. |

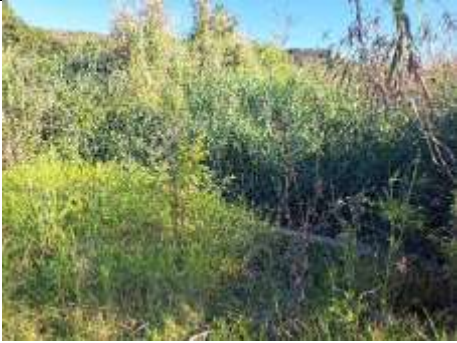
| <p>20</p> | <p>Wilson Street Street Parcel RE/2090</p> | | <p>34° 3'41.41"S, 23° 4'30.51"E</p> | <p>Culvert beneath Wilson street blocked with silt and vegetation restricting water flows.</p> | <ul style="list-style-type: none"> • Vegetation and sediment must be cleared by hand or using a small excavator positioned on the road. • Area of clearance is along the length of each culvert plus a meter either side (14m), to the depth of the concrete, and 2 m into the wetland. <p>Sediment may be used by the golf course for landscaping excluding water features.</p> |
