**Aquatic assessment in terms of Section 24G of NEMA application  
for Bosse Dam, Lower Schoonberg Farm, Western Cape**

**Prepared by: Dr. Jackie Dabrowski of Confluent Environmental (Pty) Ltd**

**For: Cape EAPrac**

**November 2019, updated April, 2021**

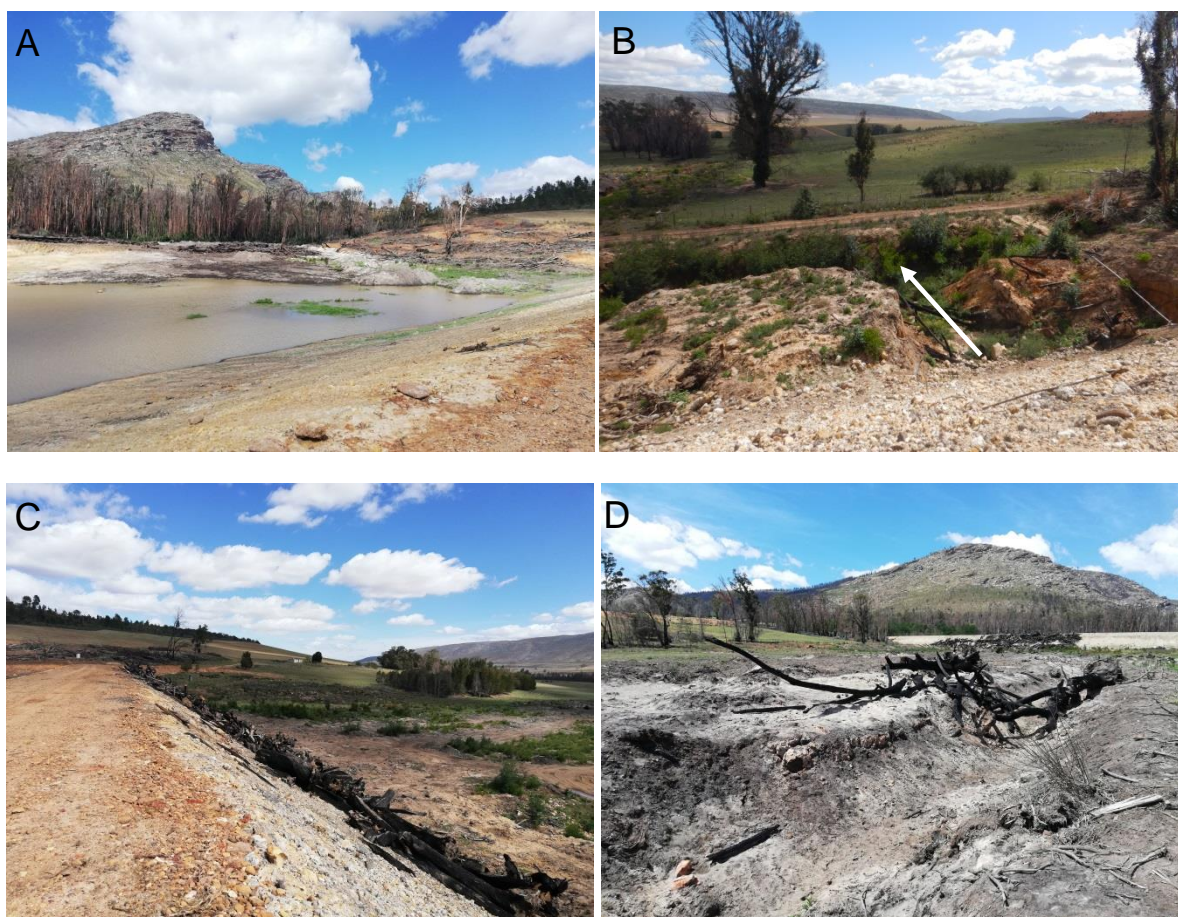
Figure 1. Photos depicting various aspects of the Bosse dam clearance and related activities, including: A) Clearing of vegetation and removal of excess sediment from the dam basin; B) the original spillway below the embankment, where erosion and under-cutting of the banks has occurred (white arrow); C) the repaired dam embankment showing burnt stumps placed for erosion control; and D) burnt trees in the watercourse channel, below the embankment (used with sediment for infilling).

- The dam embankment which is 1:2 upstream and 1:1.5 downstream. This is relatively steep for the type of material used in construction and may render the embankment more susceptible to erosion.
- Burnt tree stumps placed on the downstream slope encourage, rather than prevent erosion, and should be removed.
- The new spillway is an uncontrolled by-wash channel with no formal return channel to a natural watercourse, and will probably result in erosion along the left flank during overflow events.

Currently the dam embankment is steep, without vegetation cover, and had numerous large burnt tree trunks placed on it. All of these factors increase the susceptibility of the embankment to erosion which will compromise dam safety and further degrade the watercourse downstream.

- Burnt tree trunks should not be placed on the dam embankment, and should be removed immediately.
- The embankment should be re-vegetated using an appropriate grass cover by hydro-seeding or by hand if necessary. Compaction, exposure and the arid climate may reduce the speed and success of re-vegetation, and therefore grass may require additional support to establish. It will be important to consider:

- Burnt tree trunks should not be placed on the dam embankment, and should be removed;
- The dam embankment should be re-vegetated using an appropriate indigenous grass cover by hydro-seeding or by hand if necessary;

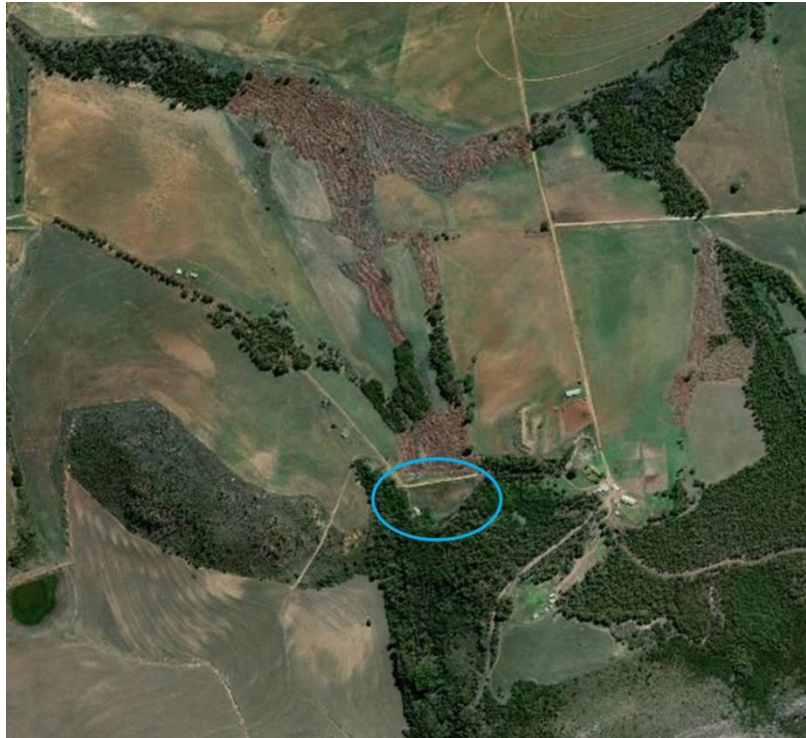
Between the end of October 2018 and January 2019 the vegetation bordering the dam, as well as the full extent of riparian vegetation below the dam along the watercourse flowing into the Brak River, has been cleared (Figure 7 and Figure 8). According to the land-owners, this vegetation mostly consisted of alien plants such as *Eucalyptus*, which was burnt in a wild-fire towards the end of 2018. Some of the excavated sediment from the dam and the burnt plant material has been used as infill along the watercourse, and the original watercourse downstream of the embankment cannot be easily distinguished.

Figure 8. Bosse Dam (blue) showing the commencement of clearing in **November 2018**.

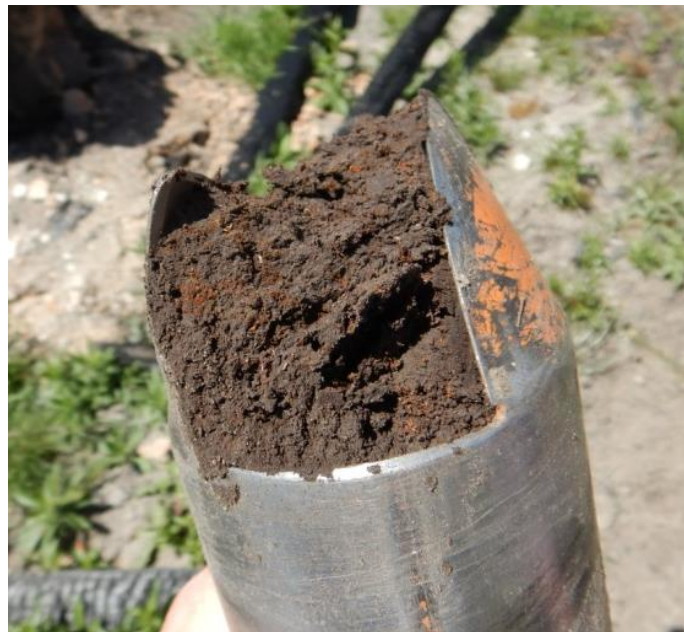
Hydromorphic soils display characteristics resulting from prolonged and repeated saturation which leads to variable states of oxidation. One of the indicators that soil has been subject to a seasonally fluctuating water table (associated with a wetland) is the presence of mottling. Mottling occurs when soils alternate between aerobic (unsaturated) and anaerobic (saturated) states. Iron is dissolved under anaerobic conditions, but is oxidised during aerobic conditions forming bright reddish-orange insoluble iron compounds. Soil augering was conducted at multiple points along the Suikerboslaagte and Brak Streams, and hydromorphic soils were identified along the full length of both watercourses assessed (Figure 10). This indicates a seasonally inundated wetland area.

Figure 10. Soil auger sample from the area downstream of the dam embankment along the Suikerboslaagte Stream.

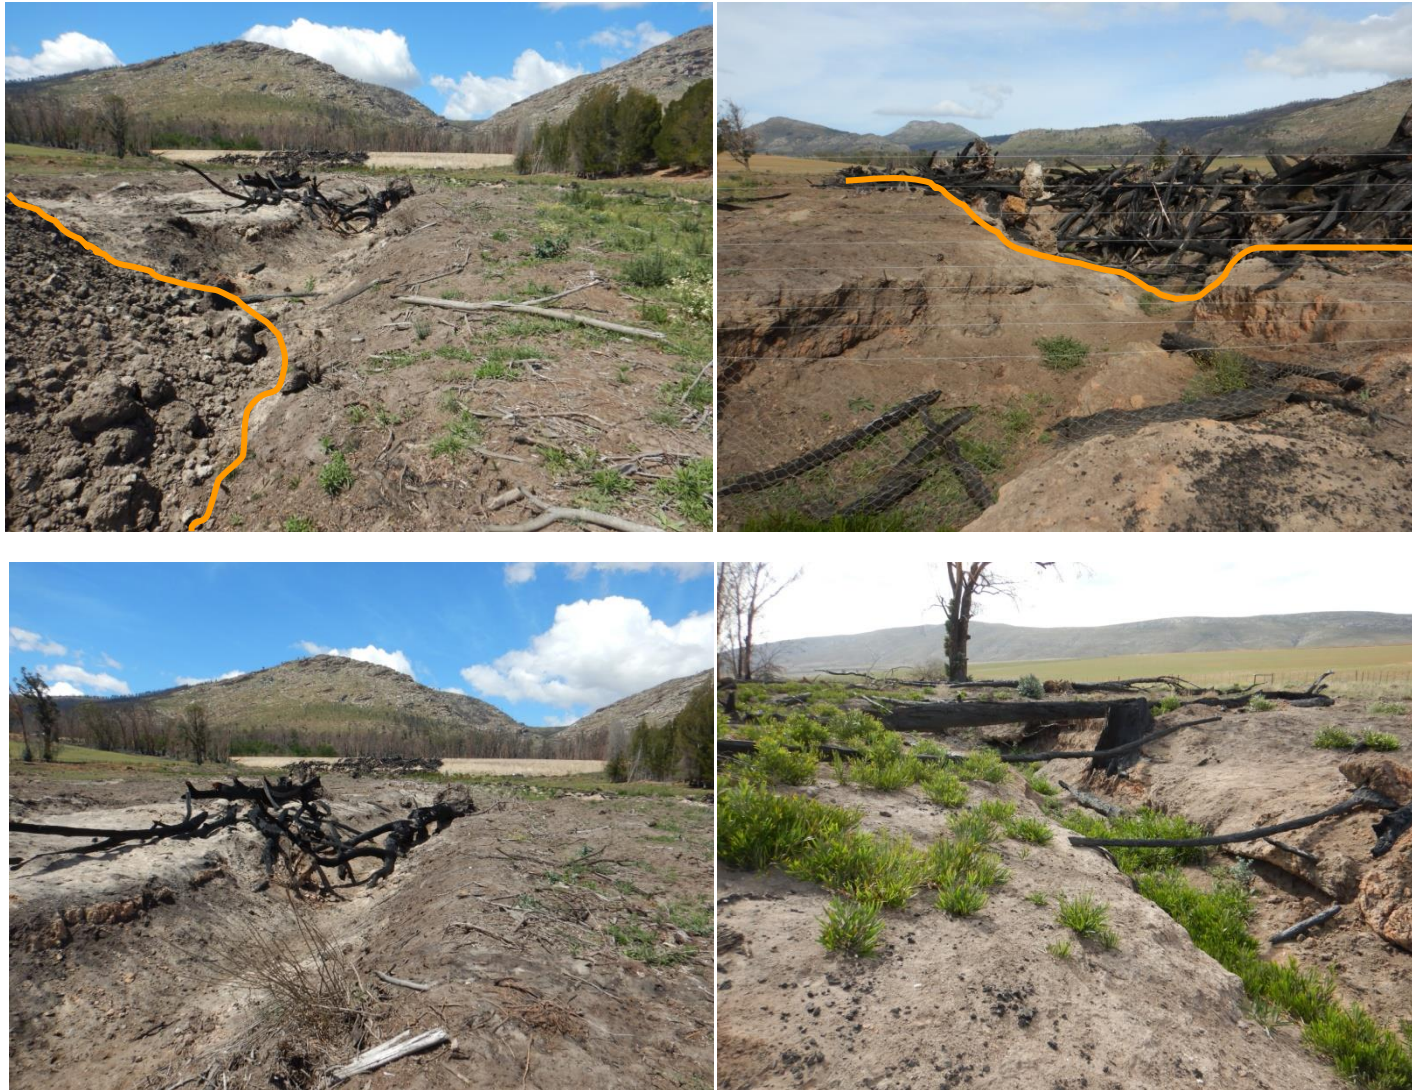
The overall PES was classified as **E, Seriously Modified** (Table 6). This is one category lower than the desktop PES which classified the Brak River as D, Largely Modified. The major change from the pre-cleared state of the wetland is the removal of (mostly alien) vegetation, infilling and levelling of the land in the vicinity of the wetlands (Figure 11). Prior to clearing activities, the Hydrology and Vegetation components would have had a similar score to the present state (Table 6), as the highest impact would have been related to alien vegetation which has now been removed, but replaced with the new impact of infilling. The Geomorphology component has likely decreased from its prior score because infilling has more of an impact on this aspect than the presence of alien vegetation. It is therefore likely that the overall PES has not changed substantially from the original (pre-clearing) state, but that the dominant impacts have changed. Most importantly, the reversibility of the impacts differs substantially because while established methods of alien vegetation control can be applied to manage and improve the watercourse, infilling is more difficult to reverse.

Figure 11. Photos of the Suikerboslaagte (left) and Brak (right) Streams showing infilled sections (above, yellow) and channelled sections (below)

**It is recommended that the PES be improved to D, Largely Modified.**

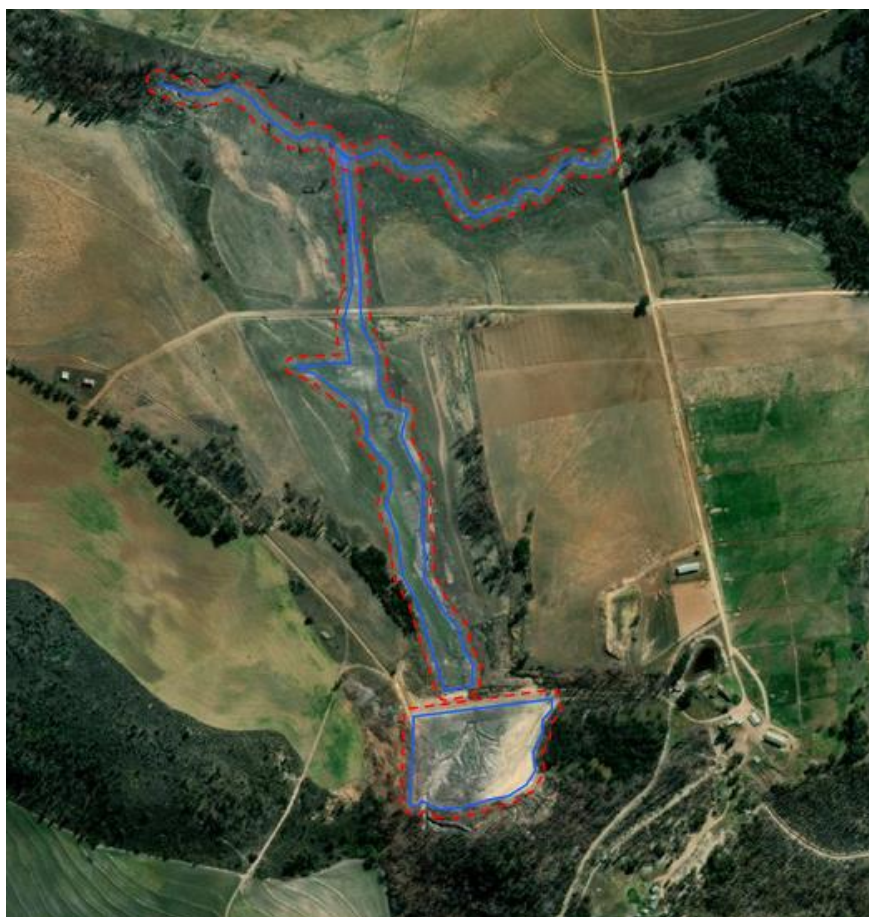
Figure 13. Proposed buffer corridors for the Bosse Dam, Suikerboslaagte (15 m) and Brak (20 m) Streams. Buffers are along the best estimation of the natural path of the watercourse.

- Heavy machinery must never be permitted in the buffer zone;
- The length of the buffer zone should be fenced with a single electric strand to prevent access by livestock, but allow for the movement of aquatic associated fauna like otters and water mongoose for instance;
- The channel should be allowed to reform naturally in the landscape, and if it deviates significantly from the selected corridor then fencing should be re-routed to maintain the buffered area around the watercourse;
- Alien vegetation must be strictly controlled within the buffer zone in order to prevent re-establishment;
- The length of the buffered area must be inspected after every overspill or heavy rainfall event to check for erosion hotspots and the appearance of a channel;
- The spillway needs to be checked after every overspill or heavy rainfall to check for erosion which must be addressed if it occurs.

The recommended buffer zone around the **Bosse Dam and Suikerboslaagte Stream is 15 m**, and around the **Brak Stream is 20 m**. The wetland area of the Suikerboslaagte is becoming more evident through satellite imagery, and therefore the buffer is 15 m from the delineated edge of the wetland (Figure 13). Whereas the buffer for the Brak Stream is 20 m measured from the channel as wetland features are less distinct.
