PO Box 10865, George, 6530 Email: jan@janbrink.co.za Our reference: JB2049-02 Your reference: Bosse Dam 2020-10-03

RE-ASSESSMENT OF BOSSE DAM SURVEY, SCHOONBERG FARM

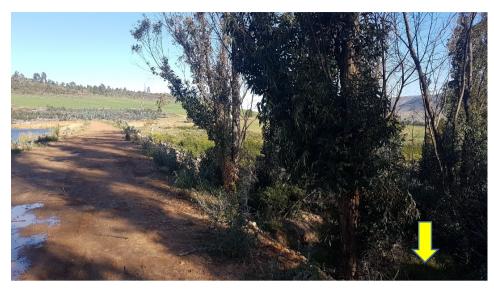
The dam's original spillway was located on the right flank, but the owner elected to move it to the left. Currently there is only a small trench visible downstream of the dam wall in the vicinity of the old spillway and it is difficult to obtain any levels of the original spillway as it is now covered by the fill of the new embankment (see Figure 1).

As the old spillway and full supply level could not be determined, it was not possible to make an accurate estimate of the original storage capacity. Based on the level of the remainder of the downstream return channel of the old spillway, a rough FSL of 603,500 m may be extrapolated. This would indicate a capacity of approximately 134 000 m³, which is ±29 000 m³ less than the new capacity.

Figure 1: Old spillway downstream channel

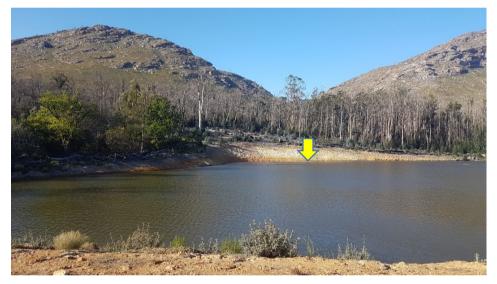
The Contractor for the remedial works estimated that they removed approximately 30 000 m³ of fill material from the basin to be used for the embankment. The bulk of this was, however, excavated above the full supply level and does not contribute significantly to additional storage capacity (see Figure 2).

Figure 2: Excavation of fill for embankment material
