## **ASSESSMENT OF BOSSE DAM, SCHOONBERG FARM**

The undersigned was appointed to provide an assessment on the design and condition of Bosse Dam on the farm Lower Schoonberg 108.

Bosse Dam As-Built

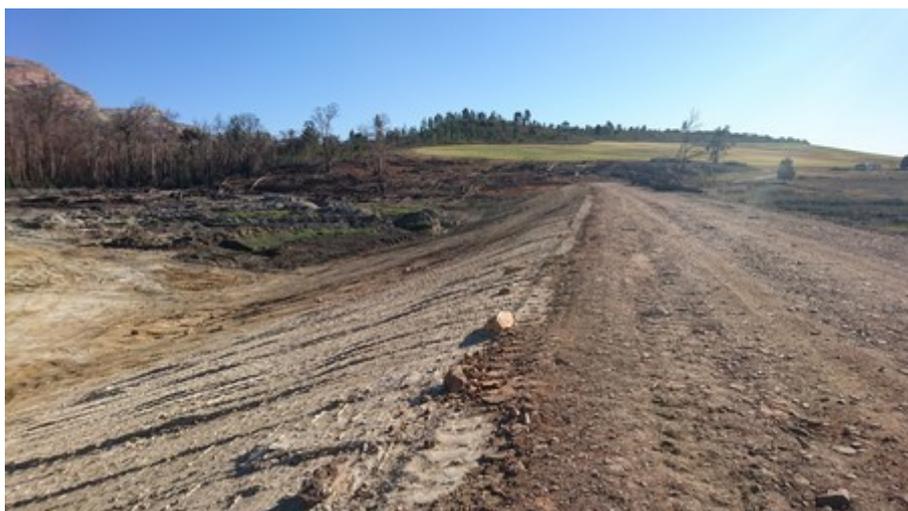
The upstream slope also requires some form of wave erosion protection. Dumped rock riprap provides the best protection, but this is an expensive solution for a relatively small dam. The owner may consider a combination of gravel and/or vegetation and regular maintenance.

**Figure 1: Crest and upstream slope**

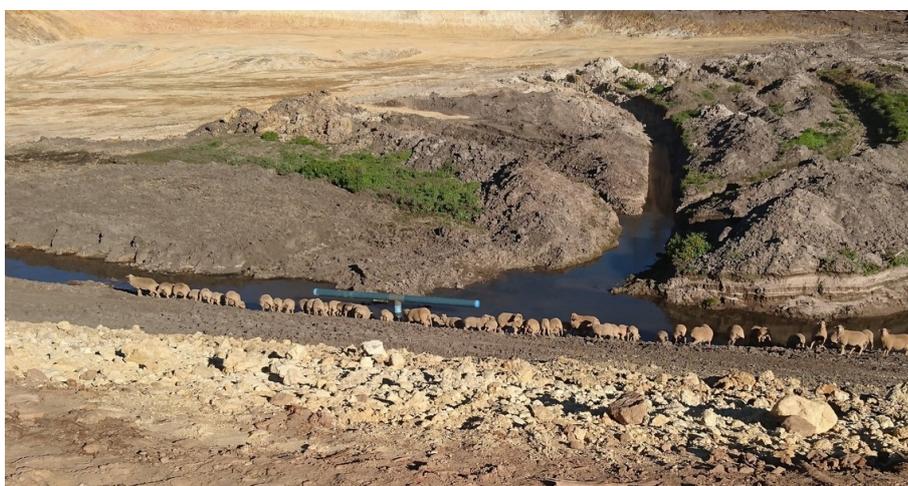
The new outlet pipe is a  $\varnothing$  250 mm Class 9 PVC pipe. The new pipe was placed in a trench through the old embankment that was excavated into reasonably competent material. Three 1,2 m x 2,5 m concrete collars were placed around the pipe in the new water tight zone. A T-piece of perforated similar PVC pipe is used as an intake strainer. It stands approximately 1 m higher than the pipe invert, effectively creating the lowest draw-down level for the dam at 598 m.a.s.l. See Figure 2. Flow control is by means of a gate valve on the downstream end of the pipe.

**Figure 2: T-piece intake strainer**

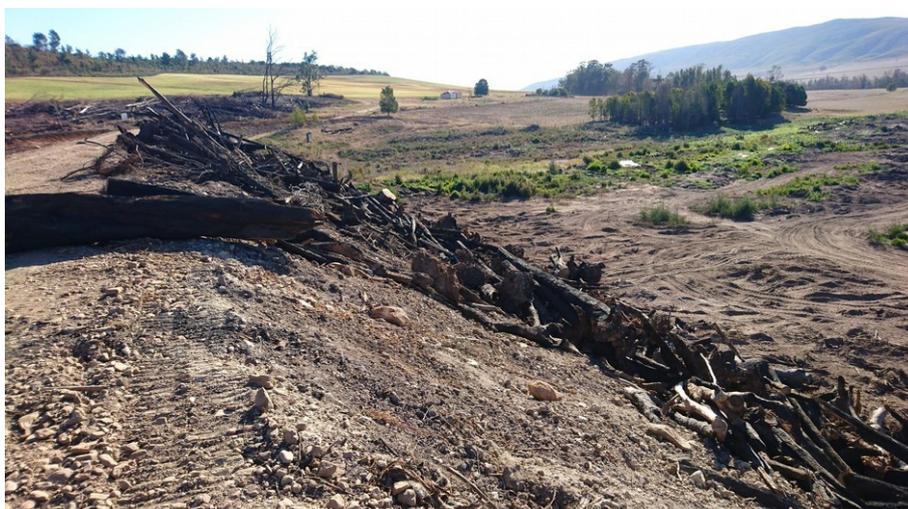
Burnt-out tree stumps were placed against a section of the downstream slope, supposedly to prevent erosion (see Figure 3). Large voids remain below and between the stumps and will hide erosion rather than prevent it. The owner was advised to not proceed with this. It is recommended that the stumps be removed and that other means of erosion protection be employed. The most effective protection of dam embankment slopes is good grass coverage. Grass grow low enough to keep the slope visible for monitoring, but matted root systems provide good erosion resistance.

**Figure 3: Downstream slope with tree stumps**

- The dam should be registered as a Category 1 dam with the Dam Safety Office.
- The extreme floods and spillway capacity should be re-evaluated in greater detail.
- The tree stumps must be removed from the downstream slope and more appropriate erosion protection implemented.
- During the first year the dam must be inspected for erosion damage after every rain storm.
- The spillway and downstream area must be inspected for erosion damage after every spill.

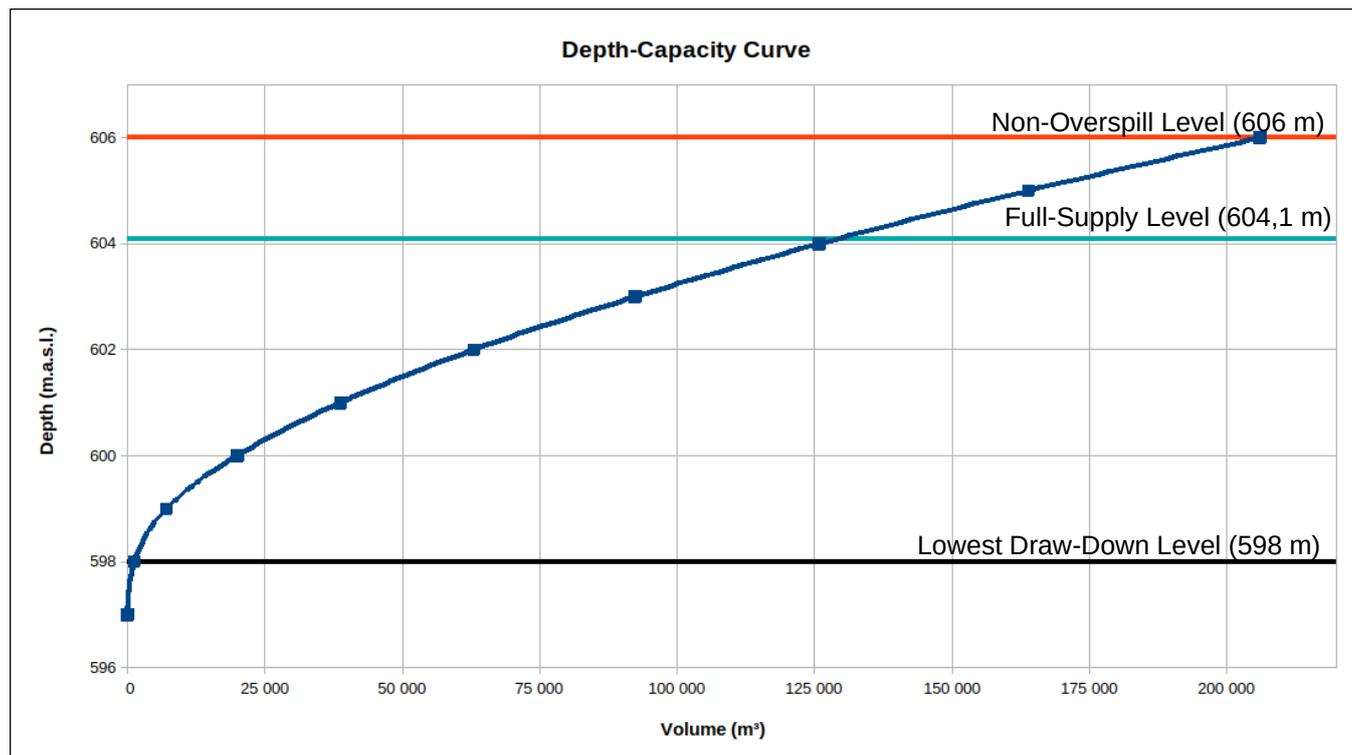
## CAPACITY CURVE

The dam's capacity was calculated by measuring the areas of the contours generated from the survey. This was then used to compile the capacity curve attached to the end of this report. The dam's capacity at full supply level (FSL), i.e. just before water starts flowing over the spillway, is approximately 130 000 m<sup>3</sup>.

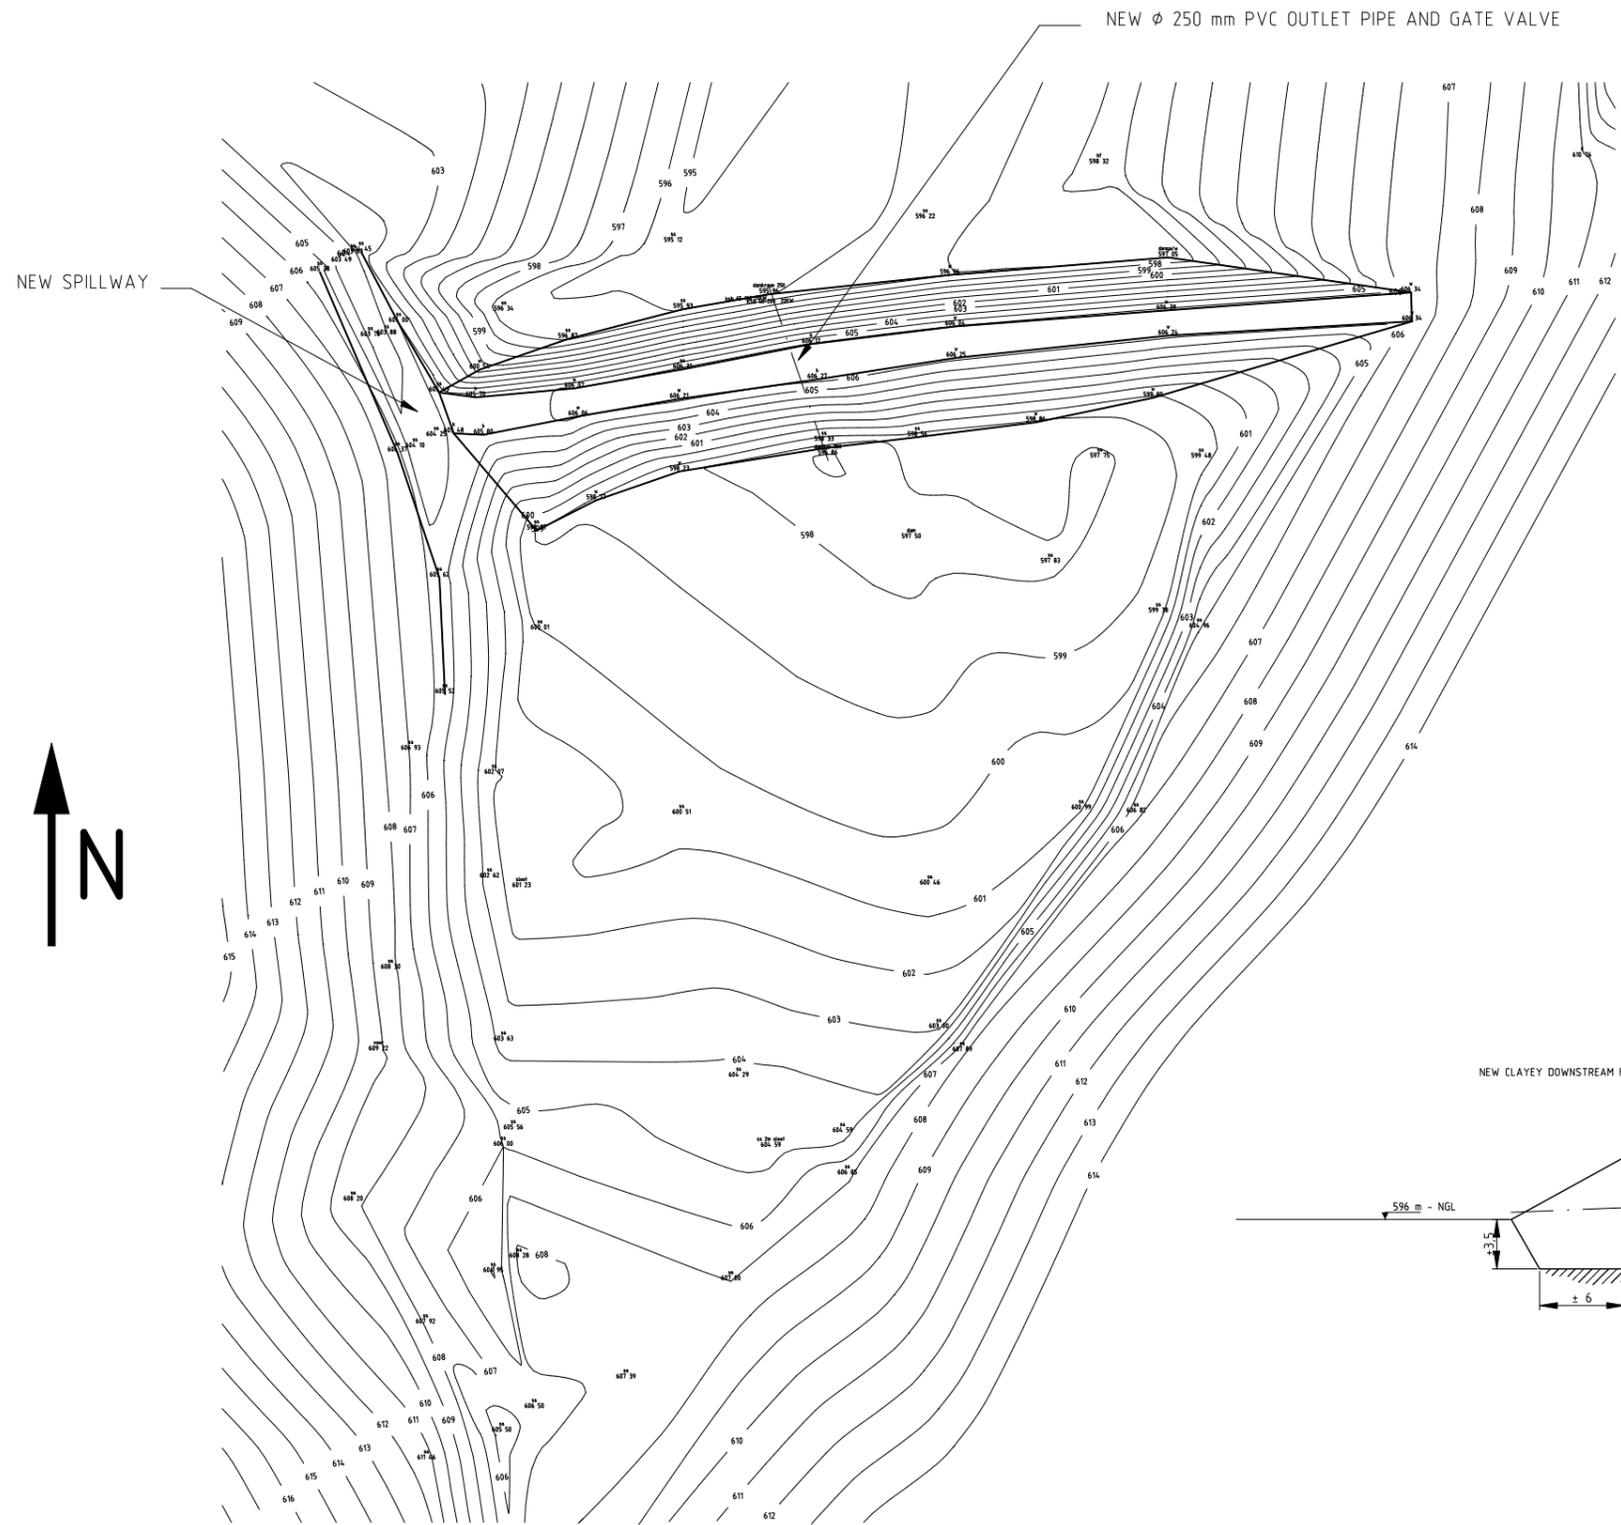
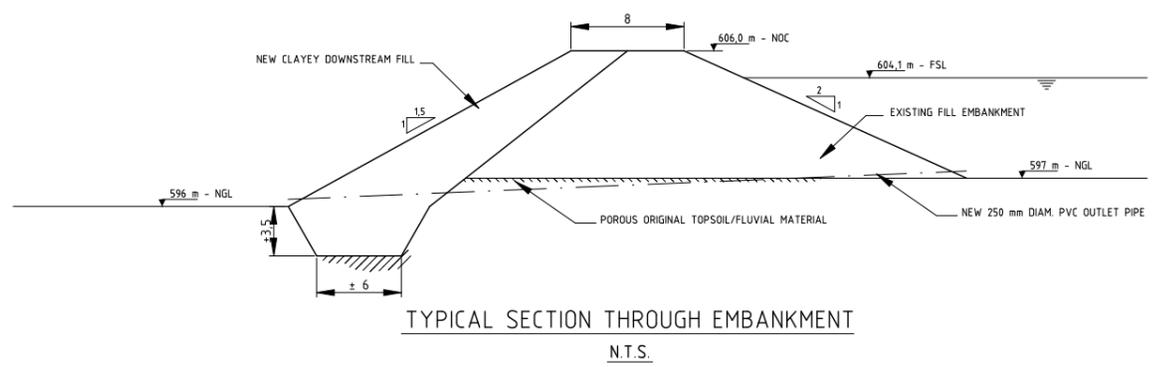
Drw Number	Revision
JB2049-01	00
Date	Drafted
2019-11-14	JAB
Scale	n.f.s.

Bosse Dam is an earthfill embankment dam with an unlined bywash spillway on the left flank. It has a single bottom outlet at the highest section of the dam. The attached drawing JB2049-01 shows the layout and a typical section through the dam. The main dimensions and pertinent figures are tabulated below.
