GARDEN ROUTE BOTANICAL GARDEN - DAM MAINTENANCE MANAGEMENT PLAN

**Rehabilitation of flood damage to the George Botanical Garden
dam wall: Aquatic specialist inputs & Environmental Control**

Prepared for SMEC (Project C1945) and the George

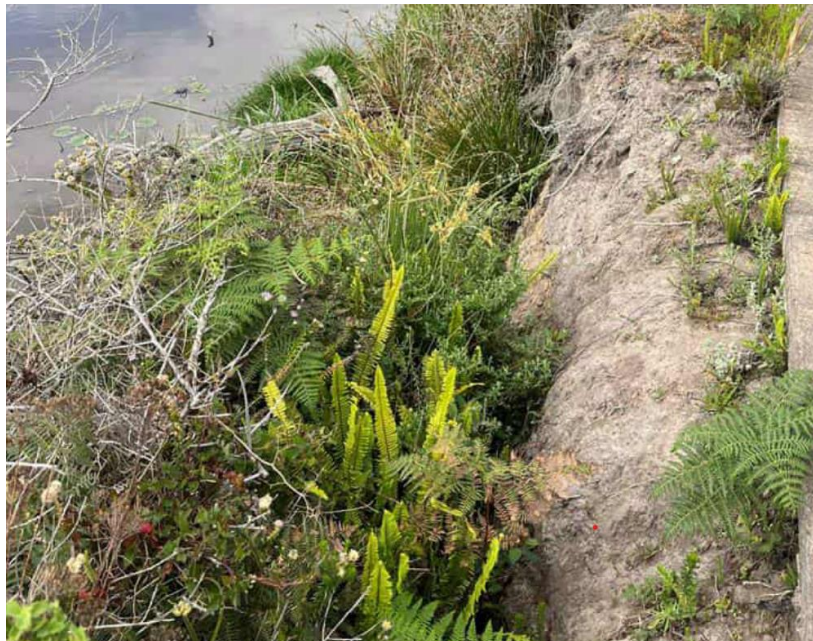
The upstream slope of the wall has eroded on the eastern, western, and southern embankments over time. Large and medium trees and vegetation have been allowed to grow into the dam wall, which have undermined its stability (SMEC, 2023; Figure 2). The overflow has been non-operational leading to higher water levels than the safe operating level, increasing the risk of further erosion. A section of walkway was recently closed due to erosion encroachments and undermining. Rehabilitation and maintenance of the dam is therefore urgently required to prevent a total collapse of the dam wall which could cause extensive damage in parts of the suburb of Camphersdrift.

Figure 2. Image of eroding dam wall along the walkway (SMEC, 2023).

The SMEC report provides detailed design and methods for rehabilitation and maintenance of the dam (SMEC, 2023). A cross section of the proposed rehabilitation of the upstream embankments is provided in Figure 3 which depicts a relatively flat slope of 1:3.5. The aim of is to improve stability, reduce erosion, increase safety during maintenance work, and reduce the risk of foundation conditions that are difficult to detect. The proposed rehabilitation measures would result in the Full Supply Capacity of the dam reducing from 27 818 m³ to 20 412 m³.

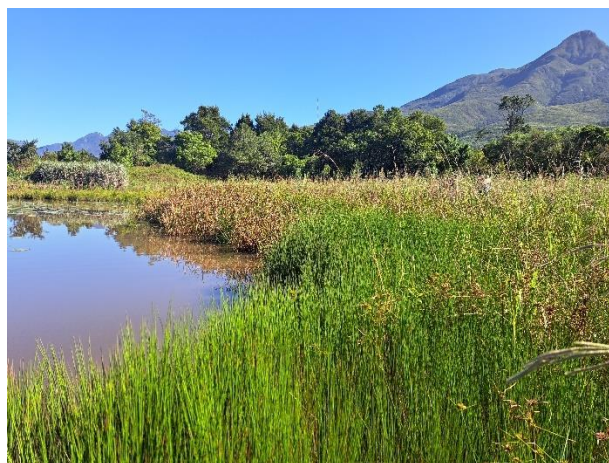
Water levels in the dam have presently been drawn down substantially and no inflow from the furrow has been directed into the dam for many months. This is to reduce the risk of further erosion and collapse of the wall. The drawn down area has resulted in the expansion of an existing area of littoral vegetation dominated by hydrophilic plant species typically associated with seasonal and temporary wetland areas. This area occurs to the north of the dam where no embankment is present and a gentle gradient leads into the dam (Figure 4 and Figure 6).

Figure 6. Northern shoreline showing extensive cover with hydrophilic vegetation.

These species are indicated in Table 2 which includes information on the species suitability for use in revegetating exposed soil on the instream embankment at conclusion of the works. Water levels in a dam fluctuate, influencing the degree to which soil is saturated, which in turn dictates the plants species suitable for revegetation. They must either be adapted to permanent saturation, periodic saturation, or dry conditions. In the context of the dam this can be classified as the low, mid, and high water zones. The high-water zone would be above the dam's full supply level (FSL) and would only ever be saturated briefly up to the freeboard level (1m) and to a minimal extent as water levels reduce via the spillway. Icons used by van Ginkel and Cilliers (2020) to categorise plants based on soil saturation preferences can be used as a guide for replanting and bank stabilisation in different soil saturation zones around the dam (Figure 7).

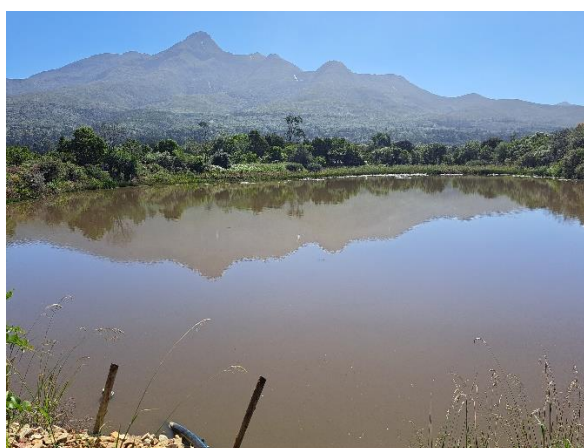
Water quality in the dam is of a high standard as it comes from a mountain stream with minimal land use impacts. This is reflected in the low Electrical Conductivity reading (Table 3). However, turbidity of the water is very high as indicated by the low clarity reading of 14 cm. Unimpacted waters are usually in the range of 40 – 60 cm even in tannin-stained waters. The high turbidity is likely due to the presence of large carp (*Cyprinus carpio*) and koi (ornamental) carp in the dam which are known to forage aggressively in bottom sediments resulting in their continual resuspension, as well as uprooting aquatic plants limiting their establishment.

Figure 8. Photo of the dam clearly showing the high level of turbidity (suspended sediment leading to low clarity result).

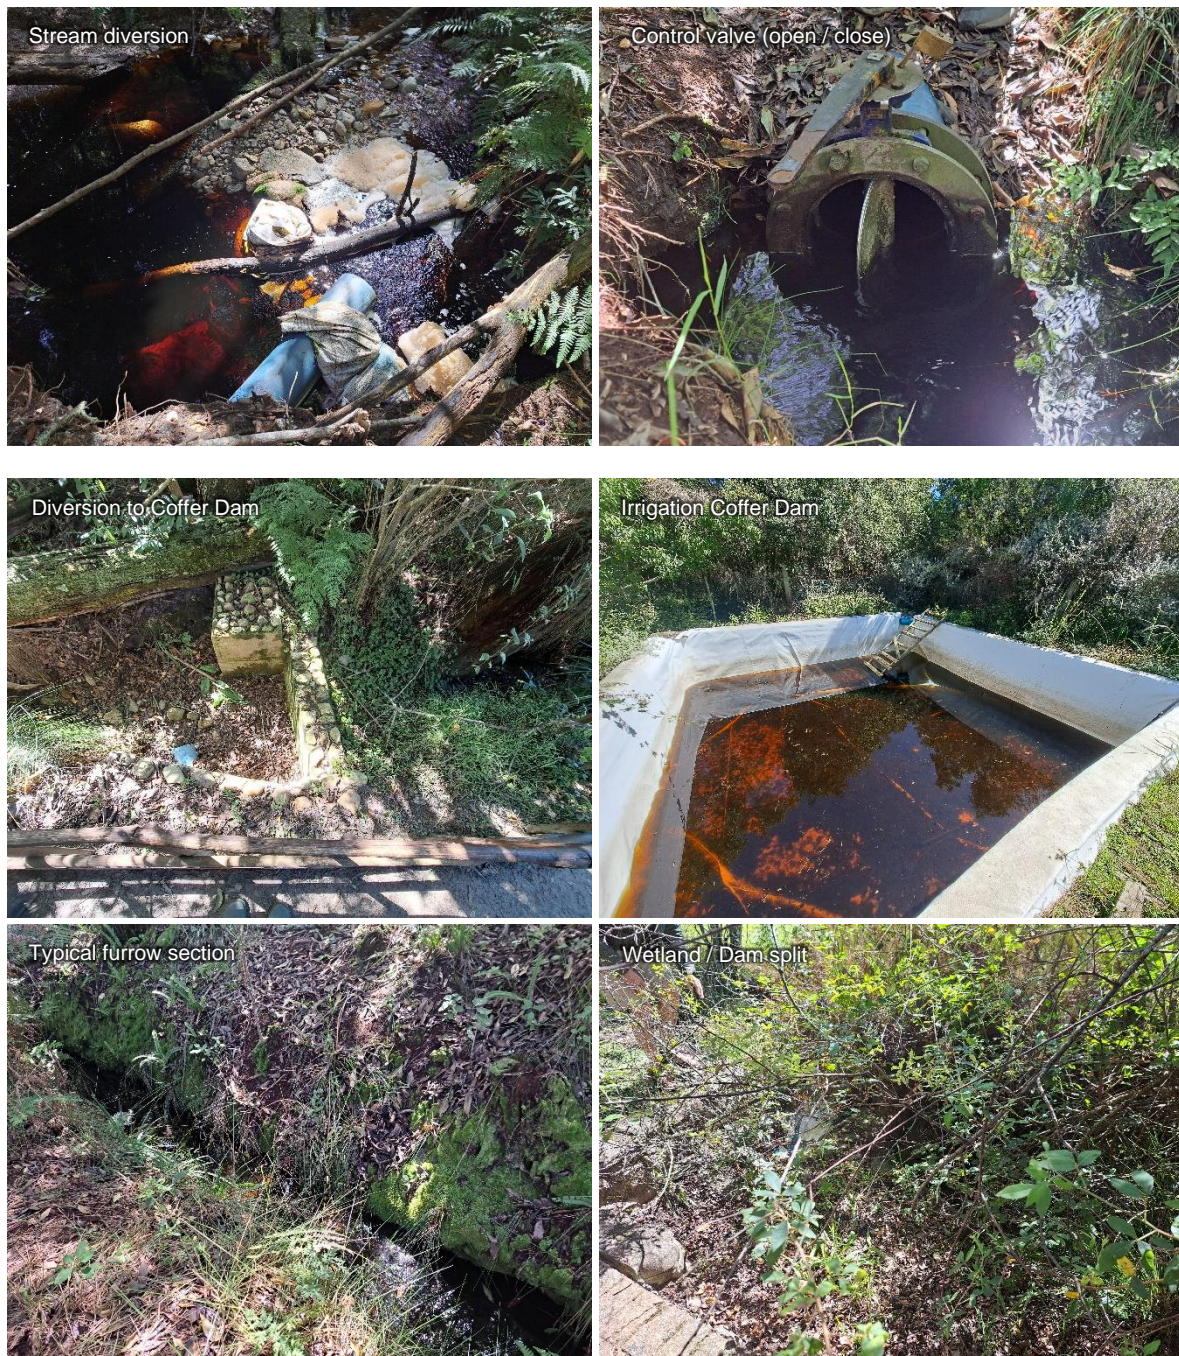
Figure 10. Photos of key operational points and features along the furrow supplying water to the botanical gardens dam mapped in Figure 9.

- The stream diversion point (Figure 10) must be kept clear of instream debris such as branches and large stones which can divert flow and cause jams. These can result in water displacement and erosion of banks. The diversion should be inspected following any rainfall event, and at least once a month.

- A stainless steel screen should be fitted over the diversion inflow to reduce the number of frogs and tadpoles from ending up in the furrow. The screen should also be checked for blockages.

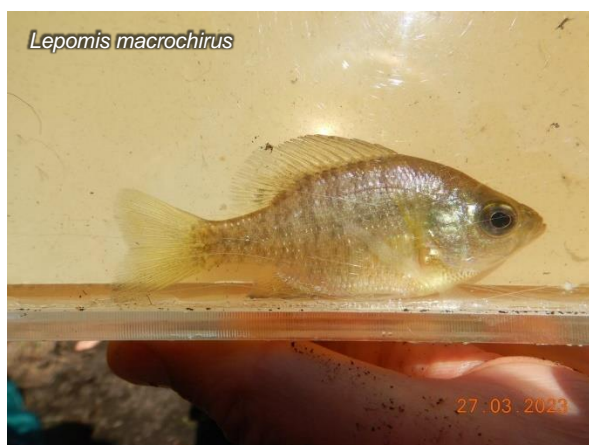
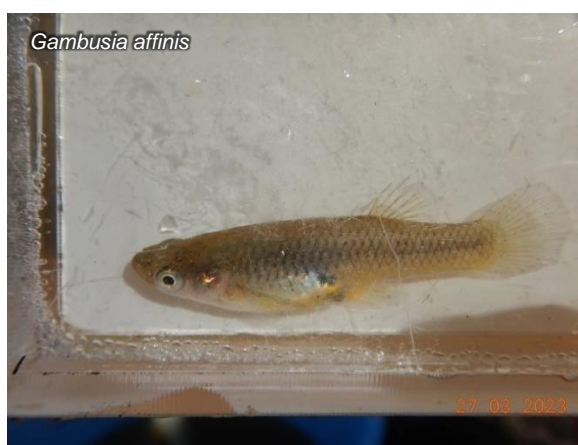
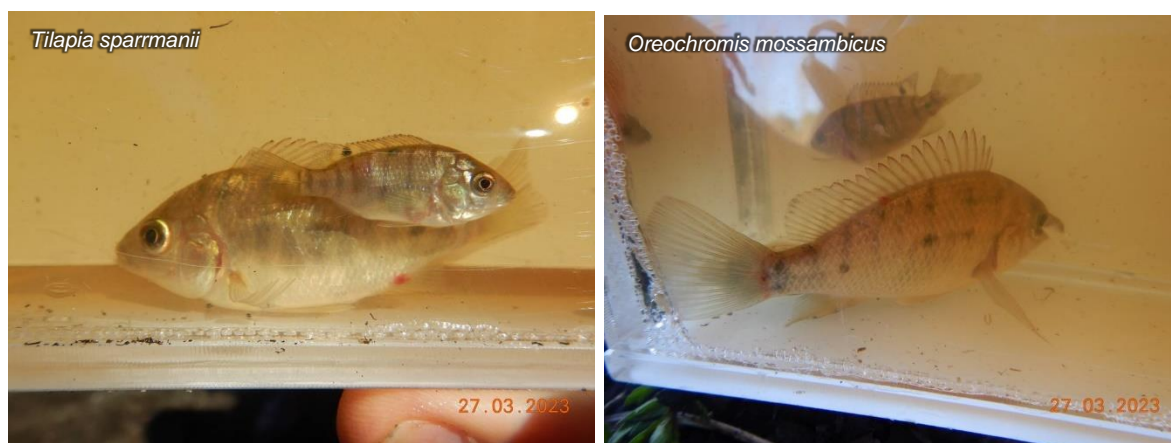
The most abundant fish in the dam were *Gambusia affinis* (Mosquito fish) and *Lepomis macrochirus* (Bluegill sunfish). Both species have been introduced to South Africa from North America and are listed as Category 1b by NEMBA (Table 4 and Table 5). Activities for these fish species are restricted as indicated in Table 5. A person may not facilitate or encourage the species to multiply, they may not be translocated, sold, traded or donated. Two fish species indigenous to South Africa, but not to the Western Cape were recorded in the dam. These were *Tilapia sparrmanii* and *Oreochromis mossambicus*. Both species have been translocated to river systems beyond their native range, and *O. mossambicus* is listed as Vulnerable due to hybridisation with introduced *Oreochromis niloticus* (not observed in the dam) in their native river systems. Both species are listed as Category 3 which carries similar restrictions to Category 1b.

Figure 11. Fish species collected during electrofishing and seine netting surveys.

Given that all the species identified in the dam are listed as invasive for various reasons in the NEMBA, it will not be possible to relocate them to alternative dams without the necessary permits. As introduced and invasive species to the area, this would also not be an ecologically well-informed decision and would set a poor example of how to manage alien fish, especially from the botanical gardens. It is therefore recommended that the fish be humanely euthanised and distributed to poor communities for food if possible. This has been achieved with carp caught from Groenvlei lake through the Gift of the Givers charitable programme. It may also be possible to enlist the services of the Invasive Fish Species Management (IFSM) group who are working with Cape Nature to remove the carp from Groenvlei. Smaller fish species that cannot be used as food for people must be humanely euthenised using a lethal dose of clove oil.
