RESIDENTIAL DEVELOPMENT ON THE REMAINDER OF PORTION 60 OF THE FARM PLATTEBOSCH NO. 485, STILL BAY, WESTERN CAPE

EA REF: 16/3/3/5/D5/19/0001/22

PHASE 1 CONSTRUCTION ECO REPORT JULY 2024

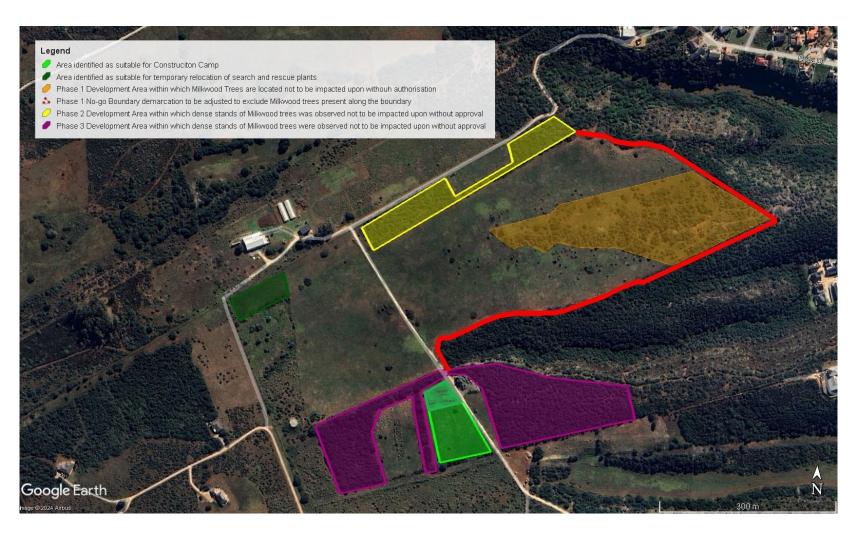
Map 1: July 2024 ECO map for indicating areas where Milkwood trees were observed and to be avoided; proposed construction camp placement; proposed search and rescue plants temporary placement; and Phase 1 no-go area boundary demarcation adjusted to exclude Milkwood trees present along the no-go boundary.

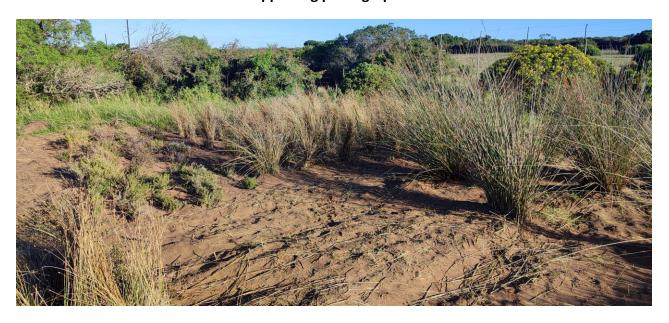
Photo 1: Searched and rescue restios and succulents (photo taken 15 July 2024).

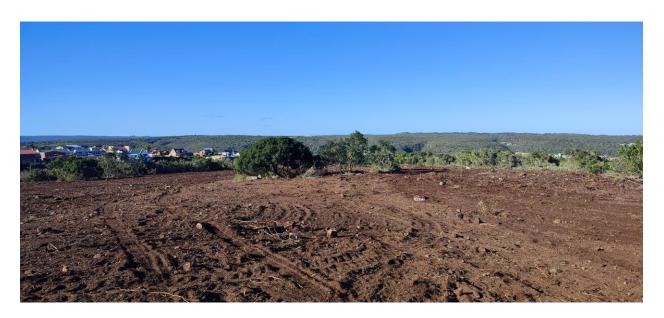
Photo 2: Remaining Milkwood trees on Phase 1 area (photo taken 15 July 2024).

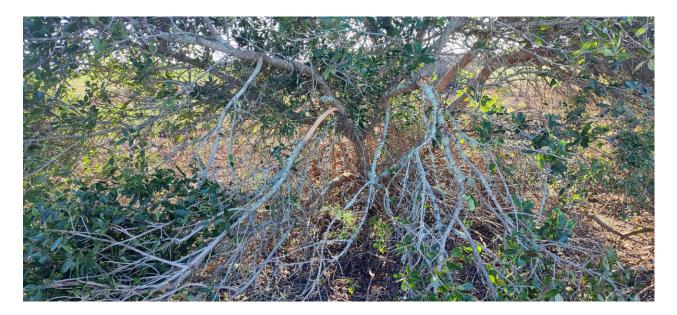
J6 Cor	omplaints	The site manager must keep a complaint register within which all public complaints must be recorded as well as how they were dealt with. To date the EA holder/developer has not received any official complaints from the public. However during an discussion between the ECO and Mr Shagon Carelse of Hessequa Municipality it was mentioned that Mr Carelse received an enquiry from the DFFE concerning site clearance activities taking place on site and potential impacts on Milkwood trees. The ECO indicated to Mr Carelse that the EA holder/developer was made aware of all requirements relating to Milkwood tree before site clearance activities started and that the ECO will monitor and report on any potential impacts observed on Milkwood trees during the monthly ECO inspections conducted. During the time of the ECO inspections that took place on 15 July 2024 no evidence of Milkwood tree materials were observed within any of the plant material stockpiles on site. Some superficial and minimal damage (less that 25% of the tree) was observed on approximately 5 of the 26 remaining Milkwood trees counted within the Phase 1 development area, however the superficial damage observed was breakage of some branches that took place

"main crown" was observed.
		Refer to the photos below.
J7	Waste Management	Closable, weather proof and animal proof waste bins must be provided at the site which is emptied on a regular basis and disposed of at the local municipal skip or landfill site. These bins may not be located within any no-go areas. A waste register must be maintained recording when, where, type of waste and how much is disposed of at the municipal skip or landfill site.
18	Fire Fighting	Suitable fire fighting equipment must be available on site i.e. fire extinguishers.
19	Ablution/Toilet Facilities	A suitable toilet i.e. portable chemical toilet must be available at the construction camp. This toilet must be serviced regularly and no leakage or pollution may occur.
J10	Stormwater Management	As per the requirements of the EMP the detailed stormwater management plan must be provided to the ECO for inputs before finalisation. The draft SWMP has been provided to the ECO for inputs and a meeting was also held with the engineer during the first ECO site visit to discuss the plans as proposed. During engineer investigations it was determined that stormwater attenuation facilities would be required within the no-go areas to accommodate stormwater from the proposed development area. After the initial site visit the ECO recommended alternative locations for the attenuation ponds taking into consideration the steep gradients of the drainage lines within the no-go areas. Before

Photo 3: Minimal damage observed on Milkwood tree located in Phase 1 cleared area (photo taken 15 July 2024).

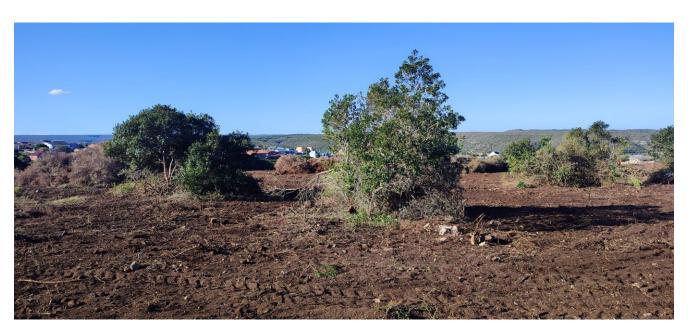
Photo 4: Remaining Milkwood trees on Phase 1 area (photo taken 15 July 2024).

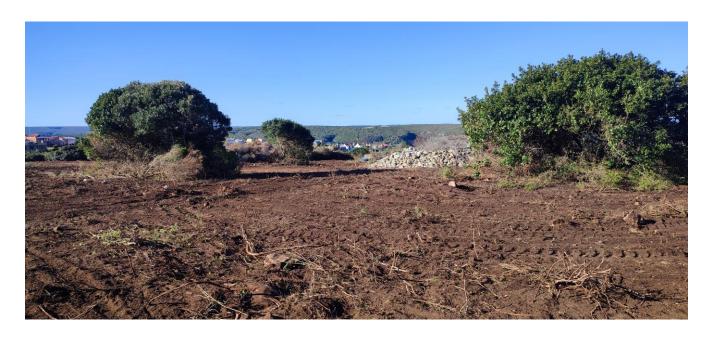
Photo 5: Remaining Milkwood trees on Phase 1 area (photo taken 15 July 2024).

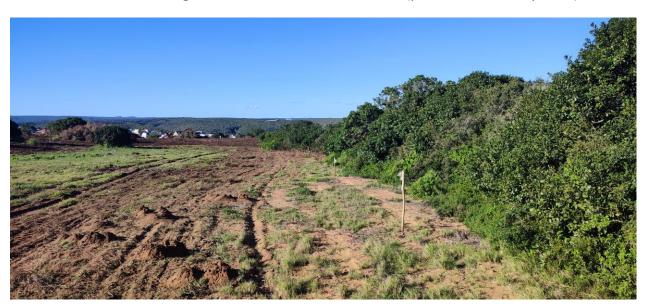
Photo 6: Demarcated no-go area (photo taken 15 July 2024).

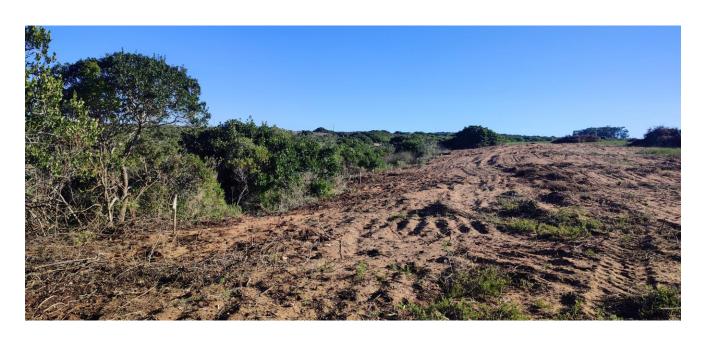
Photo 7: Demarcated no-go area (photo taken 15 July 2024)

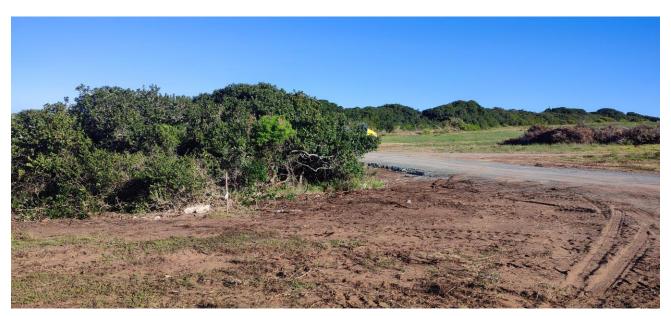
within and	during any construction activities without authorisation/permits.
	along no-go boundaries	It was observed that Milkwood trees along the no-go edge/boundaries have been avoided and that in some areas the development boundary demarcations have been adjusted to exclude the Milkwood trees and avoid potential impacts as recommended by the ECO during the start-up construction inspection.
J2	Milkwood trees within proposed development area	A total of 26 Milkwood trees were counted by the ECO located within the Phase 1 development area. NO MILKWOOD TREES MAY BE IMPACTED OR DAMAGED during any site clearance or construction activities without authorisation/permits. Extreme caution must be exercised during site clearance activities to ensure no impacts or damage to any protected Milkwood trees
		occurs.
		Once the Phase 1 development area has been cleared all Milkwood trees located within the approved development area must be recorded by the land surveyor and indicated on the proposed development layout. Thereafter this layout must be presented to the relevant official at the DFFE and applications for removal, relocation or pruning must be applied for and obtained from the relevant authority before any of these Milkwood trees may be impacted upon. As far as possible these trees must be accommodated on the layout within the proposed erven.

Photo 8: No-go boundary adjusted to exclude Milkwood tree (photo taken 15 July 2024)
