**RESIDENTIAL DEVELOPMENT ON THE REMAINDER
OF PORTION 60 OF THE FARM PLATTEBOSCH NO.
485, STILL BAY, WESTERN CAPE
EA REF: 16/3/3/5/D5/19/0001/22**

**PHASE 1 CONSTRUCTION
ECO REPORT
FOR OCTOBER 2024
(Submitted 31 October 2024)**

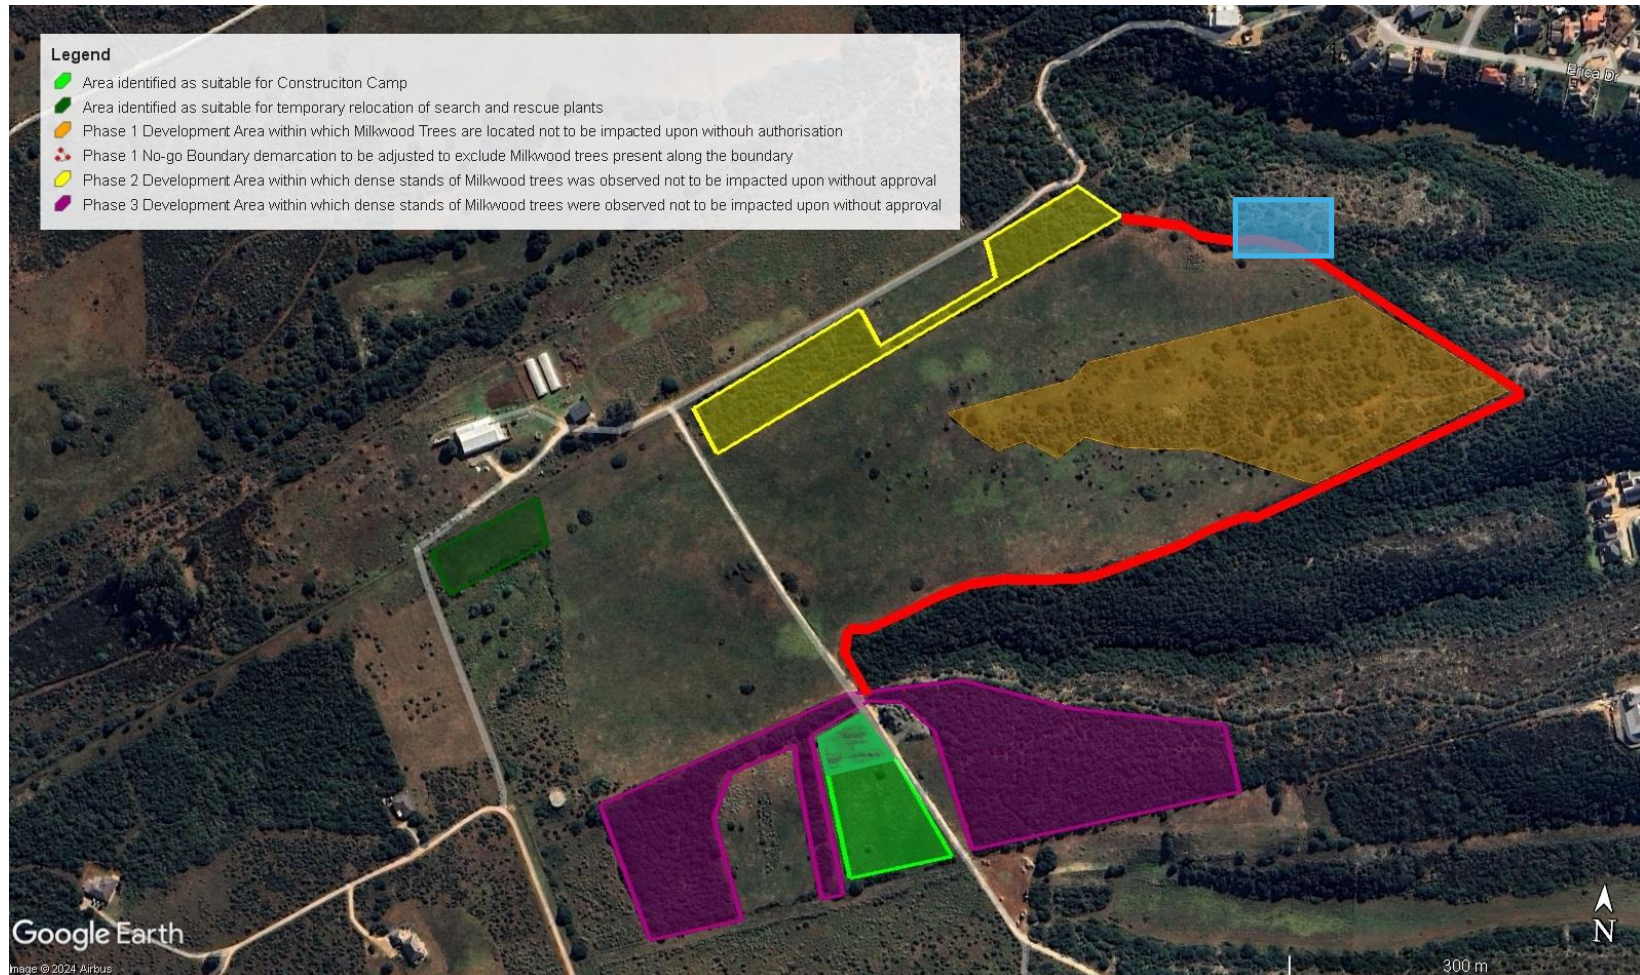
O2	Milkwood trees within proposed development area	<p>A total of 26 Milkwood trees were counted by the ECO located within the Phase 1 development area. NO MILKWOOD TREES MAY BE IMPACTED OR DAMAGED during any site clearance or construction activities without authorisation/permits.</p> <p>Extreme caution must be exercised during construction activities to ensure no impacts or damage to any protected Milkwood trees occurs.</p> <p>Phase 1 and partial Phase 2 development areas have been cleared all Milkwood trees located within the approved development area must be recorded by the land surveyor and indicated on the proposed development layout, this must be done before the next ECO site visit which is scheduled for 26 November 2024. The layout map indicating the locations of the recorded Milkwood</p>

Map 1: July 2024 ECO map for indicating areas where Milkwood trees were observed and to be avoided; proposed construction camp placement; proposed search and rescue plants temporary placement. The ECO stated that no machinery clearance are allowed within the dense stands of Milkwood Trees as identified within Phase 2 and Phase 3 areas. The EA holder however continued to clear vegetation within Phase 2 development area with machinery and this has lead to damage to dense Milkwood trees. **The blue square on the map above shows where encroachment into the no-go area has occurred, as per the recommendations no-go demarcation must be immediately reinstated as per original demarcation done by the land surveyor and the impacted no-go area must be rehabilitated**

<p>trees must be provided to the ECO before 26 November 2024 so that the ECO can check the map for correctness when conducting the next site visit. Thereafter this layout must be presented to the relevant official at the DFFE and applications for removal, relocation or pruning must be applied for and obtained from the relevant authority before any of these Milkwood trees may be impacted upon. As far as possible these trees must be accommodated on the layout within the proposed erven.</p> <p>During the July ECO report the following was recorded - <i>Dense stands of Milkwood trees were also observed within Phase 2 and Phase 3 remaining indigenous vegetation areas and when these areas are being cleared the shrubs around the Milkwood trees must be carefully cleared by hand not to damage any Milkwood trees and all Milkwood trees must be recorded and where removal or impacts on these trees cannot be avoided applications for removal, relocation or pruning must be applied for and obtained from the relevant authority before any of these Milkwood trees may be impacted upon.</i> During the ECO inspection conducted on 29 August 2024 it was observed that clearance activities has commenced within the dense stands of Milkwood trees within Phase 2 area, this was also done with machines and not by hand as recommended by the ECO. The EA holder therefore did not adhere to the recommendations of the ECO. It is recommended that the applicant immediately cease with these clearance activities within the dense stands of Milkwood trees until authorisation has been obtained from the DFFE as damage to Milkwood trees have been observed. This is the final warning and should this non-compliance not be adequately addressed in accordance with the ECO recommendations as listed above penalties will be issued to the site manager and/or EA Holder in accordance with the EMP requirements.</p> <p>Refer to the map below.</p>

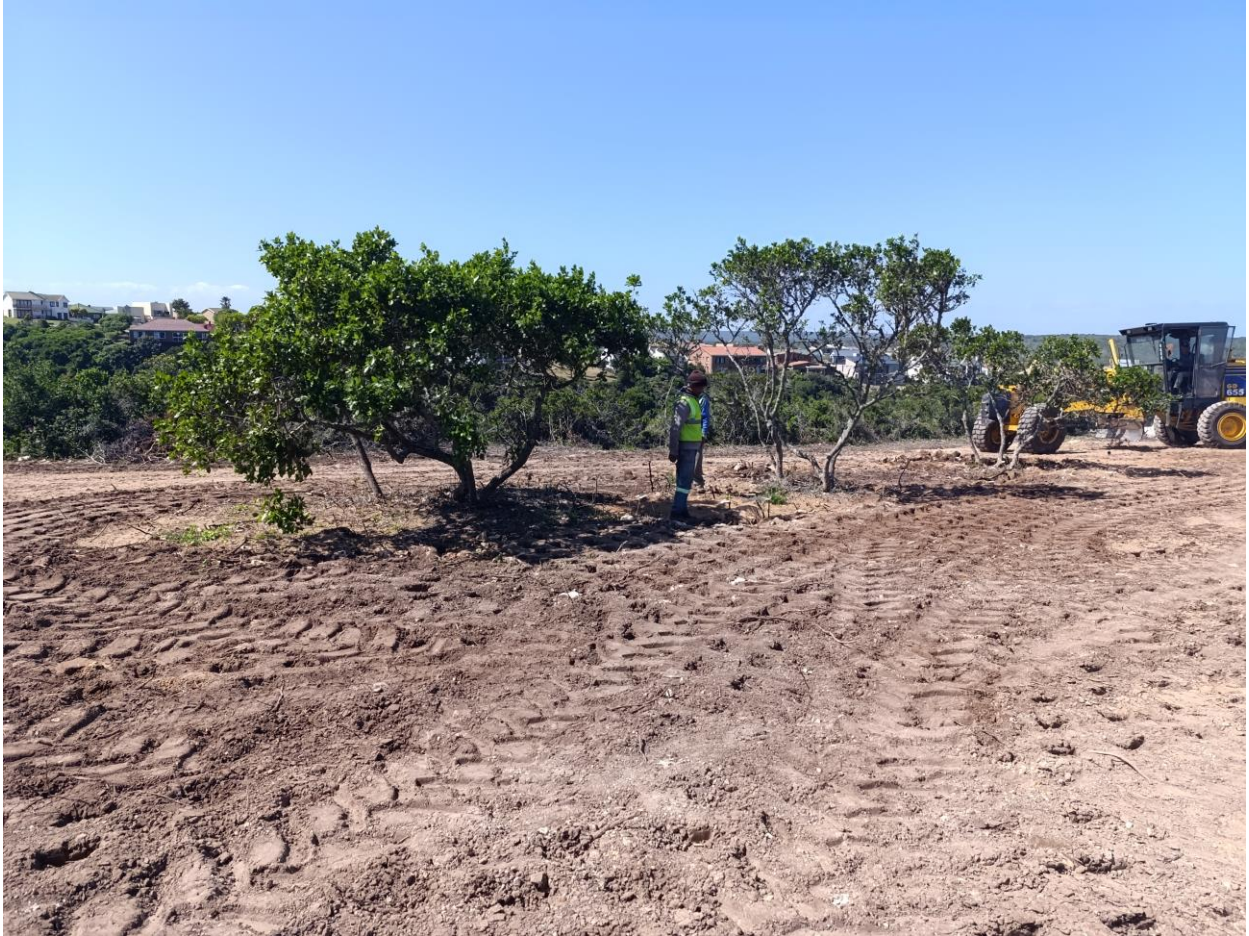
Finding No.	Area of activity	ECO Findings and Recommendations
O1 (Non-compliance finding since August	No-go boundaries and protected Milkwood trees within and along no-	During July ECO site inspection, it was found that the boundaries of the no-go areas were correctly demarcated, however during the ECO site inspections conducted on 29 August 2024, 3 and 30 October 2024 it was found that no-go demarcation points is no longer clearly visible and is not distinguishable from the demarcation being used for services layouts i.e. pipeline and roads. Some of the no-go demarcation points were moved and

Photo 1: Encroachment within no-go area to be demarcated for rehabilitation (photo taken 30 October 2024).

2024)	go boundaries	<p>encroachments have occurred into the no-go areas.</p> <p>All no-go boundaries demarcation must be immediately restored according to the no-go boundaries that was determined by the land surveyor and confirmed as correct during the July ECO inspection before site clearance commenced. The pegs used for no-go boundaries demarcation must be clearly distinguishable from the pegs used for services infrastructure layout pegs. The no-go boundary pegs must not be more than 15m apart. No developments, site clearance or road or service infrastructure developments may take place within the no-go areas without approval from the Department that these developments can occur within the scope of the Environmental Authorisation.</p> <p>Encroachments that have already occurred within the no-go areas must be demarcated and monitored for rehabilitation. Refer to the map below.</p> <p>During the ECO inspections on 3 and 31 October 2024 these requirements was discussed in detail with the site manager Mr Evan Vermaak and the EA holder/developer representatives. Since this has been a non-compliance finding since August 2024 and has not yet been addressed by the site manager this is the final warning and should this non-compliance not be adequately addressed in accordance with the ECO recommendations as listed above penalties will be issued to the site manager in accordance with the EMP requirements.</p>

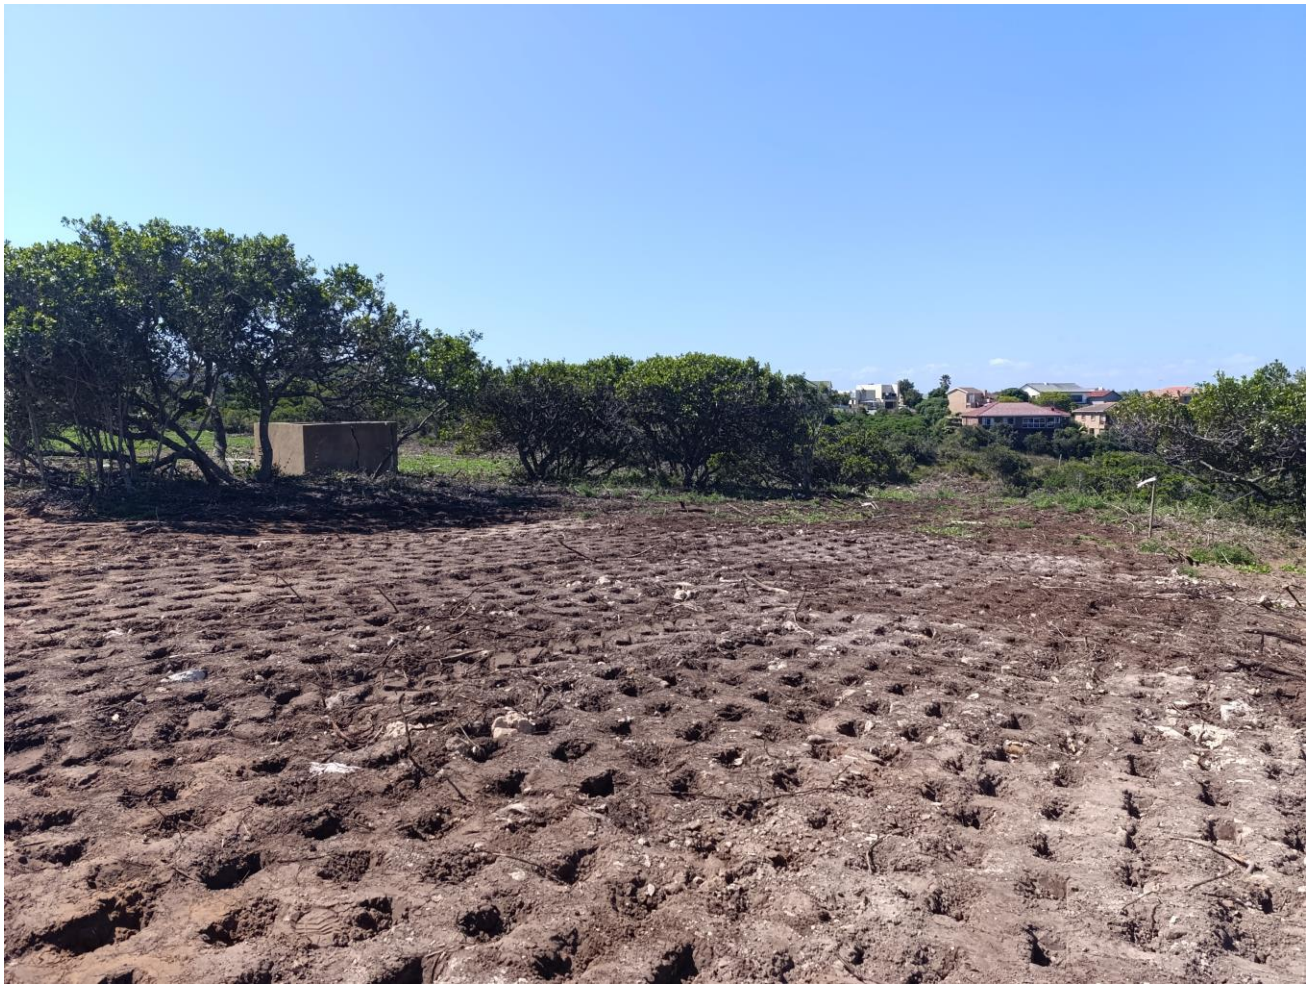
Photo 2: Encroachment within no-go area to be demarcated for rehabilitation (photo taken 30 October 2024).

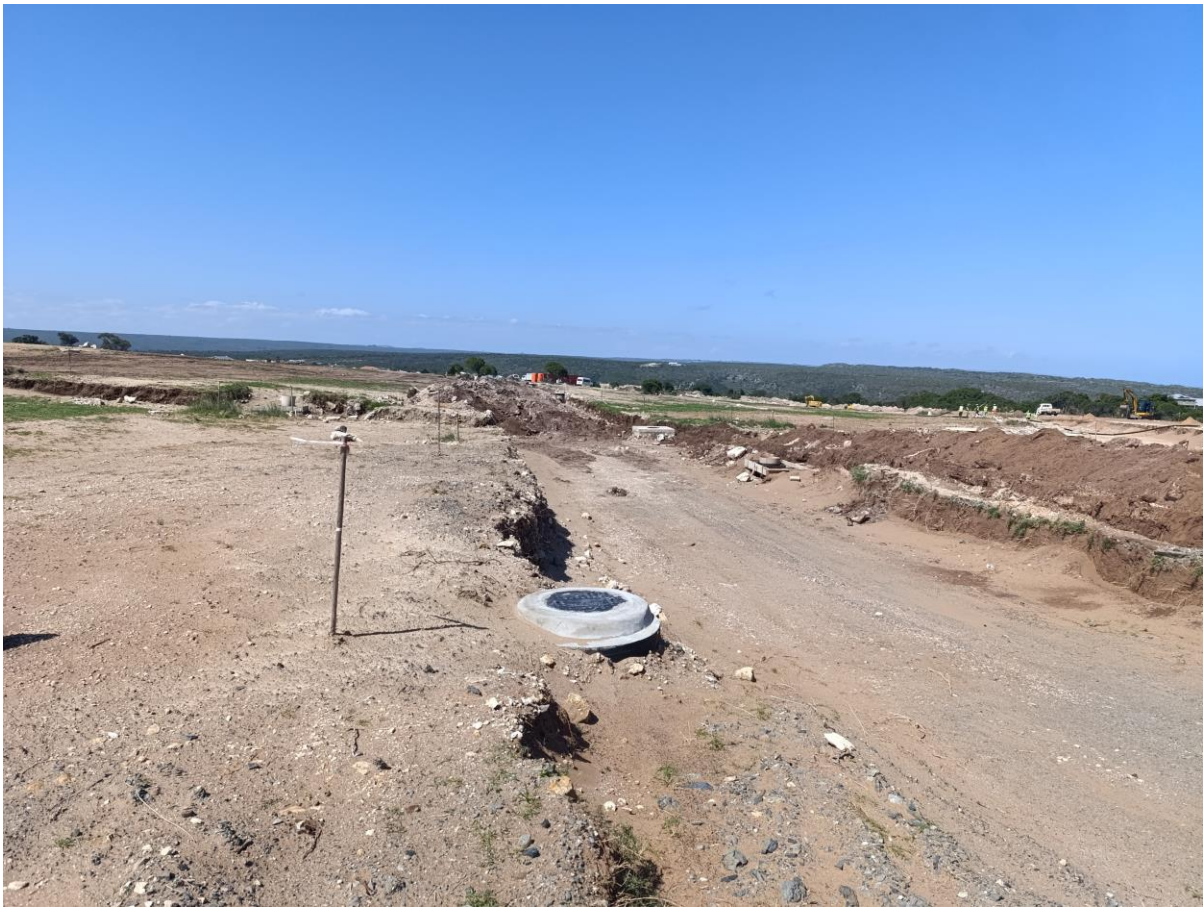
Photo 3: Phase 1 civil services construction progress (photo taken 30 October 2024).

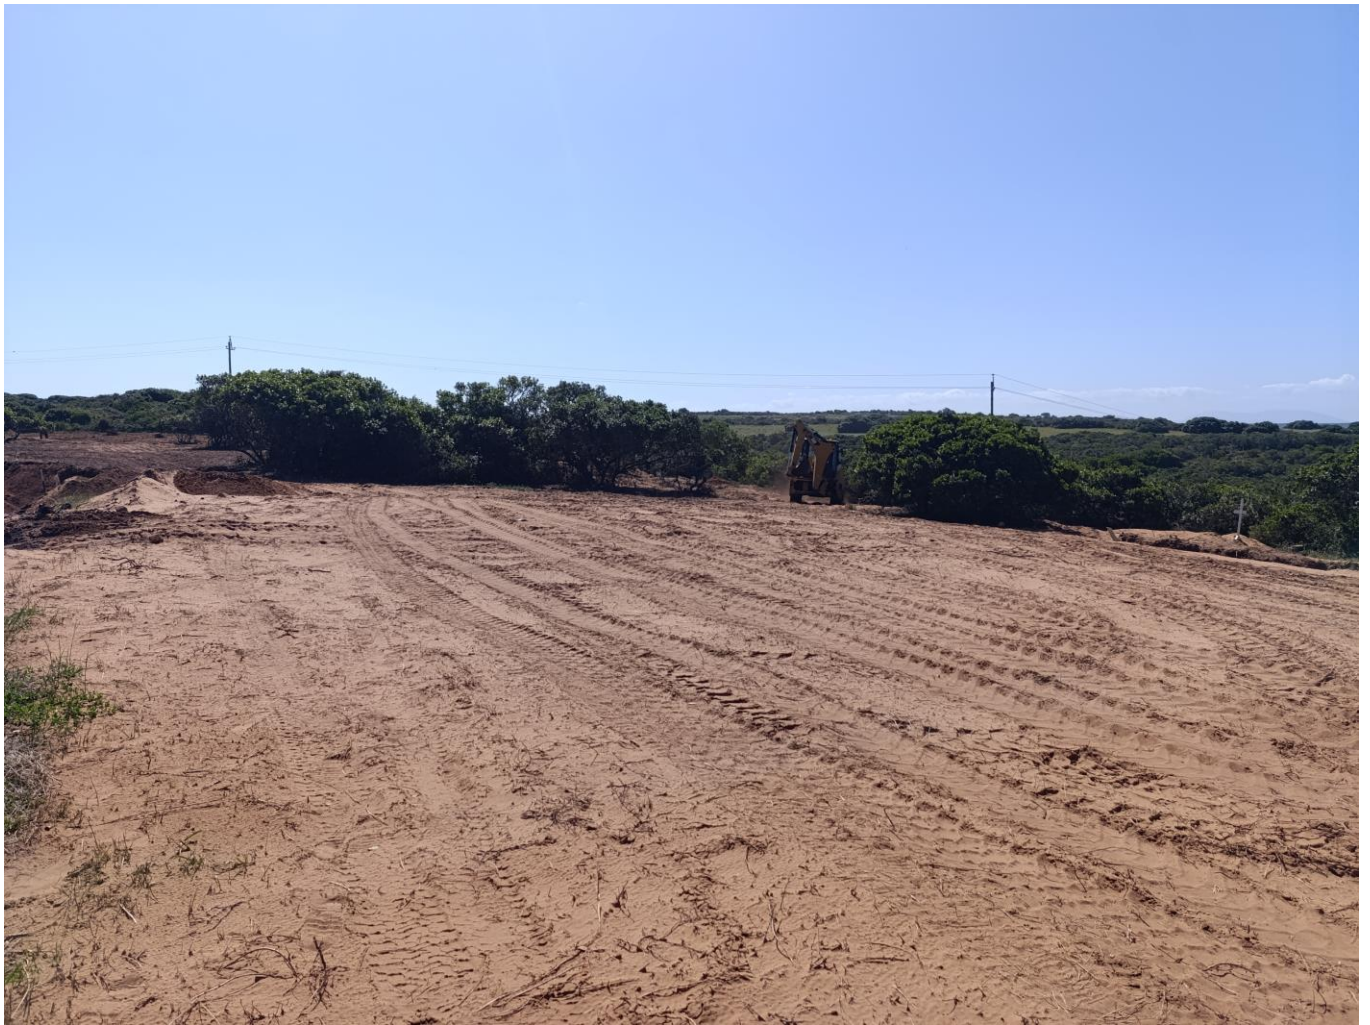
Photo 4: Civil services construction and clearing within Phase 2 area continues, despite ECO stating since start of site clearance activities that clearance within dense stands of Milkwood trees should not take place with machinery until authorisation for DFFE has been obtained to avoid any unauthorised damage to or removal of Milkwood trees (photo taken 30 October 2024).
