# RESIDENTIAL DEVELOPMENT ON THE REMAINDER OF PORTION 60 OF THE FARM PLATTEBOSCH NO. 485, STILL BAY, WESTERN CAPE

EA REF: 16/3/3/5/D5/19/0001/22

# PHASE 1 CONSTRUCTION ECO REPORT FOR NOVEMBER 2024

(Submitted 14 November 2024)

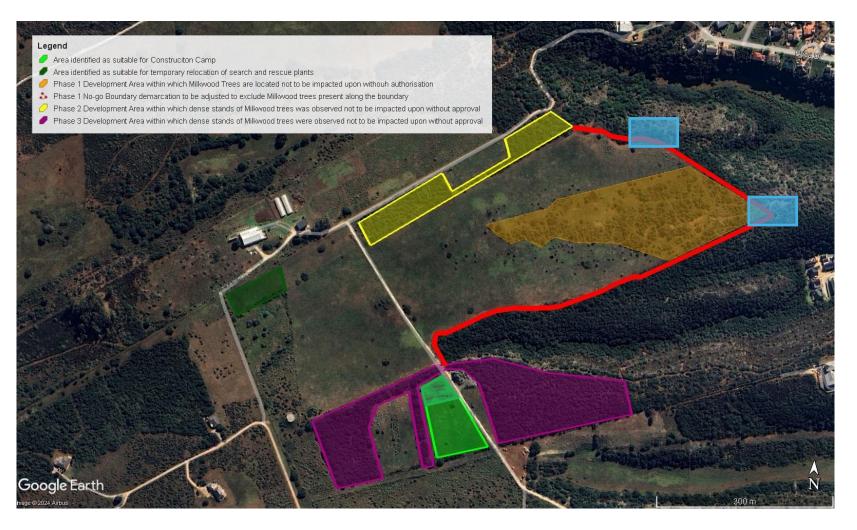
Map 1: July 2024 ECO map for indicating areas where Milkwood trees were observed and to be avoided; proposed construction camp placement; proposed search and rescue plants temporary placement. The ECO stated that no machinery clearance are allowed within the dense stands of Milkwood Trees as identified within Phase 2 and Phase 3 areas. The EA holder however continued to clear vegetation within Phase 2 development area with machinery and this has lead to damage to dense Milkwood trees. The blue squares on the map above shows where encroachment into the no-go areas have occurred, as per the recommendations no-go demarcation must remain reinstated as per original demarcation done by the land surveyor and the impacted no-go area must be monitored for rehabilitated

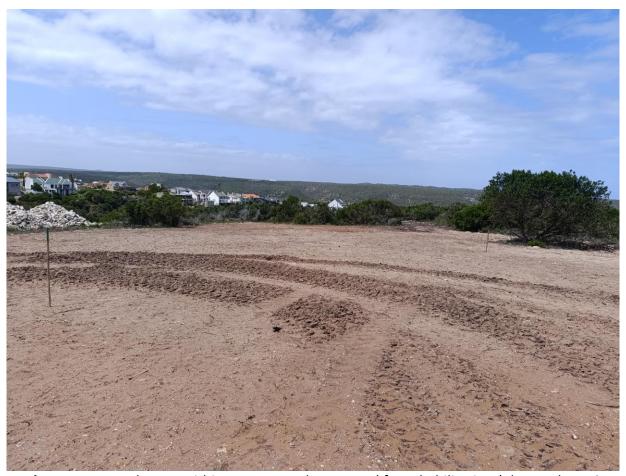
Finding	Area of	ECO Findings and Recommendations
No.	activity	
N1	No-go	During the time of the November 2024 inspection, it was found
	boundaries	that the original no-go boundaries have been restored and
	and	demarcated correctly and clearly. Demarcation must remain
	protected	throughout construction phase and the ECO will monitor the
	Milkwood	rehabilitation progress of impacted no-go area edges and
	trees within	recommend indigenous vegetation planting if required.
	and along no-	Within the north-eastern corner no-go area encroachment

**Photo 1:** Encroachment within no-go area demarcated for rehabilitation (photo taken 13 November 2024).

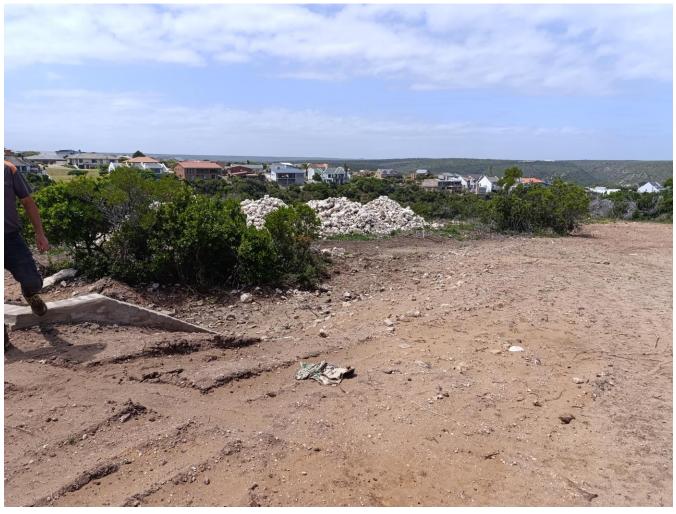
T 00	stackwilds of lime works were observed which would be well as a
	go	stockpiles of lime rocks were observed which must be removed as
	boundaries	soon as possible. These rocks may not be dumped or placed
		within any of the no-go areas.
N2	Milkwood	A total of 26 Milkwood trees were counted by the ECO located
	trees within	within the Phase 1 development area. NO MILKWOOD TREES
	proposed	MAY BE IMPACTED OR DAMAGED during any site clearance or
	development	construction activities without authorisation/permits.
	area	construction detivities without dumonsation, permits.
	area	Extreme caution must be exercised during construction activities
		to ensure no impacts or damage to any protected Milkwood trees
		occurs.
		Phase 1 and partial Phase 2 development areas have been
		cleared all Milkwood trees located within the approved
		development area must be recorded by the land surveyor and
		indicated on the proposed development layout, this must be

**Photo 2:** Lime rocks stockpiles within no-go area to be removed (photo taken 14 November 2024).

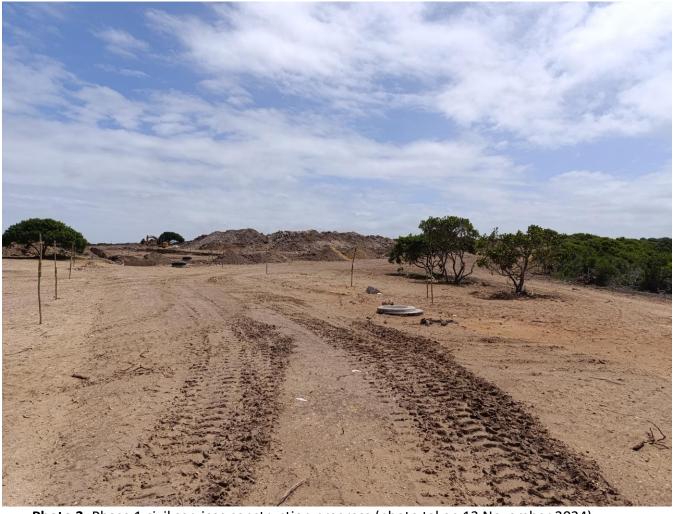
Photo 3: Phase 1 civil services construction progress (photo taken 13 November 2024).
