**RESIDENTIAL DEVELOPMENT ON THE REMAINDER
OF PORTION 60 OF THE FARM PLATTEBOSCH NO.
485, STILL BAY, WESTERN CAPE
EA REF: 16/3/3/5/D5/19/0001/22**

**CONSTRUCTION PHASE
ECO REPORT
FOR JANUARY 2025
(Submitted 30 January 2025)**

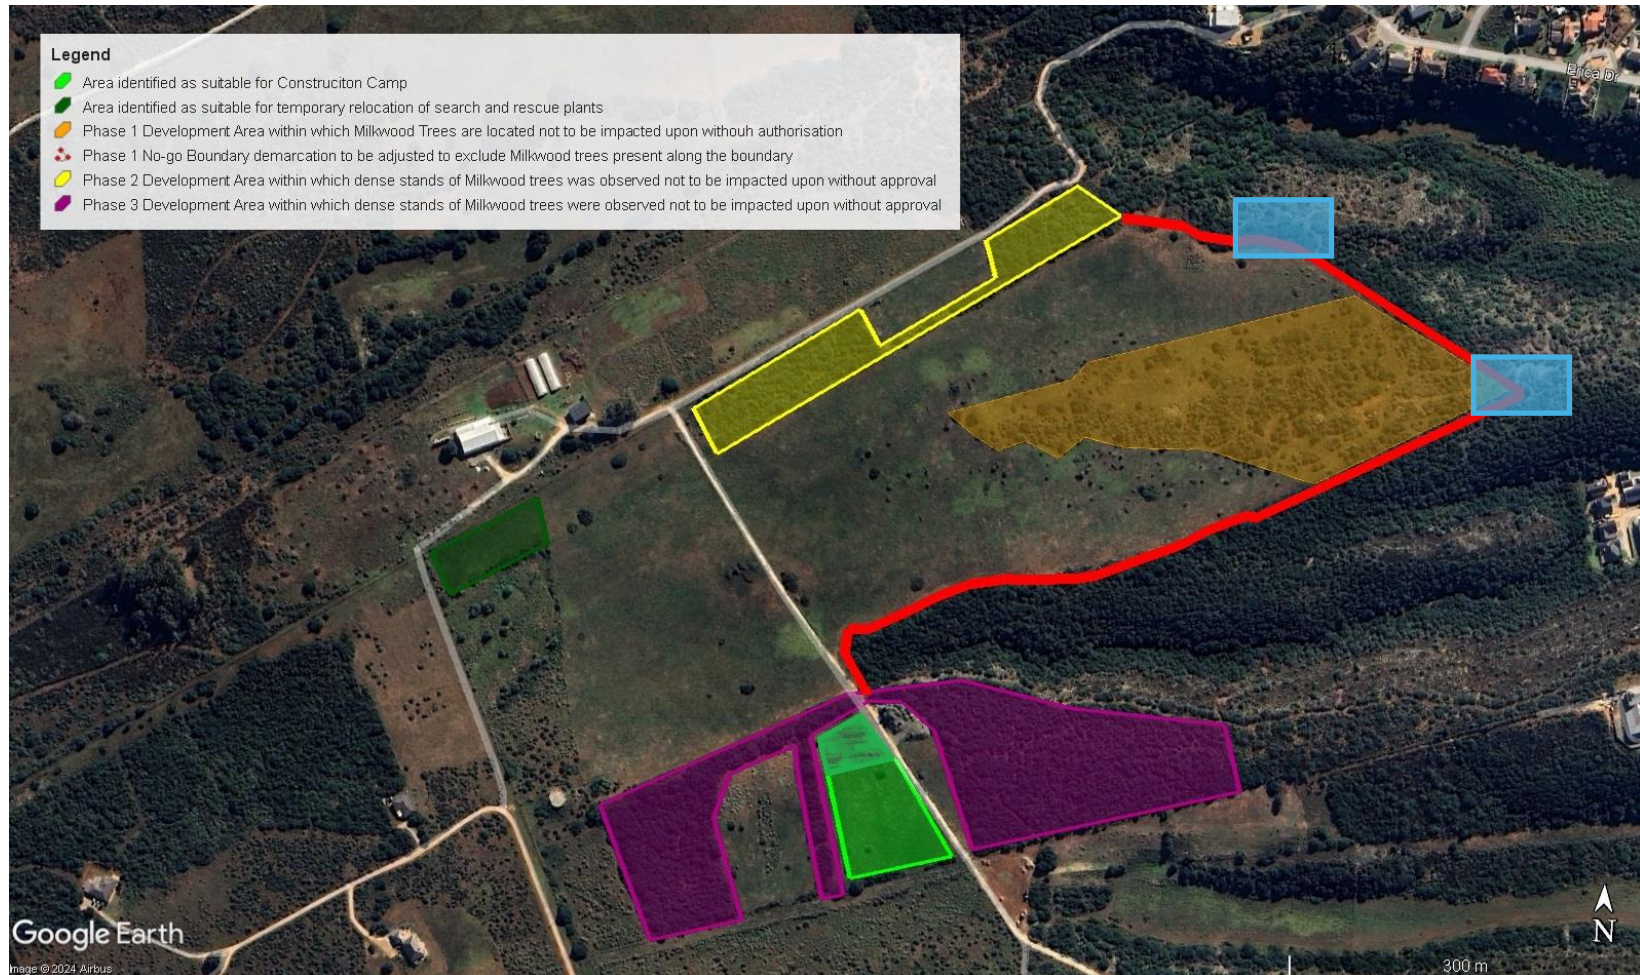
Map 1: July 2024 ECO map for indicating areas where Milkwood trees were observed and to be avoided; proposed construction camp placement; proposed search and rescue plants temporary placement. The ECO stated that no machinery clearance are allowed within the dense stands of Milkwood Trees as identified within Phase 2 and Phase 3 areas. The EA holder however continued to clear vegetation within Phase 2 development area with machinery and this has lead to damage to dense Milkwood trees. **The blue squares on the map above shows where encroachment into the no-go areas have occurred, as per the recommendations no-go demarcation must remain reinstated as per original demarcation done by the land surveyor and the impacted no-go area must be monitored for rehabilitated**

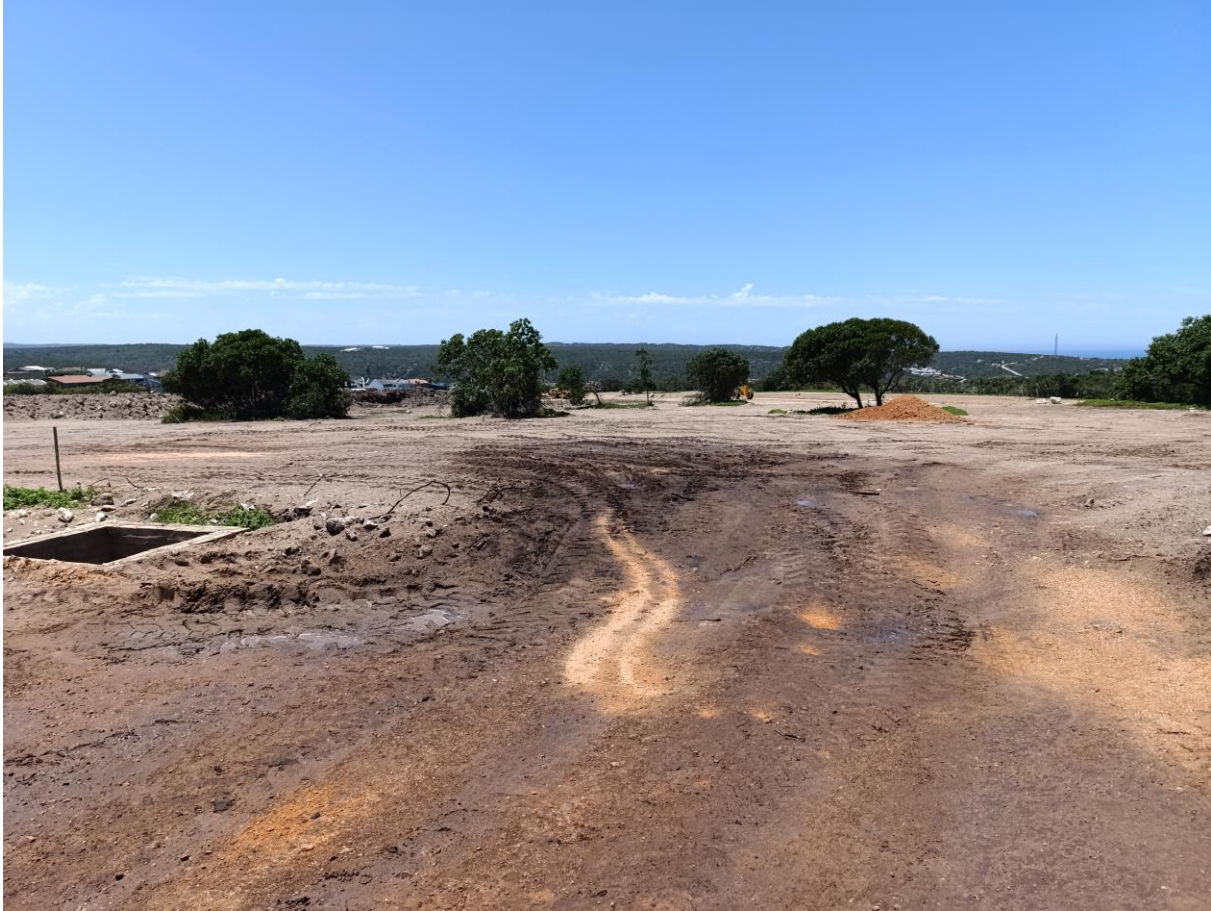
Finding No.	Area of activity	ECO Findings and Recommendations
J1	Milkwood trees within development area	<p>A total of 26 Milkwood trees were counted by the ECO located within the Phase 1 development area. The remaining presence of these Milkwood trees within the cleared Phase 1 development area was confirmed during the site visit conducted 29 January 2025. Within the norther corner of Phase 2 where vegetation clearance has already been conducted 7 clusters of Milkwood trees and 3 individual trees were recorded and photographed.</p> <p>To ensure that it can be confirmed that all Milkwood trees remain undamaged/are not removed within the development area throughout the construction and development phases all Milkwood trees falling within the development footprint area</p>

Photo 1: Remaining Milkwood trees om Phase 1 cleared area (photo taken 29 January 2025).

<p>must be recorded and indicated on the approved development layout plan.</p> <p>The developer intends to continue with clearance activities around stands of Milkwood trees falling within Phase 2 development area. At least 30 Milkwood trees as part of several clusters of Milkwood trees were recorded within the dense stand of remaining shrubs along the northwestern boundary. Clearance by hand is recommended to avoid damage to Milkwood trees and associated clusters and extreme caution must be exercised during clearance activities to ensure no impacts or damage to any Milkwood trees occurs.</p> <p>Should removal, relocation or pruning of any Milkwood trees be required application/s must be made to the DFFE for removal, relocation or pruning before any Milkwood trees may be impacted upon. As far as possible these trees must be accommodated within the layout and not removed.</p> <p>Refer to the map below.</p>

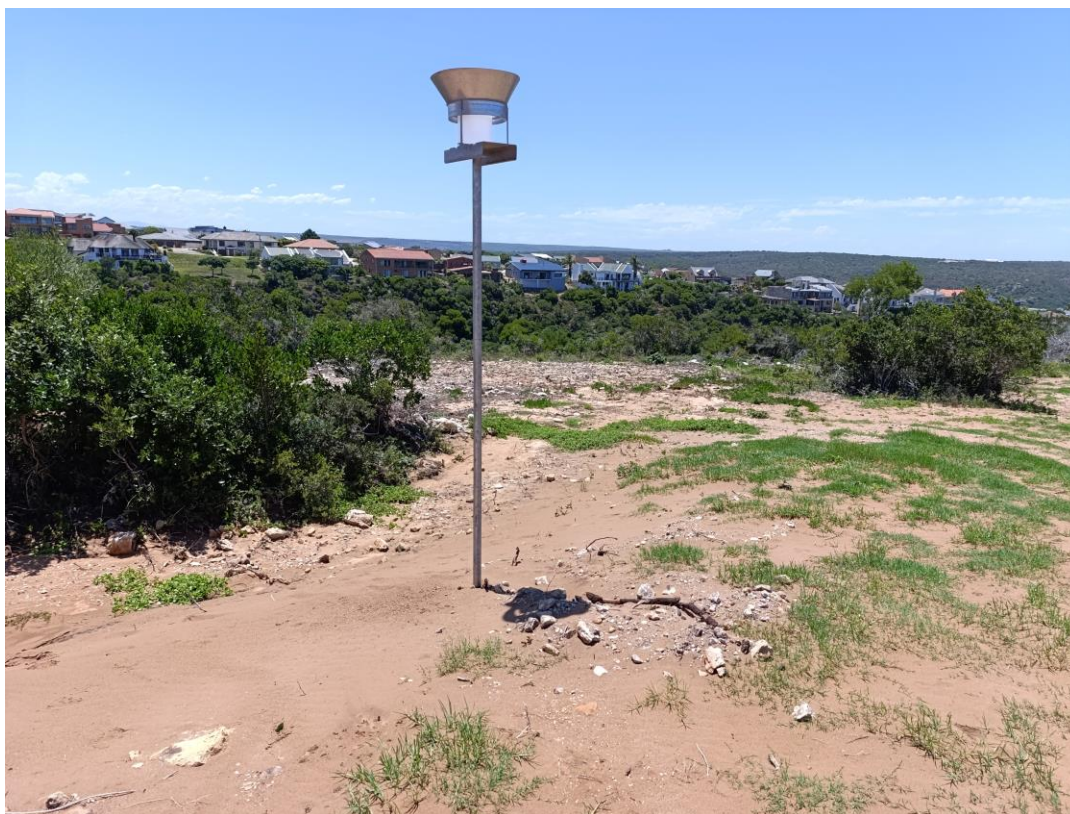
Photo 2: Dust monitoring bucket (photo taken 29 January 2025).

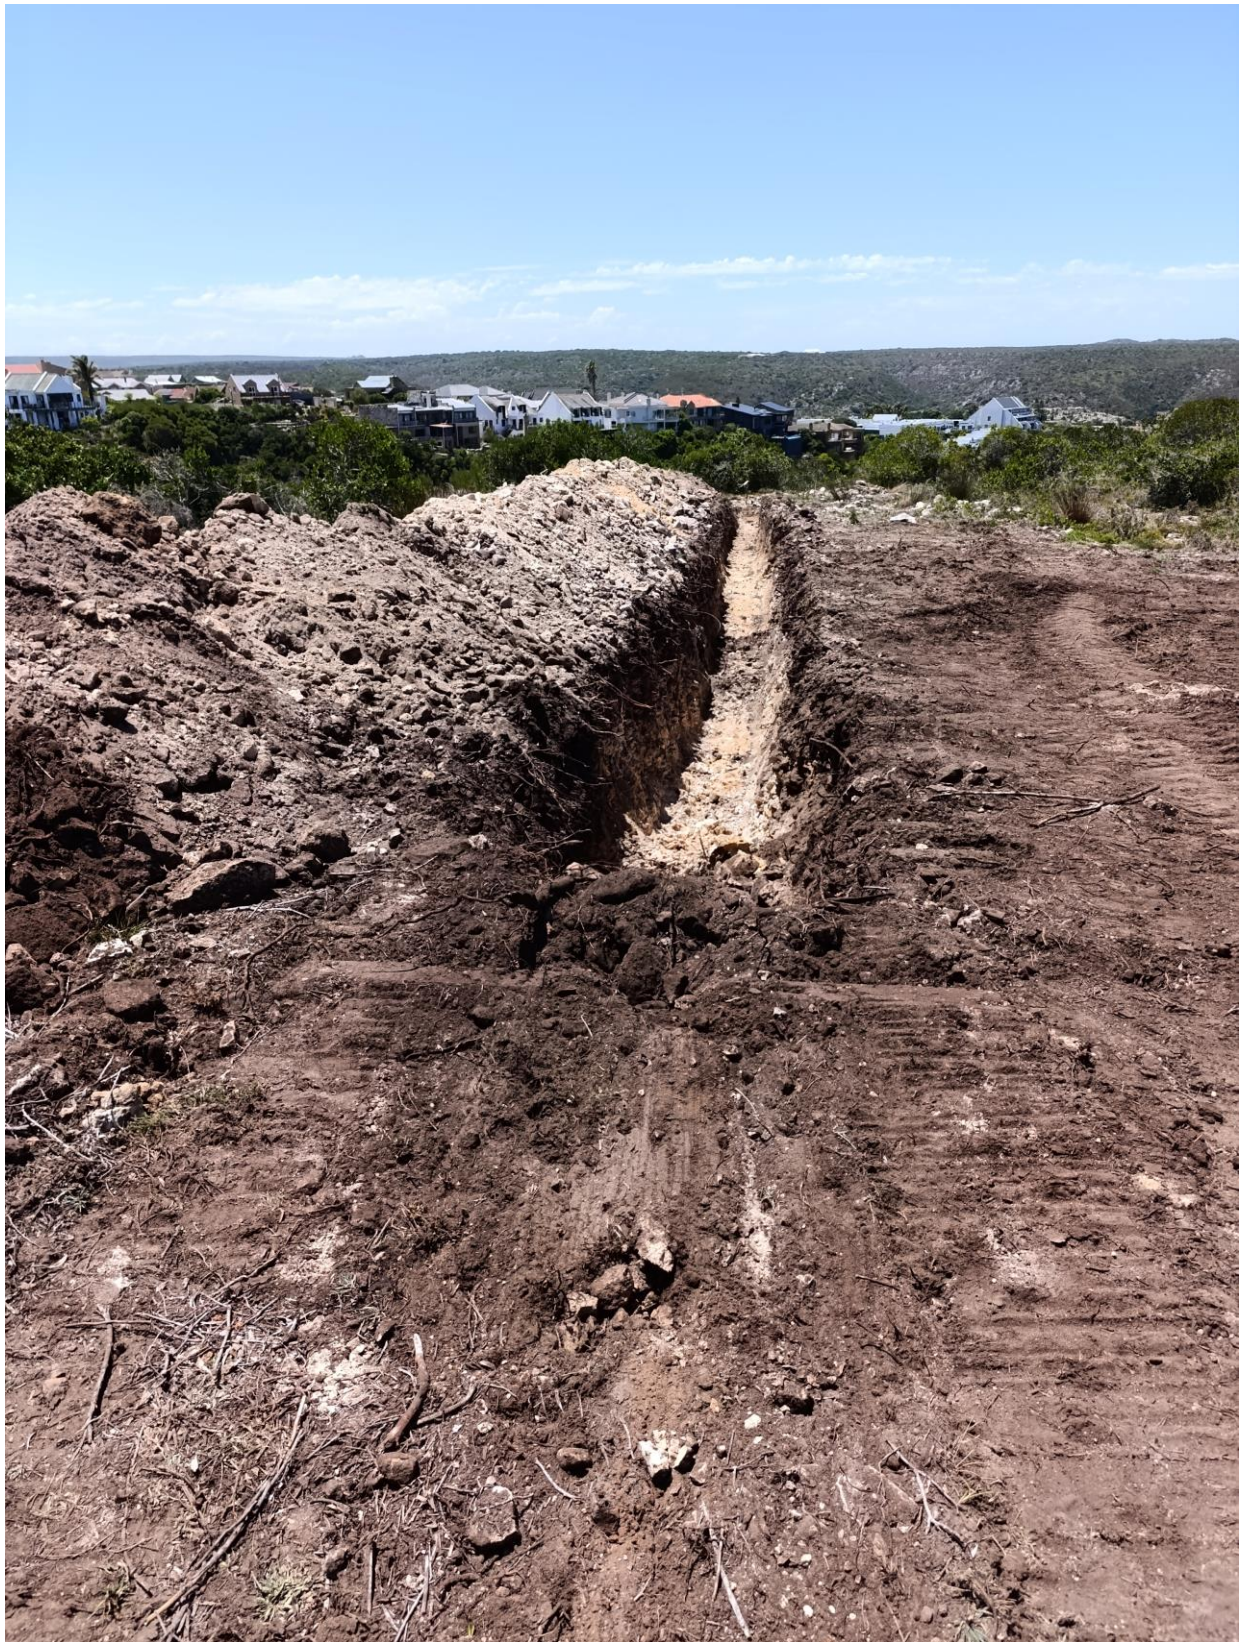
J2 (Finding since October 2024)	Stormwater Management and Services Infrastructure Proposed within No-go Areas	<p>As per the requirements of the EMP the detailed stormwater management plan must be provided to the ECO for inputs before finalisation. The draft SWMP has been provided to the ECO for inputs and a meeting was also held with the engineer during the first ECO site visit to discuss the plans as proposed.</p> <p>During engineer investigations it was determined that stormwater attenuation facilities would be required within the no-go areas to accommodate stormwater from the proposed development area. This must be confirmed by the engineer and before the detailed SWMP can be finalised and implemented it is recommended that the SWMP proposal with all associated services infrastructure plans also be represented to the Department for inputs to ensure that the proposal remains within the scope of the authorisation as it relates to the requirements of the EA and EMP.</p> <p>During the time of the site visit it was confirmed that the services plans have been finalised and observed that the laying of services pipelines has commenced within the No-go area. Previously the ECO stated that this should not occur before the services plans have been provided to the ECO and the Department for confirmation that it is in line with the approved EA and EMP</p>

Photo 3: Start of pipeline trench within no-go area (photo taken 29 January 2025).

<p>requirements.</p> <p>CONSTRUCTION OF ANY SERVICES INFRASTRUCTURE WITHIN THE NO-GO AREA MUST CEASE IMMEDIATELY AND NO CONSTRUCTION OF CIVIL SERVICES INFRASTRUCTURE I.E. ANY PIPELINES ETC. MAY CONTINUE UNTIL THE SERVICES INFRASTRUCTURE PLANS HAVE BEEN PROVIDED TO AND CONFIRMED BY THE ECO AND THE DEPARTMENT THAT IT IS IN LINE WITH THE APPROVAL REQUIREMENTS.</p>
J3	Dust Management	<p>From 12 December 2024 and throughout December 2024 and beginning of January 2025 complaints were received from two neighbouring property owners concerning excessive dust produced from the development site. The following measures have been implemented by the development to manage dust:</p> <ul style="list-style-type: none"> • Two water tankers available on site which sprays water throughout the site on a daily basis to dampen dust to prevent windblown dust. • Material Stockpiles have been relocated away from the borders of the development site and placed within a more central position. Stockpiles are also not more than 1.8m high. • A water sprinkler system has been installed throughout the site on bare areas around the edges to dampen the soil during windy conditions. • The developer has offered to pay for house cleaning services to directly adjacent homeowner affected by the dust. • Dust monitoring buckets have been installed to monitor dust levels produced to determine whether or not the amounts are within the legal limits. <p>The following dust management and monitoring measures still needs to be addressed:</p> <ul style="list-style-type: none"> • Provide a dust fallout monitoring plan. • Material causing dust i.e. sand, soil and gravel stockpiles have been properly covered and secured by

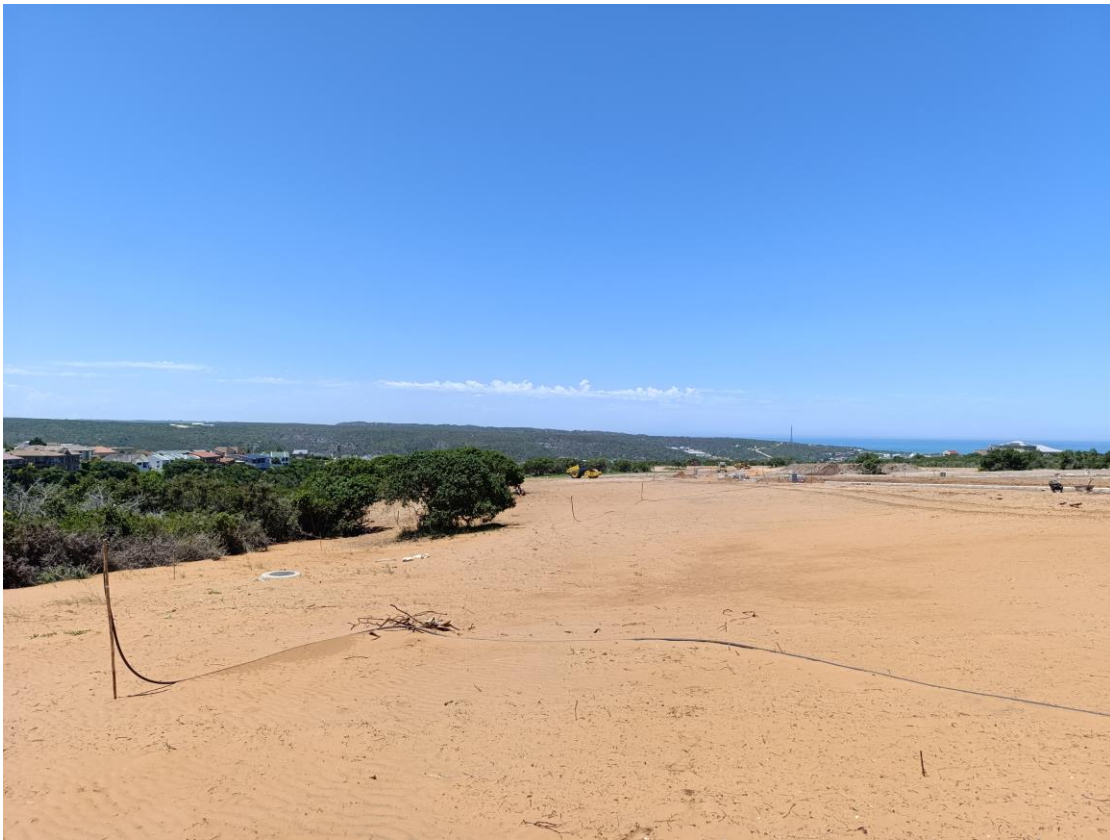
Photo 4: Sprinkler system installed (photo taken 29 January 2025)

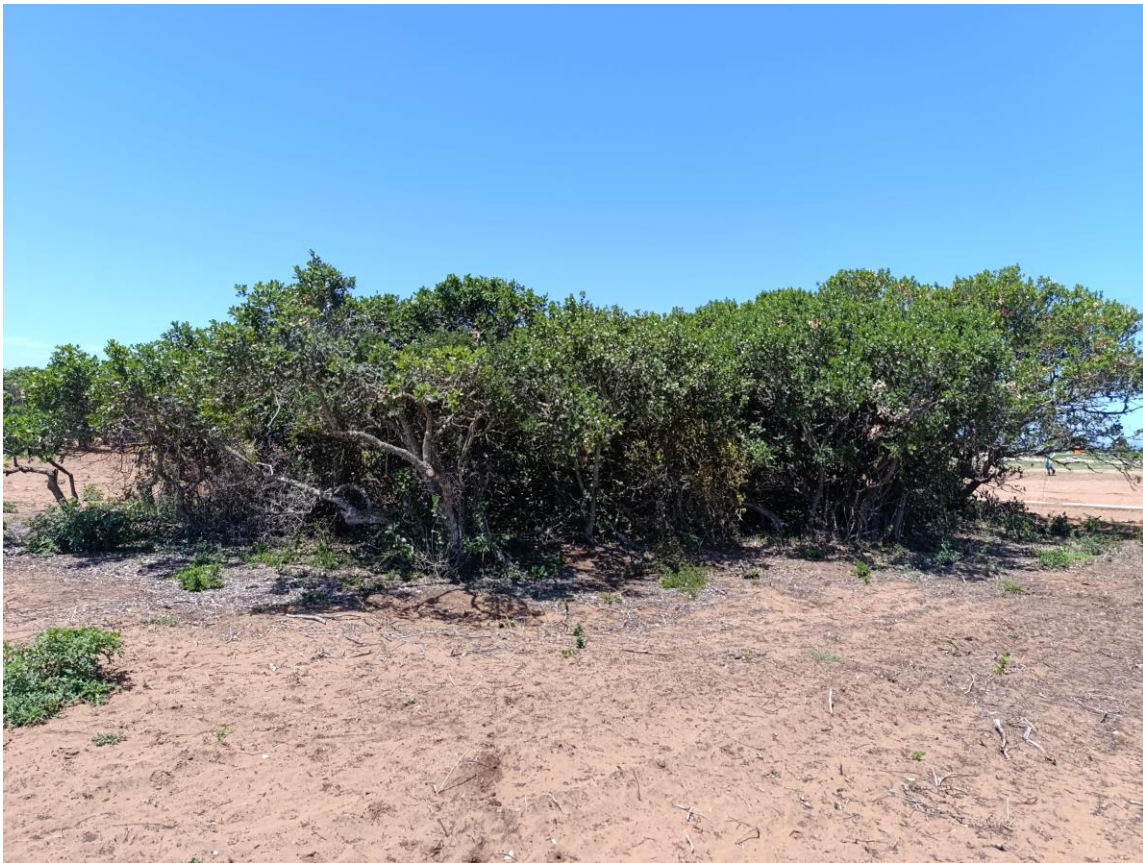
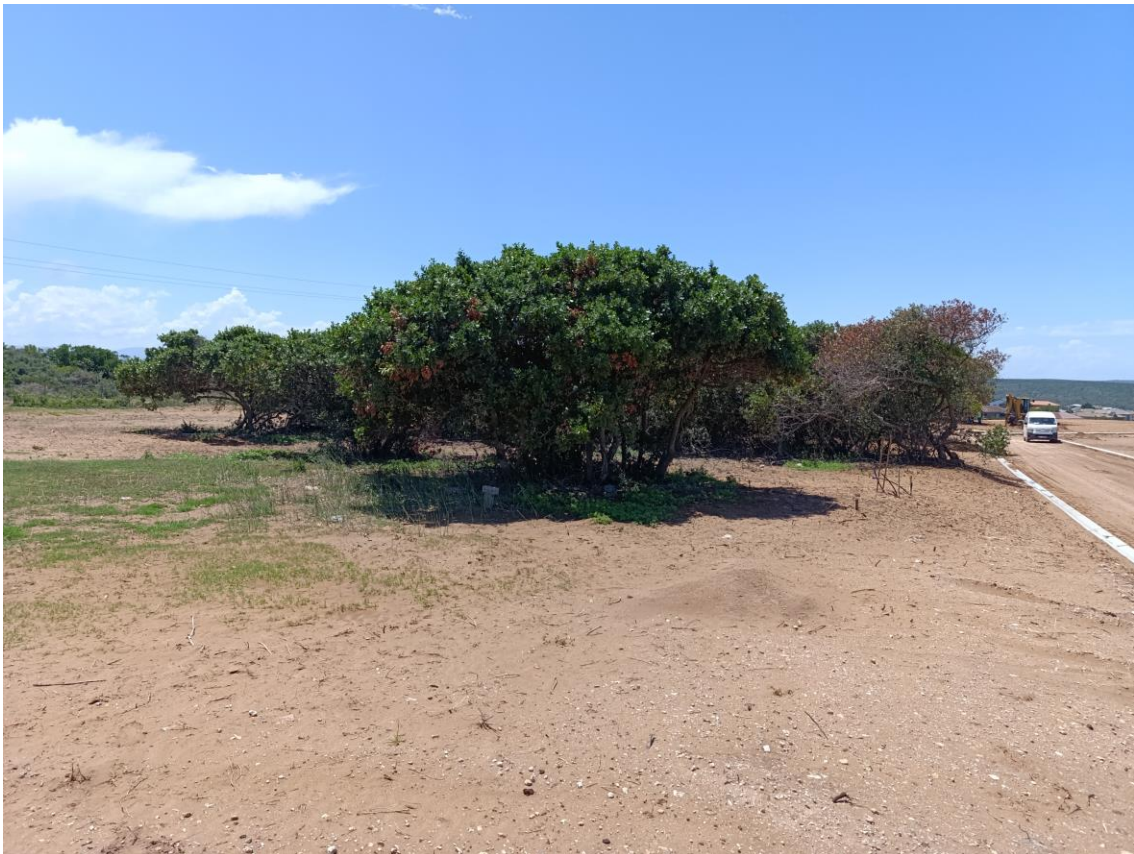
Photo 5: Milkwood tree clusters remaining within Phase 2 cleared areas (photo taken 29 January 2025)

Photo 6: Milkwood tree clusters remaining within Phase 2 cleared areas (photo taken 29 January 2025)

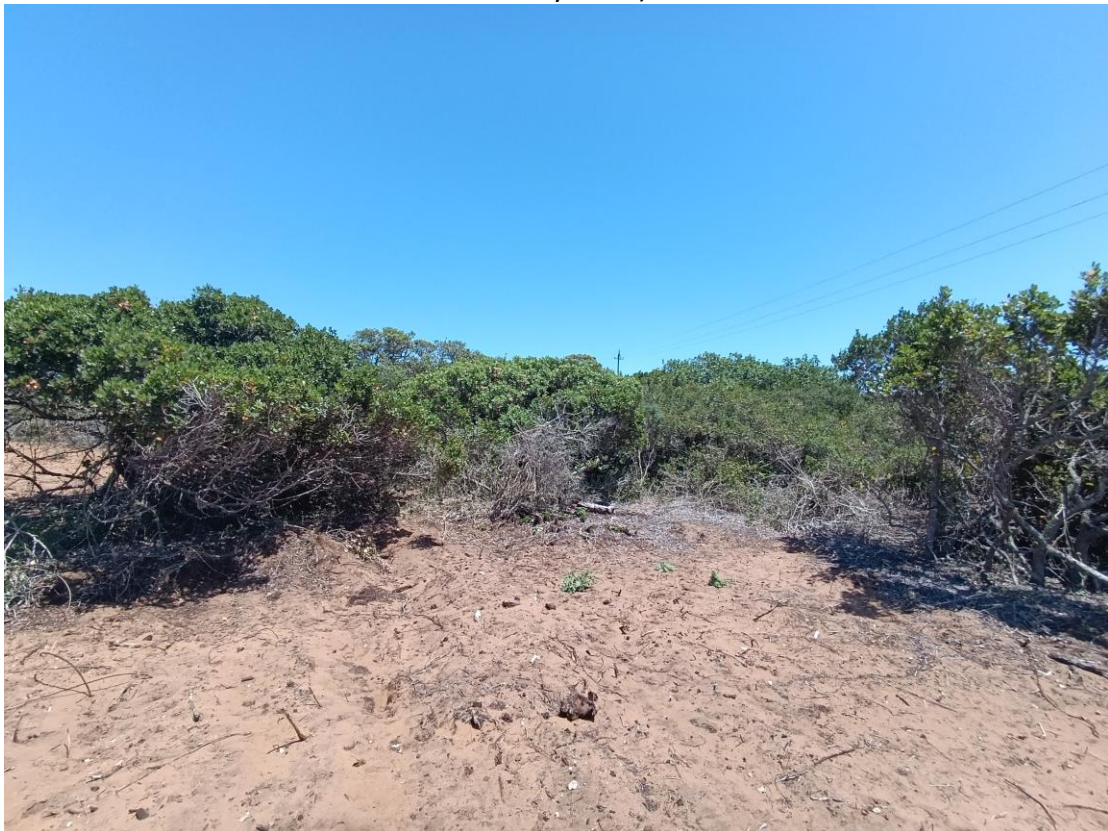
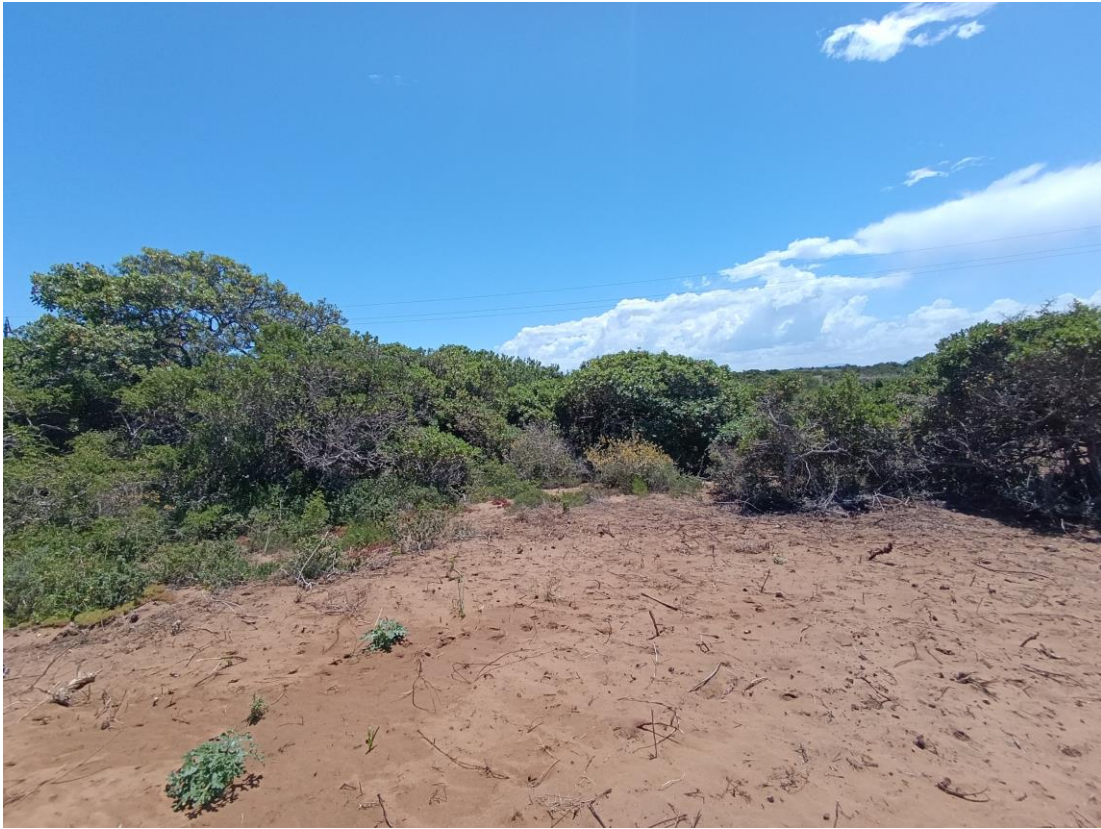
Photo 7: Milkwood trees at Phase 2 development area still to be cleared. (photo taken 29 January 2025).

Photo 8: Milkwood trees at Phase 2 development area still to be cleared. (photo taken 29 January 2025).

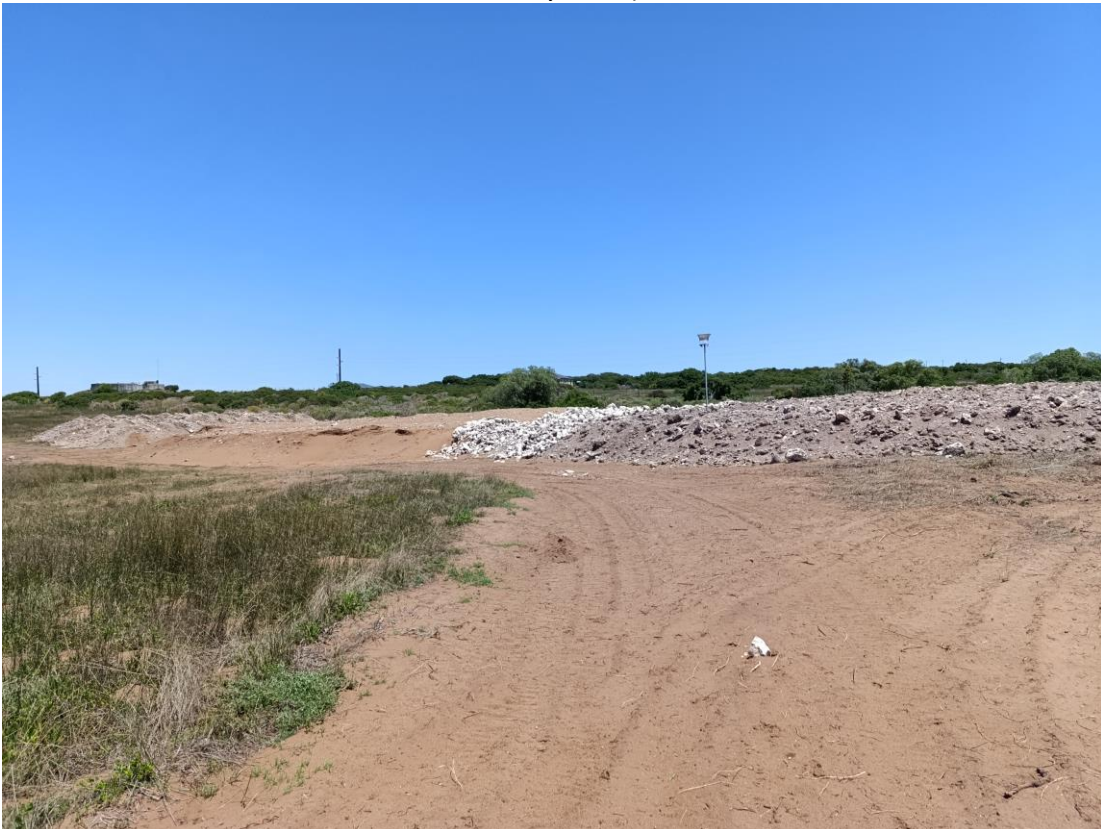
Photo 9: Material stockpiles to be covered to protect against excessive dust. (photo taken 29 January 2025)
