**RESIDENTIAL DEVELOPMENT ON THE REMAINDER  
OF PORTION 60 OF THE FARM PLATTEBOSCH NO.  
485, STILL BAY, WESTERN CAPE  
EA REF: 16/3/3/5/D5/19/0001/22**

**CONSTRUCTION PHASE  
ECO REPORT  
FOR APRIL 2025  
(Submitted 22 April 2025)**

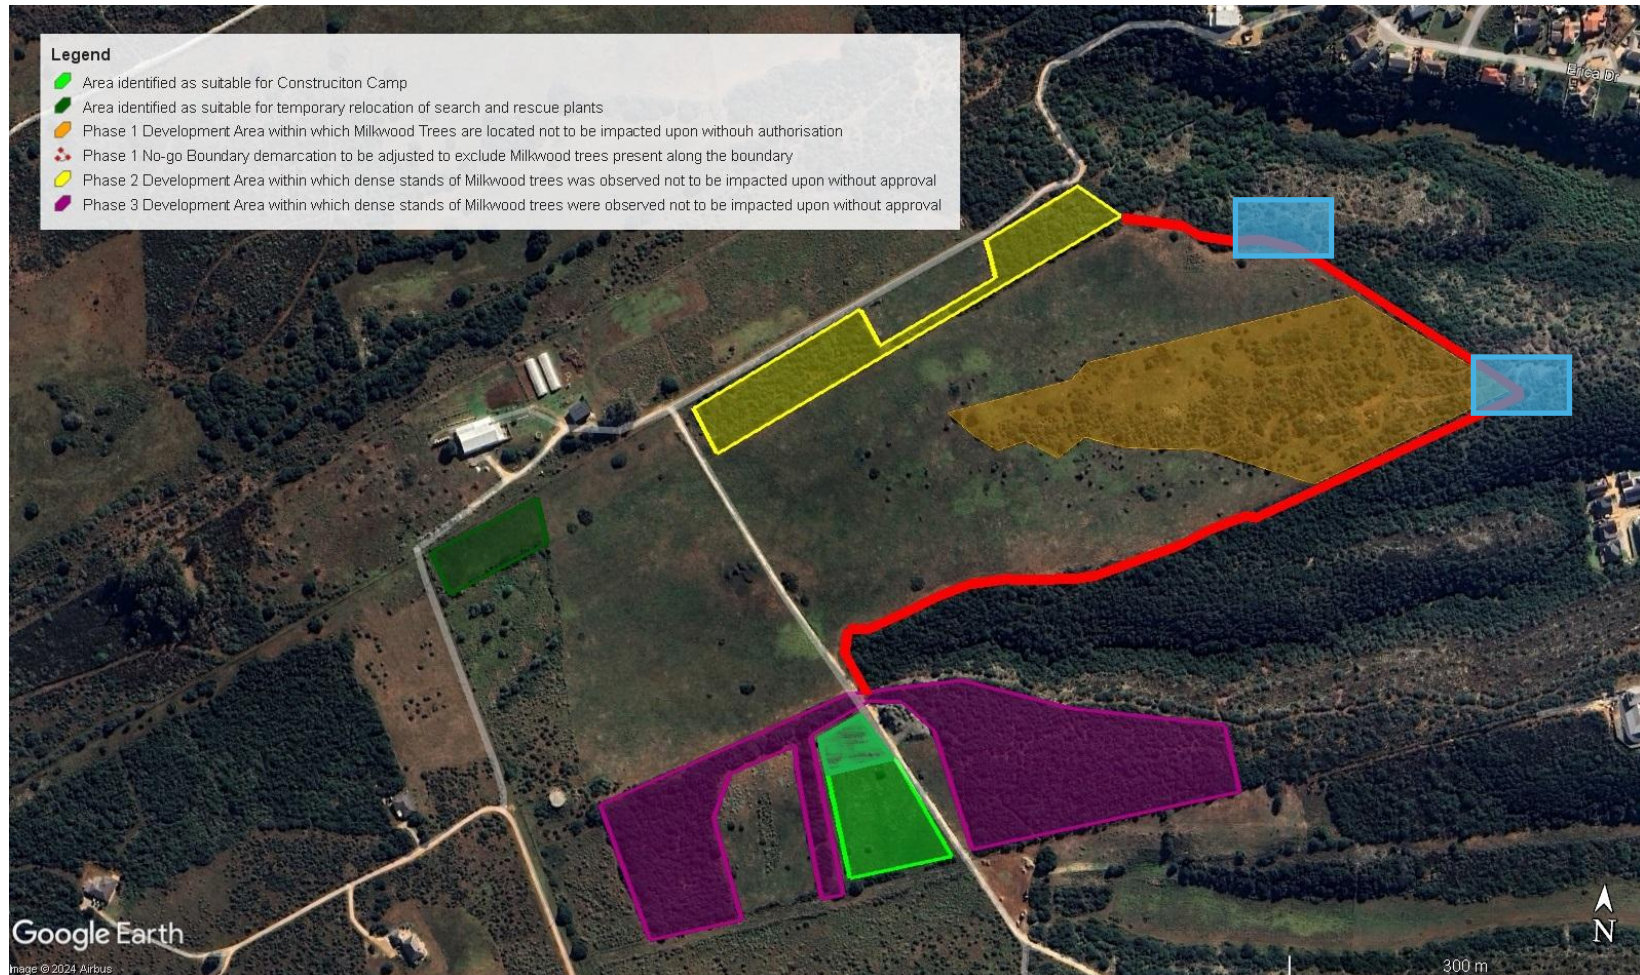
| | | <p>area. Several individual and clusters of Milkwood trees were recorded to remain within the cleared area and no significant damage or removal of Milkwood trees observed within this area.</p> <p>To confirm that Milkwood trees are incorporated into the development layout and proof that observed Milkwood trees remain undamaged/are not removed within the development area throughout the construction and development phases all Milkwood trees falling within the development footprint area must be recorded and indicated on the approved development layout plan. This is required for all remaining Milkwood trees within the already cleared Phase 1 and 2 areas as well as clearly visible Milkwood trees along the boundaries of Phase 1 and 2 and Phase 3 areas which has also been cleared.</p> <p>Should removal, relocation or pruning (of more than 25% of the canopy) of any Milkwood trees be required application/s must be made to the DFFE for removal, relocation or pruning before any Milkwood trees may be impacted upon. As far as possible these trees must be accommodated within the layout and not removed.</p> <p><b>Refer to the map below.</b></p> |

**Map 1:** July 2024 ECO map for indicating areas where Milkwood trees were observed and to be avoided; proposed construction camp placement; proposed search and rescue plants temporary placement. **The blue squares on the map above shows where encroachment into the no-go areas have occurred, as per the recommendations no-go demarcation must remain reinstated as per original demarcation done by the land surveyor and the impacted no-go area must be monitored for rehabilitated**

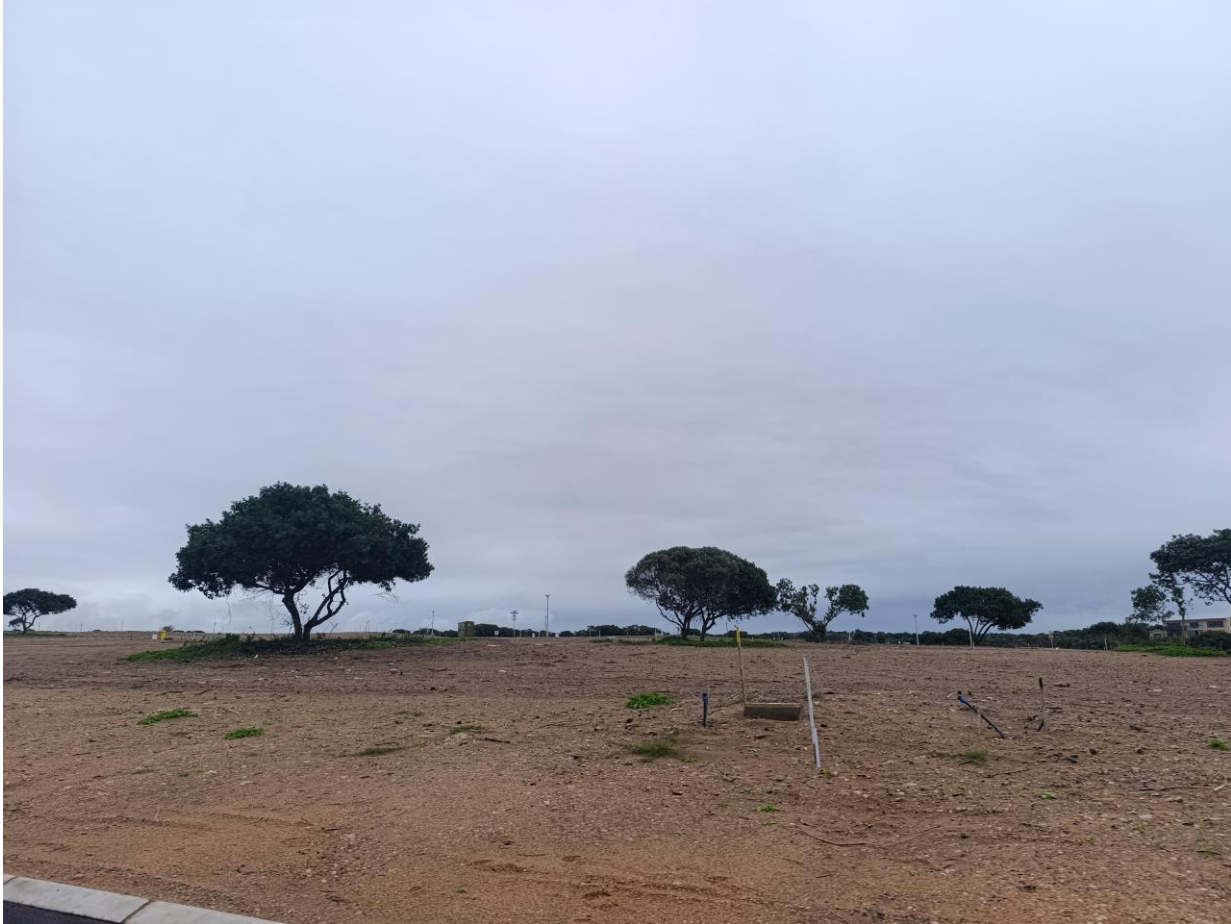
| <b>Finding No.</b> | <b>Area of activity</b> | <b>ECO Findings and Recommendations</b> |
|---|---|---|
| A1 (Finding since Sept 2024) | Milkwood trees within development area | <p>A total of 26 Milkwood trees were counted by the ECO located within the Phase 1 development area. The remaining presence of these Milkwood trees within the cleared Phase 1 development area was confirmed during the site visit conducted 29 January 2025. Within the northern corner of Phase 2 where vegetation clearance has already been conducted 7 clusters of Milkwood trees and 3 individual trees were recorded and photographed.</p> <p>During the February 2025 ECO inspection it was also observed that the developer continued with clearance activities around stands of Milkwood trees falling within Phase 2 development</p> |

**Photo 1:** Remaining Milkwood trees on Phase 1 cleared area, to be recorded on layout plan (photo taken 21 April 2025).

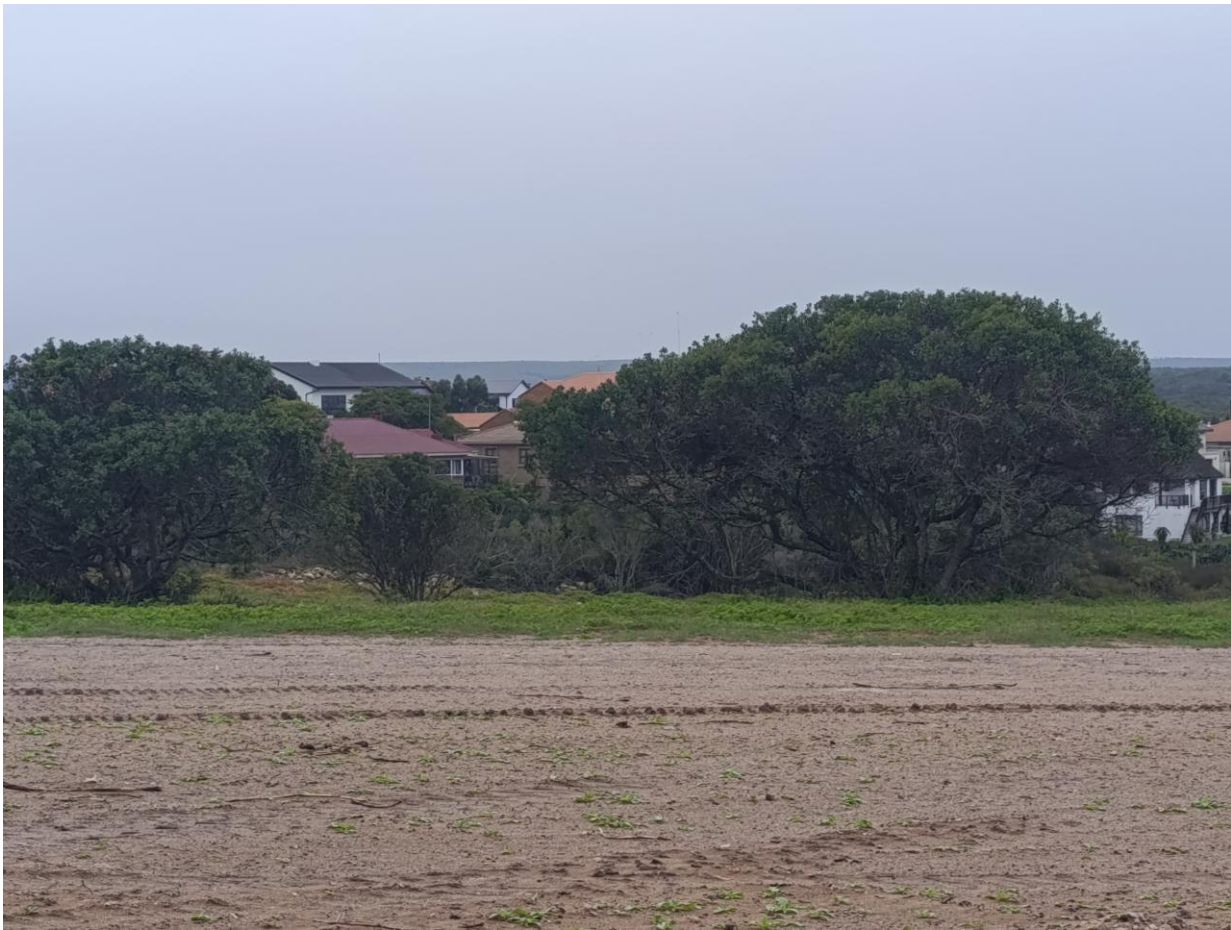
**Photo 2:** Impacted no-go/public open space area rehabilitation progress (photo taken 21 April 2025)

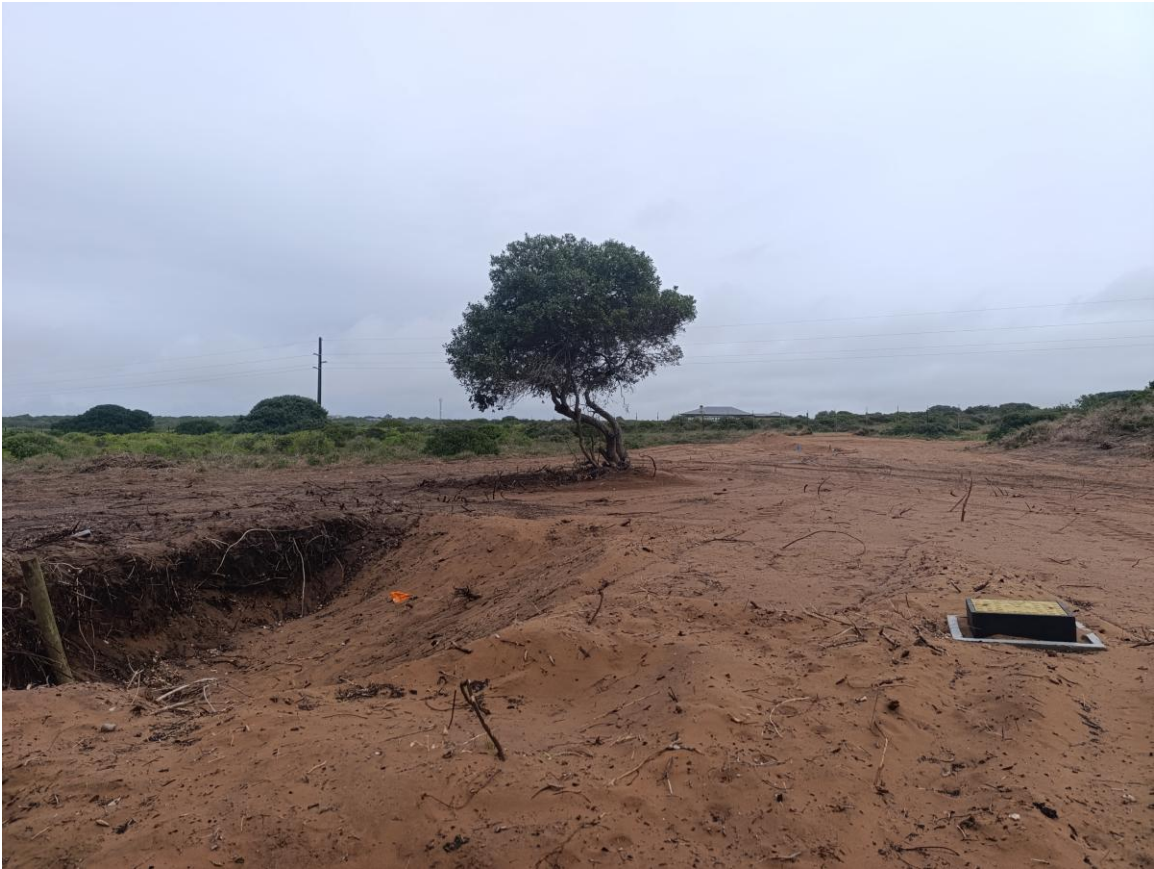
**Photo 3:** Damaged Milkwood tree along Phase 3 stabilised as observed by ECO (photo taken 21 April 2025)
