**RESIDENTIAL DEVELOPMENT ON THE REMAINDER
OF PORTION 60 OF THE FARM PLATTEBOSCH NO.
485, STILL BAY, WESTERN CAPE
EA REF: 16/3/3/5/D5/19/0001/22**

**CONSTRUCTION PHASE
ECO REPORT
FOR MARCH 2025
(Submitted 30 March 2025)**

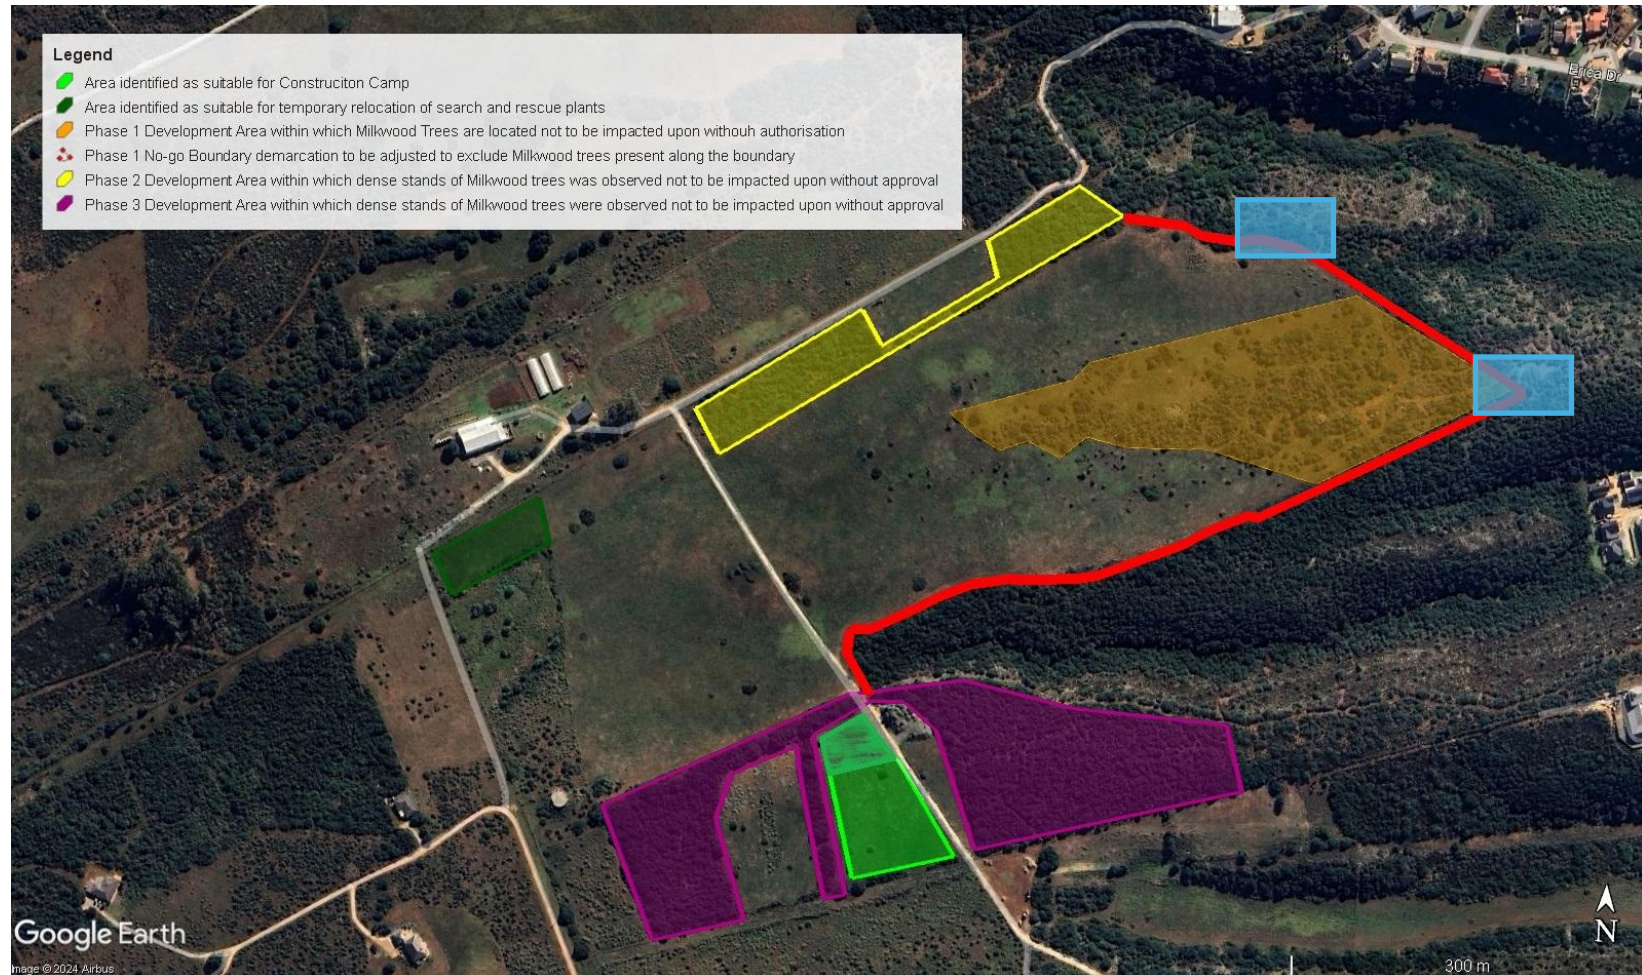
Map 1: July 2024 ECO map for indicating areas where Milkwood trees were observed and to be avoided; proposed construction camp placement; proposed search and rescue plants temporary placement. **The blue squares on the map above shows where encroachment into the no-go areas have occurred, as per the recommendations no-go demarcation must remain reinstated as per original demarcation done by the land surveyor and the impacted no-go area must be monitored for rehabilitated**

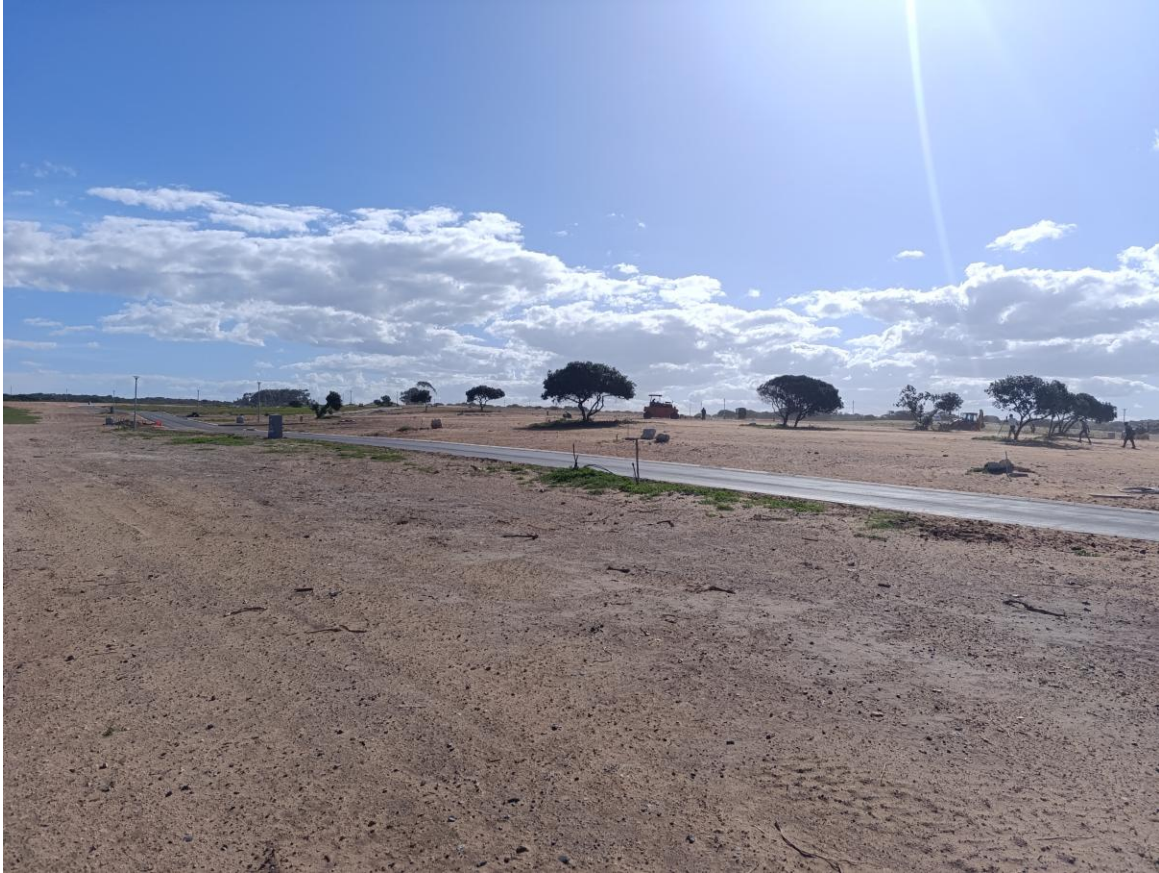
Finding No.	Area of activity	ECO Findings and Recommendations
M1 (Finding since Sept 2024)	Milkwood trees within development area	<p>A total of 26 Milkwood trees were counted by the ECO located within the Phase 1 development area. The remaining presence of these Milkwood trees within the cleared Phase 1 development area was confirmed during the site visit conducted 29 January 2025. Within the northern corner of Phase 2 where vegetation clearance has already been conducted 7 clusters of Milkwood trees and 3 individual trees were recorded and photographed.</p> <p>During the February 2025 ECO inspection it was also observed that the developer continued with clearance activities around stands of Milkwood trees falling within Phase 2 development area. Several individual and clusters of Milkwood trees were</p>

<p>recorded to remain within the cleared area and no significant damage or removal of Milkwood trees observed within this area.</p> <p>To confirm that Milkwood trees are incorporated into the development layout and proof that observed Milkwood trees remain undamaged/are not removed within the development area throughout the construction and development phases all Milkwood trees falling within the development footprint area must be recorded and indicated on the approved development layout plan. This is required for all remaining Milkwood trees within the already cleared Phase 1 and 2 areas as well as clearly visible Milkwood trees along the boundaries of Phase 1 and 2 and Phase 3 areas which has also been cleared.</p> <p>Should removal, relocation or pruning (of more than 25% of the canopy) of any Milkwood trees be required application/s must be made to the DFFE for removal, relocation or pruning before any Milkwood trees may be impacted upon. As far as possible these trees must be accommodated within the layout and not removed.</p> <p>Refer to the map below.</p>

Photo 1: Remaining Milkwood trees om Phase 1 cleared area, to be recorded on layout plan (photo taken 25 March 2025).

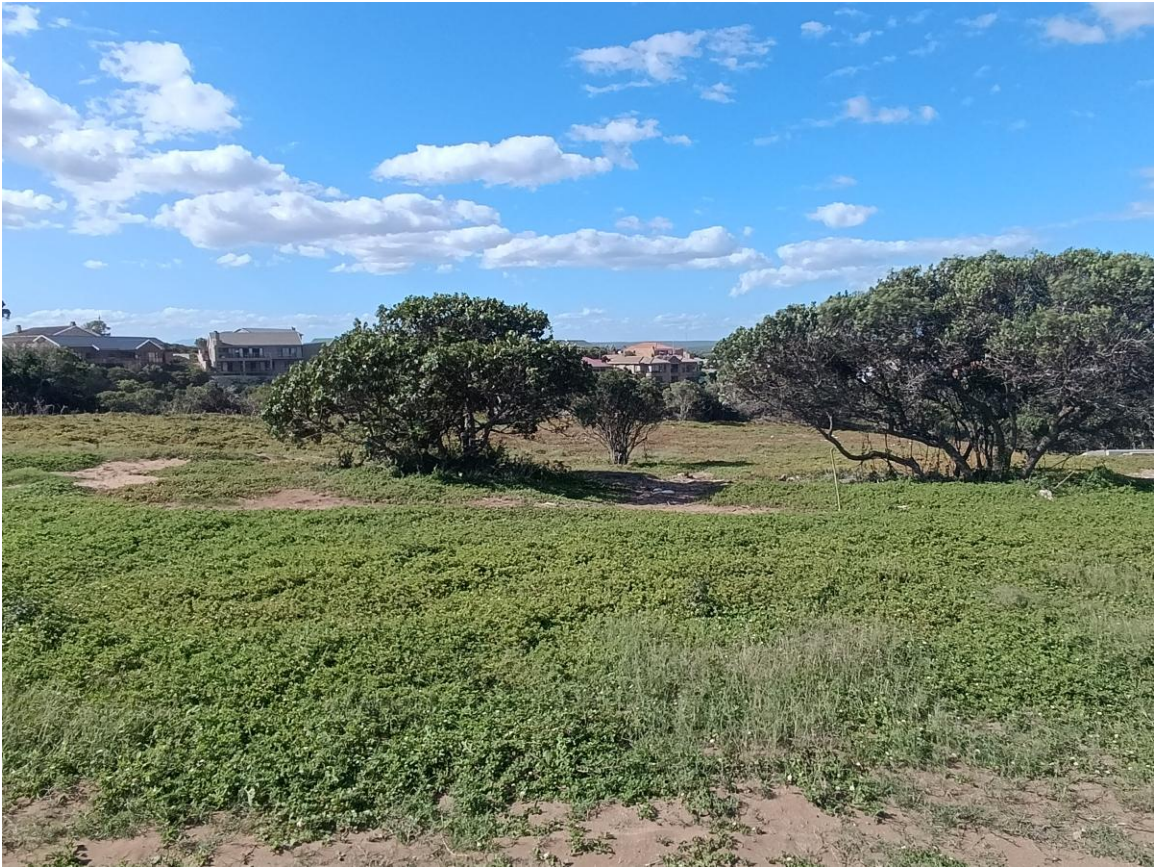
Photo 2: Impacted no-go/public open space area rehabilitation progress (photo taken 25 March 2025)

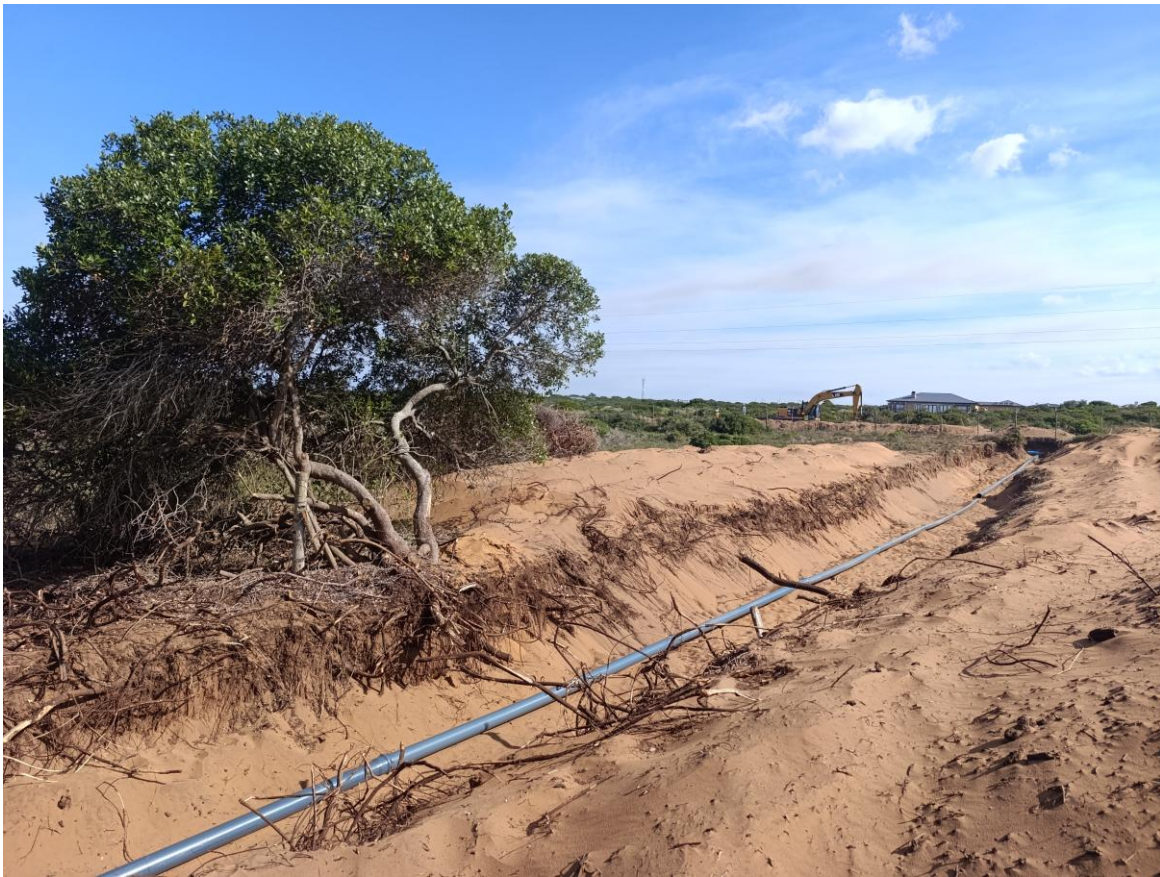
M3	Demarcation of No-go Areas	<p>During the time of the February 2025 ECO inspection, it was observed that site clearance and construction activities along the boundaries of Phase 3 public open space areas commenced without providing the ECO opportunity to inspect the correctness of the no-go boundary demarcations.</p> <p>This has led to significant damage to at least two Milkwood trees observed along the public open space boundaries of phase 3. It was discussed with the site manager on site that rehab around the damaged Milkwood trees would take place same day to try and stabilise what remains of the trees to prevent the trees from dying. Disturbances around one of the damaged Milkwood trees have been stabilised, but disturbance around the other damaged Milkwood tree observed during the Feb 2025 ECO inspection has not yet been stabilised.</p>

Photo 3: Damage to Milkwood trees along Phase 3 public open space boundary as observed by ECO (photo taken 25 March 2025)

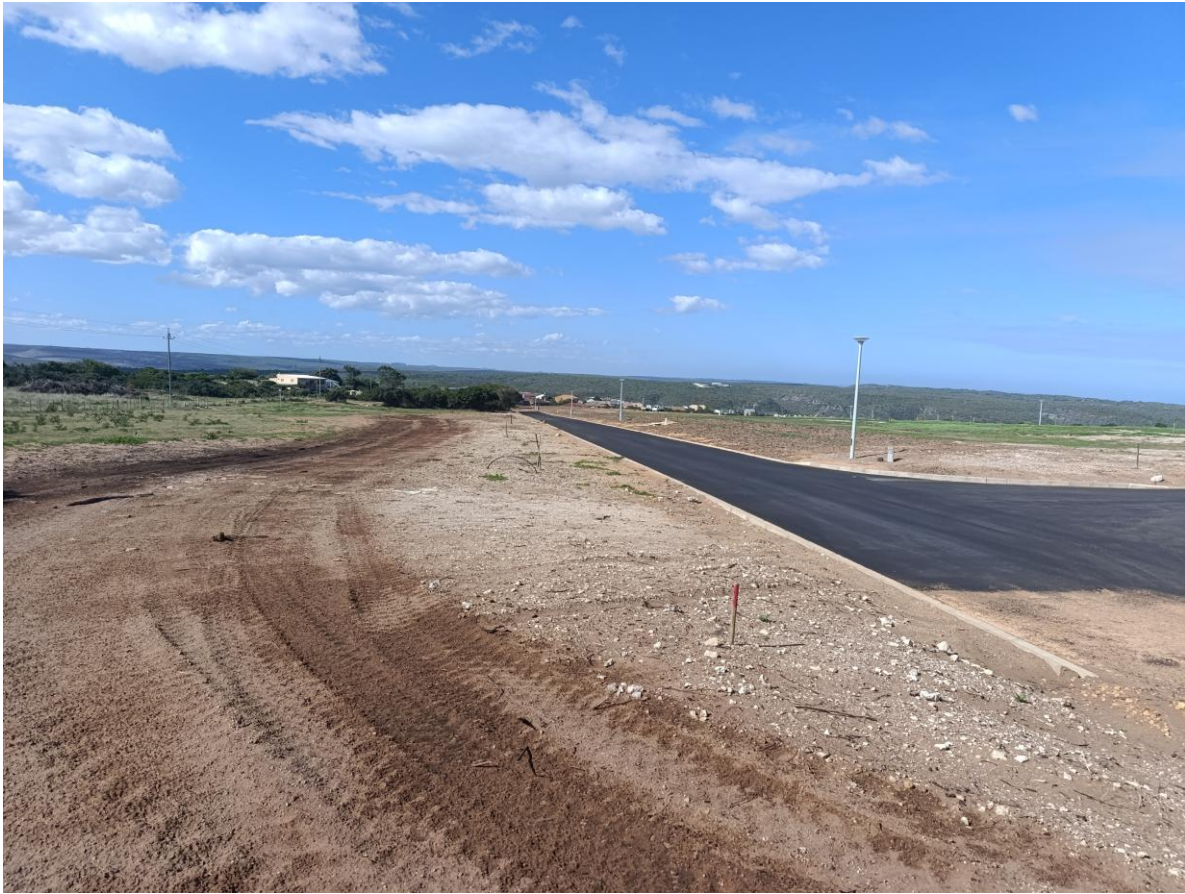
Photo 4: Progress of Phase 1 and 2 internal roads being tarred (photo taken 25 March 2025)
