RESIDENTIAL DEVELOPMENT ON THE REMAINDER OF PORTION 60 OF THE FARM PLATTEBOSCH NO. 485, STILL BAY, WESTERN CAPE

CONSTRUCTION PHASE

ECO REPORT

FOR MAY 2025

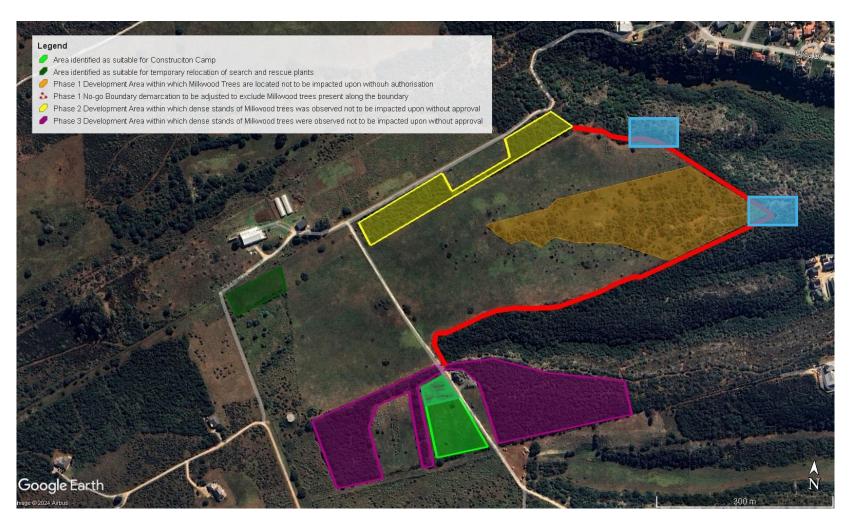
Map 1: July 2024 ECO map for indicating areas where Milkwood trees were observed and to be avoided; proposed construction camp placement; proposed search and rescue plants temporary placement. The blue squares on the map above shows where encroachment into the no-go areas have occurred, as per the recommendations no-go demarcation must remain reinstated as per original demarcation done by the land surveyor and the impacted no-go area must be monitored for rehabilitated

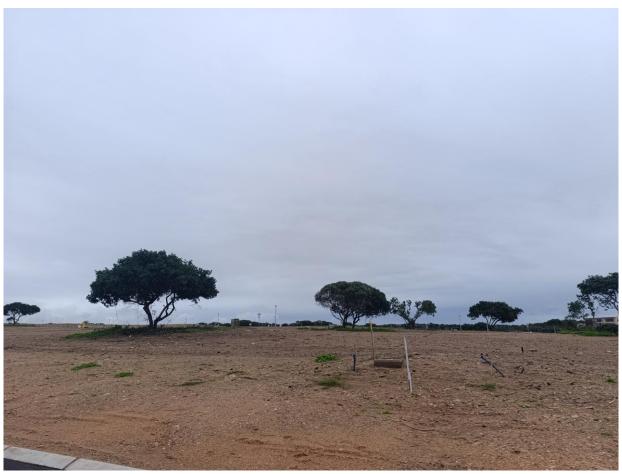
Finding No.	Area of activity	ECO Findings and Recommendations
M1 (Finding since Sept 2024)	Milkwood trees within development area	A total of 26 Milkwood trees were counted by the ECO located within the Phase 1 development area. The remaining presence of these Milkwood trees within the cleared Phase 1 development area was confirmed during the site visit conducted 29 January 2025. Within the northern corner of Phase 2 where vegetation clearance has already been conducted 7 clusters of Milkwood trees and 3 individual trees were recorded and photographed. During the February 2025 ECO inspection it was also observed that the developer continued with clearance activities around stands of Milkwood trees falling within Phase 2 development

area. Several individual and clusters of Milkwood trees were recorded to remain within the cleared area and no significant damage or removal of Milkwood trees observed within this area.

Photo 1: Remaining Milkwood trees om Phase 1 cleared area, to be recorded on layout plan (photo taken 21 April 2025).

To confirm that Milkwood trees are incorporated into the development layout and proof that observed Milkwood trees remain undamaged/are not removed within the development area throughout the construction and development phases all Milkwood trees falling within the development footprint area must be recorded and indicated on the approved development layout plan. This is required for all remaining Milkwood trees within the already cleared Phase 1 and 2 areas as well as clearly visible Milkwood trees along the boundaries of Phase 1 and 2 and Phase 3 areas which has also been cleared.

Should removal, relocation or pruning (of more than 25% of the canopy) of any Milkwood trees be required application/s must be made to the DFFE for removal, relocation or pruning before any Milkwood trees may be impacted upon. As far as possible these trees must be accommodated within the layout and not removed.

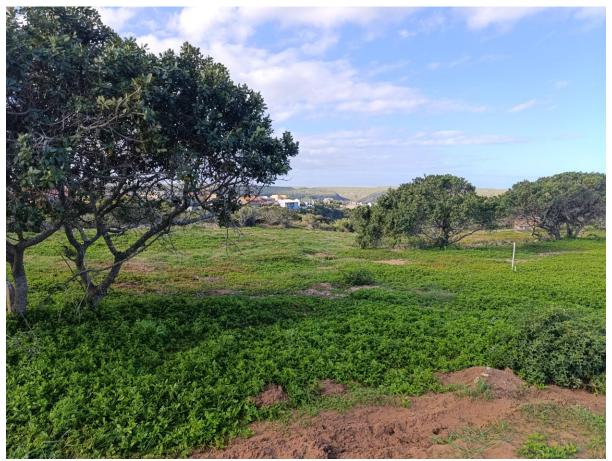
Photo 2: Impacted no-go/public open space area rehabilitation progress (photo taken 30 May 2025)

All impacted areas along the sewer pipeline route within the no-go/public open space areas must be rehabilitated with indigenous vegetation and monitored on a monthly basis (and after heavy rainfall) for signs of erosion. Should erosion be detected the ECO must be consulted for rehabilitation and stabilisation methods to be implemented.

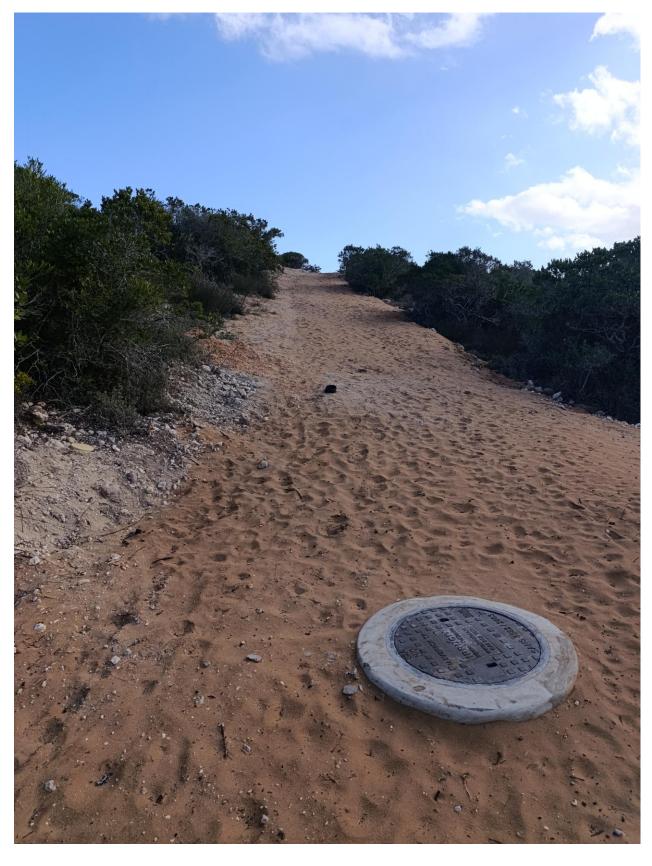
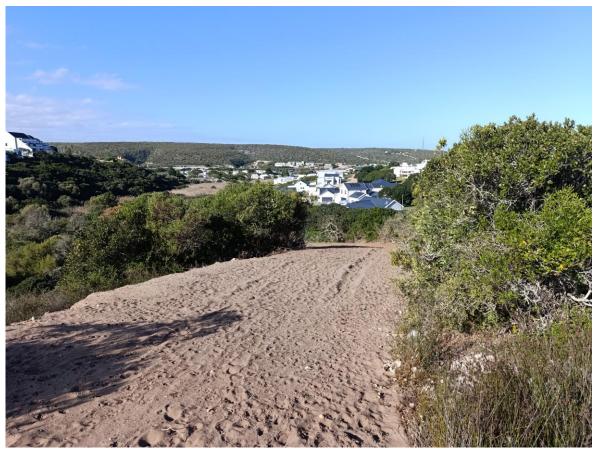
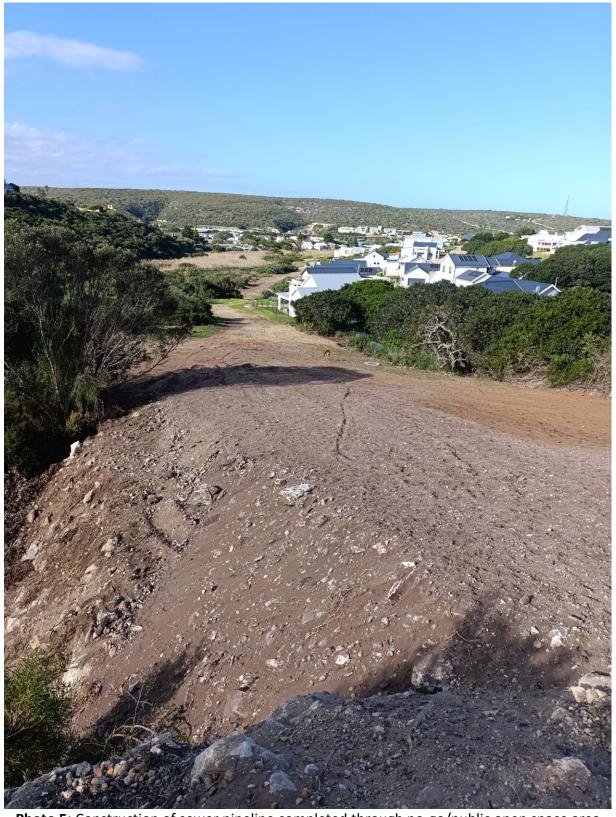
During the May 2025 ECO inspection the ECO observed that the construction of the entire sewer pipeline located within the Public Open Space/no-go area was already completed. The site manager did not provide the ECO with the amended pipeline route as requested in previous ECO reports for approval. In accordance with the approved method statement the site manager also did not peg and demarcate the 3m construction area for the entire sewer pipeline route and did not inform the ECO accordingly to obtain written confirmation from the ECO that site clearance and construction could commence.

The ECO therefore cannot confirm that Milkwood trees was avoided during construction of the sewer pipeline through the nogo/public open space area. The ECO can confirm that in some areas along the constructed sewer pipeline route section of more than 3m wide were impacted upon (vegetation completely removed).

Photo 3: Construction of sewer pipeline completed through no-go/public open space area (photo taken 30 May 2025)

Photo 4: Construction of sewer pipeline completed through no-go/public open space area (photo taken 30 May 2025)

Photo 5: Construction of sewer pipeline completed through no-go/public open space area (photo taken 30 May 2025)
