1<sup>st</sup> DAM SAFETY INSPECTION REPORT  
of  
**Byevanger Dam**

12 September 2019

Report No: C235A-D02-1

**FIRST DAM SAFETY INSPECTION REPORT  
OF  
BYEVANGER DAM**

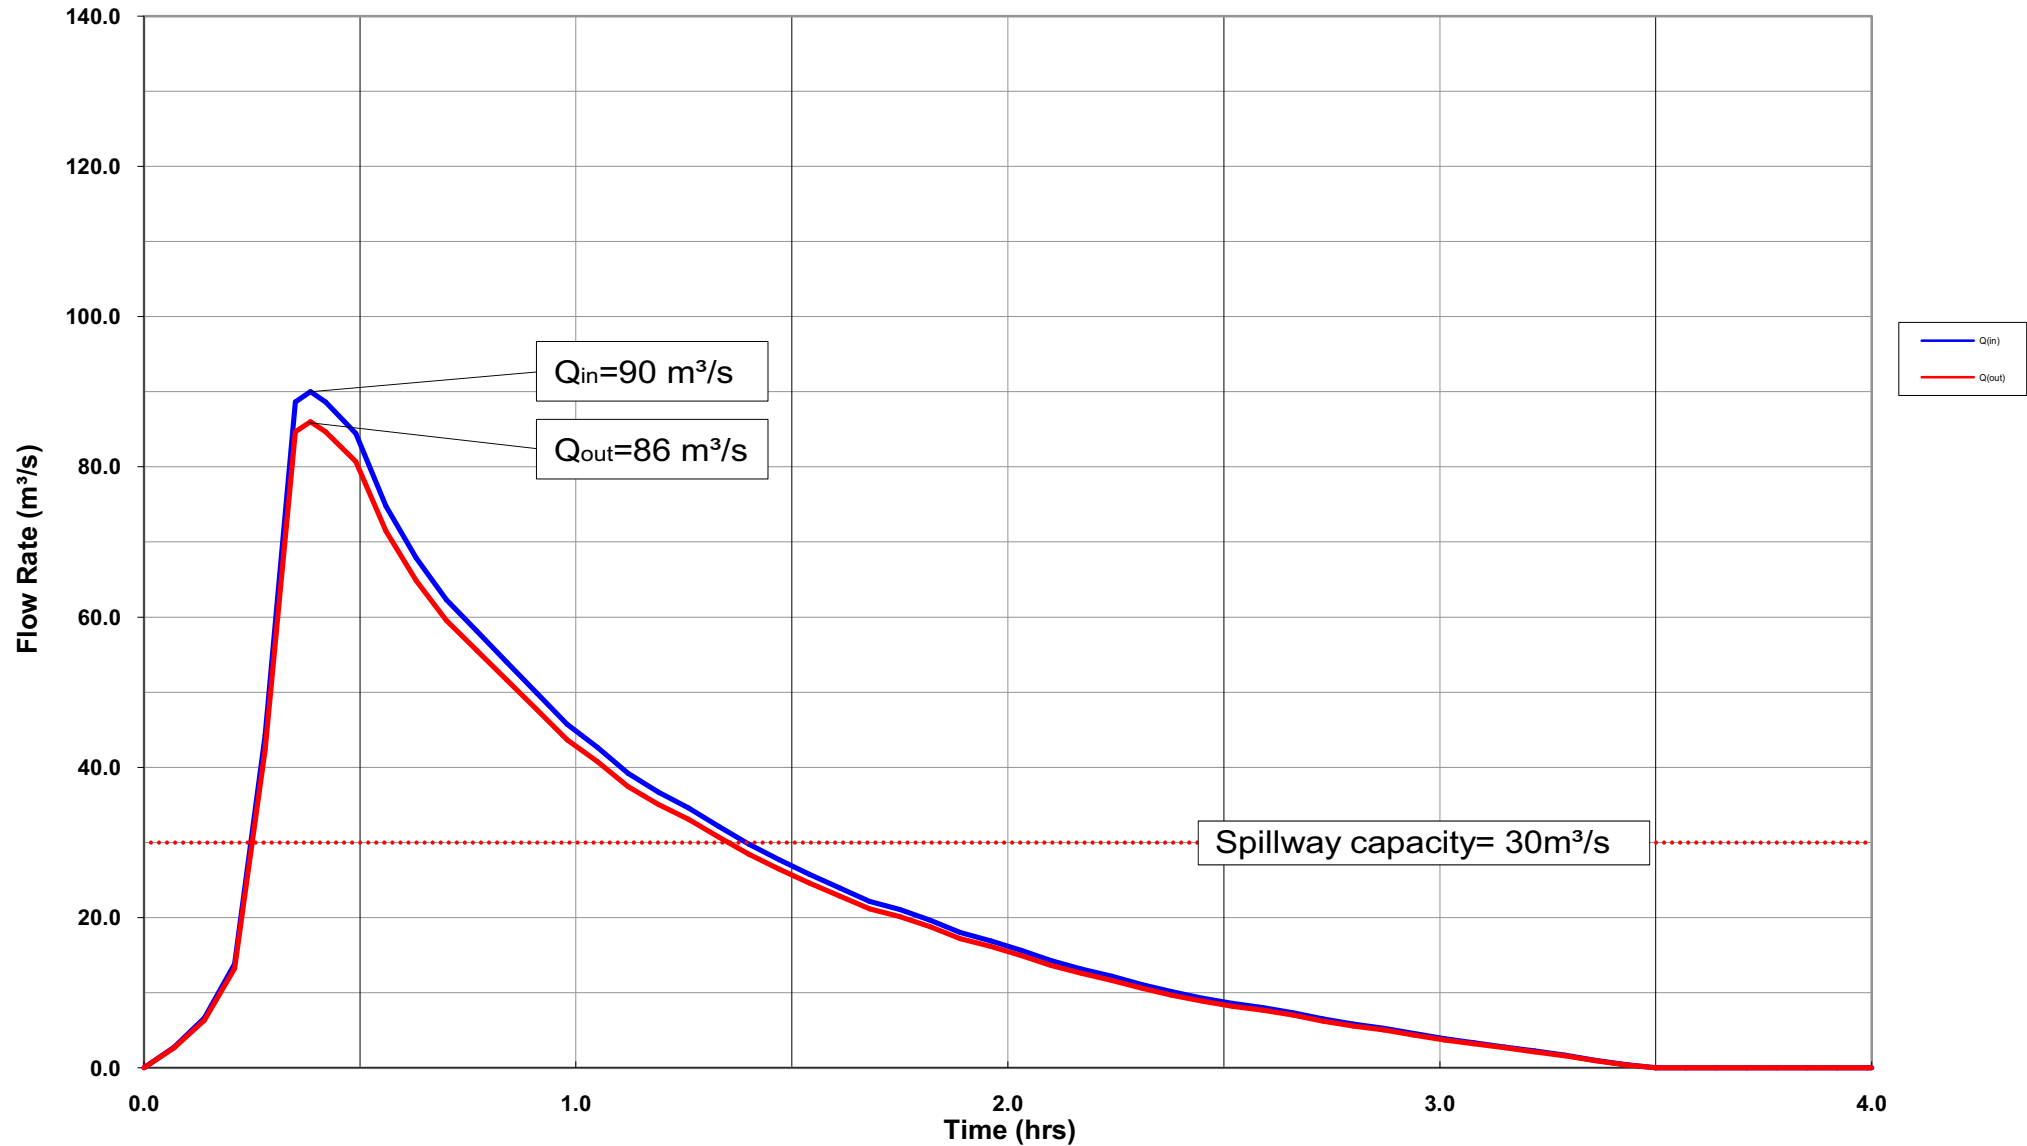
SEF = PMF (Cat.II Small Sig.)

The capacity of the spillway is regarded inadequate and the non-overspill crest will be overtopped in the event of the RDF & SEF occurring.

Overtopping at a max flow rate of 56m³/s

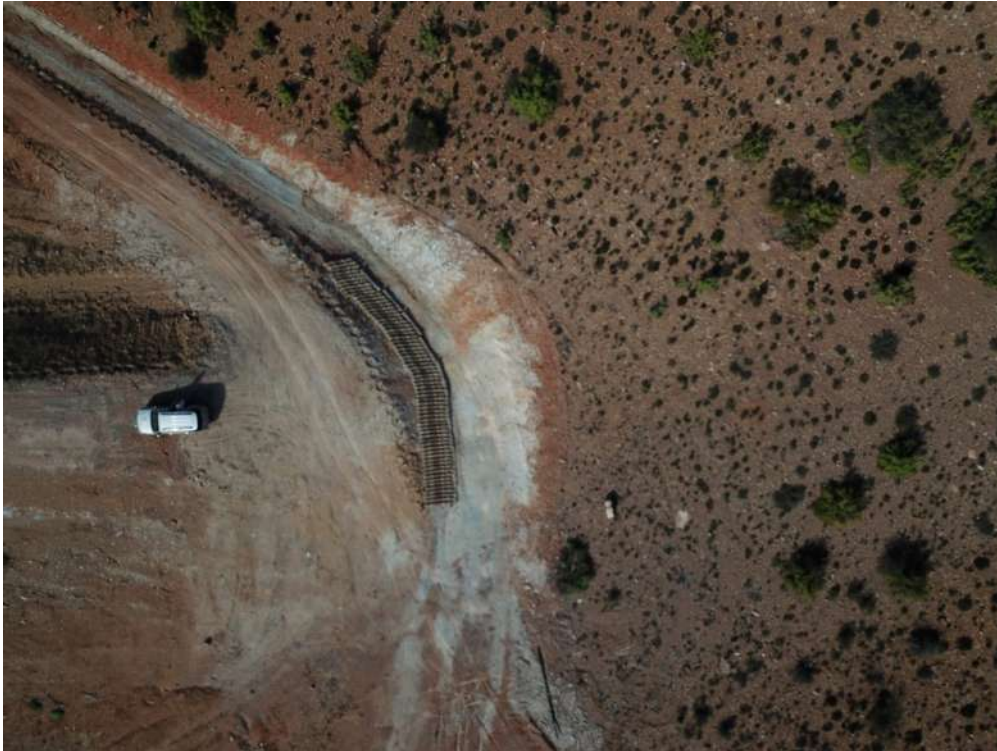
**Photo 1**

Final evaluation of spillway capacity: The spillway channel was found to be inadequate for the calculated RDF and SEF flood peaks. For the dam to service at least the RDF flood peak, the spillway channel will have to be enlarge by increasing the freeboard and the spillway channel width. (See Photo's 1,3,10-12,16,17)

No structures within the spillway channel, concrete beams are placed on the left retaining wall. Spillway appears stable but too small for calculated flood peaks. (See Photo's 1,3,10-12,16,17)

Aerial view of the spillway channel on the right flank with forebay and crest visible.

No.	Description of Activity flowing from recommendations	Planned Start Date	Actual Completion Date (only if completed)
1	Urgently adjust the spillway channel capacity to service the RDF flood peak by increasing the freeboard to 2.5m and the spillway crest length to 9m, but complying with the Sec. 24G NEMA and current WULA process.	27 Jan 2020	
2	Provide the upstream slope with rip rap placement as protection against erosion, but complying with the Sec. 24G NEMA and current WULA process.	27 Jan 2020	
3	Fill and compact with appropriate materials the low spots/potholes on the non overspill crest to prevent further degradation, but complying with the Sec. 24G NEMA and current WULA process.	27 Jan 2020	
4	Provide grass growth for the downstream slope to prevent/repair erosion process, but complying with the Sec. 24G NEMA and current WULA process.	27 Jan 2020	
5	Ensure that the dam does not store any water at all to comply with the Dam Safety Office/Environmental directive and to comply with the Sec. 24G NEMA and the current WULA process.	27 Jan 2020

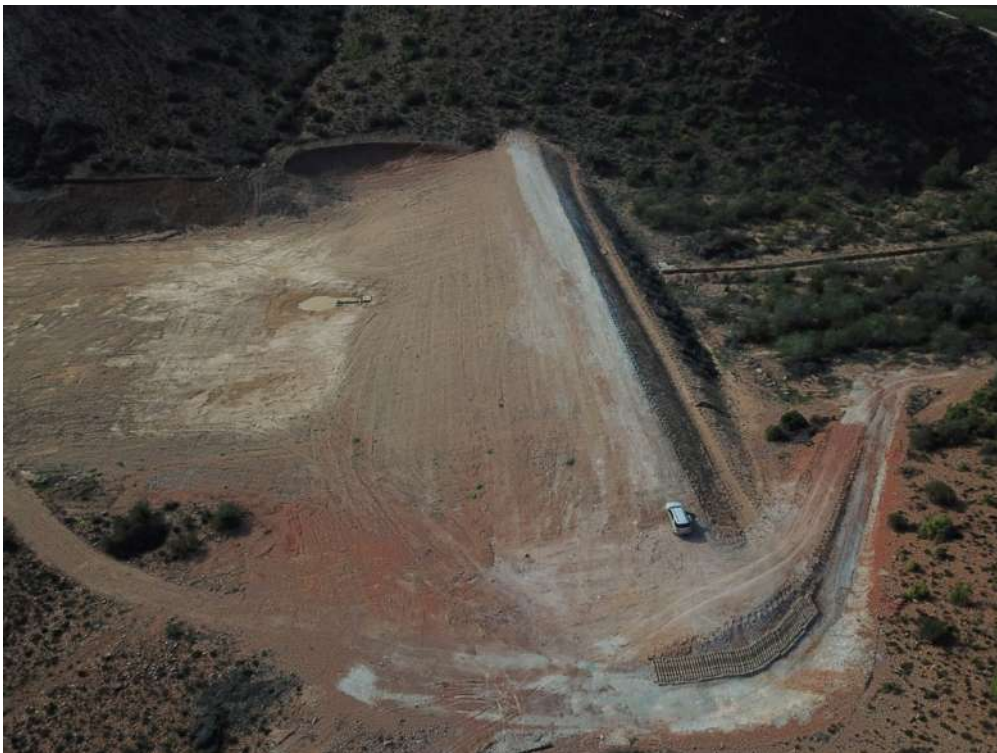
**Photo 2**

Slope protection measures (if any): Only gravel surface with no additional protection. (See Photo's 2,5-7,13,14)

Are there signs of erosion? Yes Describe: Minor signs of erosion visible, rip rap placement recommended.

Aerial view of the embankment from the right flank with the dam basin visible.

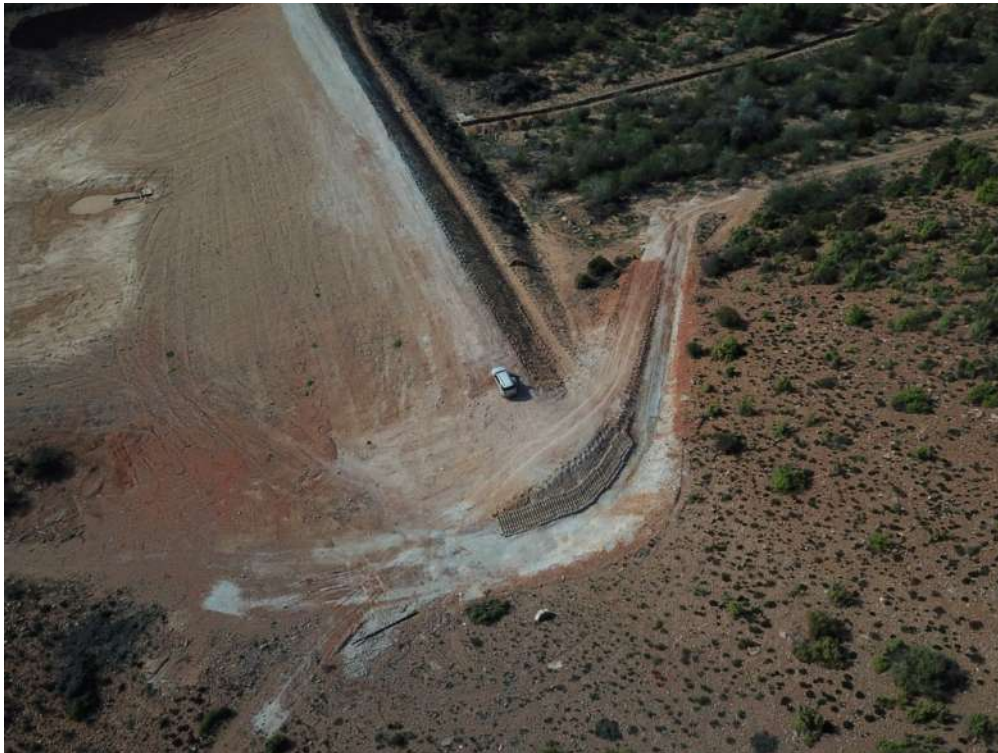
**Photo 3**

View of the right hand section embankment and spillway channel from the right flank.

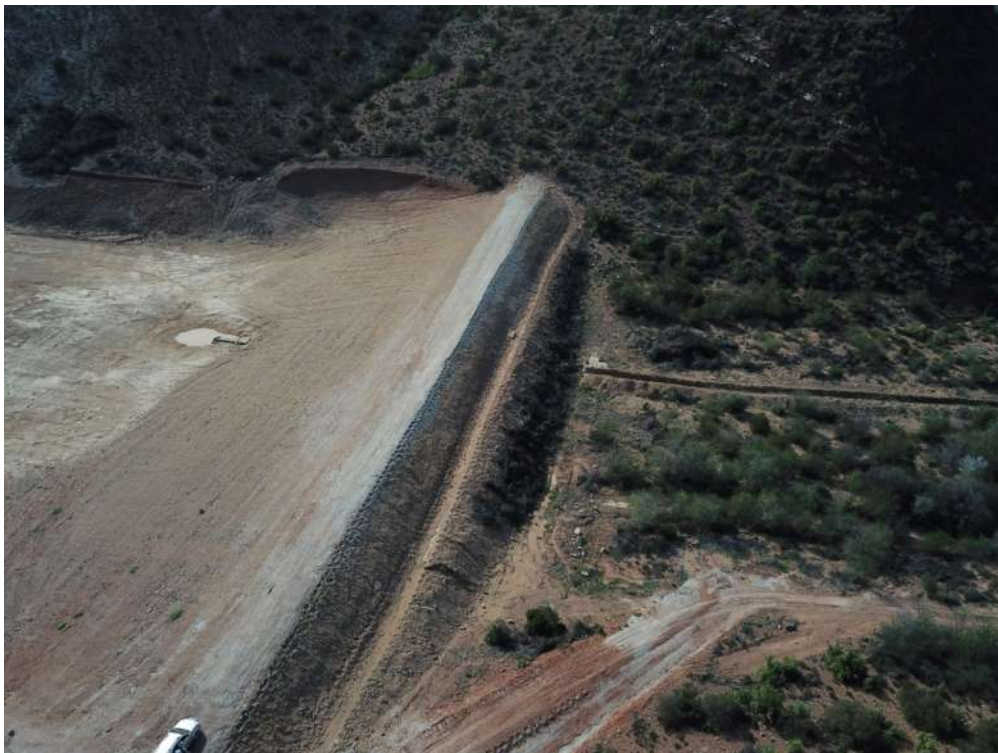
**Photo 4**

Slope protection measures (if any):   Mostly rocky surface with some shrub growth at the lower section of the face. (See Photo's 4,8,9,21)

Are there signs of erosion?   Yes   Describe:   Only minor signs of erosion.

Aerial view of the downstream slope and toe with vegetation visible.

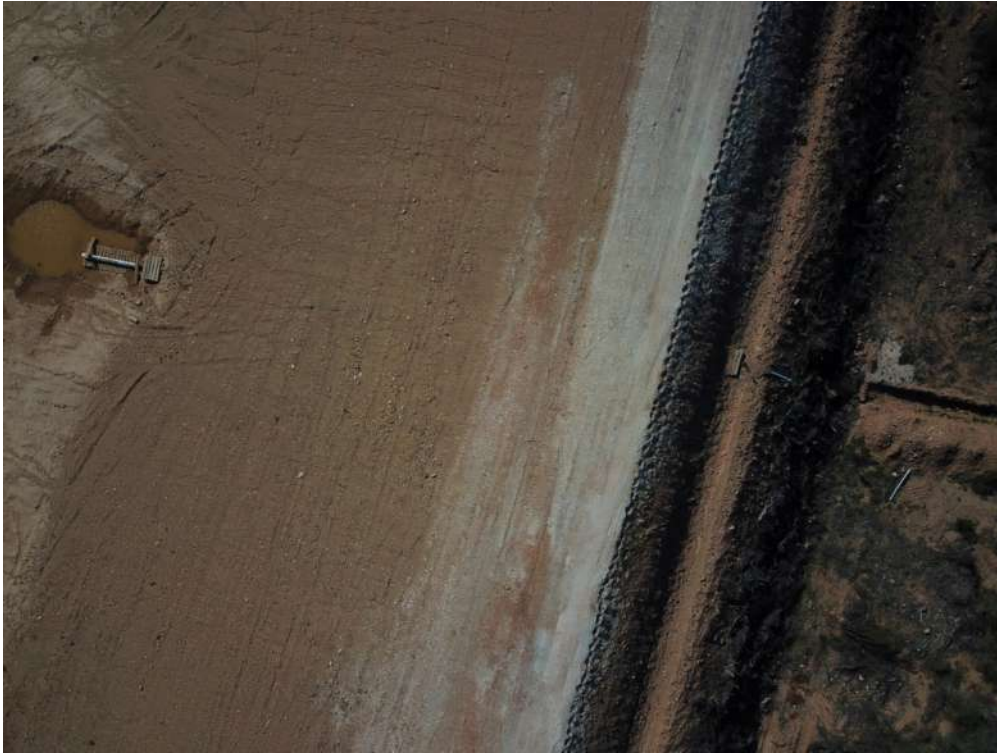
**Photo 5**

Condition of outlet pipe foundation: The outlet pipe foundations appear to be stable on both the upstream and downstream sides. (See Photo's 5,22,24)

Aerial view of the middle section embankment with outlet pipe inlet upstream and the outlet pipe trench at the downstream toe.

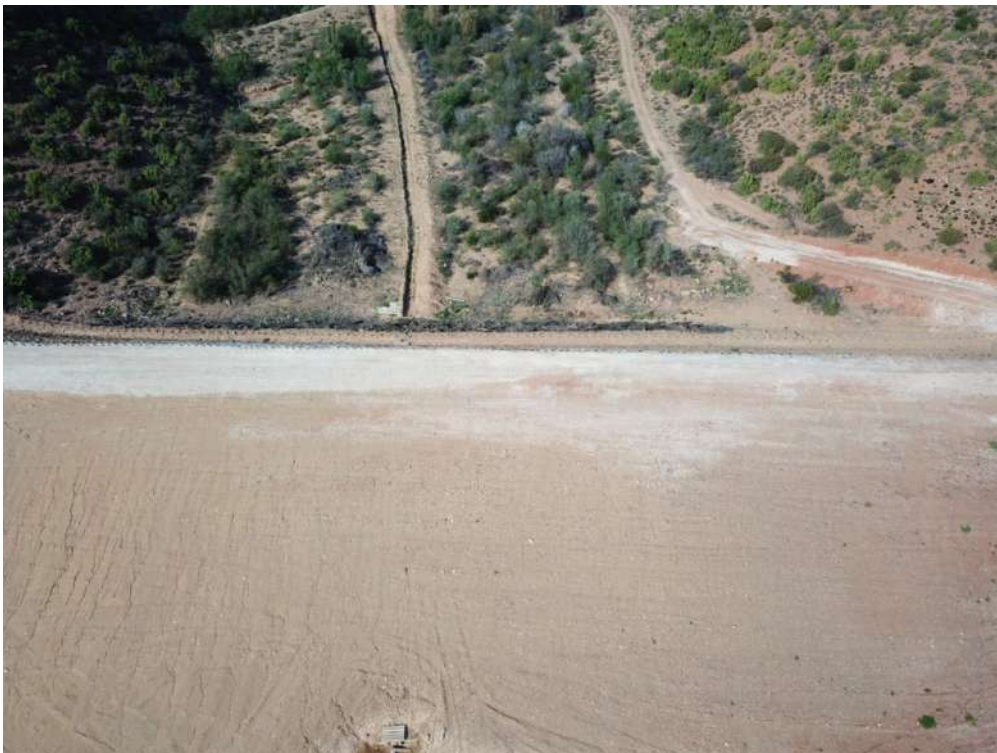
**Photo 6**

Aerial view over the upstream slope looking downstream.

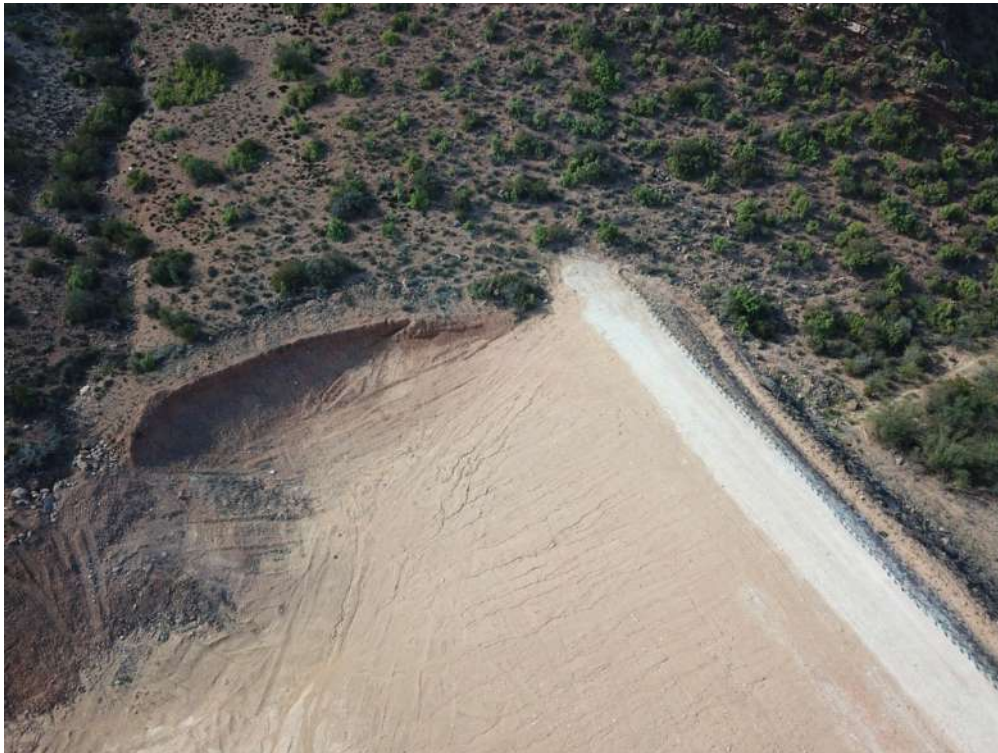
**Photo 7**

Aerial view of the left flank with left section embankment including the dam basin.

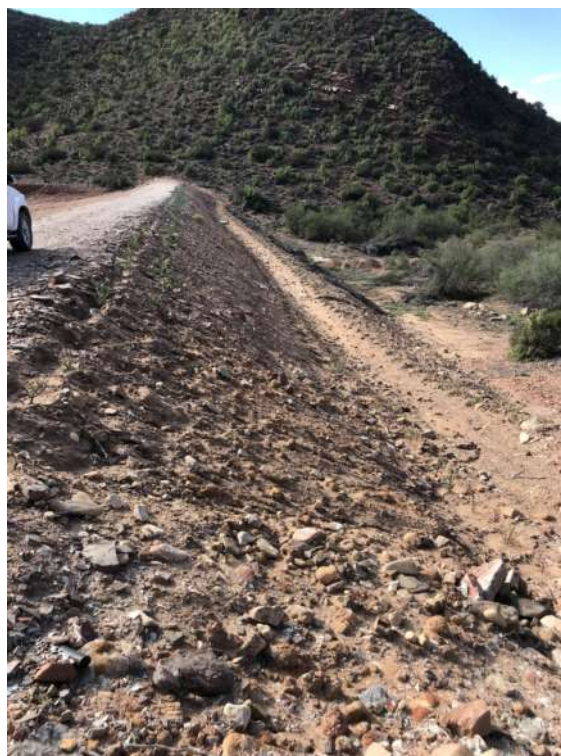
**Photo 8**

General view of the downstream slope and toe with minor erosion visible.

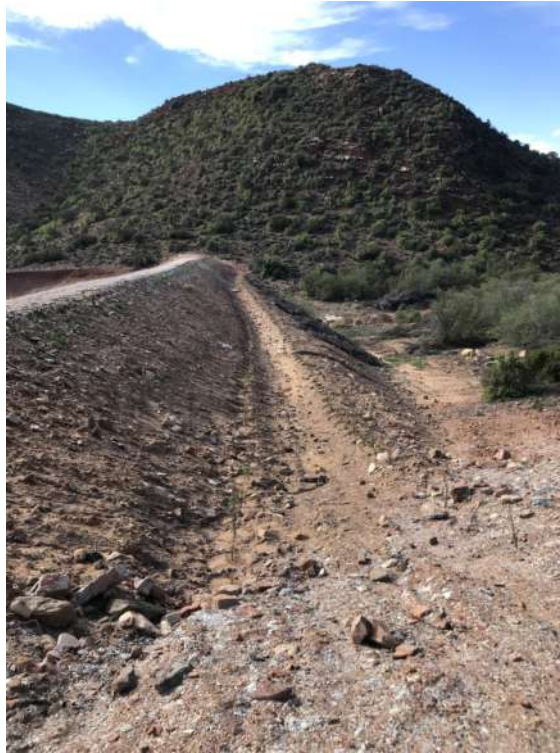
**Photo 9**

General view of the stepped downstream slope with minimal erosion.

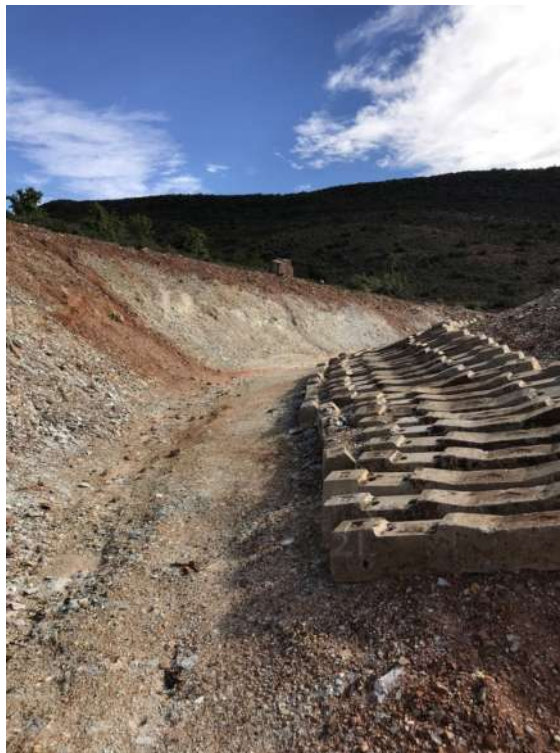
**Photo 10**

View inside the spillway channel looking upstream with concrete block placement as protection.

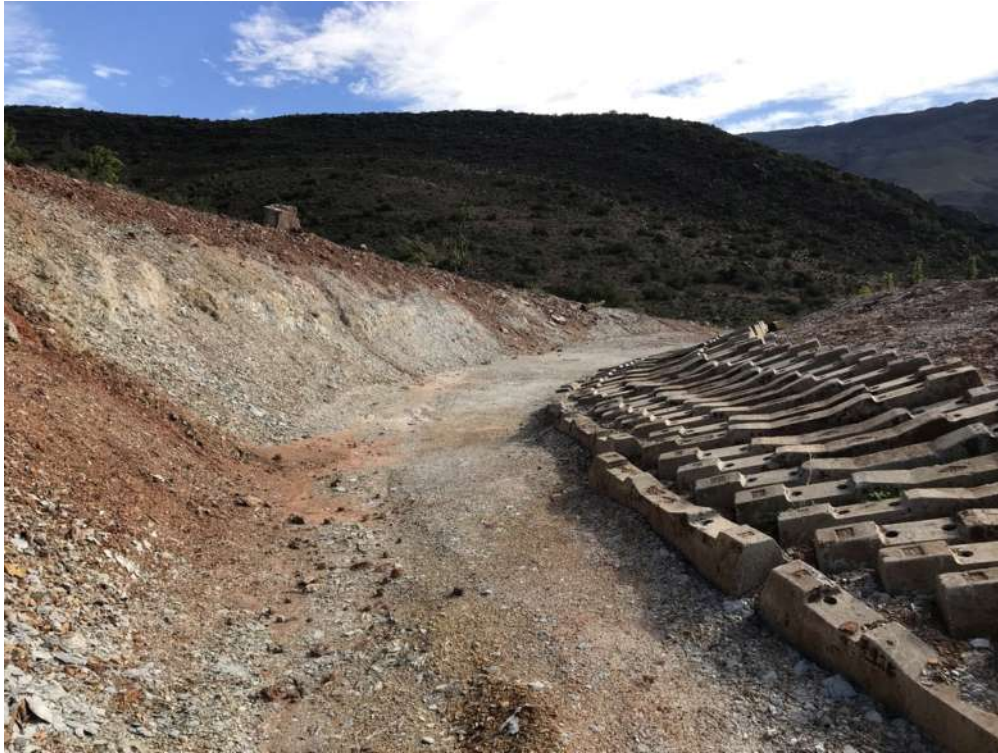
**Photo 11**

View inside the spillway channel looking upstream with concrete block placement as protection.

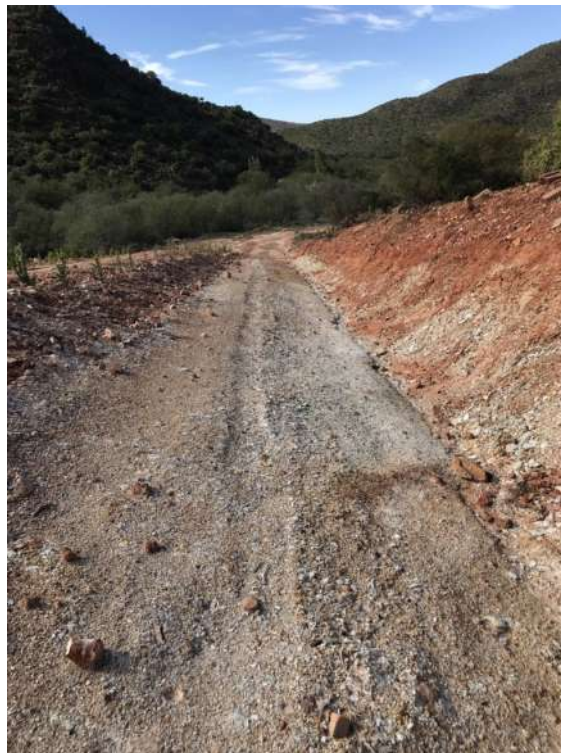
**Photo 12**

View inside the downstream section spillway channel on the right flank.

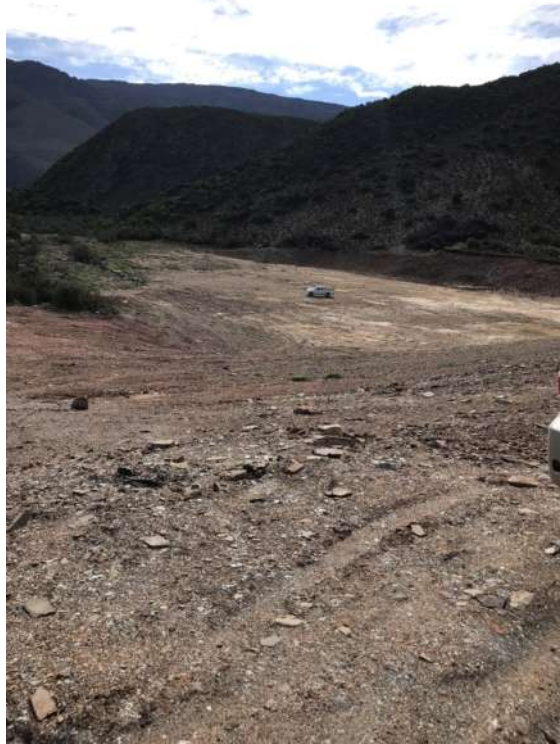
**Photo 13**

View over the right hand section upstream slope and dam basin.

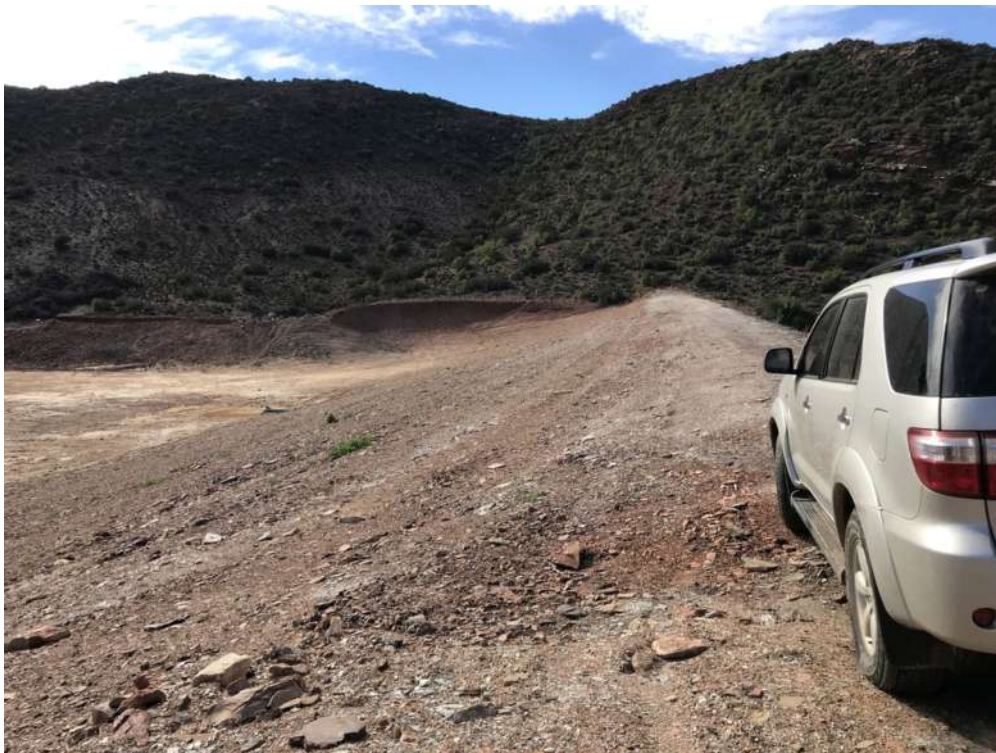
**Photo 14**

General view of the upstream slope with gravel surface, but riprap placement required.

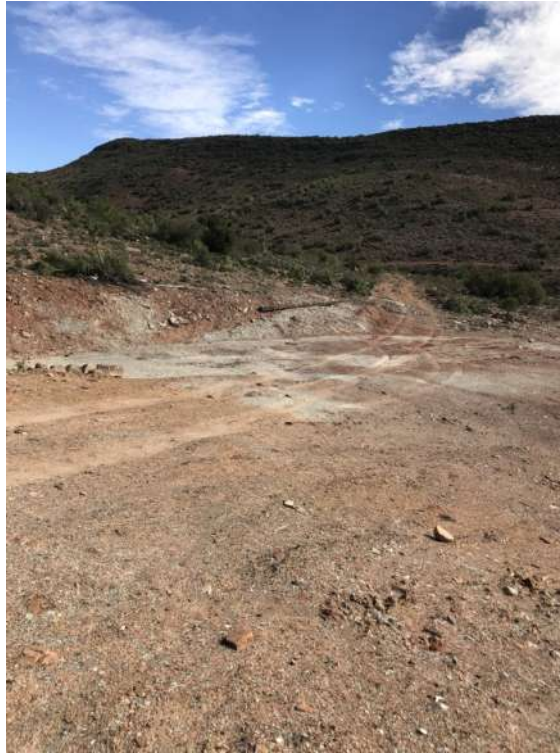
**Photo 15**

Right hand section upstream slope overlooking the spillway channel forebay.

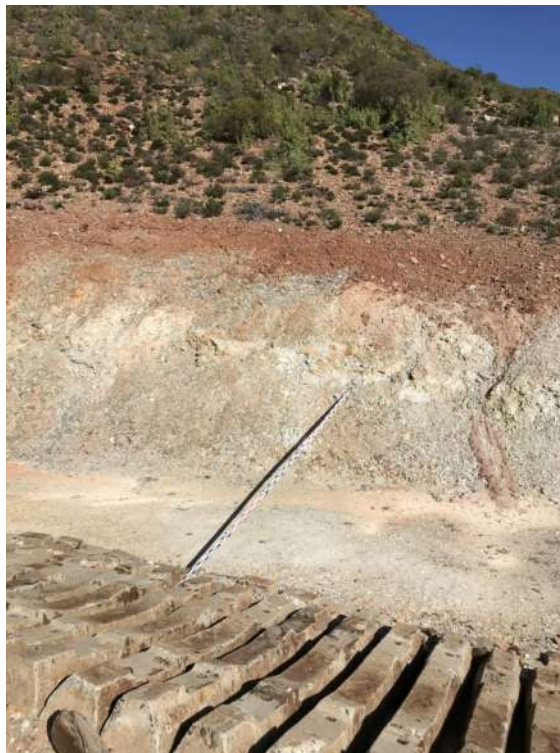
**Photo 16**

View inside the spillway channel with dimensions taken.

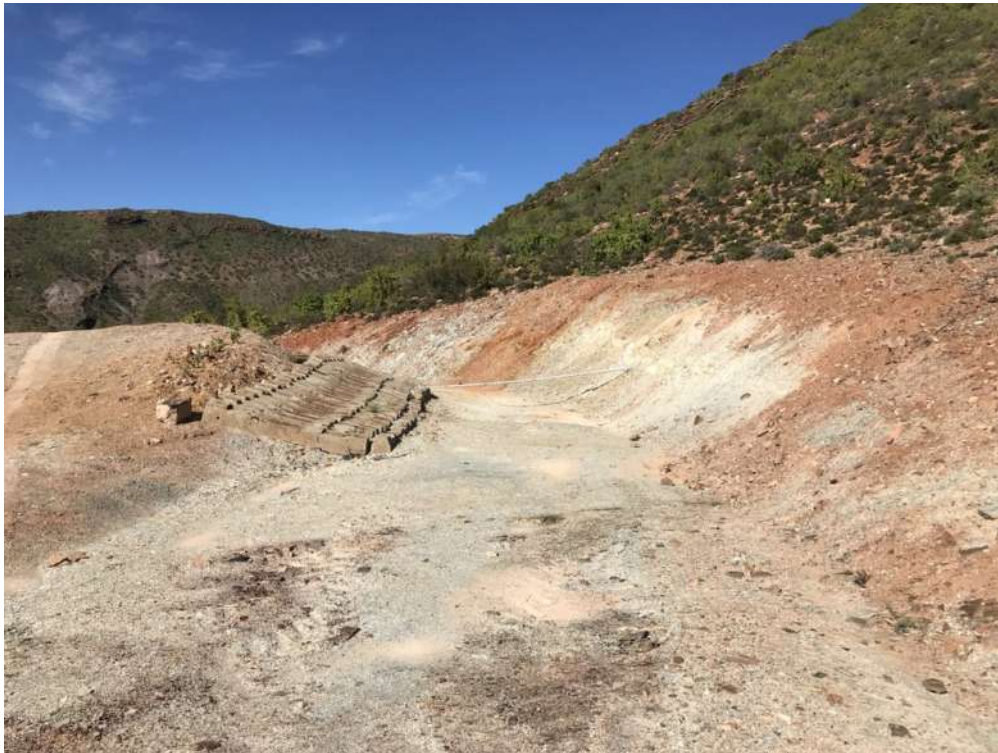
**Photo 17**

View inside the spillway channel from the forebay looking downstream, with profile visible.

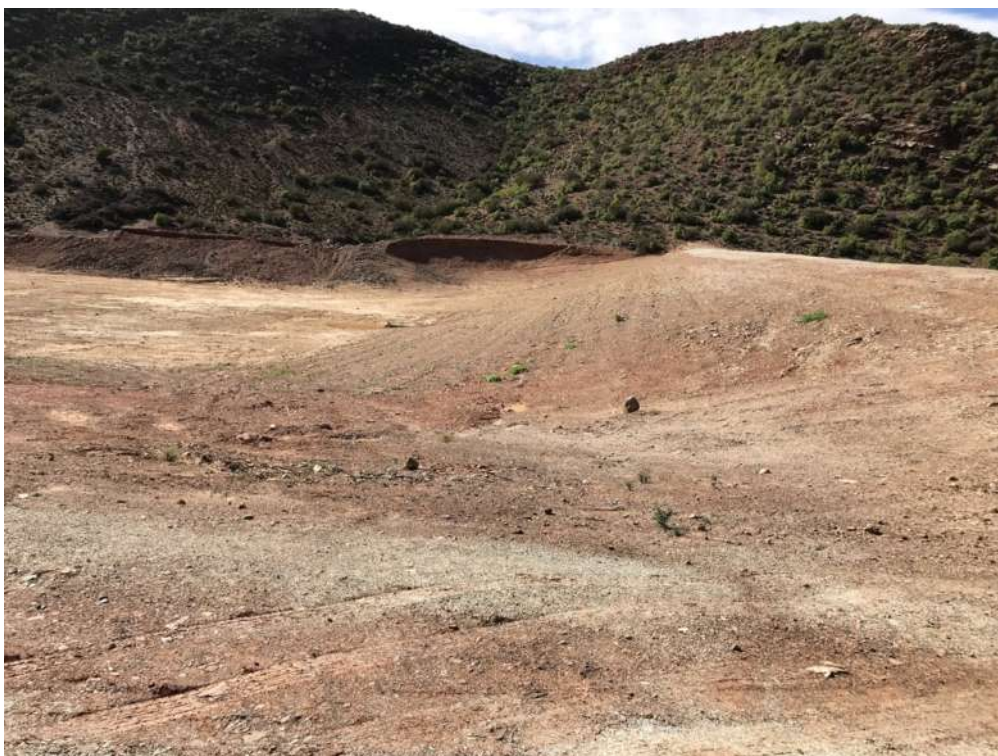
**Photo 18**

General view of the upstream slope from the right flank. Even gradient and minor erosion visible.

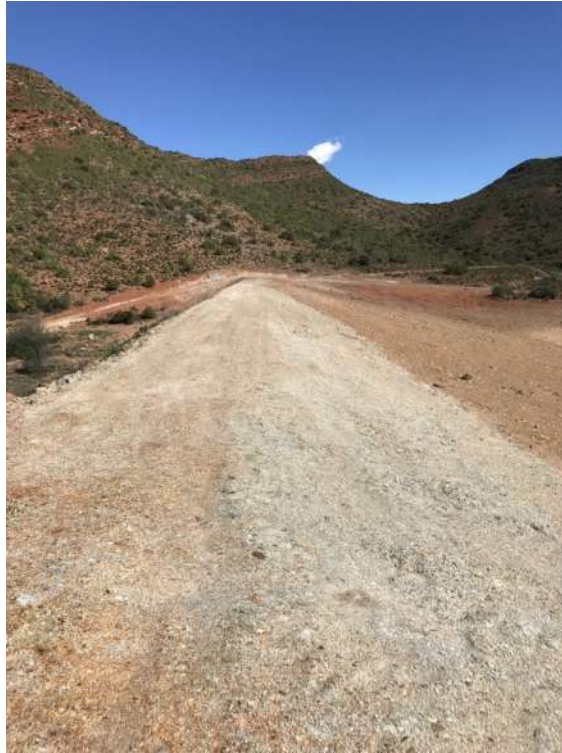
**Photo 19**

Is the crest still level or has settlement occurred? Mostly level with very slight undulations

Middle to right hand section non overspill crest with even profile. Low spots to be filled.

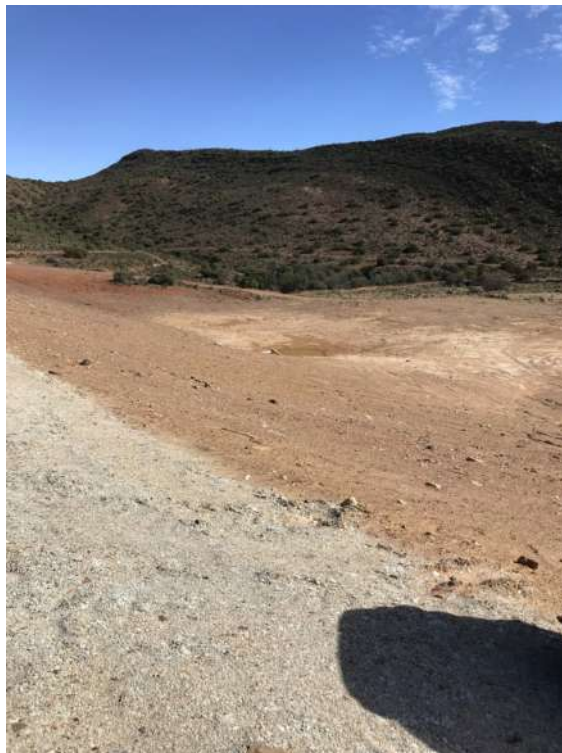
**Photo 20**

Right to middle section upstream slope overlooking the dam basin.

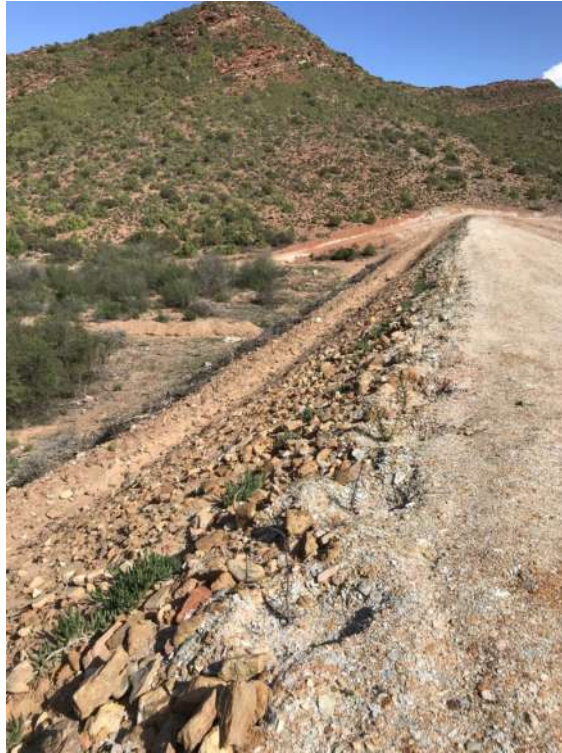
**Photo 21**

Middle section downstream slope with gravel and rocky surface, protecting against erosion.

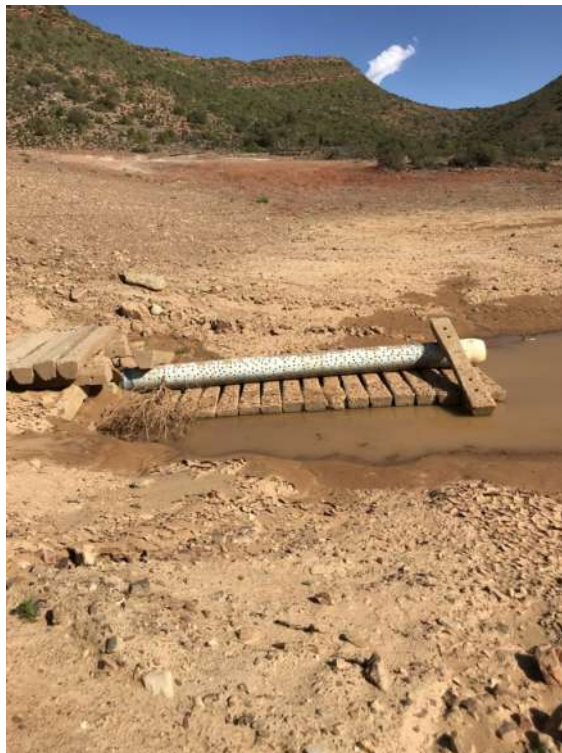
**Photo 22**

Inside the dam basin with the outlet pipe inlet visible.

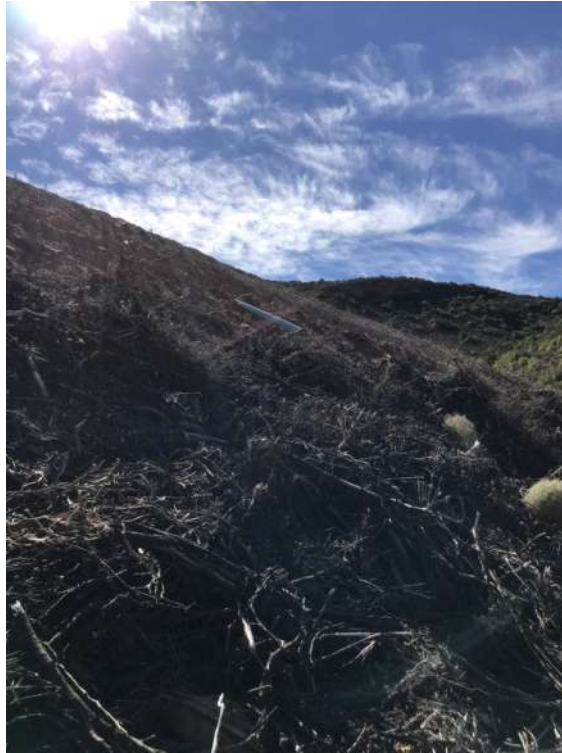
**Photo 23**

Middle section downstream slope with minimal erosion.

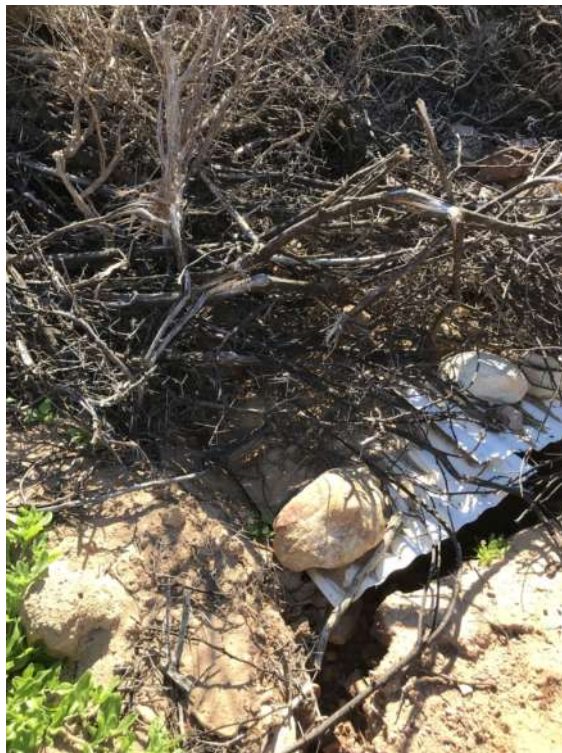
**Photo 24**

Middle section downstream toe with temporary cover over the outlet pipe.

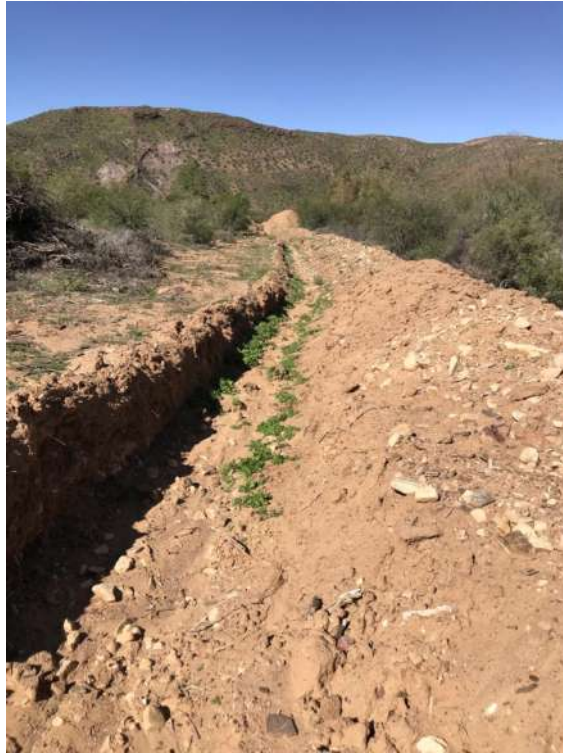
**Photo 25**

View at the middle section downstream toe with excavation for outlet pipe connections.
