GROOTVADERSBOSCH MANAGEMENT ROADS

CONDITION ASSESSMENT - STORMWATER DAMAGE

PROJECT REF NO: 11755000

30 July 2025

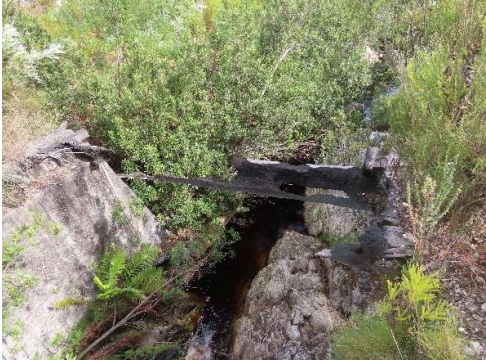
Barendkoen Road Bridge	
  <p>Figure 4: Photo 1, southern abutment of burned-down bridge.</p>

<p>Figure 5: Photo 2, remnant of burned wooden bridge deck.</p>
  <p>Figure 6: Photo3, northern abutment of burned-down bridge.</p>	  <p>Figure 7: Photo 4, view of abutment wall.</p>

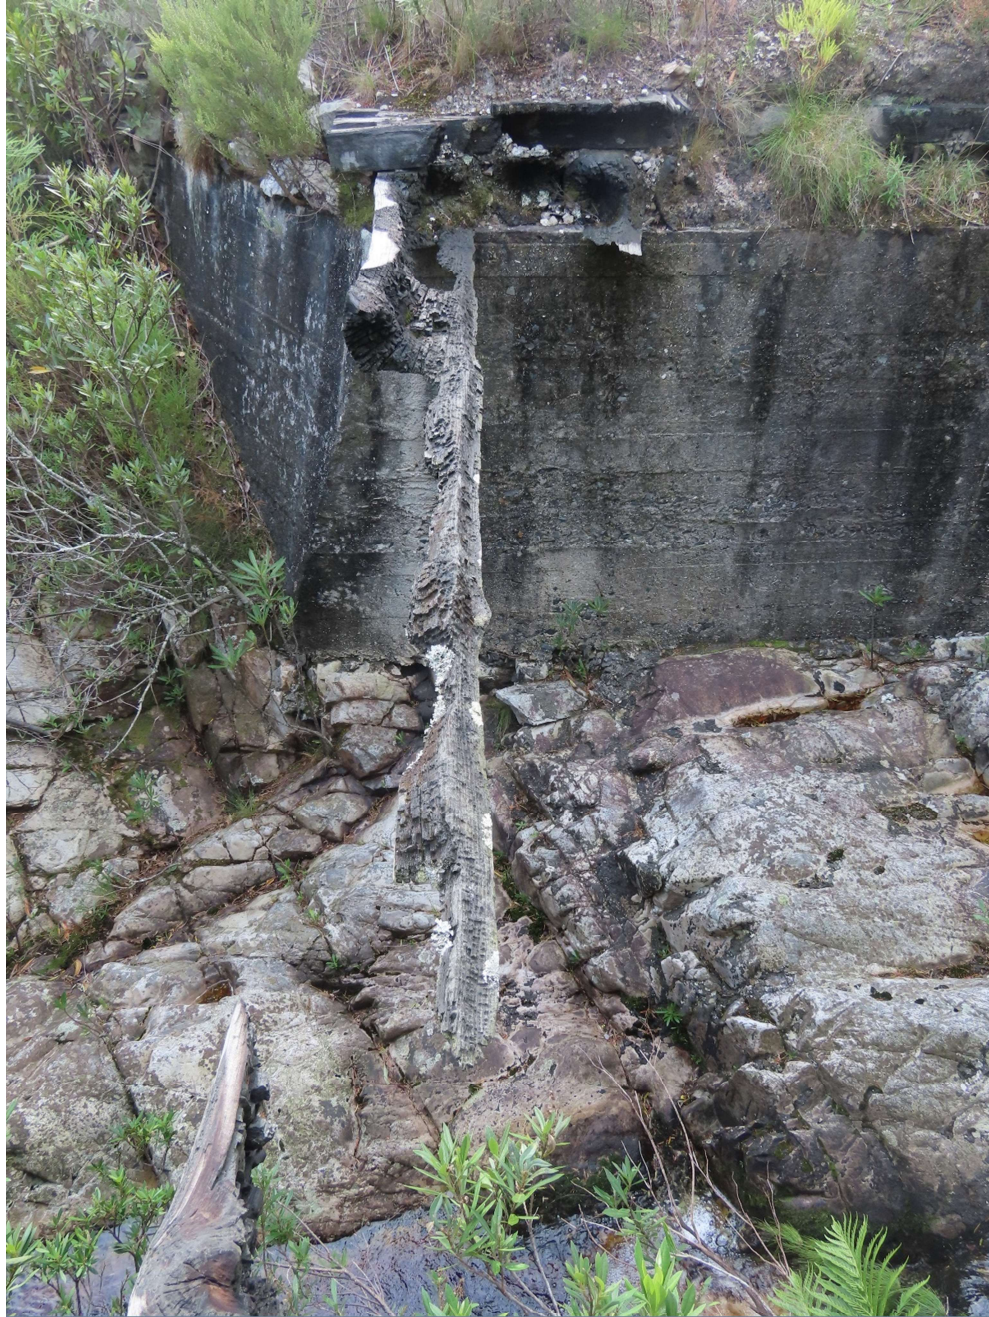
Figure 8: Photo 5, remnant of burned wooden bridge deck.

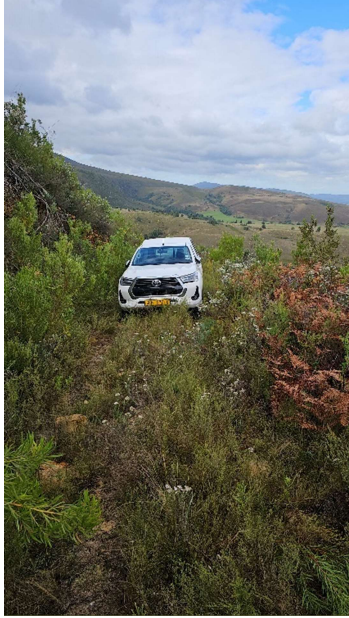
Figure 9: Photo 18, two-track route with vegetation in the center.

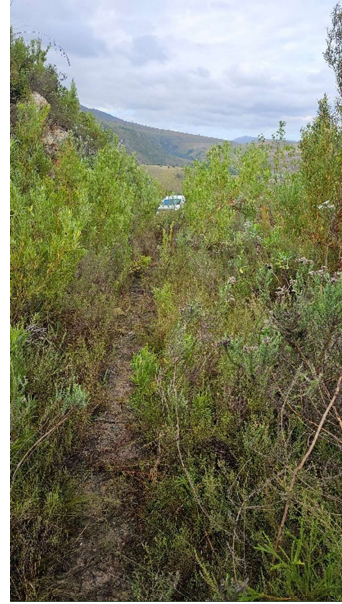
Figure 10: Photo 17, track overgrown with dense fynbos, impeding vehicle movement.

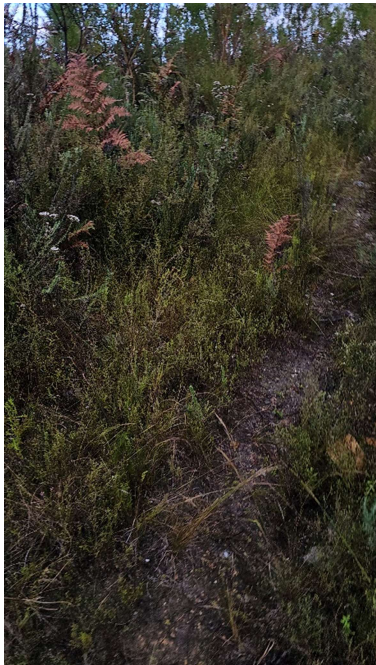
Figure 11: Photo 3, dirt and rocky surface.

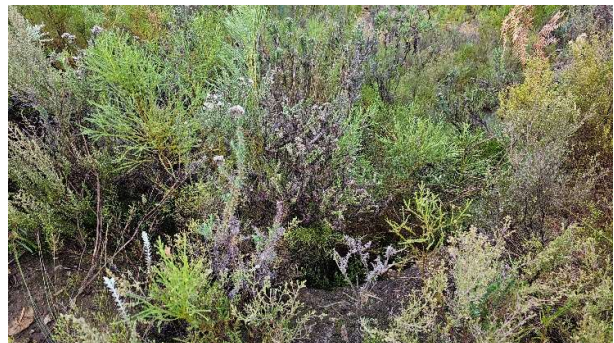
Figure 12: Photo 4, signs of a developing slope failure or slip were observed along the lower edge of the track.

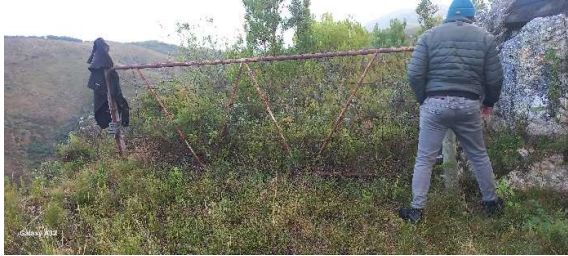
Figure 13: Photo 5, boundary gate delineates the Grootvadersbosch Nature Reserve limits.

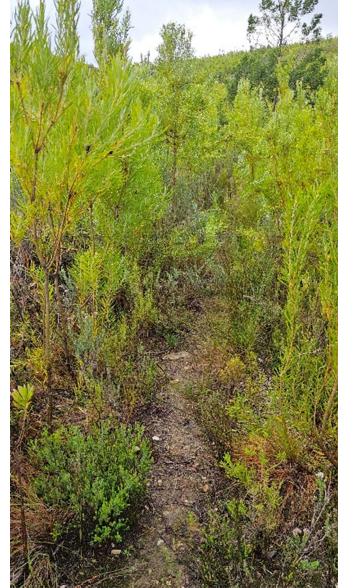
Figure 14: Photo 9, extremely uneven terrain, exposed bedrock, and heavy vegetation.

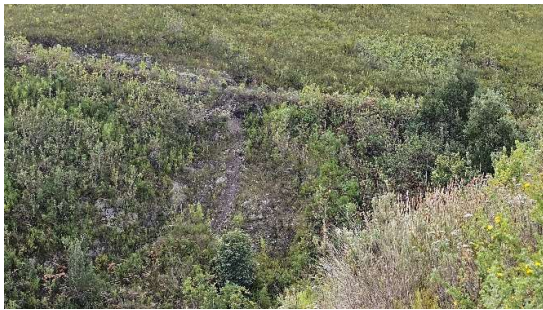
Figure 15: Photo 11, signs of slope failure or slip observed from a photo taken from a distant vantage point.

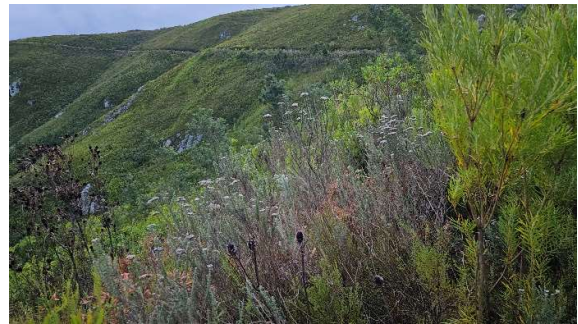
Figure 16: Photo 19, track surface is generally firm but uneven, with frequently exposed rock and scattered boulders along the route.

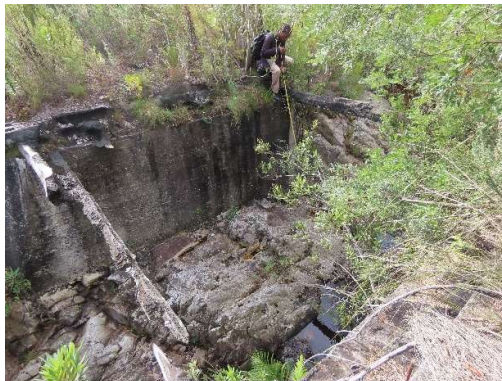
Figure 17: Photo 20, burned-down bridge.

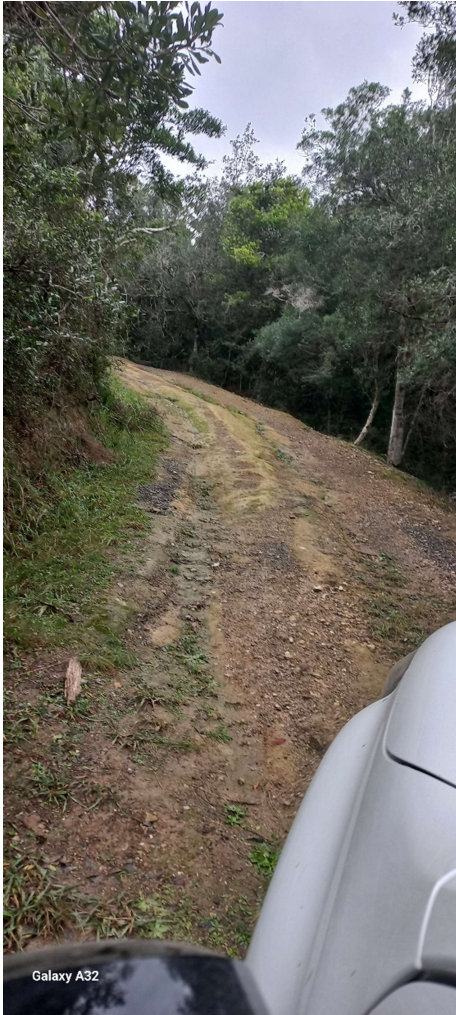
Figure 18: Photo 6, road is in poor condition, with significant rutting and muddy wheel tracks.

6	350				
7	530				
8	640				
9	640	640			
	640		3.Average	The management road is in poor condition, with significant rutting and muddy sections, especially in the wheel tracks. These features indicate inadequate drainage and a surface prone to softening and damage during wet weather. Standing water and saturated soil increase the risk of vehicles slipping, reducing accessibility and posing safety concerns for routine operations. The surface remains uneven and stony, with loose rocks and exposed aggregate further hindering access.	Open side drains and construct waterbars to divert surface runoff. Fill eroded areas with compacted rocks and gravel to restore surface integrity. Regrade and reshape the road to improve drainage and reduce rutting. Stabilize the surface using a suitable gravel layer, and implement routine maintenance to ensure ongoing accessibility.
10	755				
11	755				
	790	150			
13	790		1.Excellent	At the time of the assessment, the field ranger (Sam Pinzi) confirmed that a contractor has been appointed to address the stormwater-related damage at the Redwood Maintenance Road bridge.	No remedial work is required in this section. Repair and rehabilitation work is reportedly underway or scheduled to commence shortly.

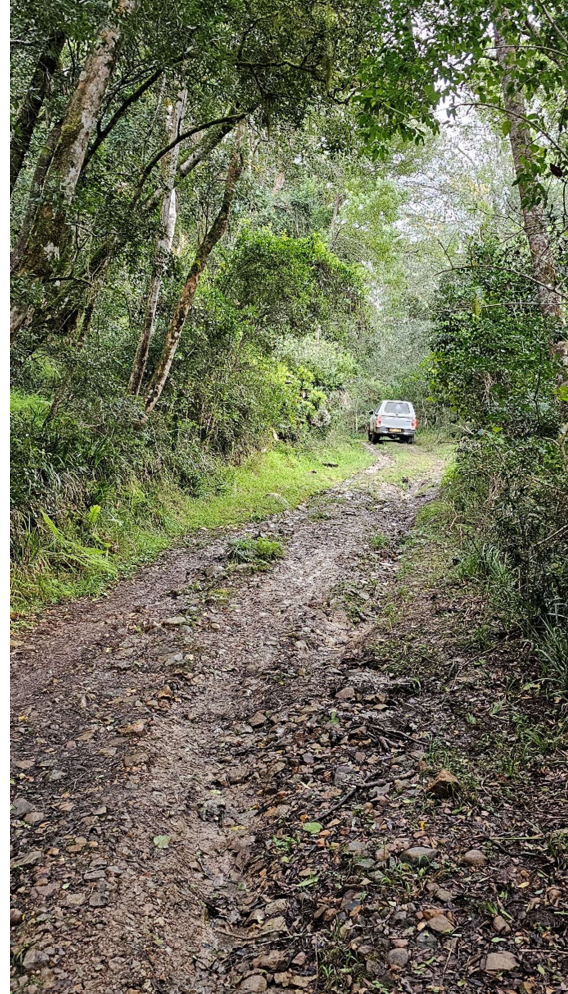
Figure 19: Photo 10, the surface remains uneven and stony, with loose rocks and exposed aggregate further hindering access.
