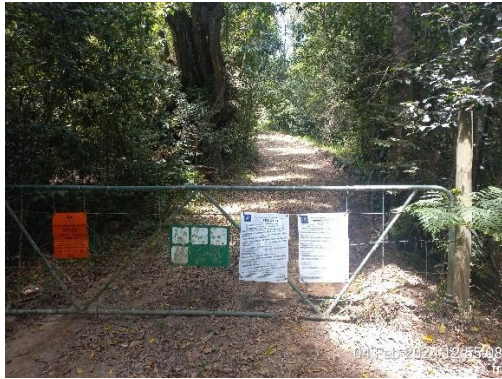
Entrance to 'Ysterhoutrug Road' off R339.

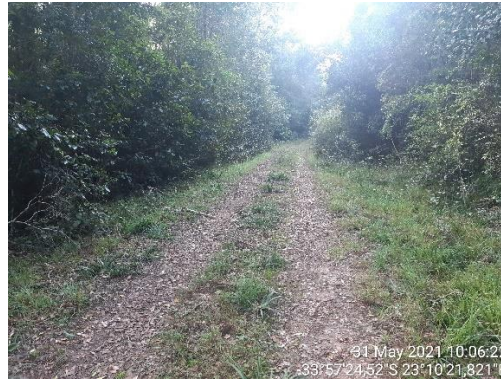
'Ysterhoutrug' track to site.

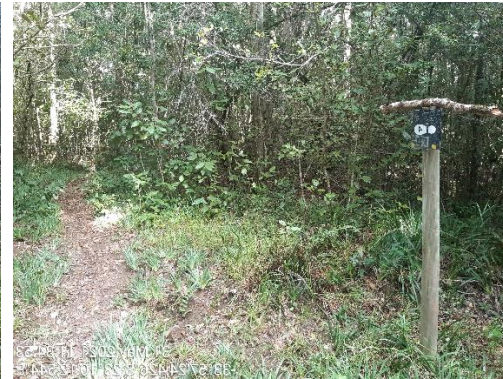
Outeniqua Trail crosses access track.

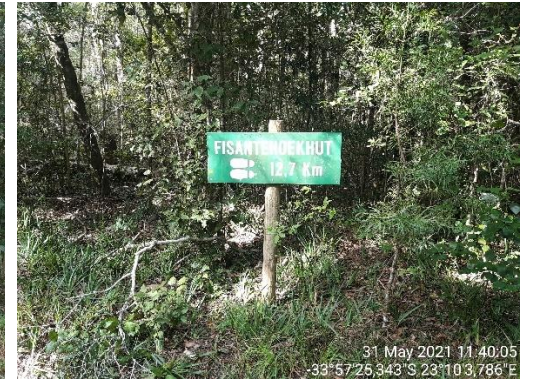
Signage for Outeniqua Trail along access track.

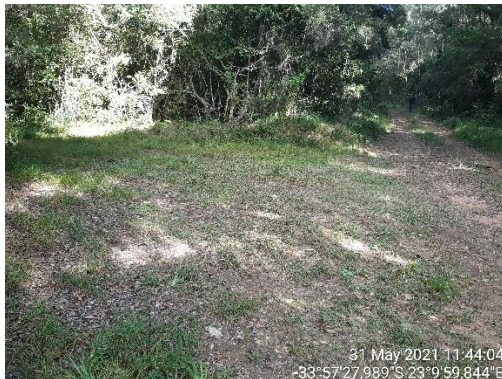
Existing clearings along access track – ideal for delivery & temporary laydown of site materials.

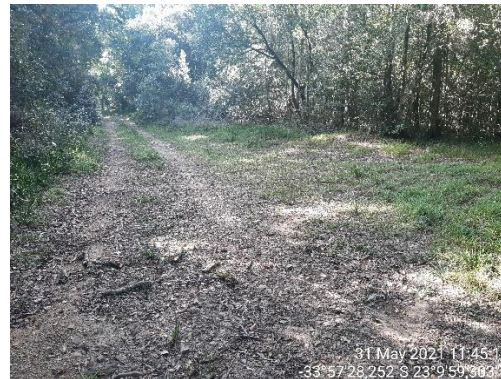
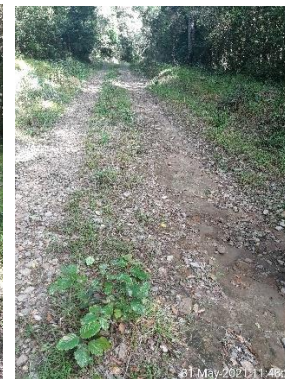
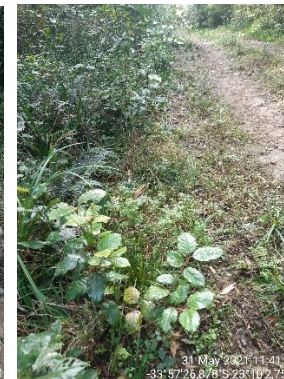
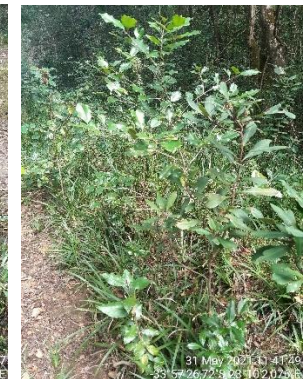
Several tree saplings within track median & shoulders which will require rescue.

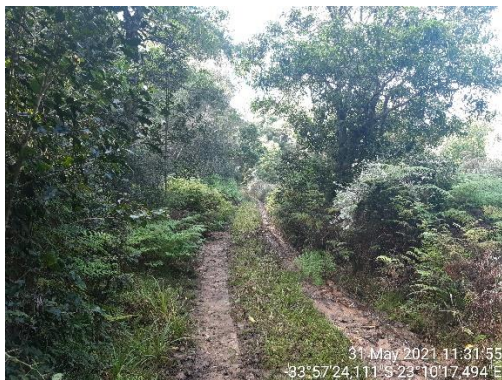
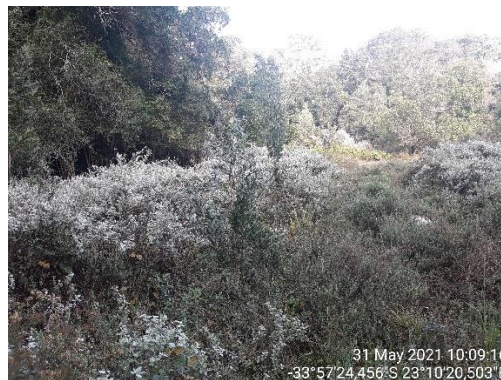
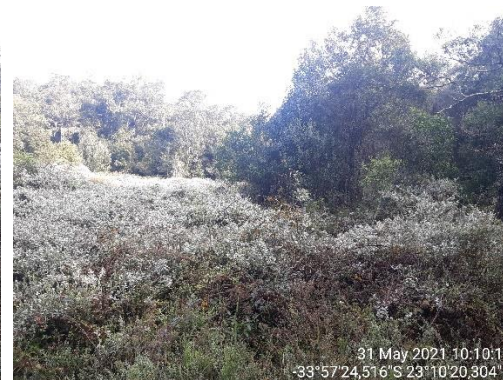
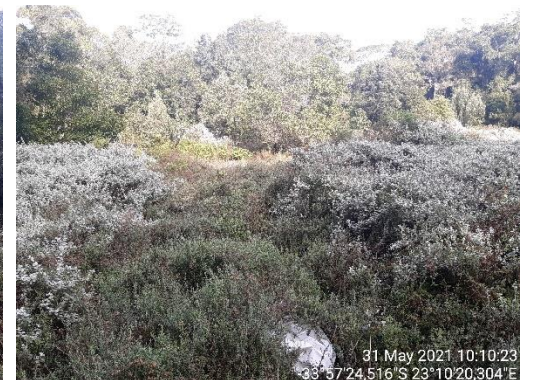
Access track / road below existing of clearing of site. Site clearing overgrown with dense stands of *Helichrysum sp.*, Bramble & ferns. Several tree clumps to be avoided.

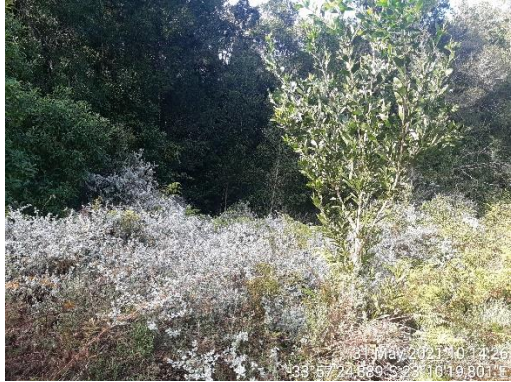
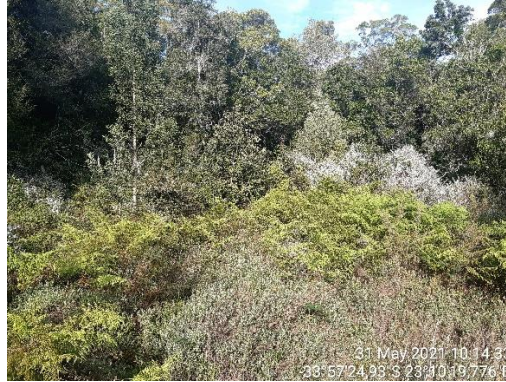
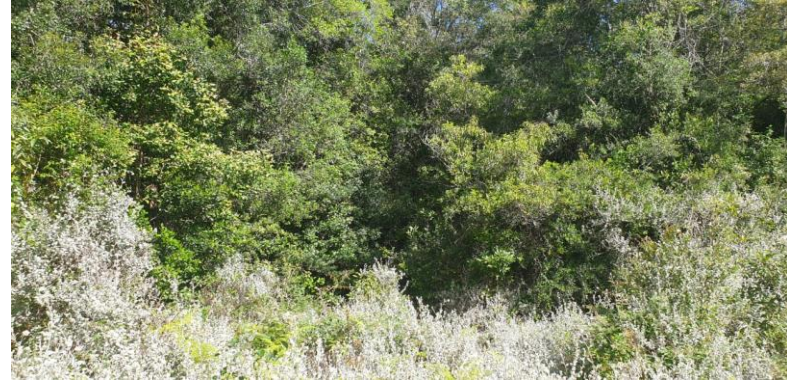
Several stands of alien invasive trees noted in May 2021 around edge of clearing of site.

Alien trees were cut down under supervision of SANParks during Nov.2021, to allow better visibility and access to the site for specialist assessments.

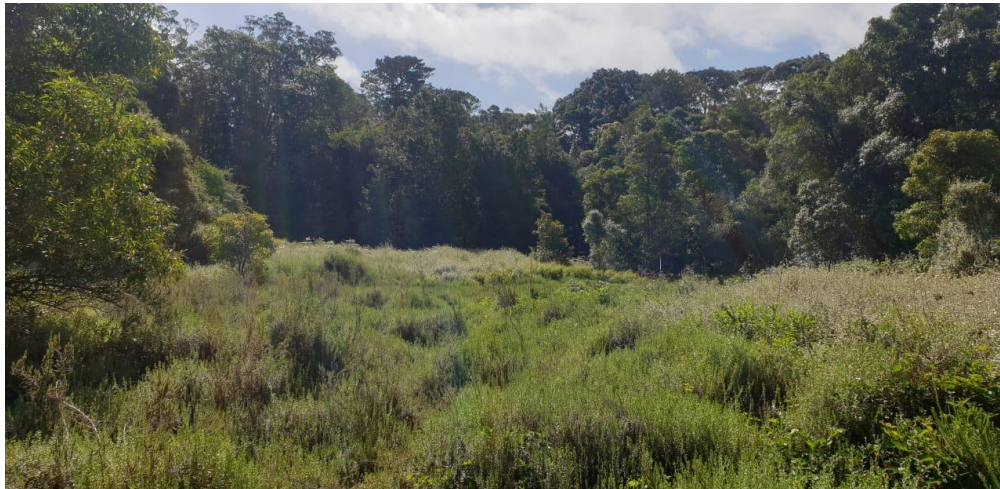
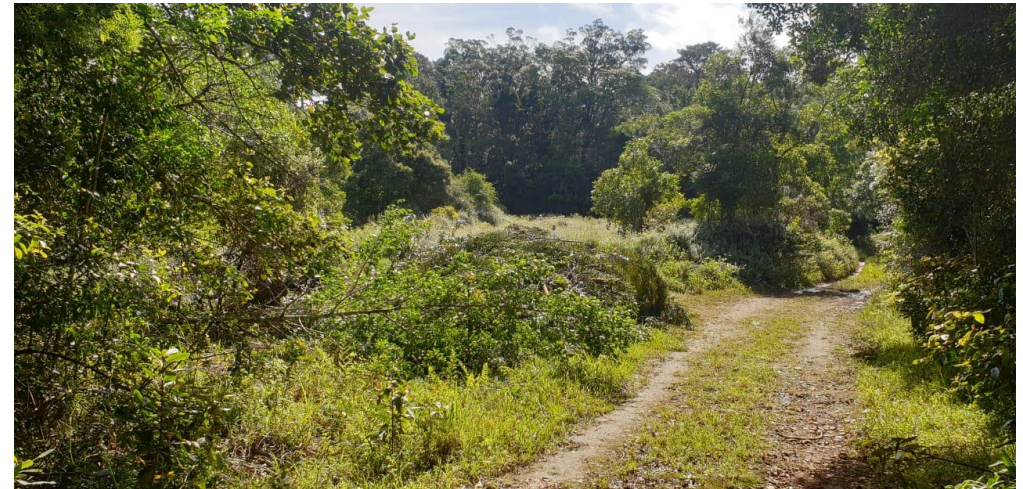
Photos of site clearing clear of alien invasive trees – provided by SANParks: Diepwalle Section Ranger in Nov.2021.

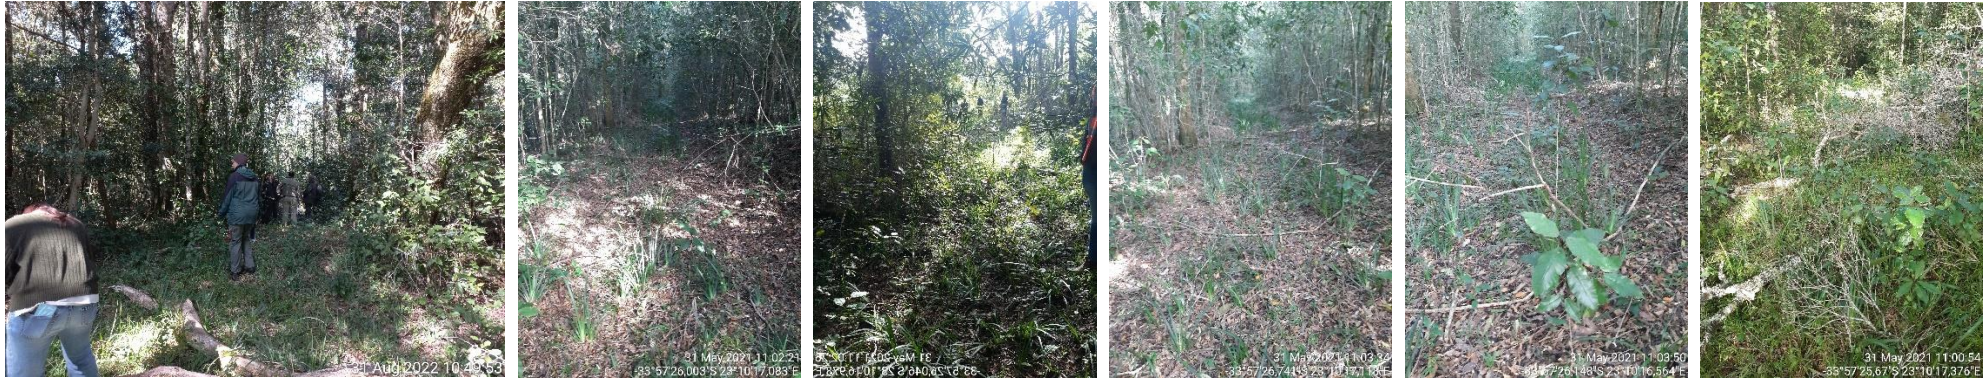
Existing slip-paths into surrounding Forest – to be used to access the proposed guest tent site during construction & as soak-aways for clean grey-water.

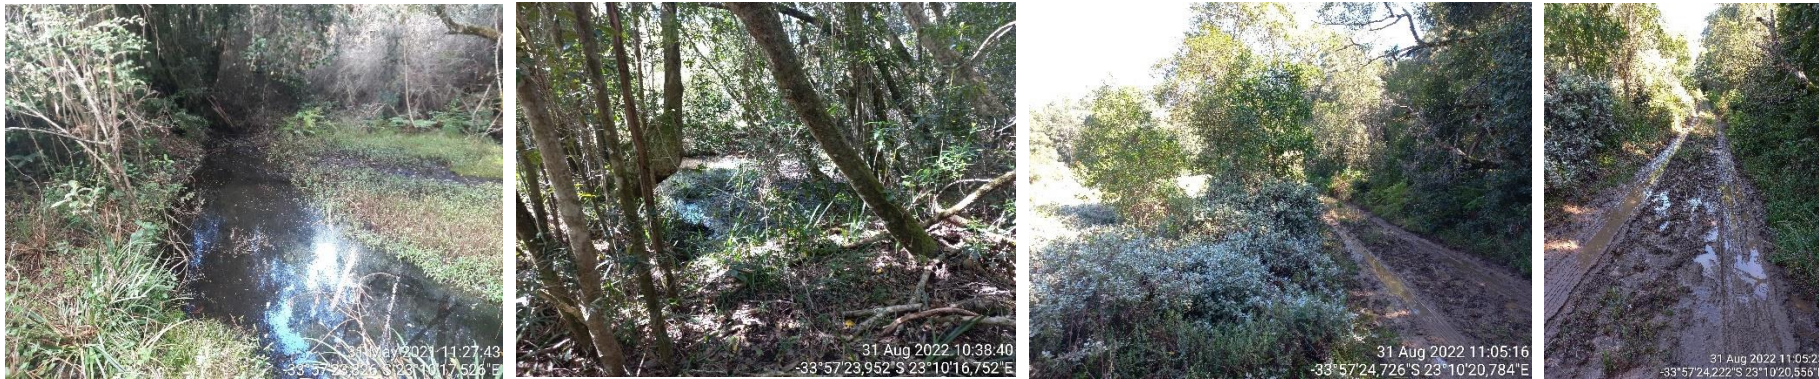
Excavated Pond / Pool on western edge of site clearing – to be avoided by development.

Road below site – waterlogged during high rainfall periods.

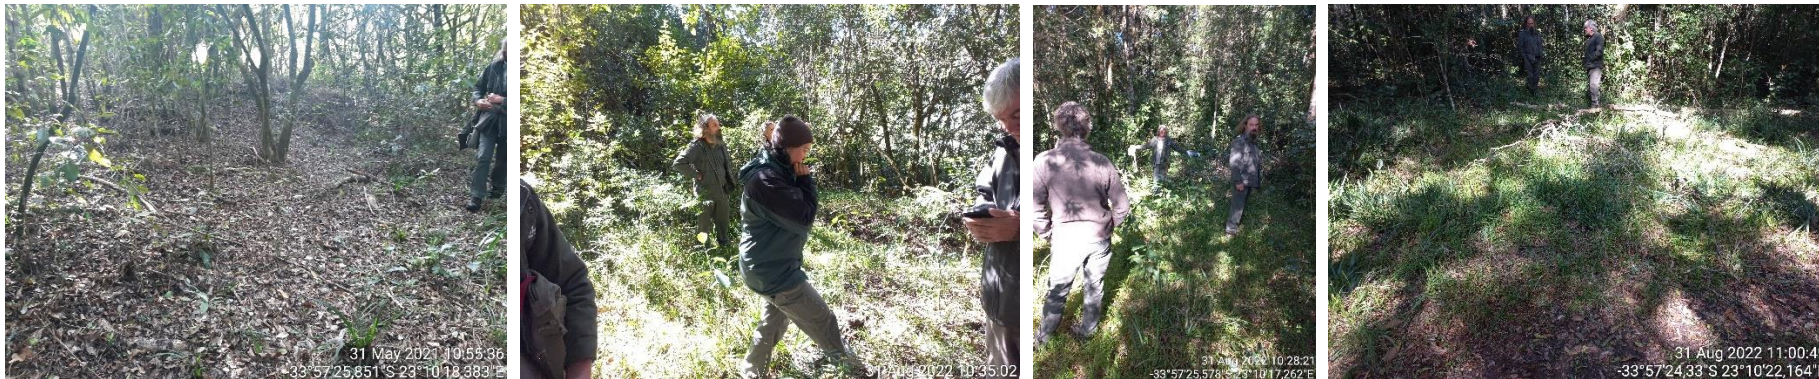
Existing gaps / clearing among trees if Forst fridge, earmarked as potential locations for guest tent platforms. Exact location & orientation of platforms to be guided by SANParks during construction.

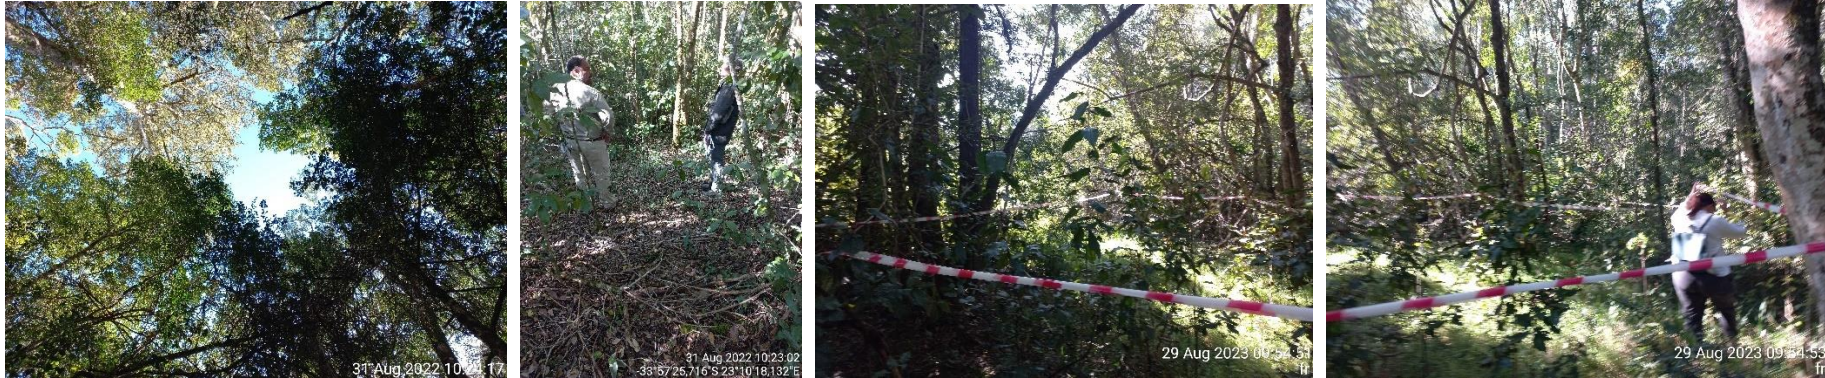
View into Forest canopy above gap in Forest. Gaps / clearings in trees in Forest fringe adjacent to existing site clearing. Demarcated by SANParks to inform final layout alternative.

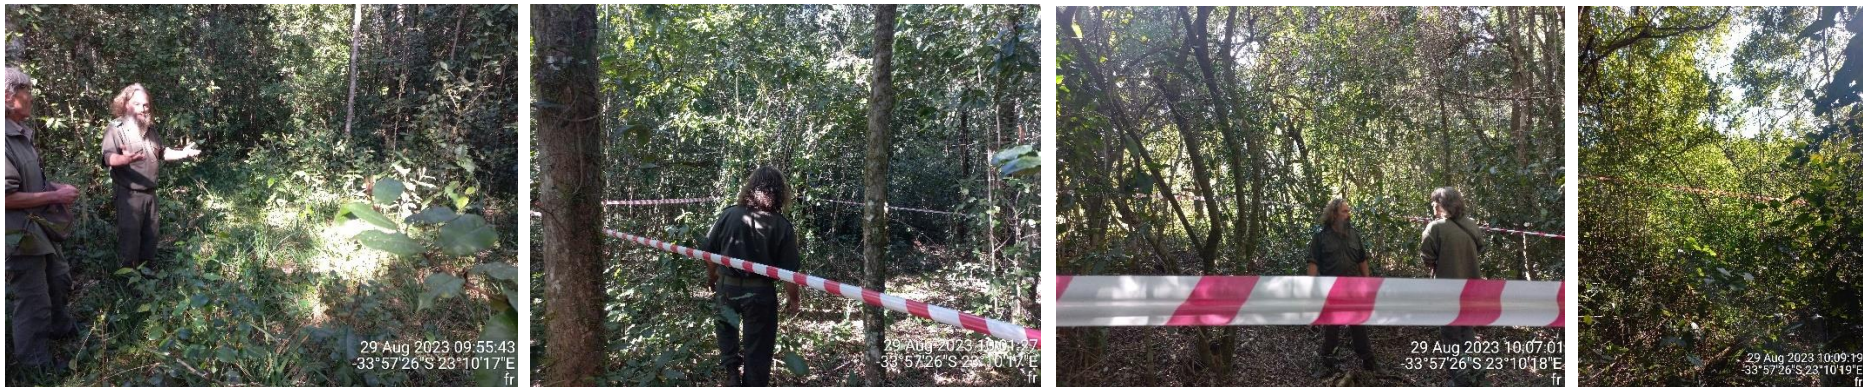
Site meeting with SANParks to pick up potential guest platform sites (demarcated by SANParks) on GPS for final layout design and assessment by specialists.

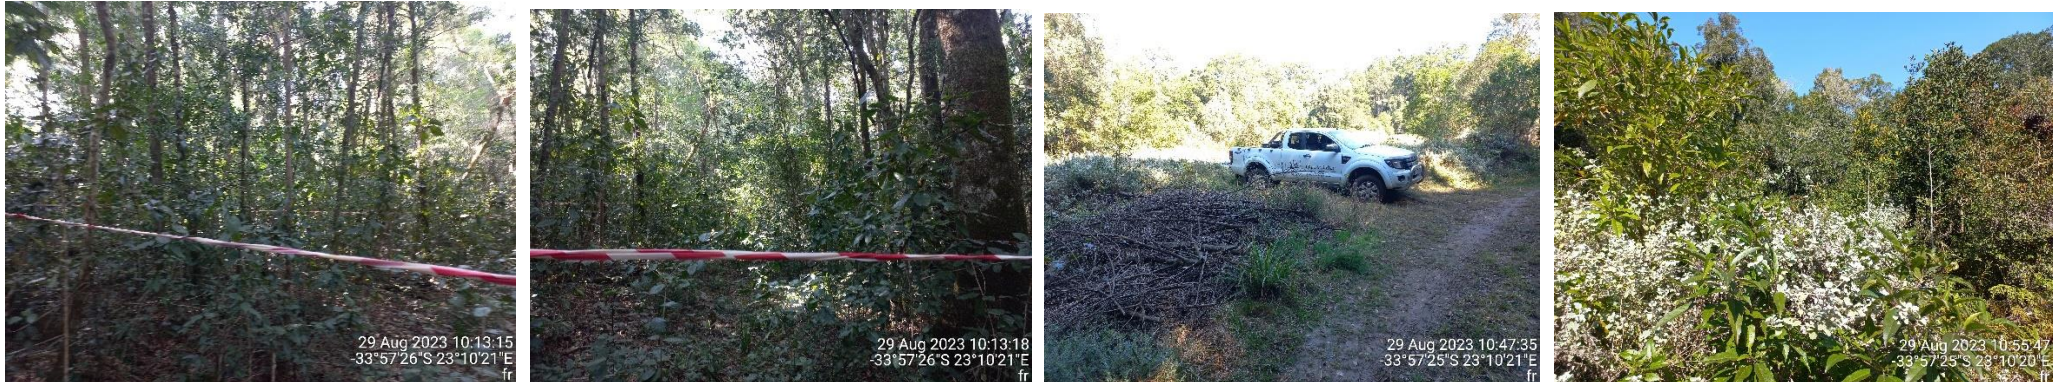
Potential guest tent platform site just within the edge of the Forest fringe.

Proposed vehicle turning loop in existing clearing. Forest tree clump in clearing to be avoided.

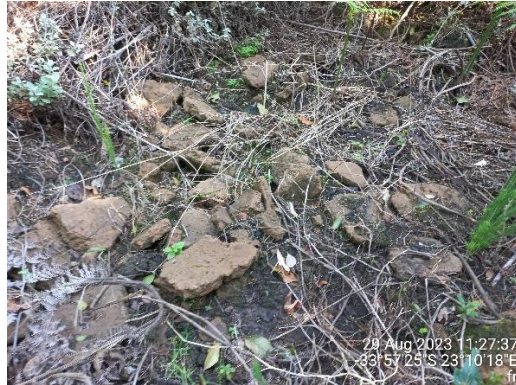
Abandoned concrete waste left behind by previous site activities (elephant boma / film-set structures).
