PRELIMINARY GEOTECHNICAL REPORT

PROPOSED RESIDENTIAL DEVELOPMENT ON REM ERF 2833, GROOTBRAK, MOSSEL BAY

22 April 2024 (Rev 0)

Prepared by: OUTENIQUA GEOTECHNICAL SERVICES 23 CLYDE ST KNYSNA 6571

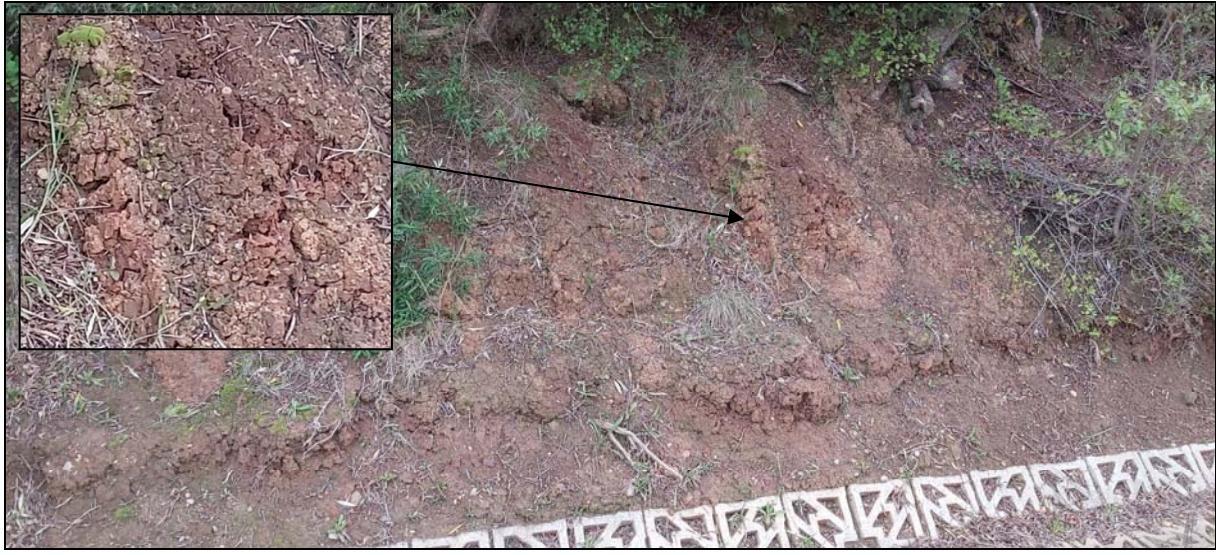
Geotechnical conditions associated with the Kirkwood Formation typically include a clayrich soil profile, which is prone to expansion and contraction (active soil) with fluctuations in ground moisture content, and particularly influenced by seasonal changes in rainfall. An exposure of such typical clayey soil profile was observed in the road cutting along the southern boundary of the site (see Figure 6). The fine-grained soils are also typically prone to a reduction in shear strength, and this can cause settlement of foundations and instability on very steep slopes and excavations. Exposed soils are also prone to erosion and dispersion under the influence of concentrated stormwater. Shallow groundwater seepage (a perched water table) is also expected on slopes in wet conditions. In summary, special consideration will be required in the engineering design to mitigate any negative impacts these factors may have on structures and civil services.

Figure 6: Reddish orange clayey soil profile exposed in road cutting along southern boundary of the site (inset: shattered clay structure)

Foundations on potentially expansive and/or compressible soils may require special reinforcement and stiffening to resist movement. Bearing pressures may also be restricted, particularly for foundations on or near slopes or retaining walls. Detailed investigations including laboratory testing of soil is recommended in order to provide more information for design purposes.

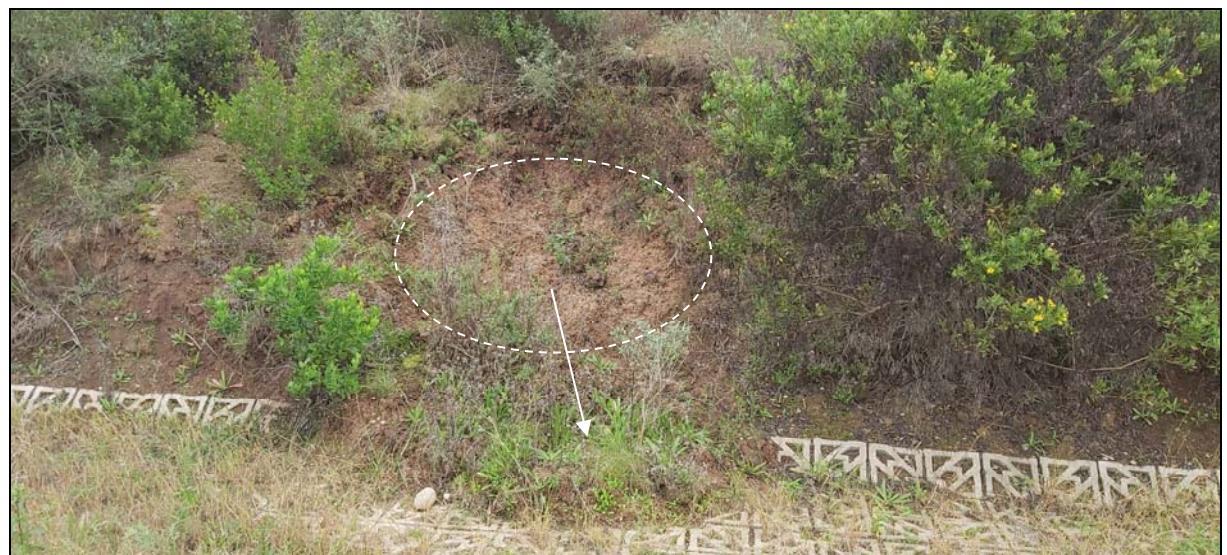
The natural slope gradients on the site were estimated ranging between $1v:8h/~7^{\circ}$ (low) on the southwest (lower) side to $1v:3h/~18^{\circ}$ (steep) on the northeast (higher) side of the site. No signs of any significant slope stability issues were noted in the general site area, although a detailed survey could not be undertaken due to the dense vegetation cover, particularly along the natural drainage line that bisects the site. A small-scale soil slip was, however noted along the very steep road cutting embankment along the southern boundary (see Figure 7). The gradient of this embankment was estimated at $1v:1.5h/34^{\circ}$ (very steep). In general and under normal conditions, natural slopes with a gradient of 1v:4h (14°) or less with no superimposed loading are considered to be generally stable, and natural slopes steeper than this are considered marginal or unstable and may require special consideration.

Figure 7: Small soil slip on the road cutting along the southern boundary

The proposed site development plan generally appears to take into account the site topography and slope constraints, as the development areas are confined to areas where slope gradients are less than or equal to 1v:4h, which is considered stable. Special attention is, however, drawn to the steep embankment along the southern boundary which falls within the proposed erven in this area. Special mitigating measures are recommended here, e.g. a development set-back line of 3m from the crest of the slope or, alternatively provision should be made to support/retain this embankment with suitable methods.
