Maintenance Management Plan for the Bigai River Floodplain, Knysna, Western Cape.

Prepared for: Knysna Municipality

May 2023 (updated September 2023)

of **Confluent Environmental (Pty) Ltd**

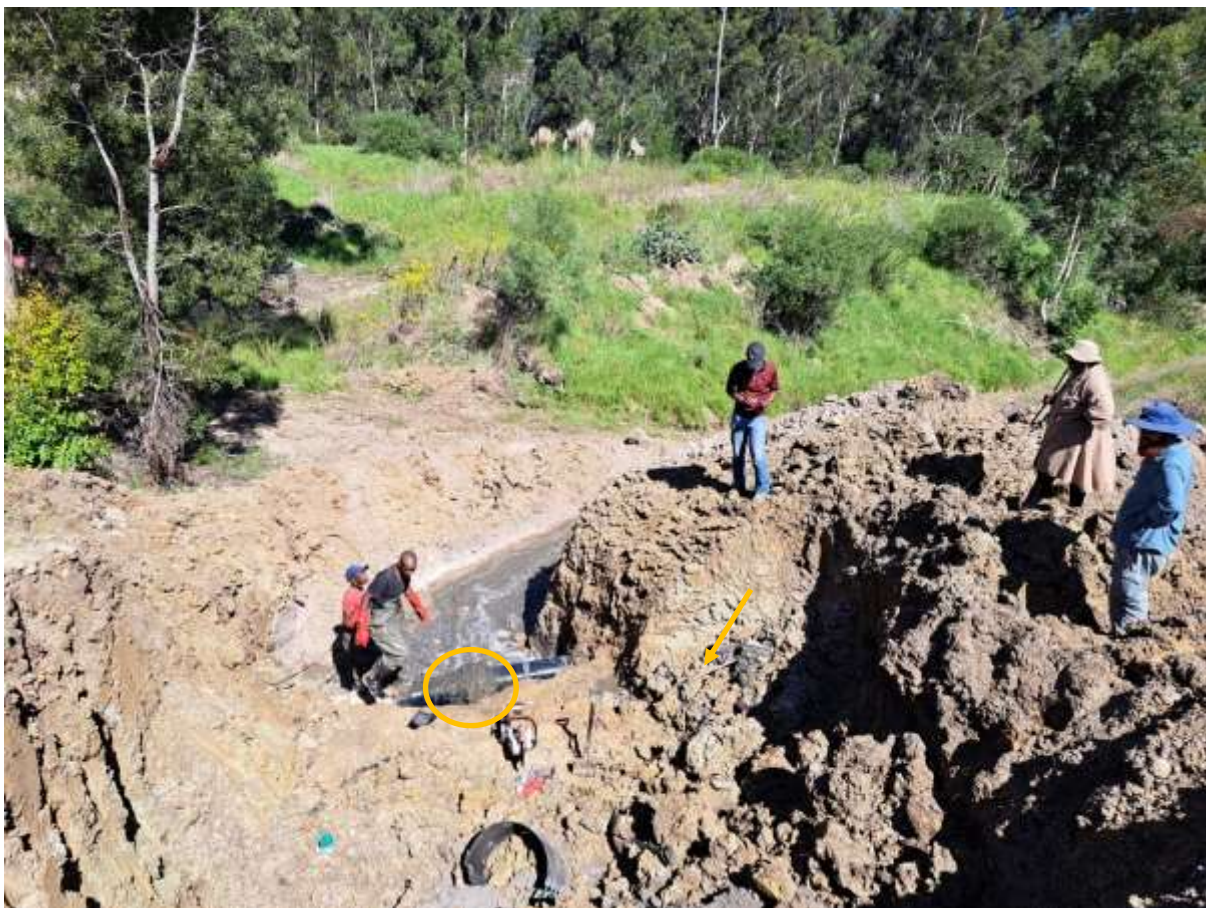
Figure 10. Photo taken on 31 March 2023 of a bulk sewerline that was opened to remove a blockage due to a walking crutch (arrow). Raw sewage and silt flowed straight downslope into the Bigai Wetland.

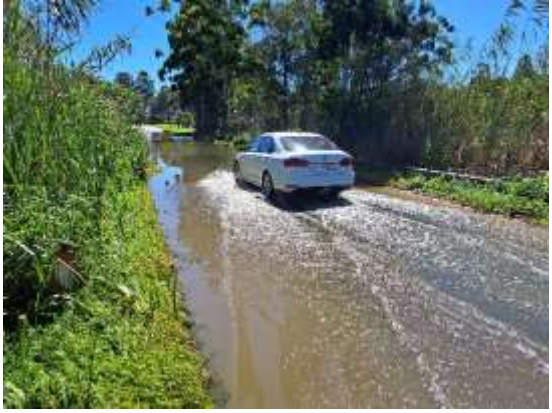
34° 3'30.89"S, 23° 4'48.73"E
Howard Street between the Knysna golf course and Erf 12403. Water flows from the site onto the road.

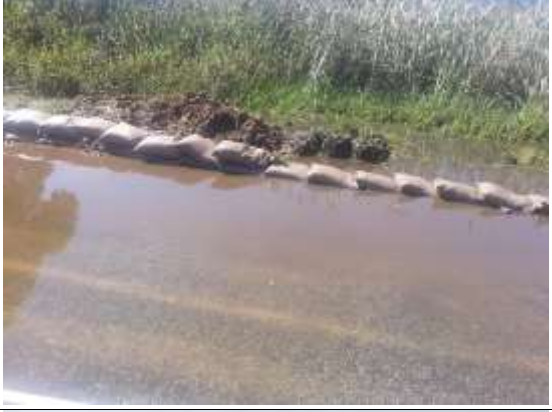
34° 3'13.13"S, 23° 4'17.58"E
Wilson Street. Water flows over the surface of the wetland preferentially towards the electrical sub-station which is not aligned with culverts.

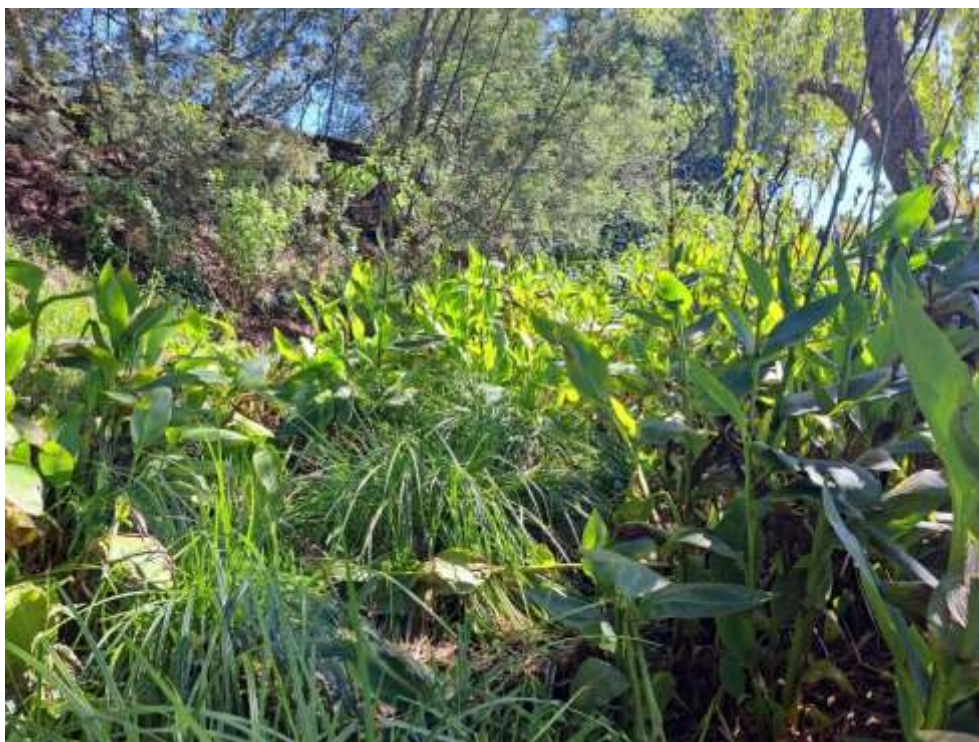
Figure 14. An example of extensive stands of alien vegetation in the drainage channel (*Canna indica*) and above on the flood berm (*Acacia mearnsii*) at the golf course.

melanoxyton), which should be cleared and managed on an ongoing basis through follow up clearing. Manage large alien trees (mainly black wattle) growing along the top of the flood protection berm. These trees are prone to falling over, taking out large pieces of the berm with them. Removal of the trees is not only a legal requirement of the landowner (Knysna Municipality) but will prolong the life of the berm. Trees should be cut and the stumps treated with a registered herbicide (gel type is good as it does not dribble or spread easily). Woody material must not be discarded into the Bigai River or into the artificial drainage channel.

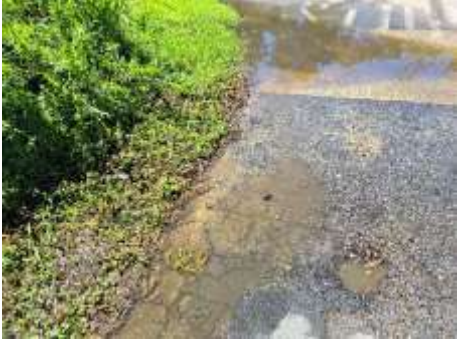
No.	Location	Photo	GPS Coordinate	Description	Maintenance Actions
1	Kennet Street Street Parcel RE/2090

34° 3'32.50"S, 23° 4'50.66"E	Culvert. Water pushing up (observable flow) through the road surface	<ul style="list-style-type: none"> Investigate presence of culvert either side of the road. If present, the culvert must be cleared by hand of vegetation, sediment & litter. Area of clearance is along the length of each culvert plus a metre either side, to the depth of the concrete, and 2 m into the wetland. Sediment may be used by the golf course for landscaping excluding water features.
2	Howard Street 2 culverts up and downstream 10m and 4m in length Street Parcel RE/2090

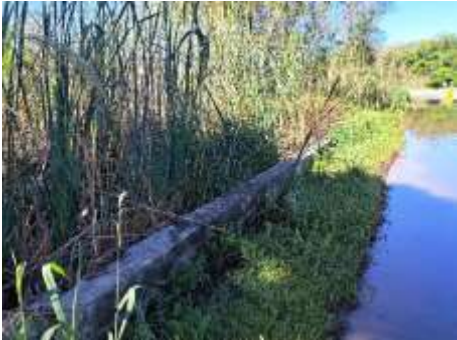
4 m culvert: 34° 3'31.13"S, 23° 4'49.43"E & 10m culvert: 34° 3'30.68"S, 23° 4'48.46"E	Culverts completely covered by vegetation and silt up and downstream of the road crossing.	<ul style="list-style-type: none"> Vegetation and sediment must be cleared by hand or using a small excavator positioned on the road. Area of clearance is along the length of each culvert plus a meter either side (12m and 6m respectively), to the depth of the concrete, and 2 m into the wetland. Sediment may be used by the golf course for landscaping excluding water features.

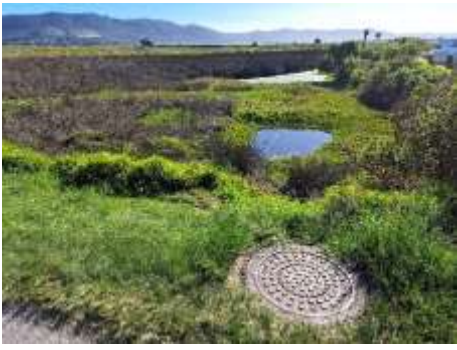
<p>34° 3'12.94"S, 23° 4'11.06"E</p>	<p>Culvert must be checked for flow conveyance. The invert level may be too high and require lowering. Silt and vegetation must be cleared if necessary.</p>	<ul style="list-style-type: none"> • Vegetation and sediment must be cleared by hand. • Area of clearance is along the length of each culvert plus a metre either side, to the depth of the concrete, and 2 m into the wetland. • Sediment may be used by the golf course for landscaping excluding water features. • As soon as the culvert is cleared, a silt fence must be installed on the estuary side of the culvert to prevent excessive siltation from entering the estuary.

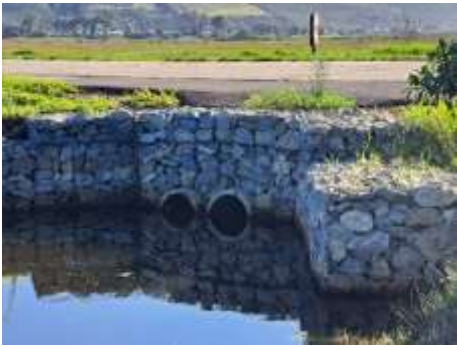
<p>11</p>	<p>George Rex Drive Street Parcel RE/2090</p>

<p>34° 3'20.34"S, 23° 4'10.73"E</p>	<p>Culvert recently upgraded and functioning well. May require periodic clearance of silt and vegetation reducing conveyance.</p>	<ul style="list-style-type: none"> • If flows are blocked in either direction it is necessary to clear vegetation, silt and litter from the culvert by hand. • Area of clearance is aligned with the gabions, plus a metre either side, to the depth of the gabions and 2 m into the wetland / estuary. • Sediment may be used by the golf course for landscaping including water features. • As soon as the culvert is cleared, a silt fence must be installed on the estuary side of the culvert to prevent excessive siltation from entering the estuary.

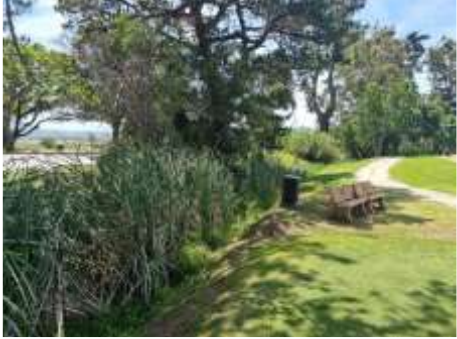
<p>14</p>	<p>Golf course 9th hole drainage channel (artificial) Erf 2233</p>

<p>900 m length from: 34° 3'33.03"S, 23° 4'44.66"E To 34° 3'35.83"S, 23° 4'11.96"E</p>	<p>Historical artificial channel that drains water off the 9th hole has silted up and requires sediment and vegetation removal.</p>	<ul style="list-style-type: none"> • Check the weather forecast and plan work for a dry spell lasting at least a week. • Excavate silt and vegetation in the direction from upstream to downstream. • Clearance can be by hand and/or a small excavator positioned on the adjacent fairway. • Clear silt and vegetation from the channel, measuring 2 m wide and 50-80 cm deep. • Ensure the channel is graded in a gentle slope in a downstream direction. • Clear 100m per week over 5 weeks. In this manner disturbance to wildlife will be minimised. • Alien plants should be removed during this process and include Canna lilies (<i>Canna indica</i>). <ul style="list-style-type: none"> • Cleared sediment can be used for landscaping outside of water features by the golf course. • Ensure excavator has no leaks and is in good working order. • All workers must dispose of litter or waste in bins and must not damage or pollute the drainage channel.

The drainage channel on the golf course parallel to the Bigai River is completely overgrown with vegetation which limits the function of this channel in conveyance of flows. Methods are provided in Table 9 for the excavation of accumulated silt and vegetation. Recommendations are made for the disposal of silt on site in the golf course. The golf course uses such silt for landscaping features along fairways, but the silt may not be used in any water features on the golf course.
