HERITAGE IMPACT ASSESSMENT

Proposed Development of the Bulskop PV Facility and Associated Infrastructure on Remaining Extent (Portion 0) of Farm 423 near Beaufort West, Western Cape

Prepared by CTS Heritage

November 2021

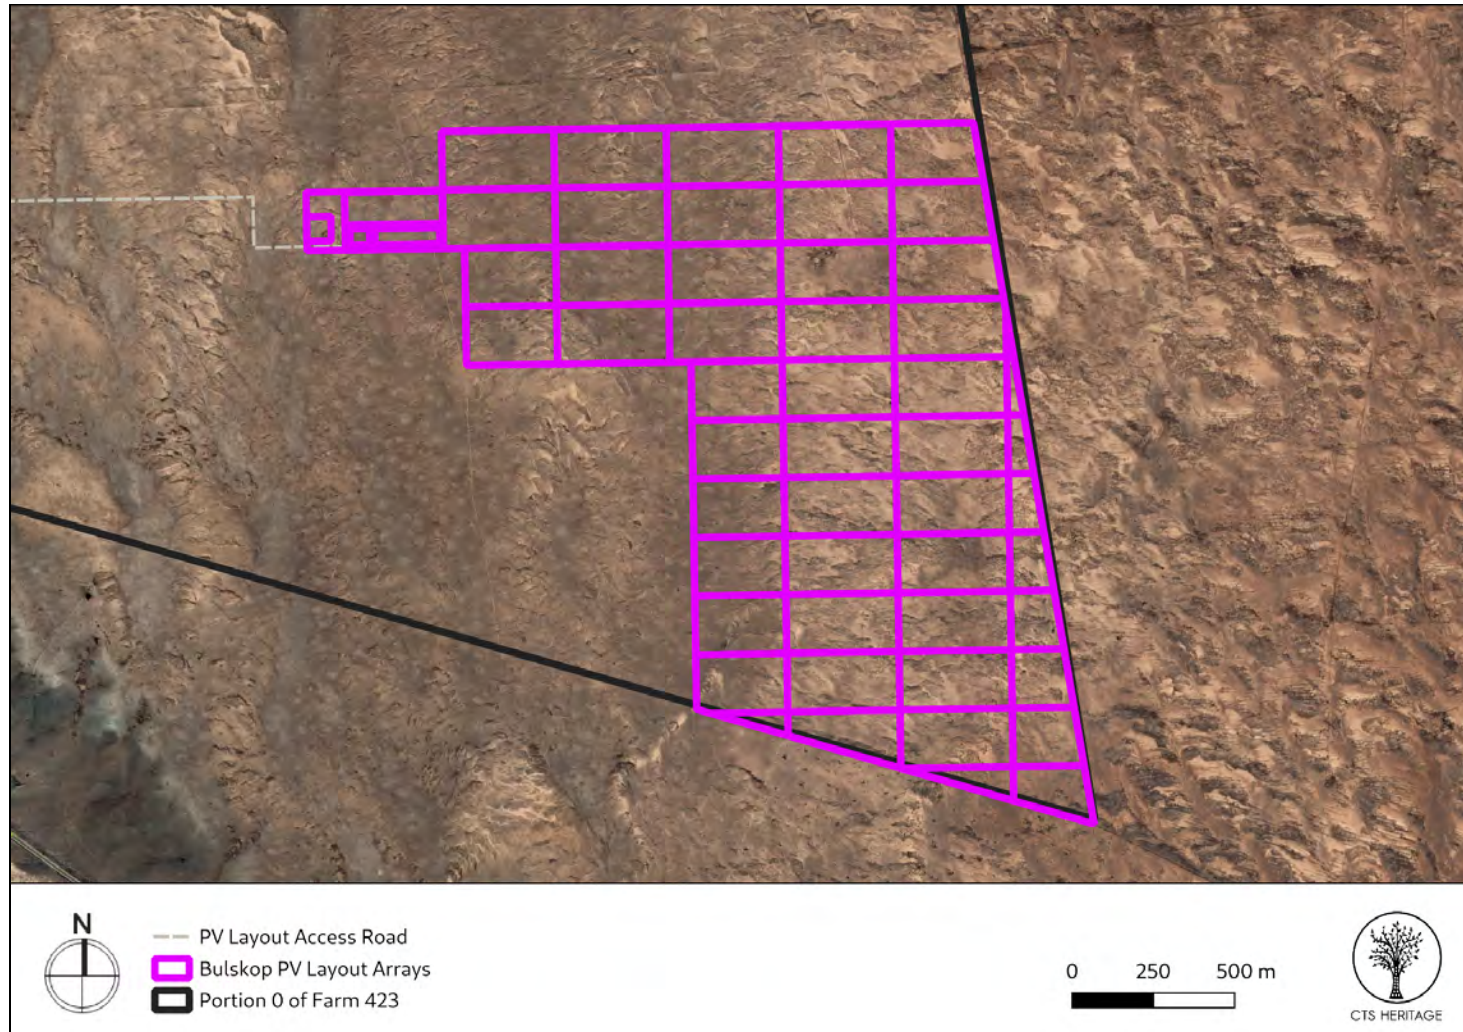
Figure 1.3: The proposed development layout of the Bulskop PV Facility

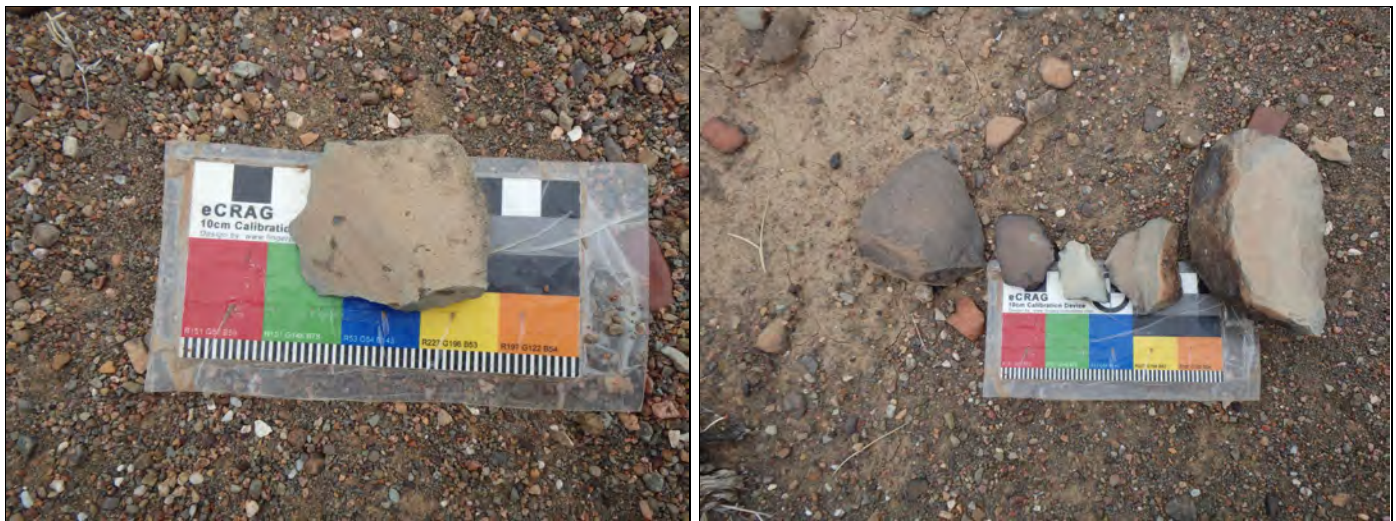
POINT ID	Site Name	Period	Description	Co-ordinates		Grading	Mitigation
BLK 030	Bulskop 030	MSA	Open site with mixed raw materials, flakes, cores, siltstone, hornfels. Floodplain, vegetation slightly better condition here due to groundwater	-32.40809	22.69982	IIIC	None required
BLK 055	Bulskop 055	Modern, Historic	Hansrivier farmhouse complex. Currently abandoned – consists of a main farmhouse painted yellow with green corrugated roof and outbuildings as well as vandalised/ruined labourers cottages.	-32.39148	22.62556	IIIC	50m Buffer

Figure 5. Observation BLK030 (Grade IIIC)

Only one archaeological resource of contextual significance was identified (BLK030). This site has been sufficiently recorded and no further mitigation is recommended. Furthermore, based on the available layout, no impact to this site is anticipated as it is located well away from the Bultskop PV development footprint.
