WATER USE LICENCE APPLICATION SUMMARY REPORT

**Establishment of Vineyard on Portions 43, 104 and RE/7 of Farm
444, Plettenberg Bay, Western Cape.**

Aquatic Assessment Report

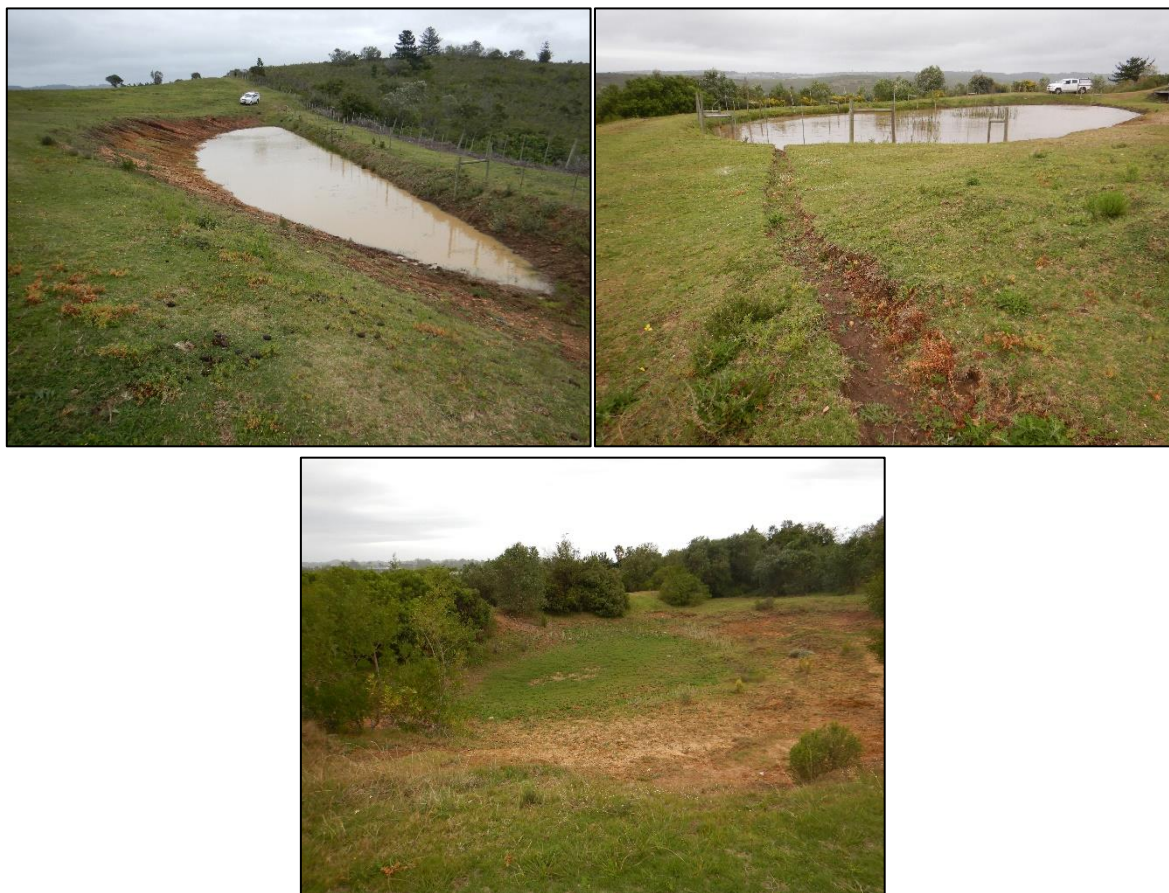
Figure 5: Photographs of three offstream dams located on 104/444 and RE/7/444.

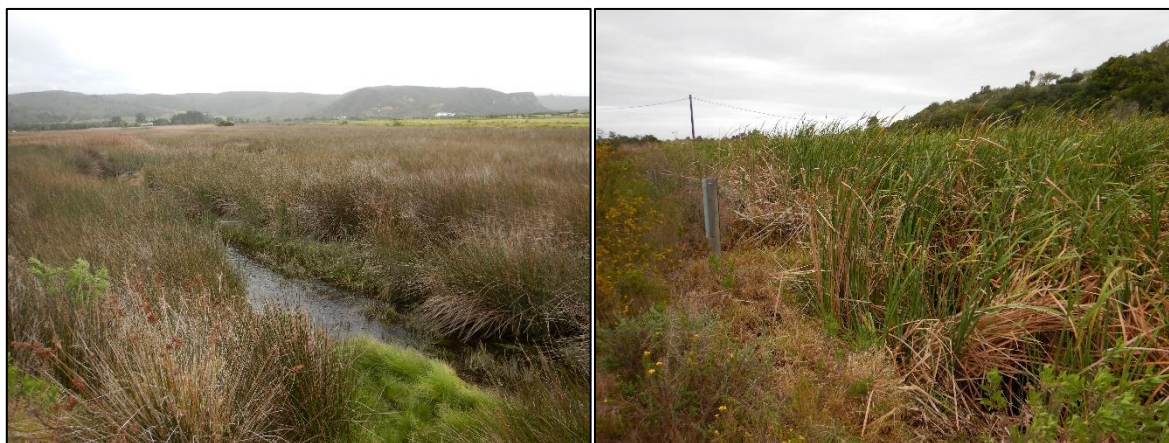
Figure 6: Dense stands of *Juncus kraussii* (left) and *Typha capensis* (right) downstream and upstream of Rietvlei Road, respectively.

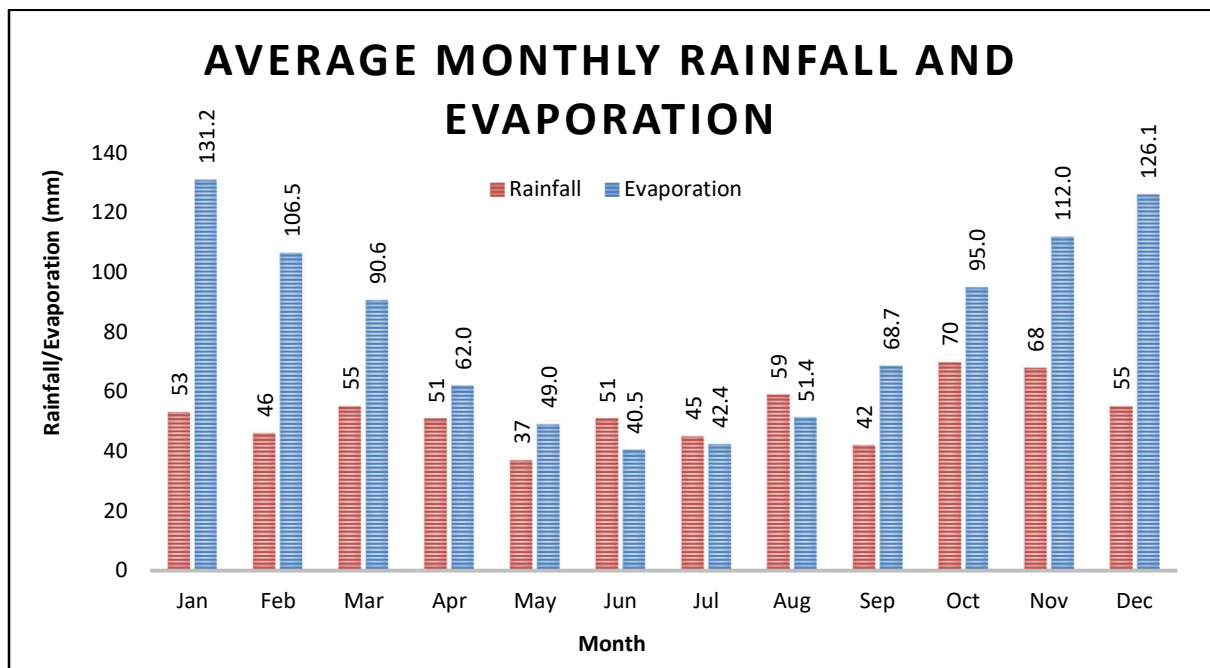
Figure 3: Average monthly rainfall and evaporation for the Wilderness area (DWA, 2015)

Evapotranspiration is relatively low (about 1 000 mm/a), but still results in an environmental moisture deficit for 9 months of the year (**Figure 3**).

- *The project area has a mild climate with approximately 650 mm of rainfall distributed relatively evenly through the year.*
- *Evapotranspiration is relatively low but still results in an environmental moisture deficit for 9 months of the year.*

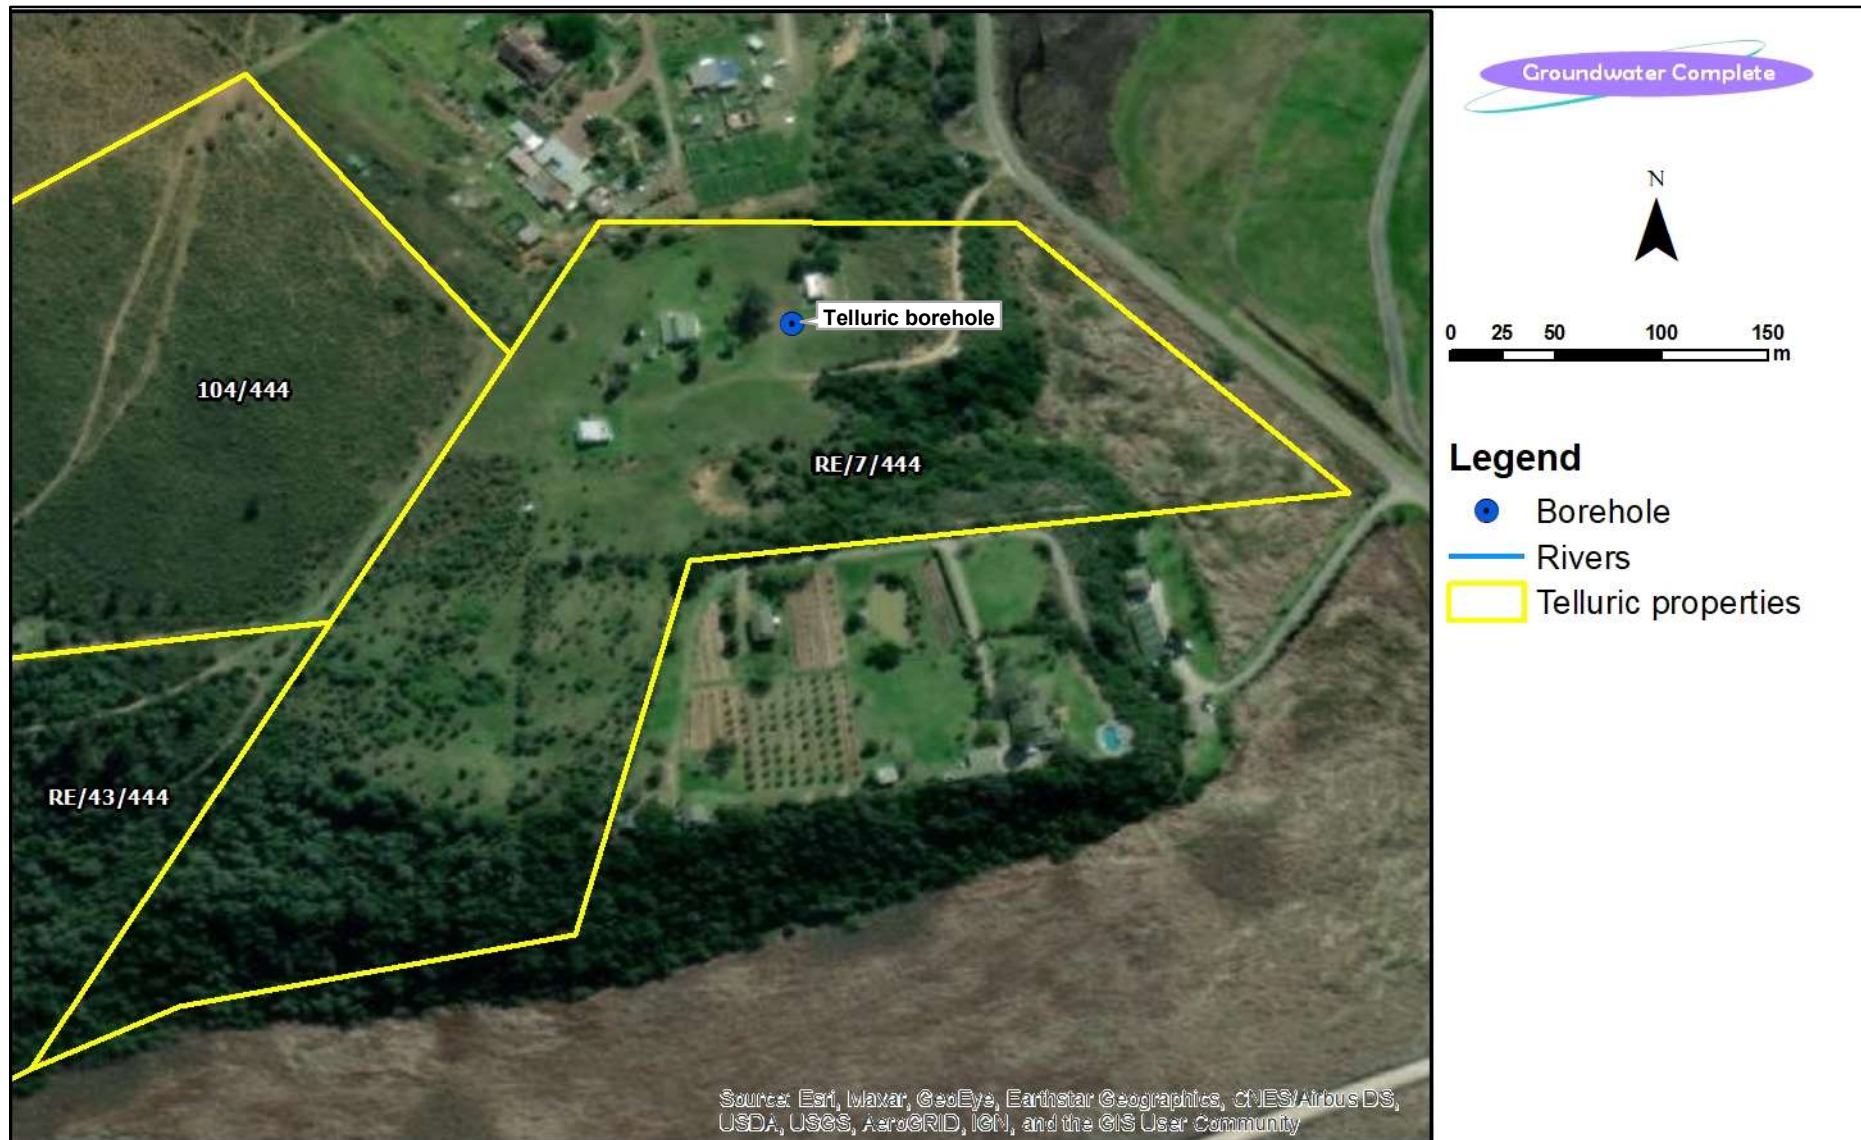
Figure 7: Map indicating the location of the Telluric borehole

A borehole was originally drilled on Telluric in September 2021 to a depth of 199 meters. After drilling and when an attempt was made to conduct an electrical conductivity (EC) profile of the borehole it was found that the borehole collapsed at 75 mbs. The borehole could not be stabilised to install casing and a new borehole was drilled at the end of November 2021 three meters south of the original borehole to a final depth of 151 mbs. The new borehole was equipped with a grout seal around solid steel and solid uPVC casing down to 123 meters, and perforated uPVC casing within a gravel pack from 123 meters to 147 mbs.

- The first water was encountered at a depth of 35m, but was of poor quality having an EC of up to 1600 mS/m.
- Fresher water was intersected at a depth of 130 mbs.
- The borehole was drilled to a depth of 151 mbs and casing was inserted to 147 mbs and a final electrical conductivity of 97 mS/m.

A map of the location of the borehole is provided in **Figure 7**. The drill log of the first boreholes is provided in **Figure 9**. Down to its final depth of 151 mbs the final borehole is the same as the first one.

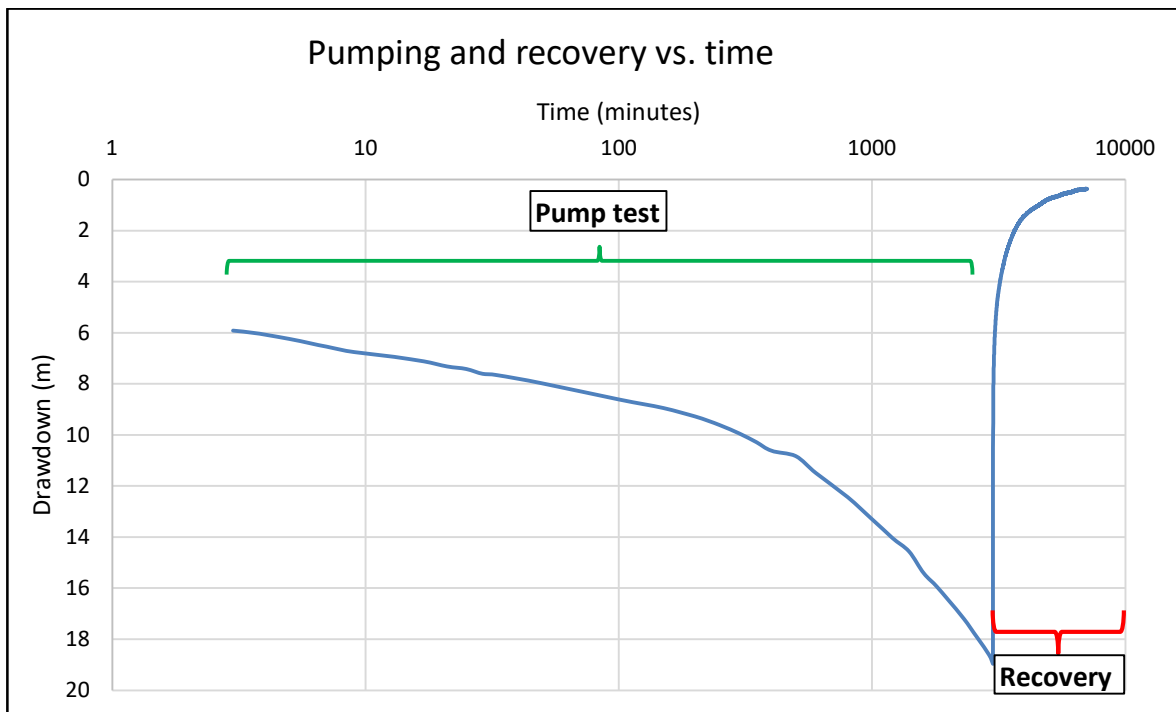
After completing the pumping test, the recovery of the borehole was also measured. Analysis of the recovery data is another way to estimate the hydraulic parameters of the borehole. The recovery test data can be viewed in **Figure 13**.

The recovery rate of the piezometric head in the borehole was good. The borehole water level recovered to around 90 % after only 13 hours of recovery (following 48 hours of pumping). A transmissivity of 11 m²/d was calculated from the recovery data. This transmissivity is somewhat higher than the transmissivity calculated during the pumping test, however the recovery test often indicates a higher transmissivity and shows that the calculated pump test transmissivity can be considered as a conservative estimate.

Figure 13: Recovery data measured after the pump test for the Telluric borehole

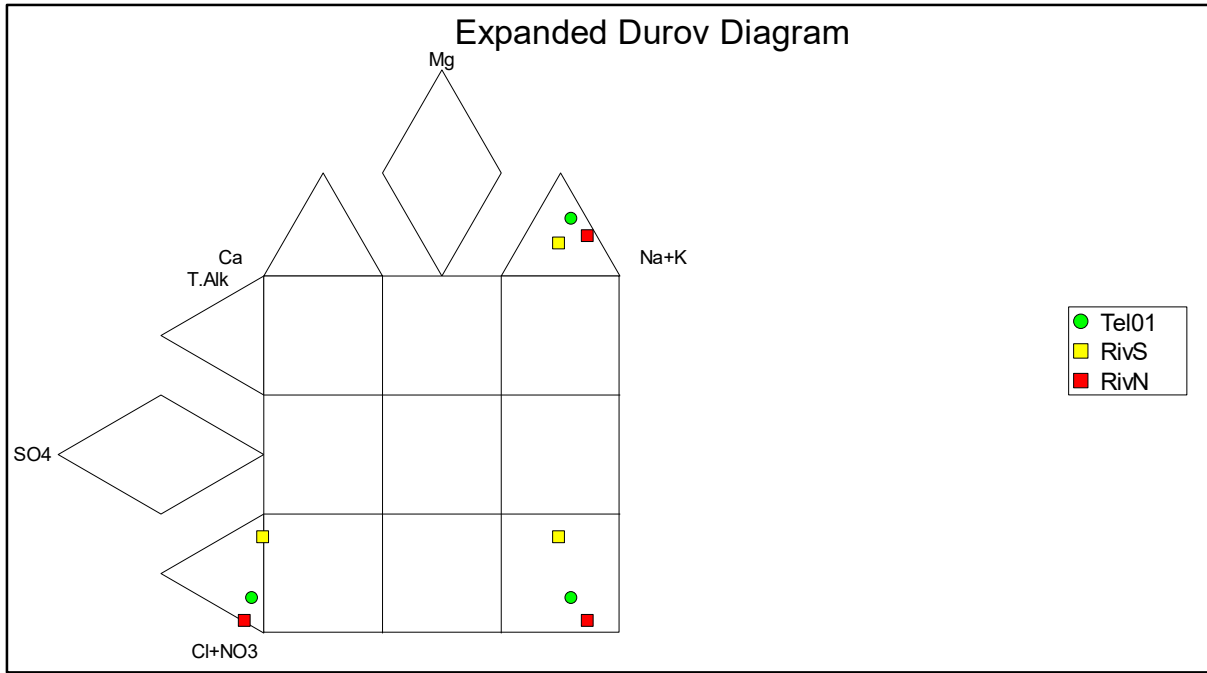
- *Groundwater from the Bitou river (to the north) sampling point is considered to be of poor quality with numerous exceedances of the South African National Standards (SANS 241:2015).*
- *The southern Diep river sampling point*
- *Groundwater from the Telluric borehole is considered to be of very good overall quality.*

Figure 16: Expanded Durov diagram of Telluric groundwater chemistries.

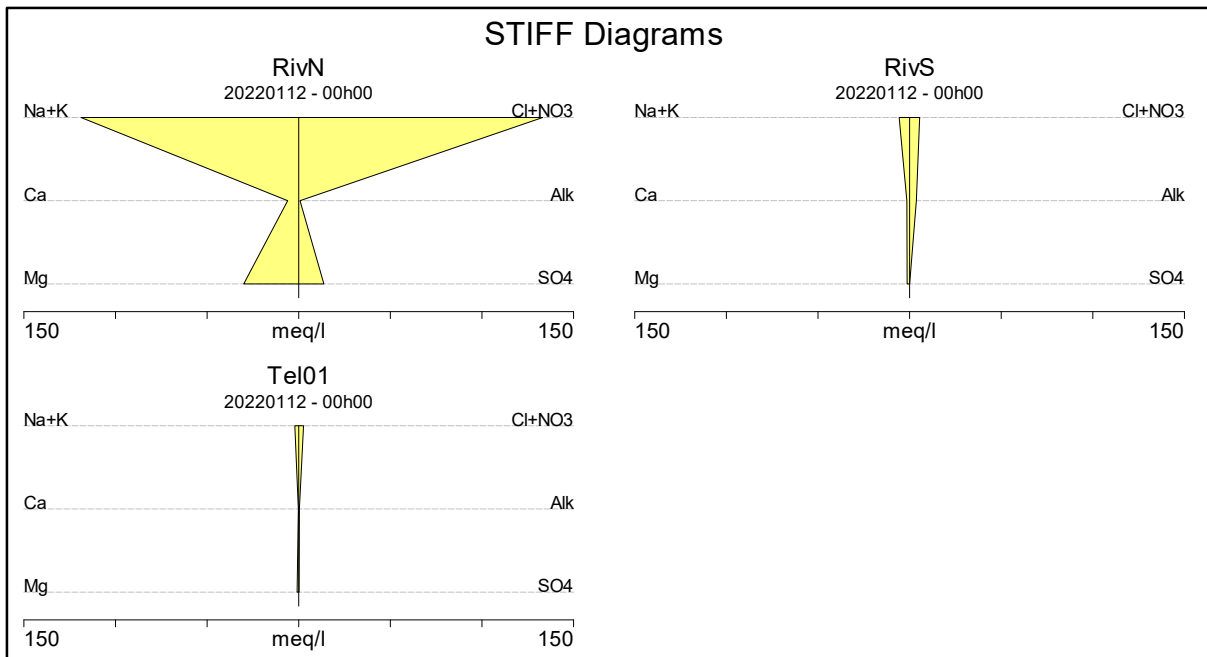
Figure 17: Stiff diagram of Telluric groundwater chemistries.
