Aquatic Biodiversity Impact Assessment

Proposed construction of Plett Lagoon residential estate on Erf
6503, Plettenberg Bay, Western Cape

Confluent Environmental (Pty) Ltd

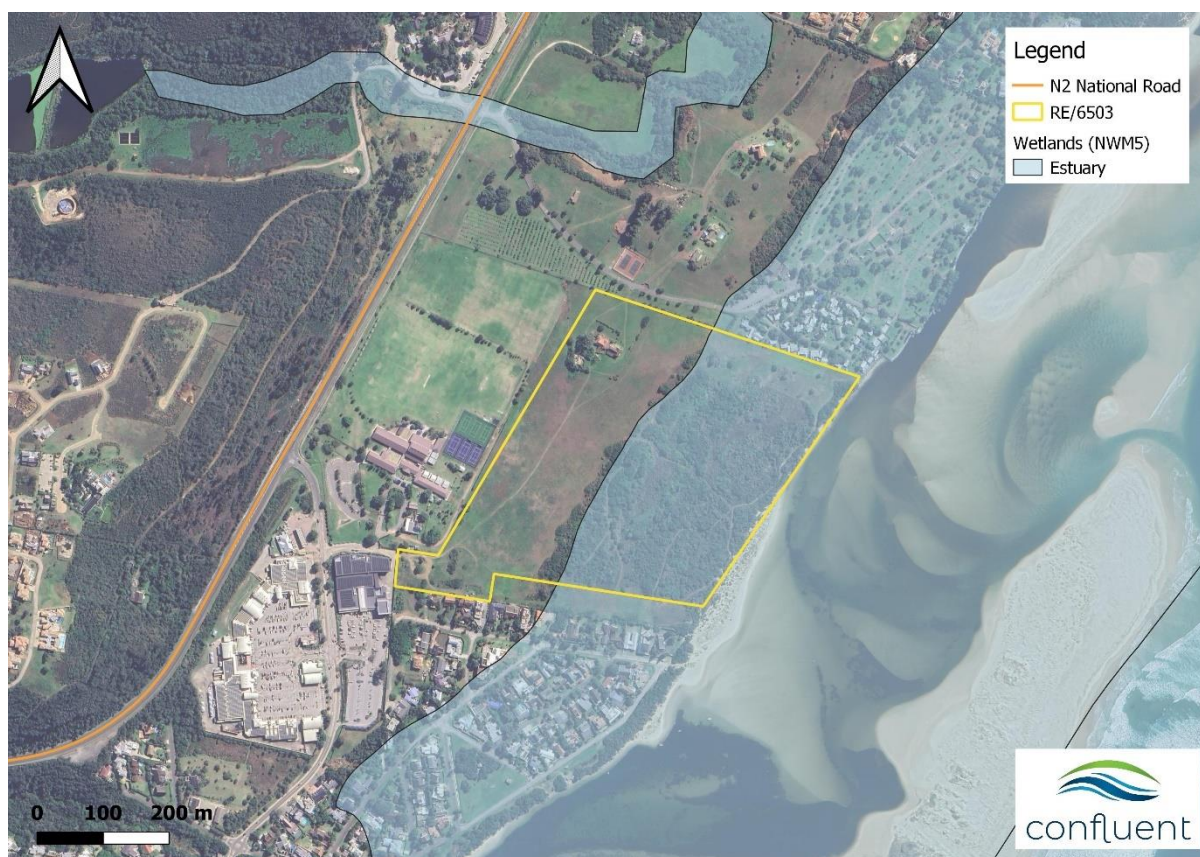
Figure 1. Proposed site of a housing development known as Plett Lagoon Estate on RE/6503, Plettenberg Bay.

Confluent Environmental Pty (Ltd) were appointed by Cape EAPrac to provide aquatic specialist inputs to the proposed residential development known as Plett Lagoon Estate on RE/6503 (Figure 1). The property is approximately 19 hectares in extent and is in the town of Plettenberg Bay between the Keurbooms Estuary to the east and the Plettenberg Bay Primary School to the west. Site access is via Beacon Way on the southwestern corner of the property. The eastern portion of the site is below the 5 m.a.m.s.l. contour which places it in the Estuarine Functional Zone of the Keurbooms Estuary Figure 1.

The only mapped aquatic feature proximal to the site is the Keurbooms Estuary which is indicated as the area below the 5 m.a.m.s.l. contour (Figure 1 and Figure 12). The 0.5 m contours are shown for this area as they provide a more detailed picture of the micro-topography.

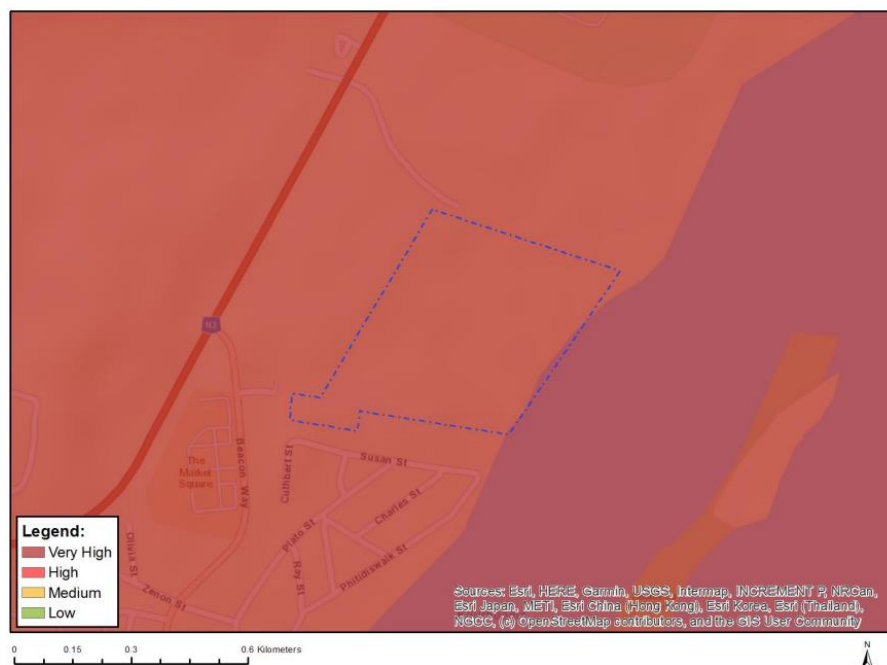
Figure 7. Results of the DFFE Screening Tool which indicate Very High Sensitivity of the Aquatic Biodiversity theme.

According to the Department of Environment, Forestry and Fisheries (DFFE) screening tool, aquatic biodiversity at the site has a **Very High** sensitivity (Figure 7). The sensitivity features identified are:

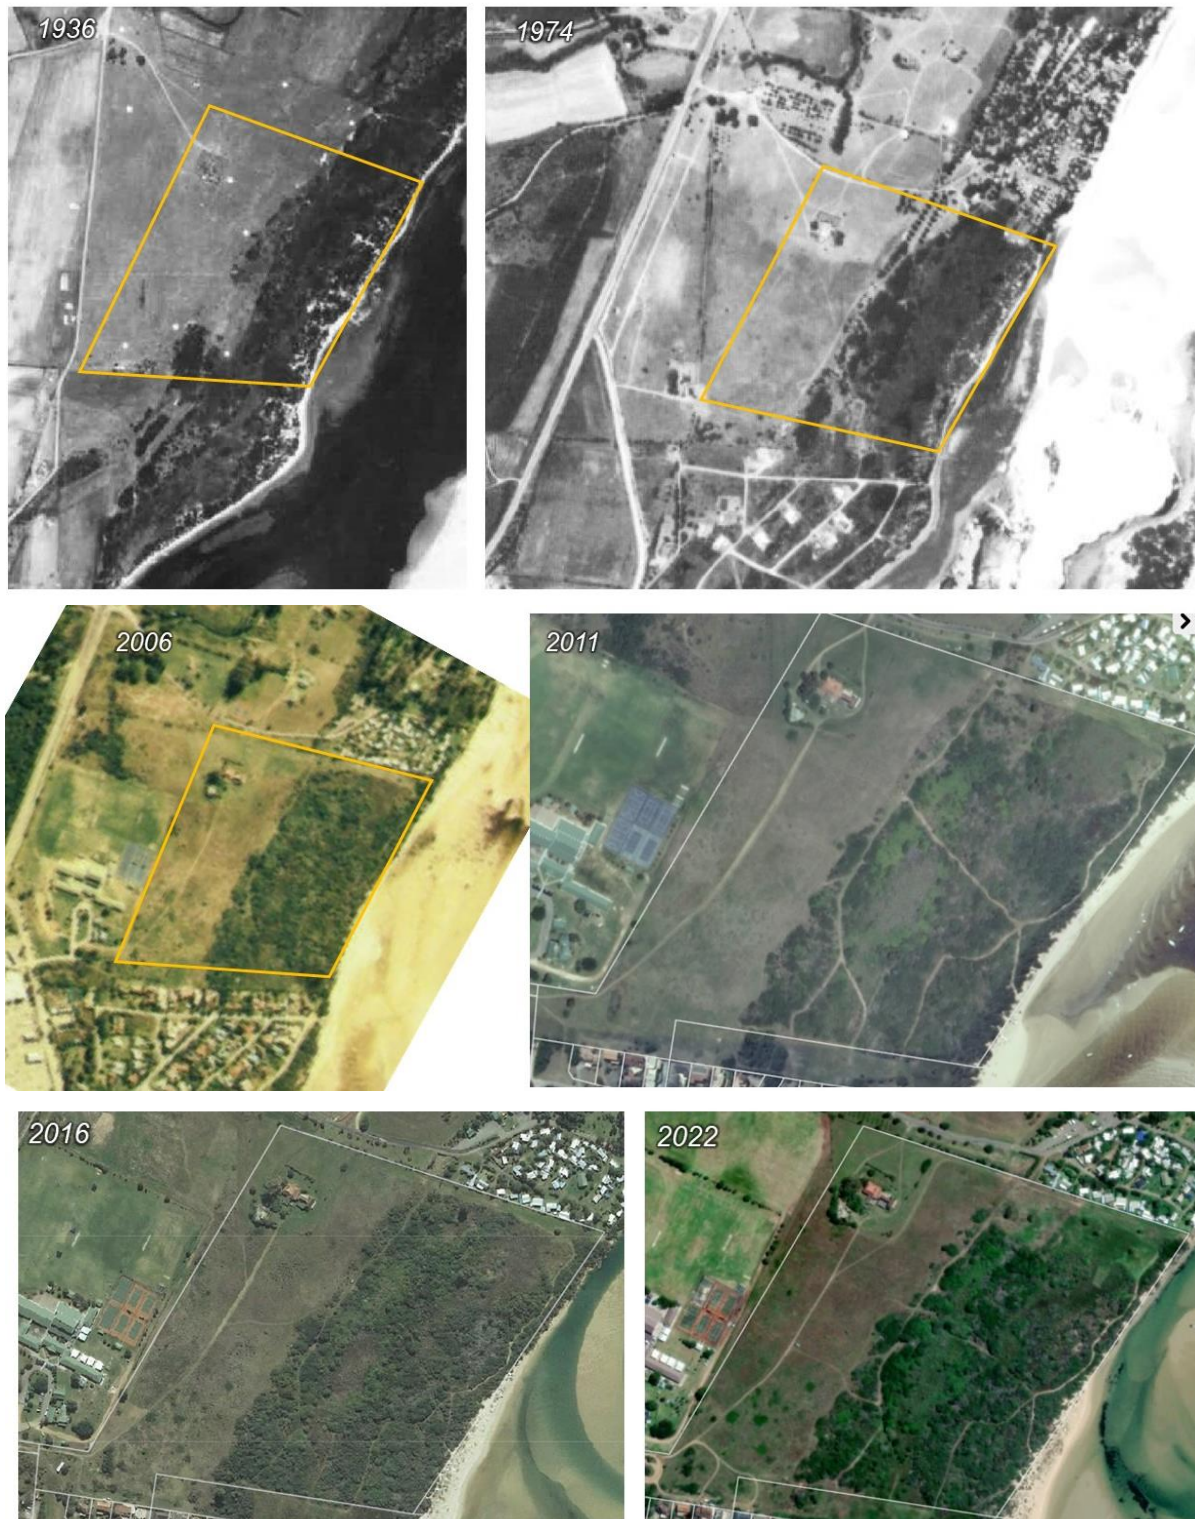
Figure 13. Historical photos showing the approximate property boundary for a period of 86 years (CD:NGI & Google Earth imagery).

Historical aerial and satellite photos were examined of the site over a period of approximately 8 decades (Figure 13). In the earliest photo from 1936, very little development had occurred either on the property itself or in the neighbouring properties. The difference between the more grassy, open vegetation to the west of the site, compared to the more densely vegetated eastern portion is evident throughout the site's history. Dense vegetation along the lagoon no

the neighbouring properties was cleared for construction of housing developments around the 1970s. The residence located on RE/6503 in the northern corner was evident as a small settlement in 1936 and has always been the site of a residence to the present day. Footpaths through the wetland were evident from 2011, although they were probably present for a while before then, but overgrown.

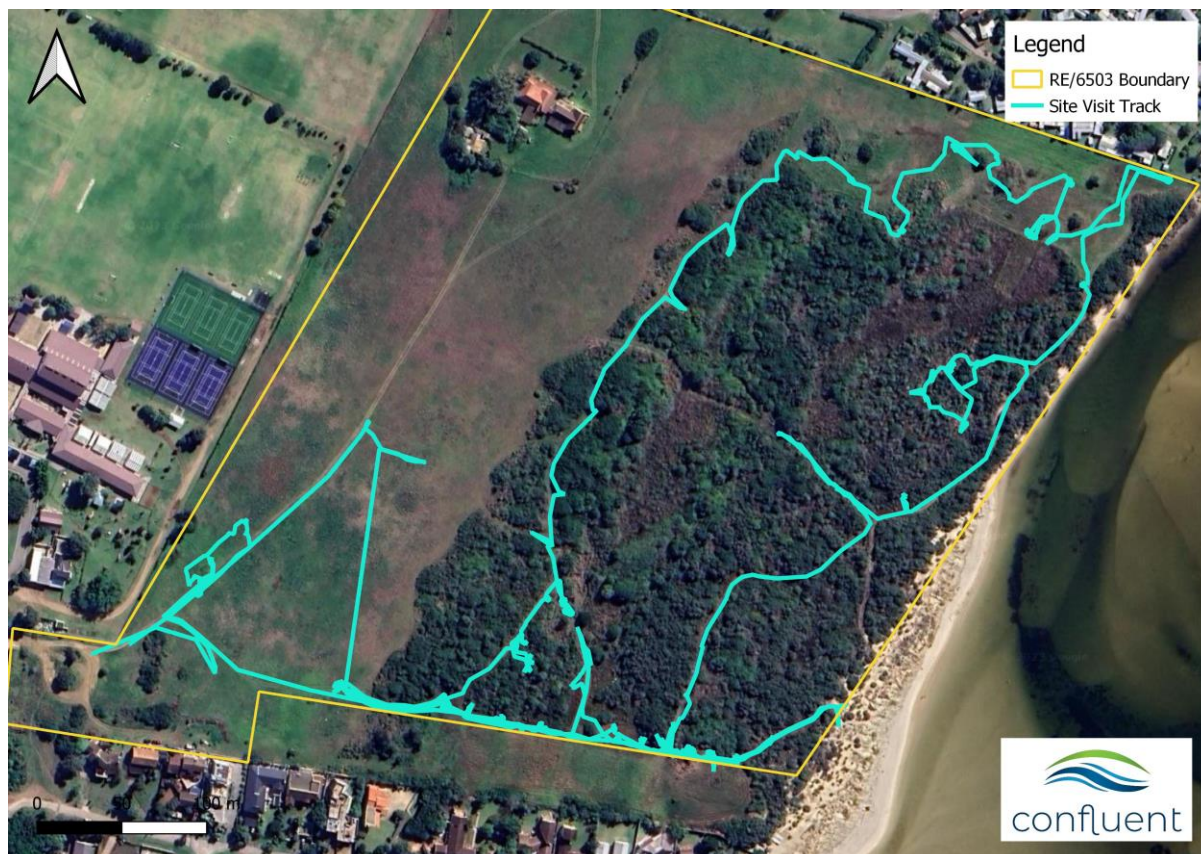
Figure 14. GPS track of route walked during the site assessment on 21 May 2023.

The site was visited on 21 May 2023. Above average rainfall had been experienced in the Garden Route in May and it rained periodically during the site assessment. An extensive area of 5.2 km was walked to assess aquatic features where accessible (Figure 14).

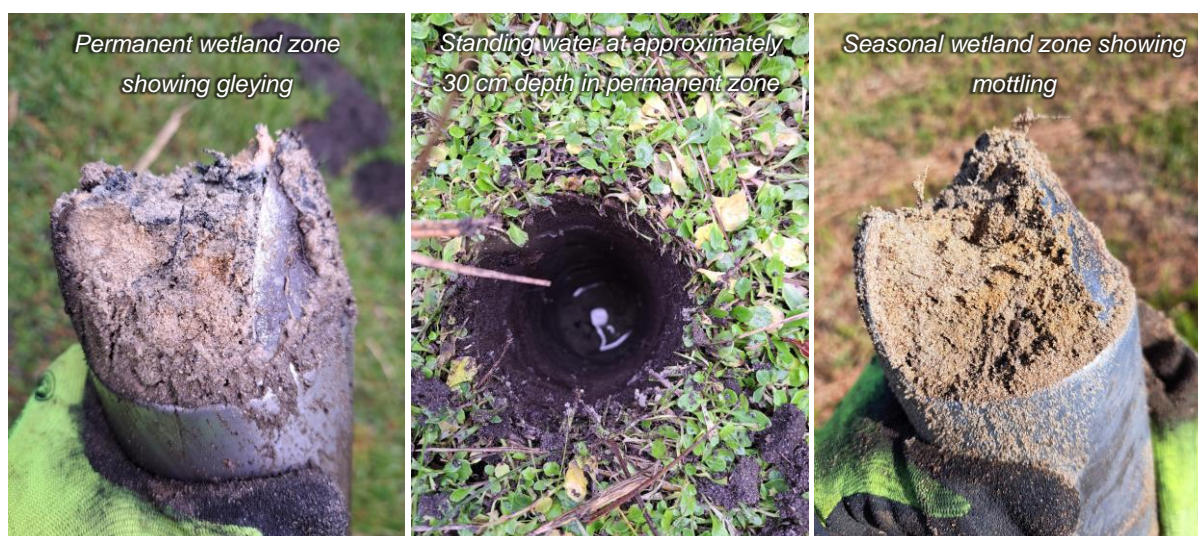
Figure 15. Wetland soil indicators observed at the site.

Hydric soils display indicators which are predominantly formed by the accumulation or loss of iron, manganese, sulfur or carbon under permanent or periodic saturated and anaerobic conditions. Sandy soils such as those on the RE/6503 seldom show the same degree of mottling and gleying as saturated or seasonally saturated soils with a higher clay content. Nonetheless, soils from multiple points showed degrees of mottling and gleying in permanent and seasonal zones of the wetland, and standing water was often present from 30 cm depth (Figure 15).

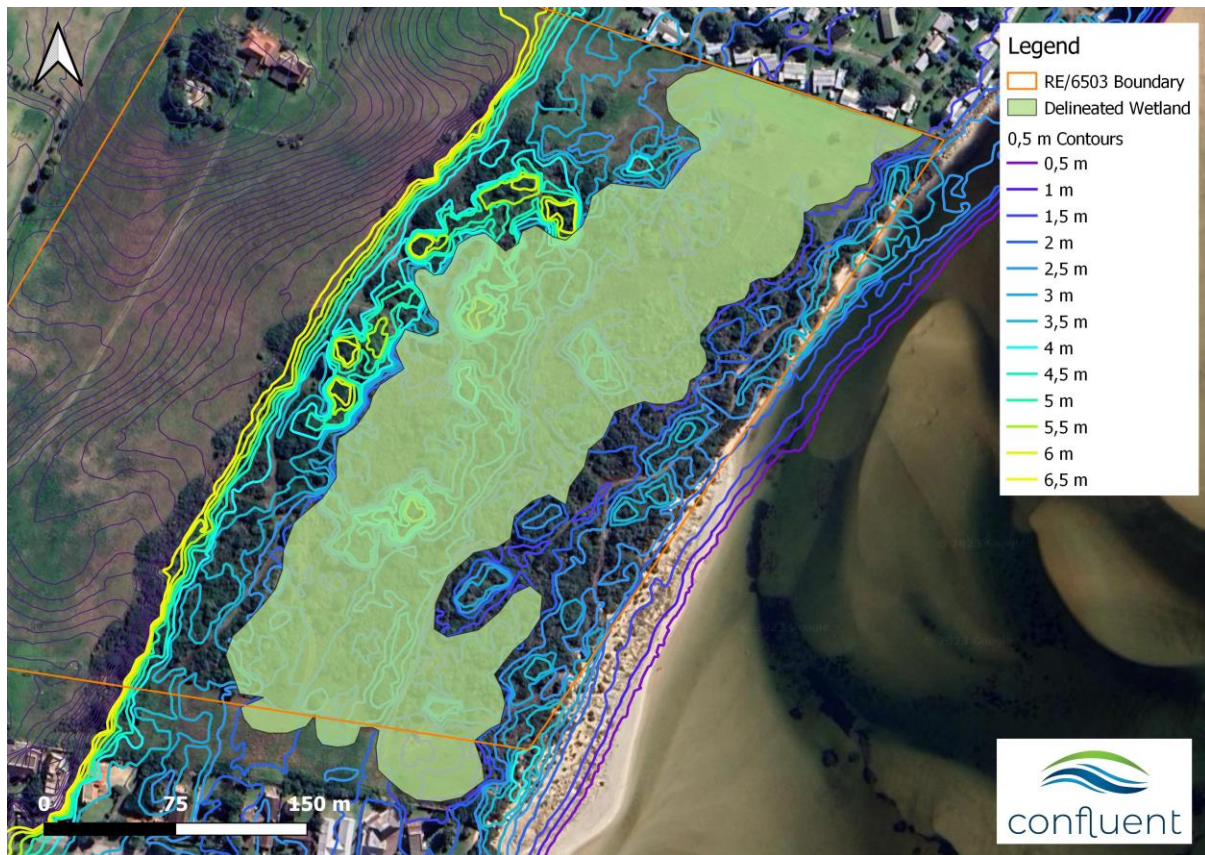
Figure 16. Wetland delineation based on soil, vegetation, and topography of the site.

Wetland vegetation and soil auger results observations were combined with the fine-scale site topography to delineate the depression wetland as indicated in Figure 16. The wetland is mostly located below the 2.5 m to 3 m.a.m.s.l. contours at the site.

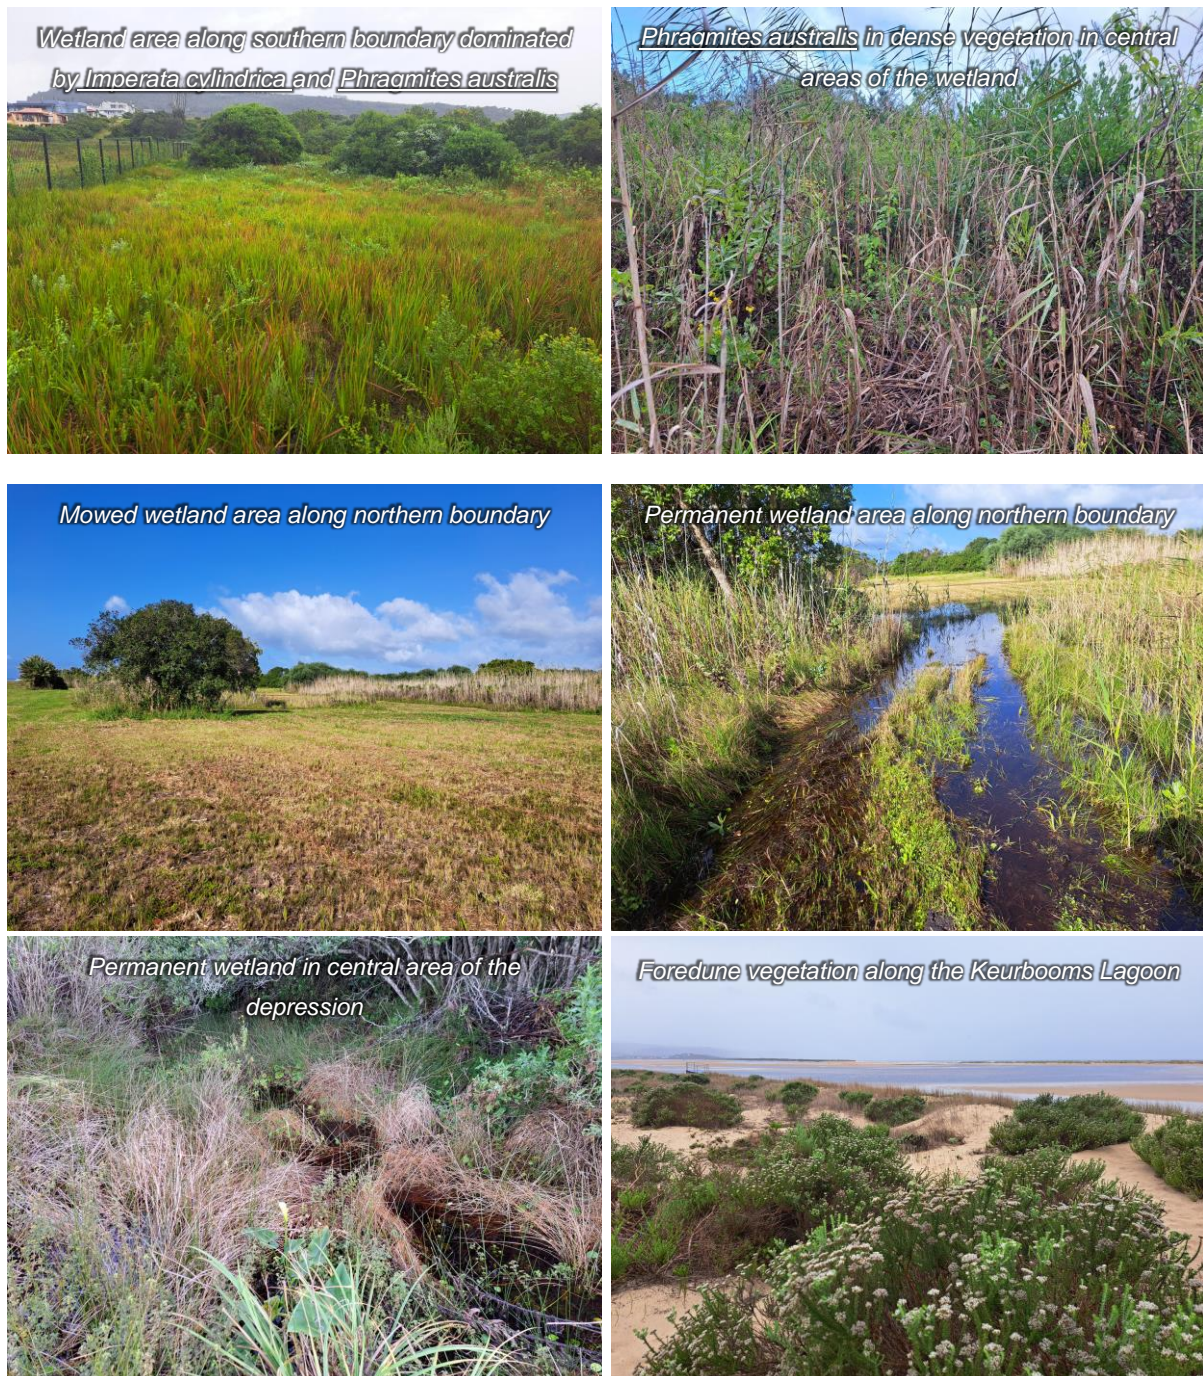
Figure 18. Photos of various wetland and estuarine features on RE/6503.

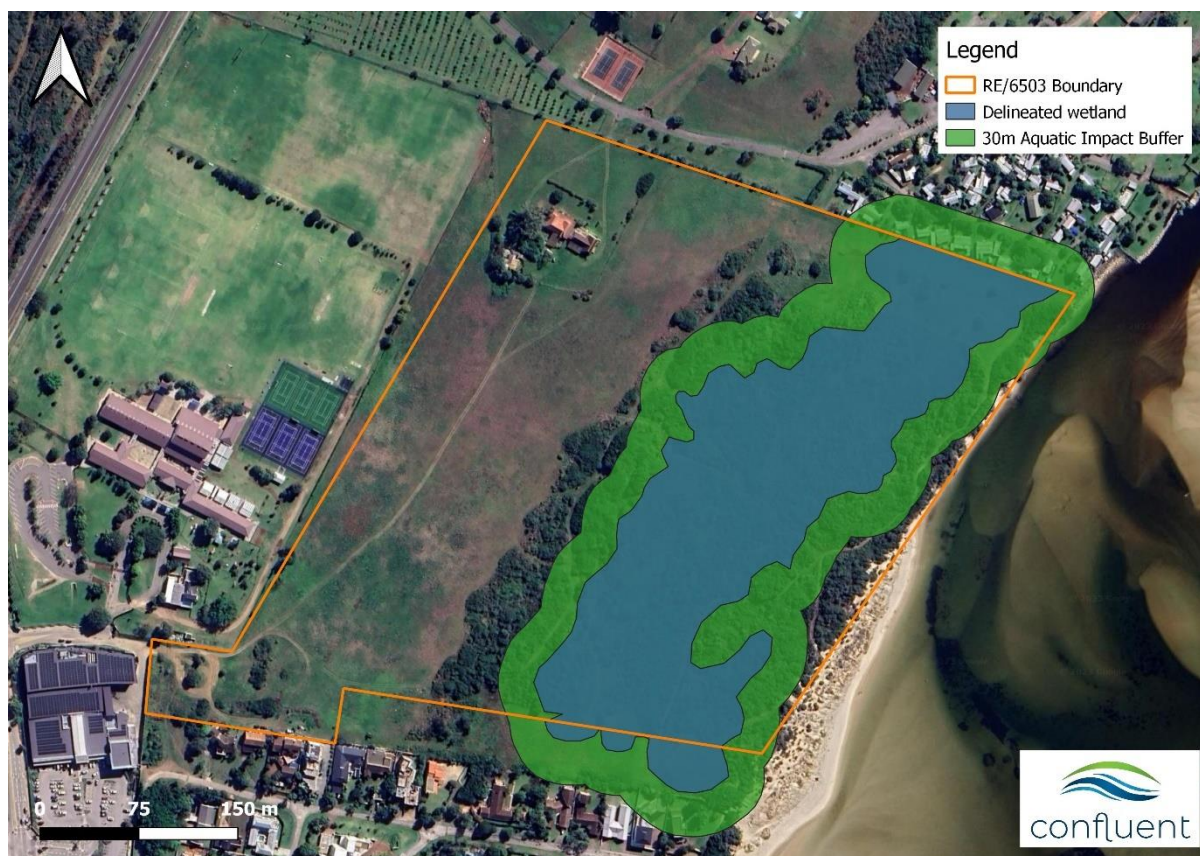
Figure 19. Delineated wetlands and 30 m wetland buffer in relation to the remainder of the site.

development. The width of the aquatic impact buffer zone was determined to be **30 m** through use of the site-based wetland buffer tool developed by Macfarlane & Bredin (2017).

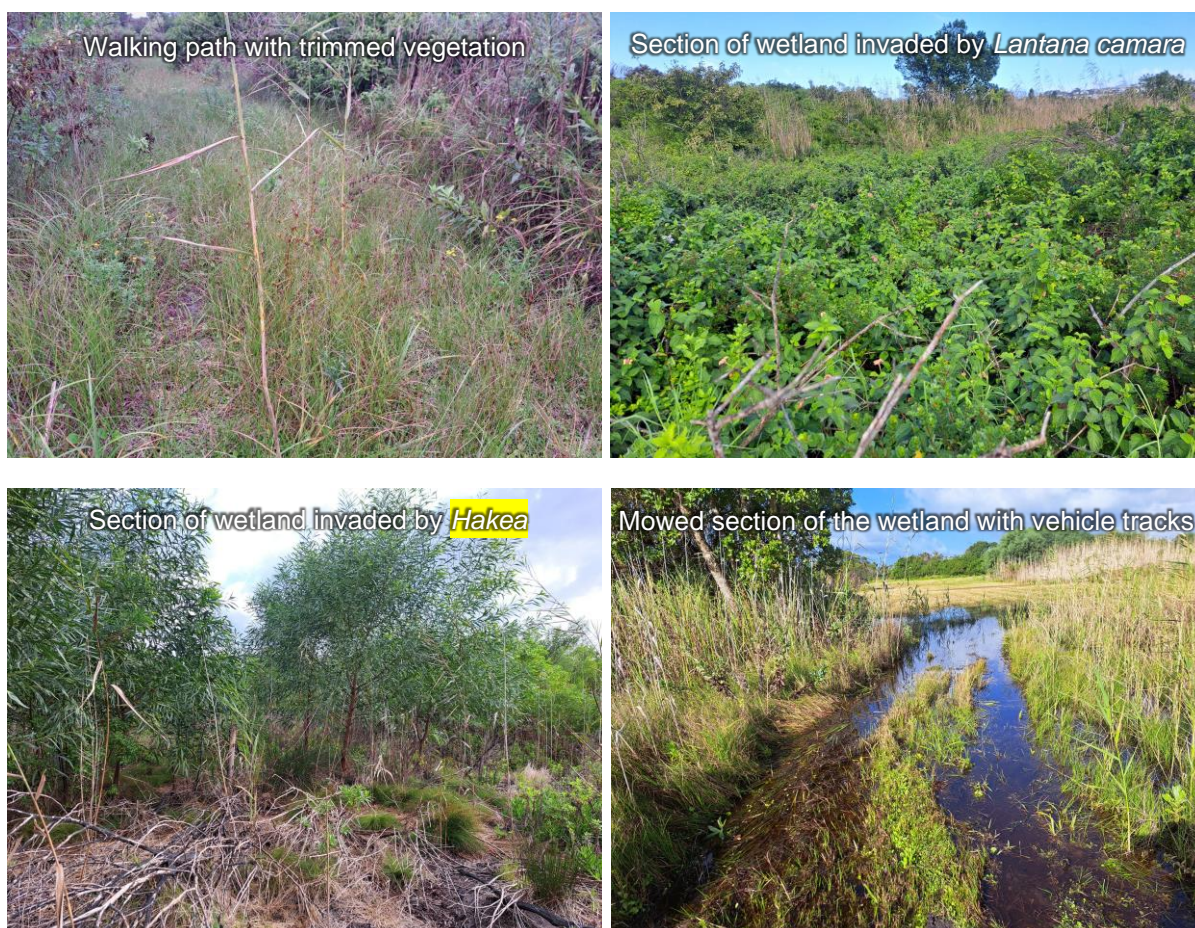
Figure 20. Photos of various impacts affecting vegetation of the wetland.

The PES of the wetland was determined using the updated WET-Health Version 2 method described by Macfarlane *et al.* (2020). Methods for the assessment are provided in Appendix 1. The result of the assessment was an overall **PES of A, Natural**, although the score was close to the boundary with B, Largely Natural. Minor impacts have occurred which have slightly reduced the state of the wetland from its natural reference condition (Figure 20). These are summarised as follows:

Most impacts affect vegetation which is reflected in the score of B, Largely Natural, determined in the PES assessment. Minimal impacts were observed to affect the wetland's hydrology water quality or geomorphology.

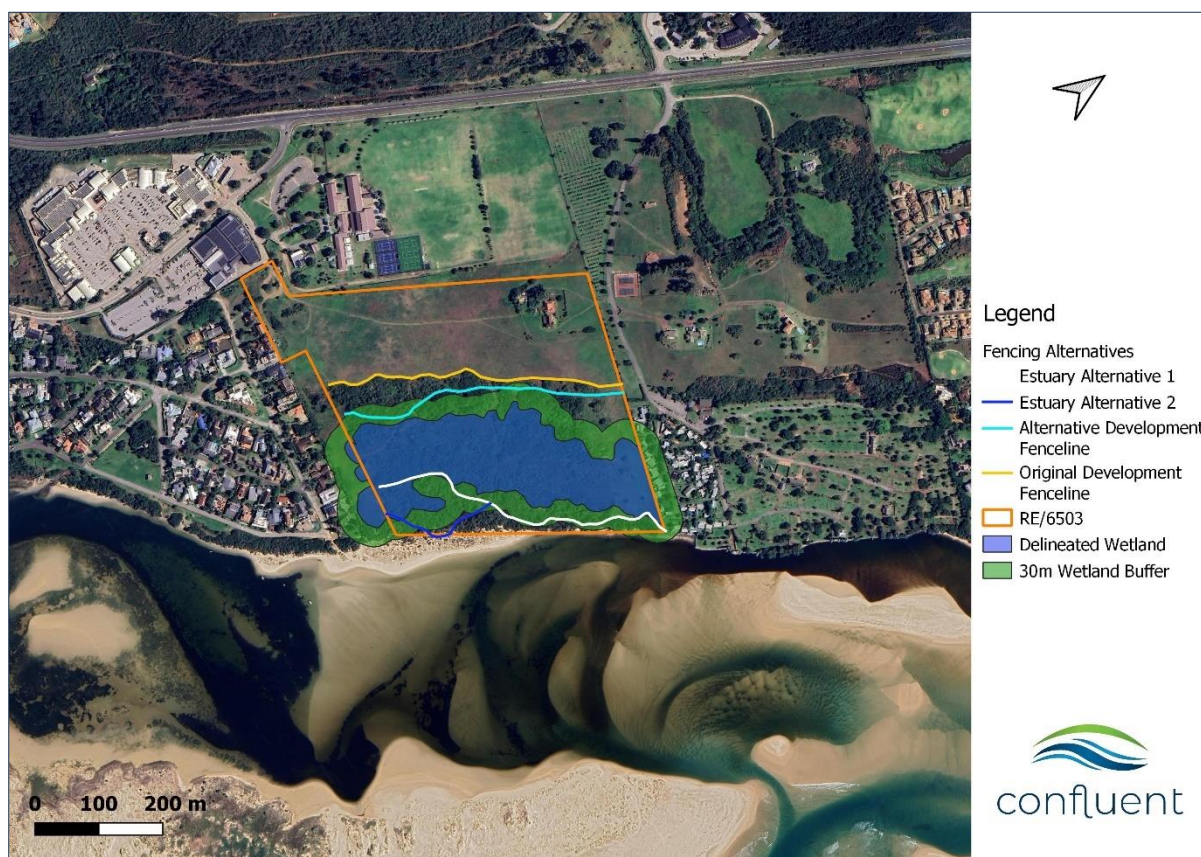
Figure 22. Rotated view of RE/6503 showing the alternative fenceline options in relation to the surrounding area and delineated wetland features.

Throughout comparisons of fenceline alternatives reference is made to Figure 22 and Figure 23. Benefits of the original fenceline (yellow line) were that it completely avoided the buffer and wetland area, minimised vegetation disturbance, and did not intersect any of the more natural habitat associated with the wetland and buffer area (Figure 22). The original fence resulted in zero direct impacts to the wetland or buffer, from an aesthetic perspective the developer would prefer to place the fence at the bottom of the slope along an existing pathway, which would reduce vegetation disturbance compared to areas outside of paths, but would fragment an area of about 1.3 ha of more natural vegetation from the adjacent wetland area and encroach into the buffer, quite close to the wetland in places.

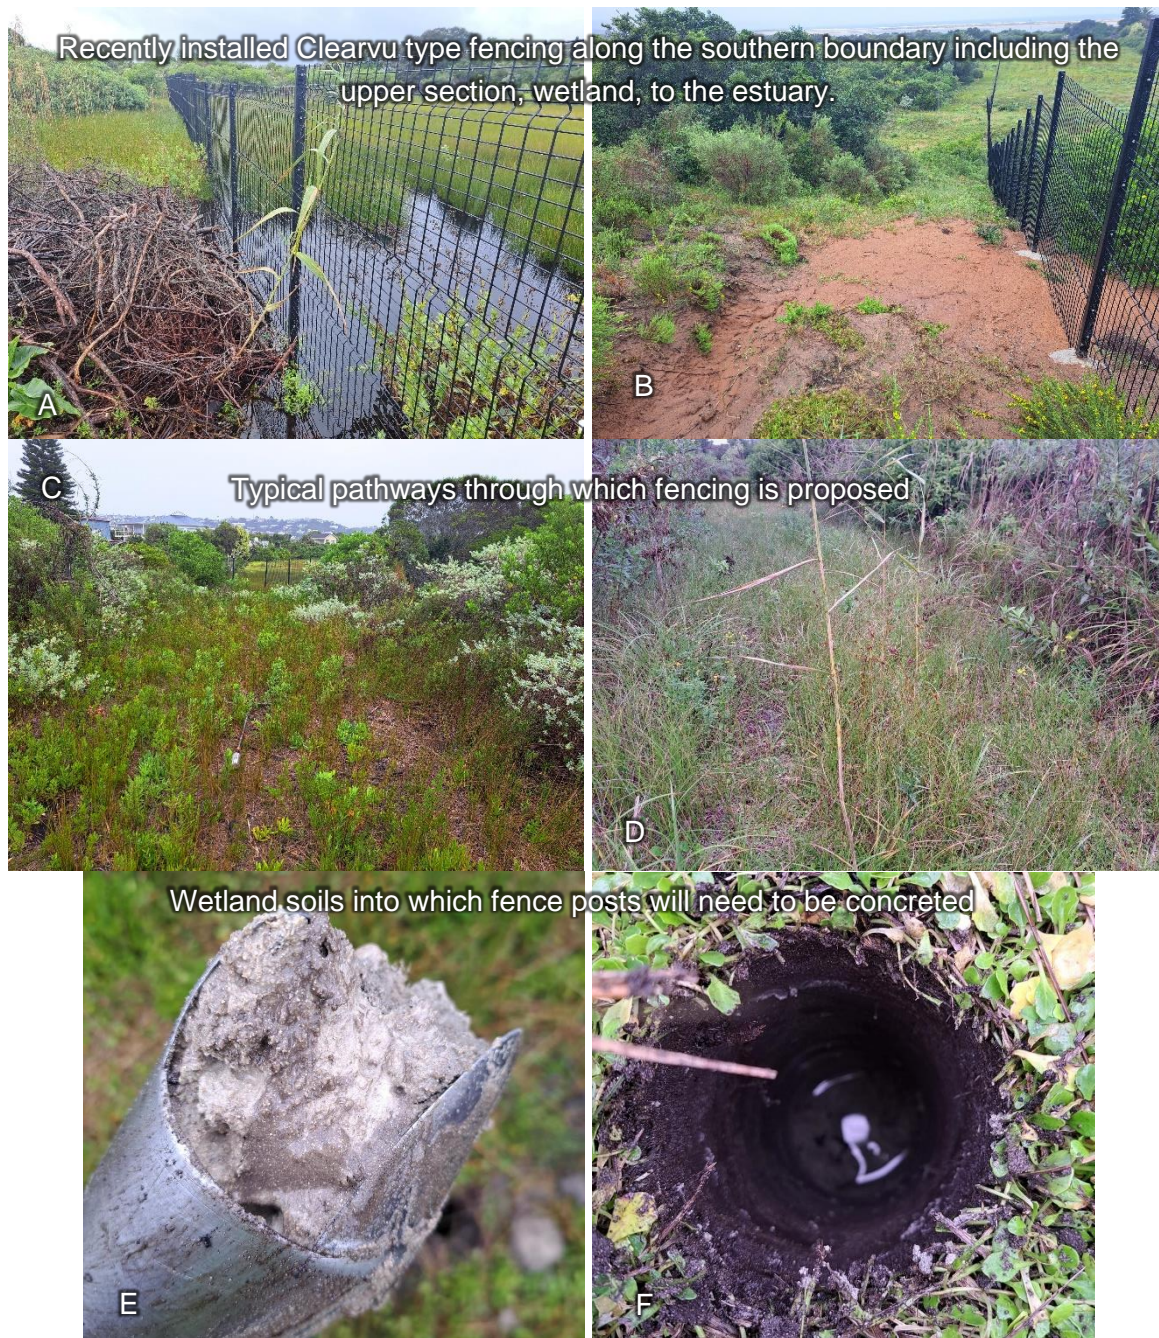
Figure 23. Photos of existing a proposed aspects of the alternative fenceline options.

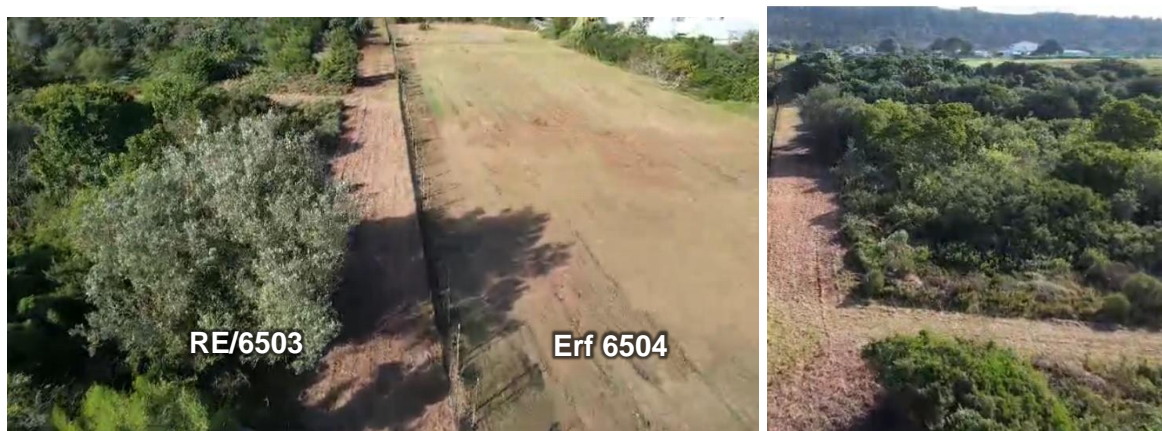
Figure 24. Photos supplied by landowner showing current approach to cutting firebreaks (cut by the Southern Cape Fire Protection Agency) looking East along the boundary fenceline (left) and a fire-fighting access road into the open space around the wetland (right).

Landscaping along the edge of the built estate, fire-breaks cut along the property boundary, and pathways in the open space area all contribute to fragmentation of the wetland and associated thicket vegetation (Figure 24). While this has all occurred historically, the lack of significant development and fencing across the site created less fragmented conditions than the future scenario anticipated with development of the estate. Therefore, the management of this area should be reconsidered.
