Erosion management and realignment of the approved Thembalethu sewerline to accommodate informal human settlement.

Aquatic Specialist Assessment for Proposed Amendment to Water Use License 16/K30C/CI/2723.

Prepared For: Cape EAPrac
Author: Dr. Jackie Dabrowski (PhD)
Confluent Environmental Pty (Ltd)
7 St. Johns Street,
Dormehls Drift,
George, 6529
SACNASP: Pr. Sci. Nat. (Aquatic Science) – 115166
Date: April 2024
Version: Final

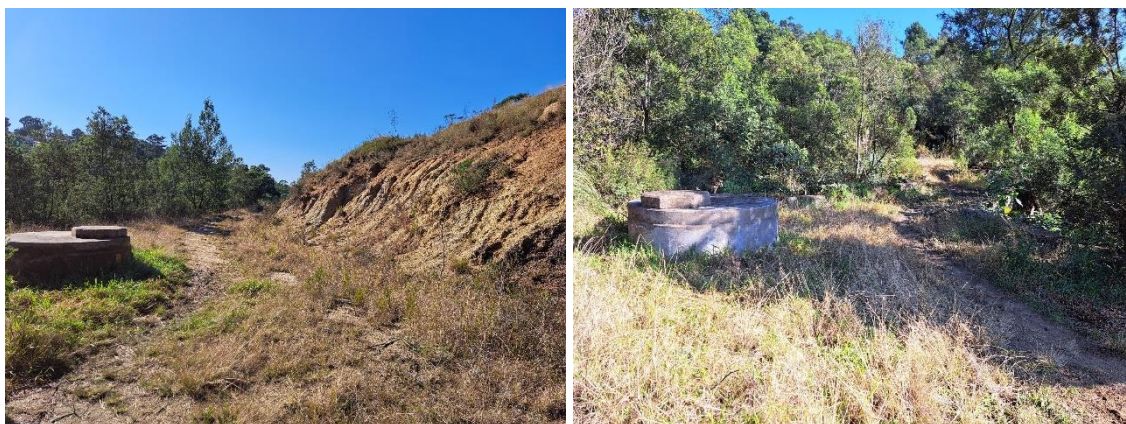
Figure 3. Example of the bulk sewer line installed on the opposite side of the Skaapkop River in Pacaltsdorp where the sewerline has become a single lane dirt track following benching.

It is envisaged that the end result of installing the pipeline will be a level road cut into the slope in places which will enable access and maintenance of the sewer line. An example from an existing portion of the installed sewer line is shown in Figure 3.

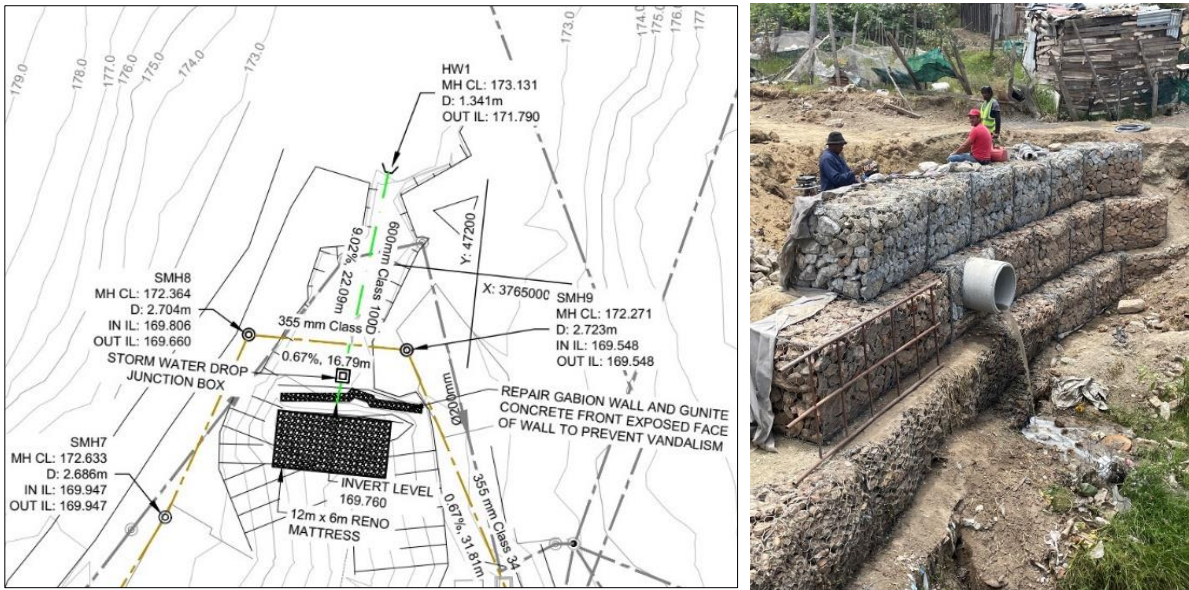
Figure 4. Diagram (left) showing plan view of the proposed reno mattress below the sewer line crossing supported by gabions. In addition, the location of a formalised stormwater headwall is proposed upstream (green dotted line). Inset photo shows emergency work undertaken to restore the sewer line crossing with potential for undercutting due to water falling at the toe of the gabions.

The existing Water Use License authorizes the sewer line crossing at point 4 (See Figure 2; 34 0'41.14S, 22 29'19.68E; Portion 58/197 Sand Kraal / Tylora Farm). This section of sewer line had already been constructed, but was subsequently badly damaged due to flooding and erosion, resulting in a request to undertake emergency repair work to reconstruct the crossing in terms of Section 20 of the National Water Act. Whilst working on the site, the engineer observed that a plunge pool below the sewer line crossing is likely to form which could undermine the gabions recently reconstructed, compromising their stability in the long term and possibly resulting in repeated failure. **The proposal is therefore to protect the stream bed from the fall of water at the toe of the gabions using a reno mattress.** This feature should arguably have been included in the original WULA as erosion at the toe of gabions where a significant fall of water occurs is a common problem. The proposed reno mattress is 6 m wide and 12-15 m long (Figure 4).

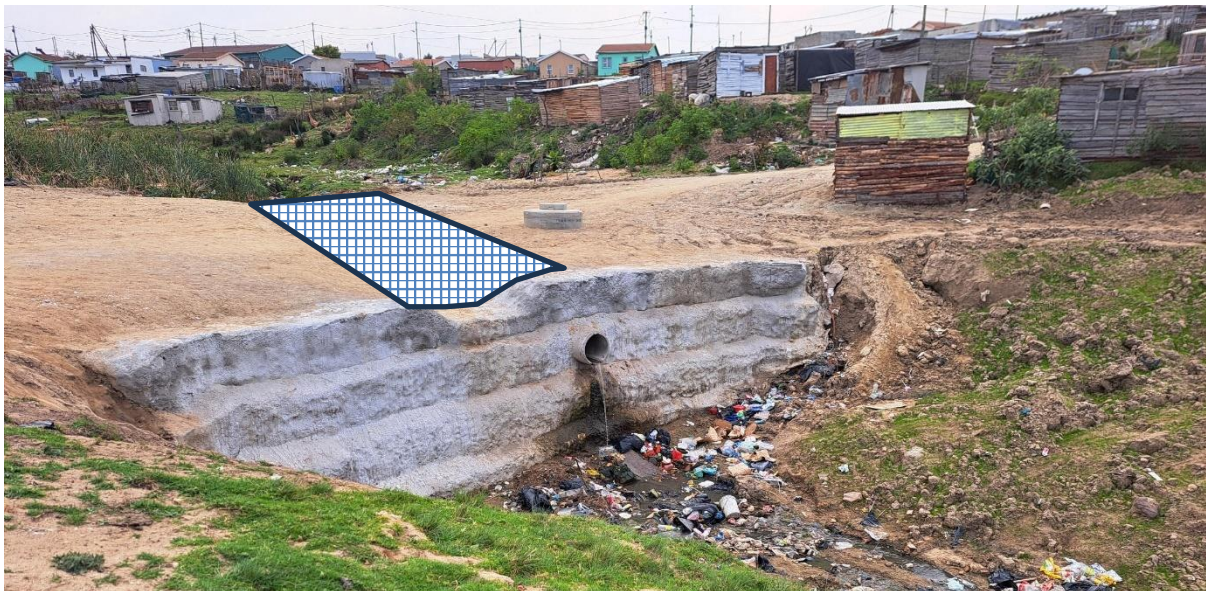
Figure 6. Photo taken of the almost completed emergency repairs indicating the need for a reno mattress below the piped outlet, and the proposed emergency overflow above the pipe where reno mattress protection is also recommended.

Since emergency stabilisation of the sewer line has been completed, it has become evident that the piped inflow continuously blocks up with litter with the result that the water overtops the crossing point and washes down the face of the gabions. As an emergency back up to this situation, the engineer has recommended that the top of the crossing be protected with a reno mattress to ensure that the flow (which is spread) does not cause erosion over the top surface. A basic representation of this proposal is provided in Figure 6.

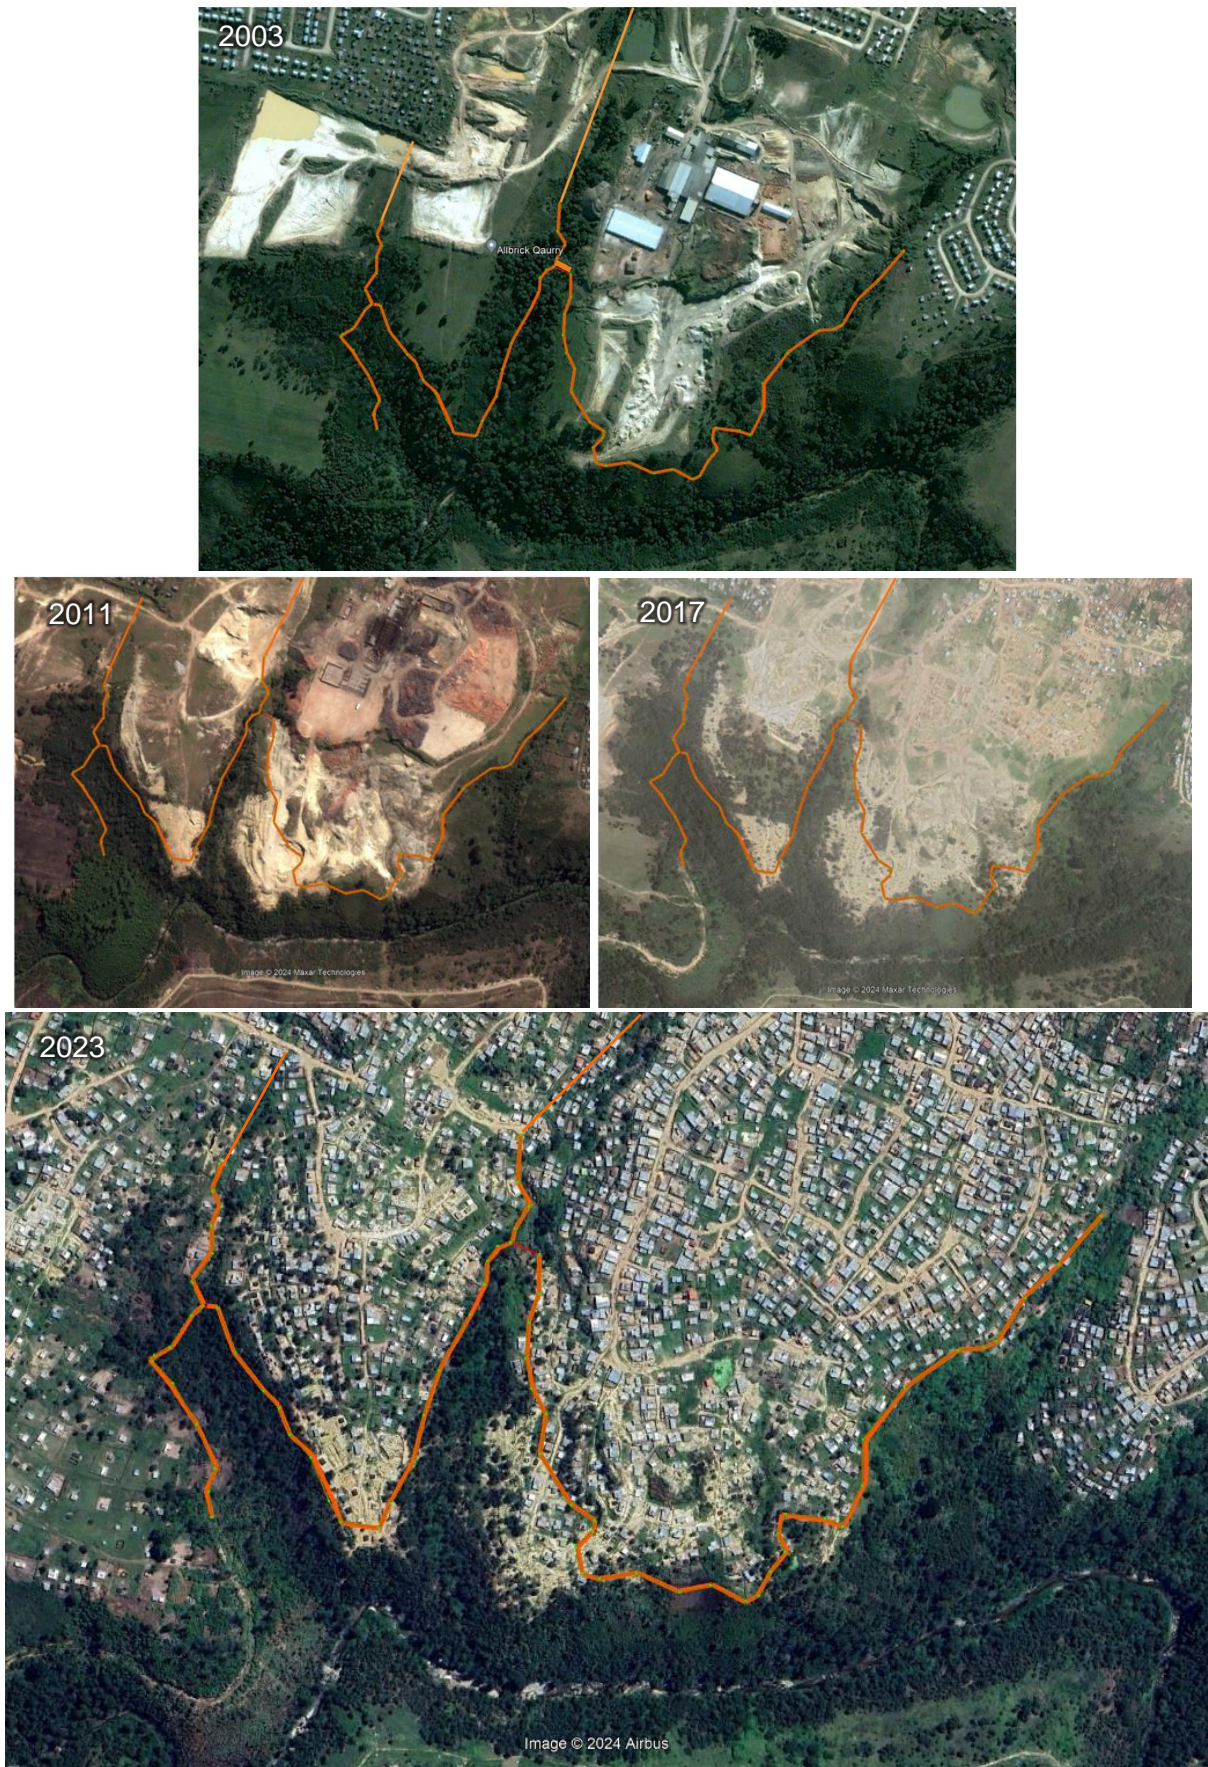
Figure 11. Historical imagery of the proposed realignment of the Themba sewer line.

The realigned pipeline traverses the steep edge of land that was previously used as a quarry for brick-making. The quarry was active for approximately 2 decades appearing in the mid to late 1990s. Areas were alternately mined then rehabilitated, and the quarry was finally closed in around 2017. Following this, informal settlement of the area began which has progressed to high density settlement of the area in poorly suited areas including drainage lines and steep slopes (Figure 11). It is clear from the series of satellite images presented that the realigned pipeline traverses areas of significant historical disturbance due to mass earthworks. More recent disturbances include sprawling informal settlement in close proximity to watercourses with associated informal waste disposal of solids and liquids.

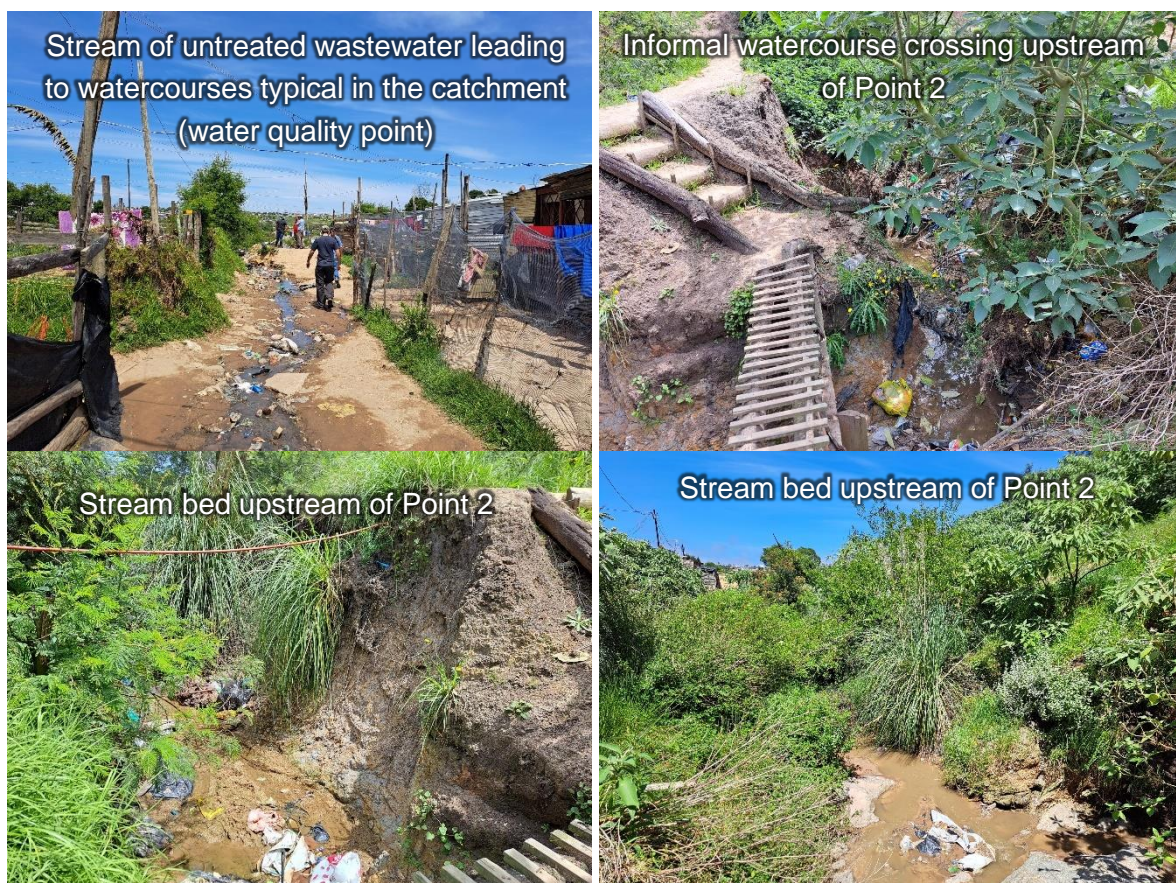
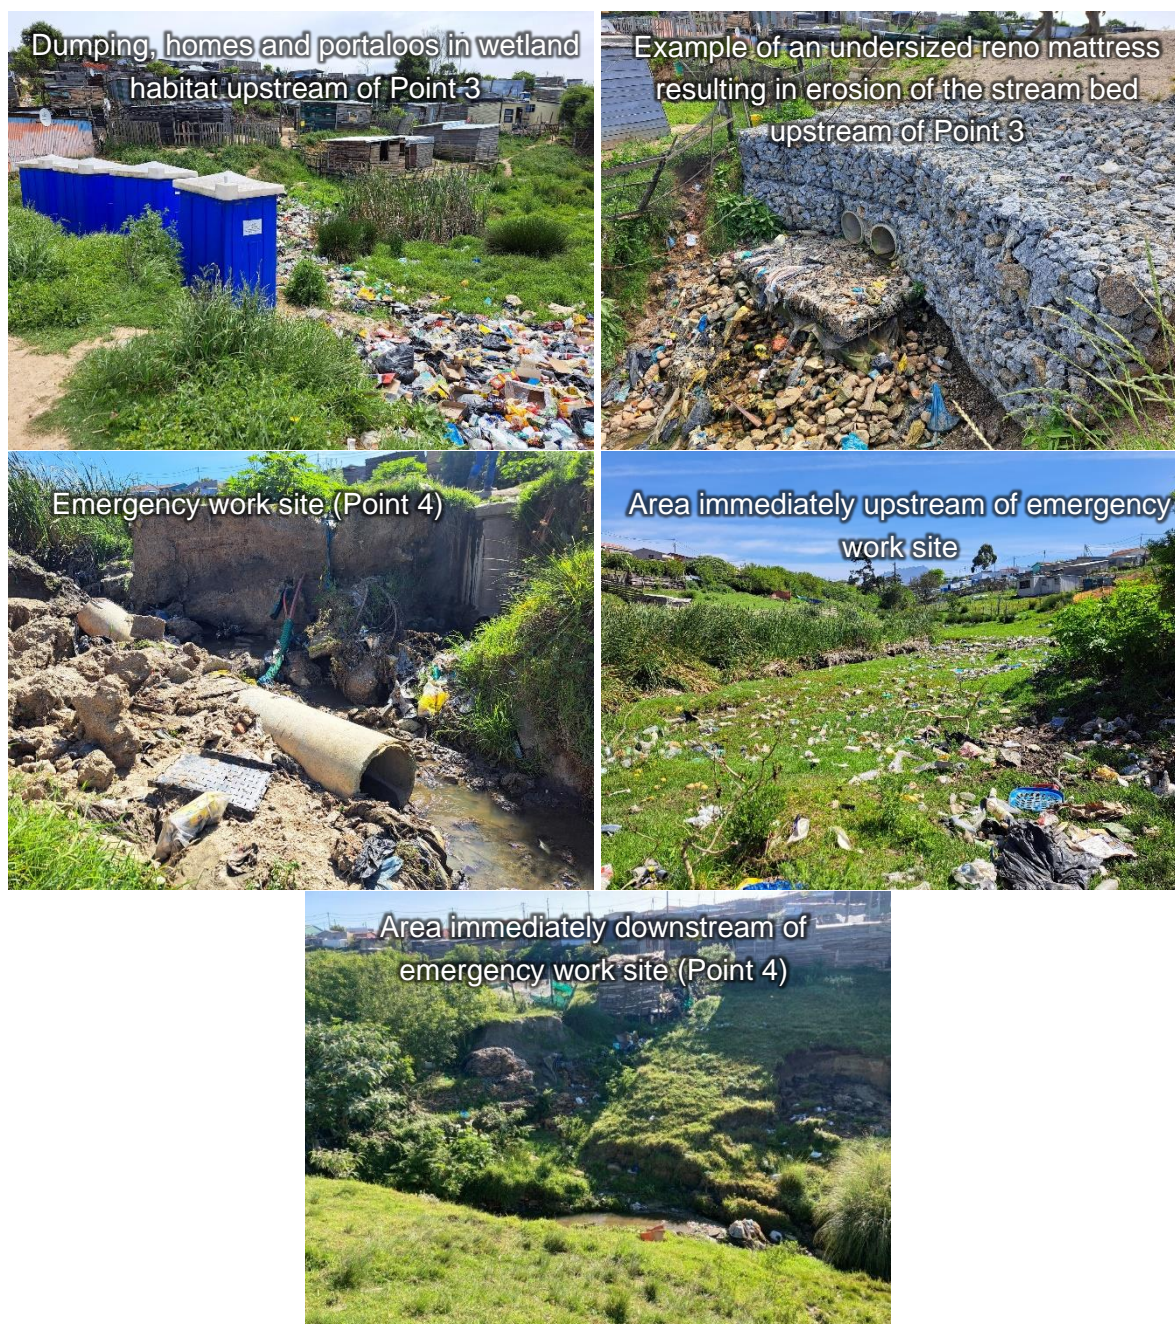
Figure 13. Photos of various site aspects taken during the site visit on 1 November 2023.

A series of photos taken during the site visit of points representative of local conditions at most of the sites is presented in Figure 13. These show some of the typical impacts affecting streams in the area including dumping, discharge of untreated wastewater, vegetation clearing, alien invasive plant invasions, poorly conceived infrastructure, and precariously located dwellings.
