## **GEORGE MUNICIPALITY**

### **PROJECT 20 (5): UPGRADING THEMBALETHU BULK SEWER – PHASE 3 AND 4**

### **CONCEPT & VIABILITY REPORT**

**REPORT NO: 1762: REV NO. 1**

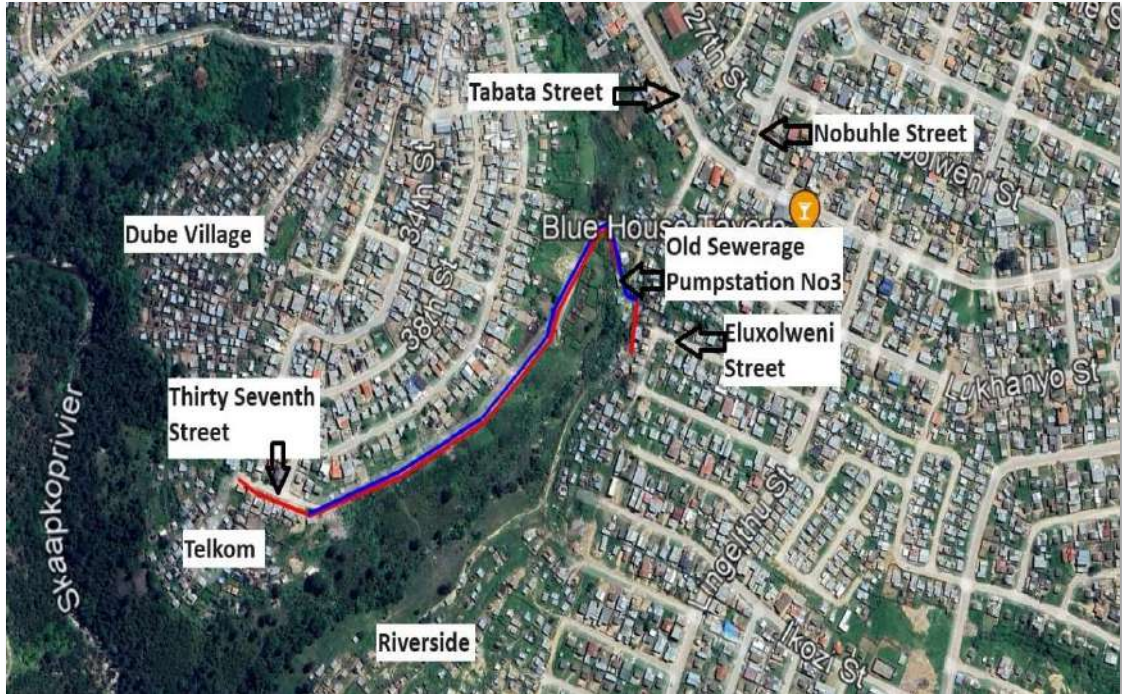
- Existing bulk sewer with poor gradient
- New bulk sewer with min fall 1 in 150

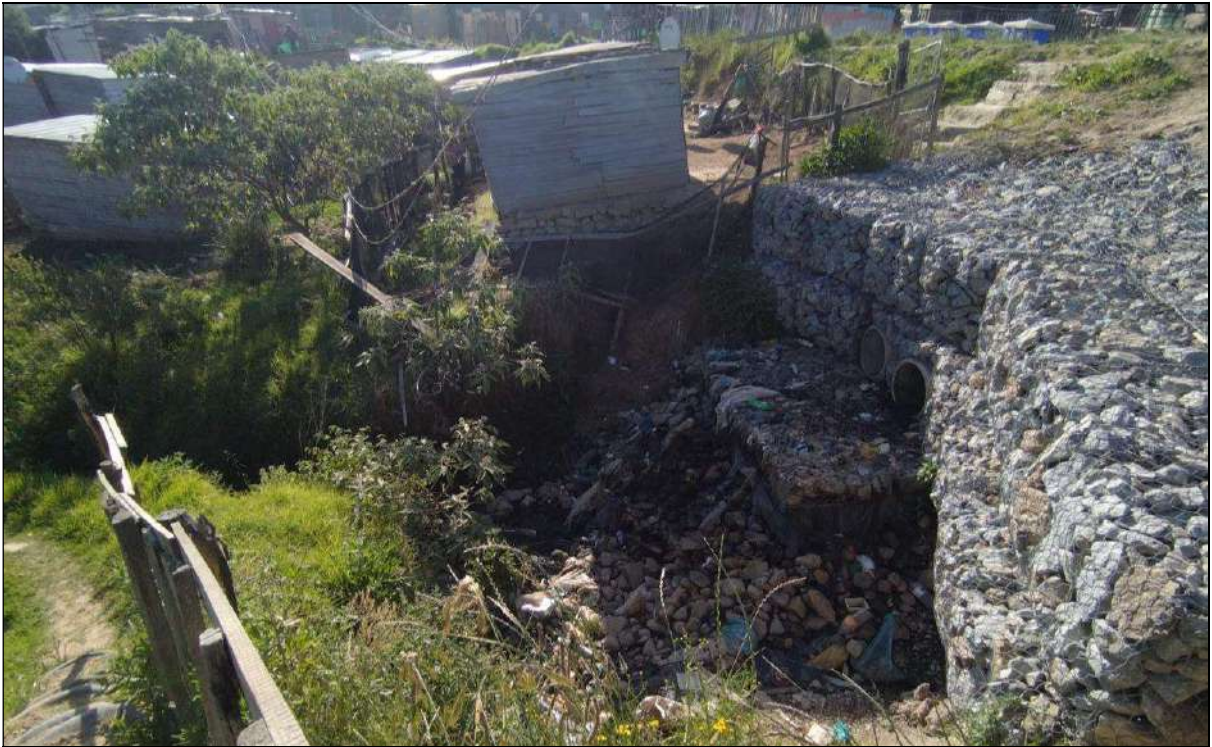
**Figure 7: Existing stormwater pipe culvert near TP4**

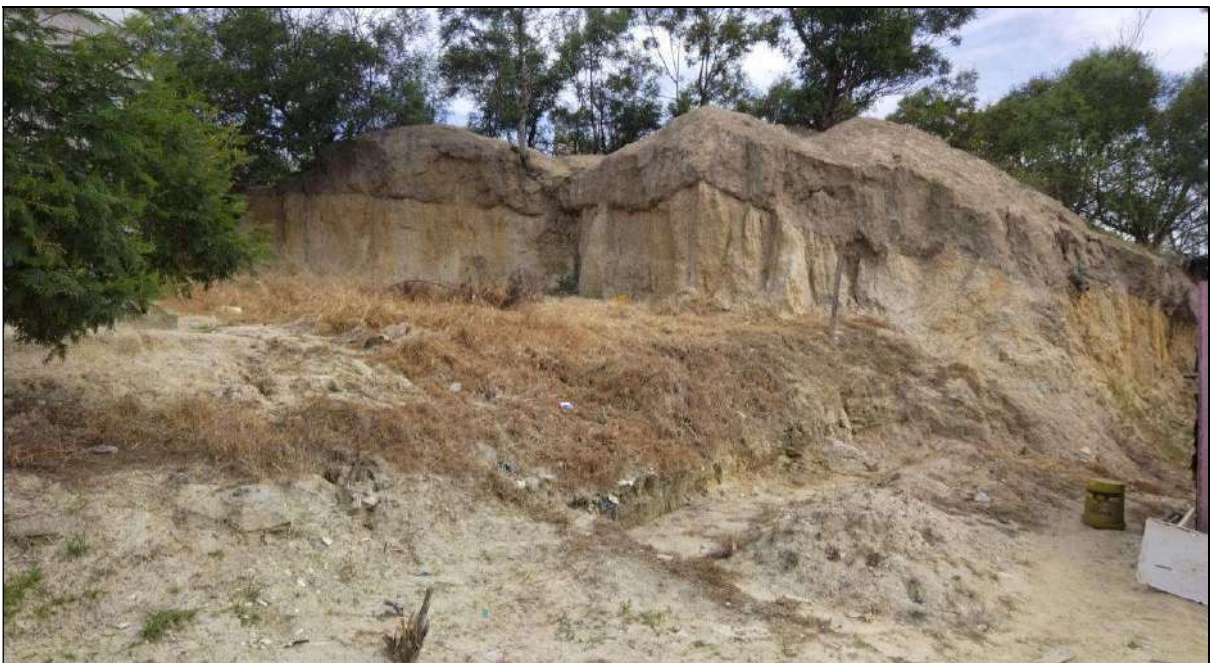
**Figure 9: Mounds of soil associated with the old mining activities**

The local site topography and ground surface conditions at the time of the investigation were very uneven in places due to historical mining operations associated with the old Allbrick Quarry, and there were several old excavations, erosion dongas and mounds of soil, producing a highly irregular ground surface (see Figure 8 to Figure 10).

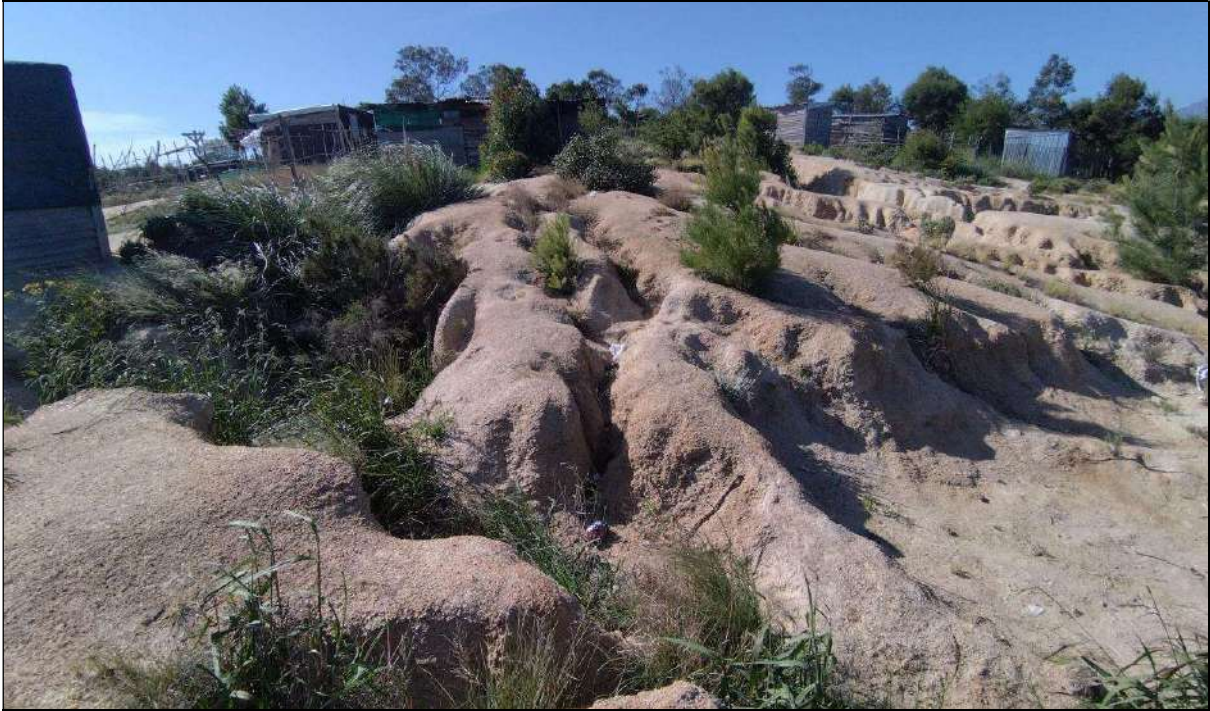
**Figure 10: Erosion dongas commonly seen on the site**

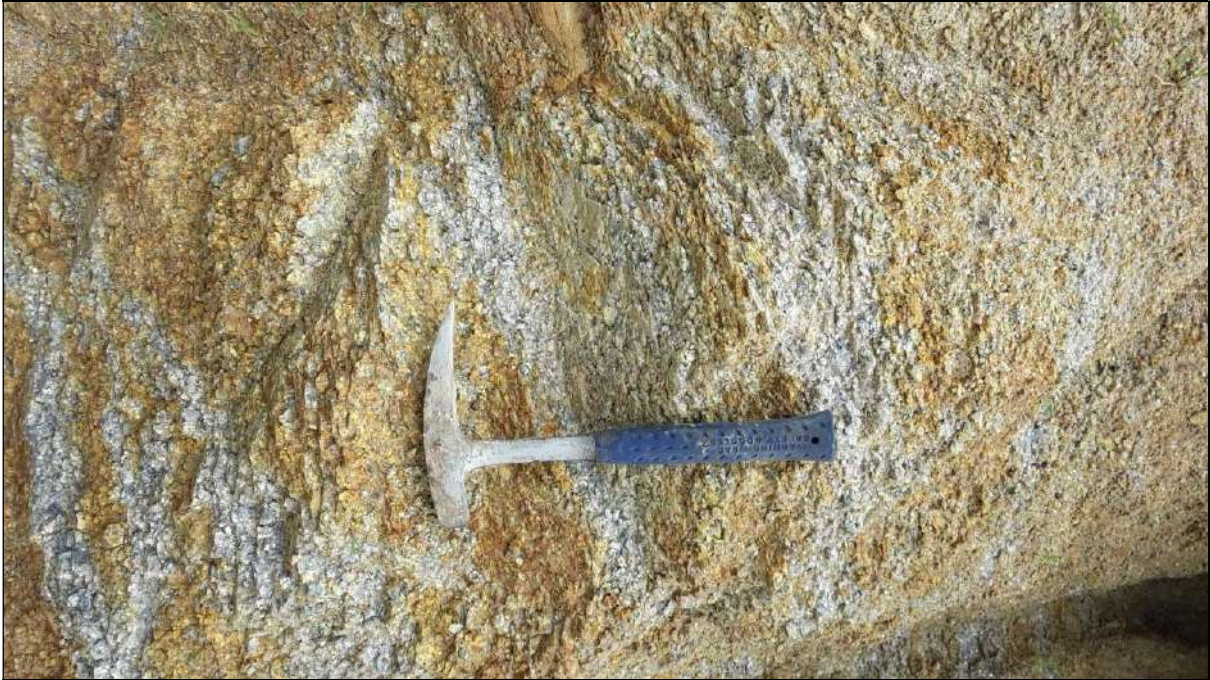
**Figure 12: Exposure of weathered granite near site**

The underlying rock profile consisted of a “weathered zone” underlain by a “fresh zone”. The weathered zone typically ranges from light grey to light orange brown, highly to moderately weathered, highly fractured, very soft to soft rock which can probably be ripped using mechanical methods. Apart from some isolated metapelitic xenoliths (schist, phyllite), no other rock types or formations occur in the quarry area.

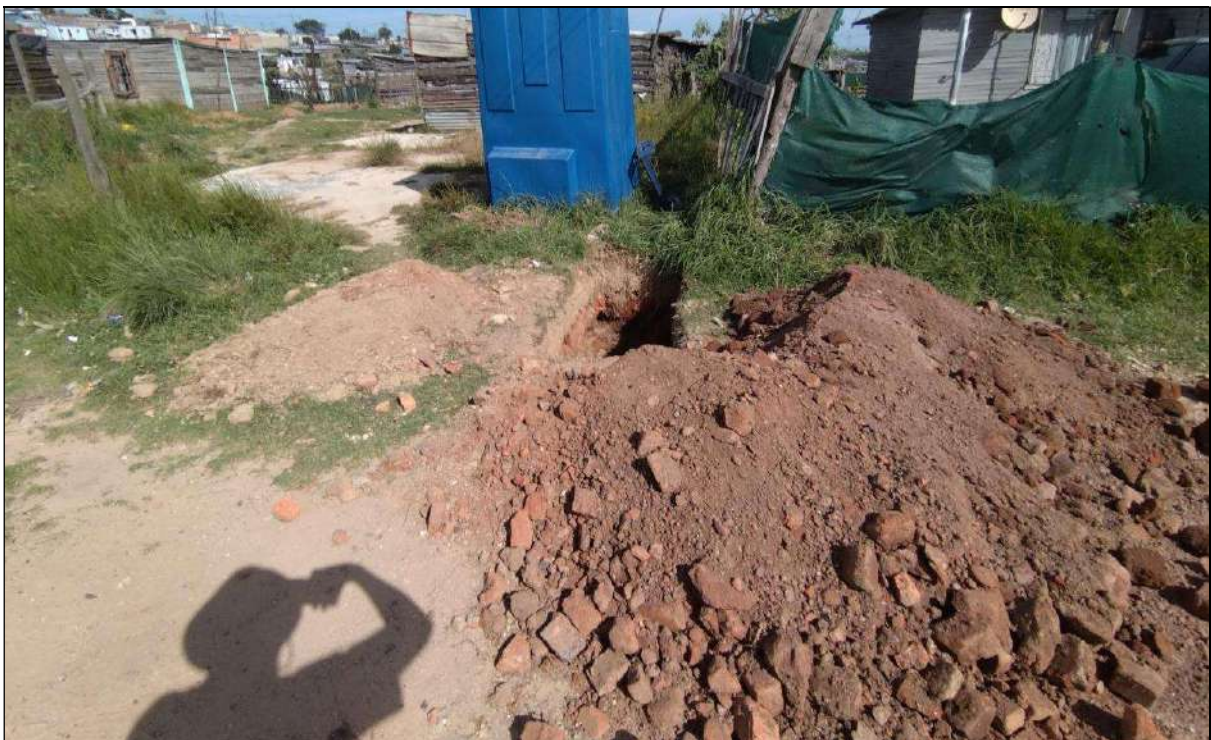
**Figure 15: Brick rubble fill encountered at TP1**

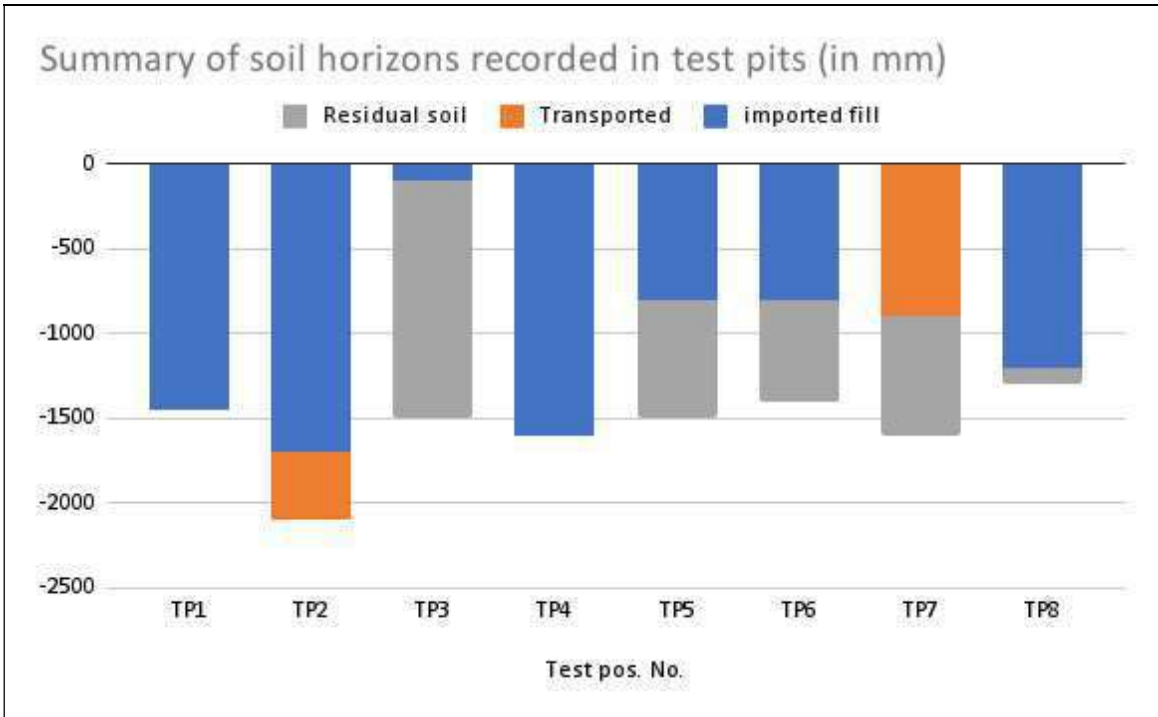
**Figure 18: Summary of the soil profiles**

A map of the test positions was provided in Figure 17 and a summary of the test pit data was provided in Figure 18 and Table 1.

In situ penetration tests (DCP) conducted through the upper 2m of the profile indicated that the soil was typically variable in consistency/strength. The fill material was typically loose/very loose (see TP2, TP4, TP5 & TP6) but the natural soil profile was relatively dense (medium dense to dense/stiff). There were some localised increases in penetration rate near the upper contact of the residual soil, which may indicate the presence of moist soil or seepage (e.g. at TP7 @1m).

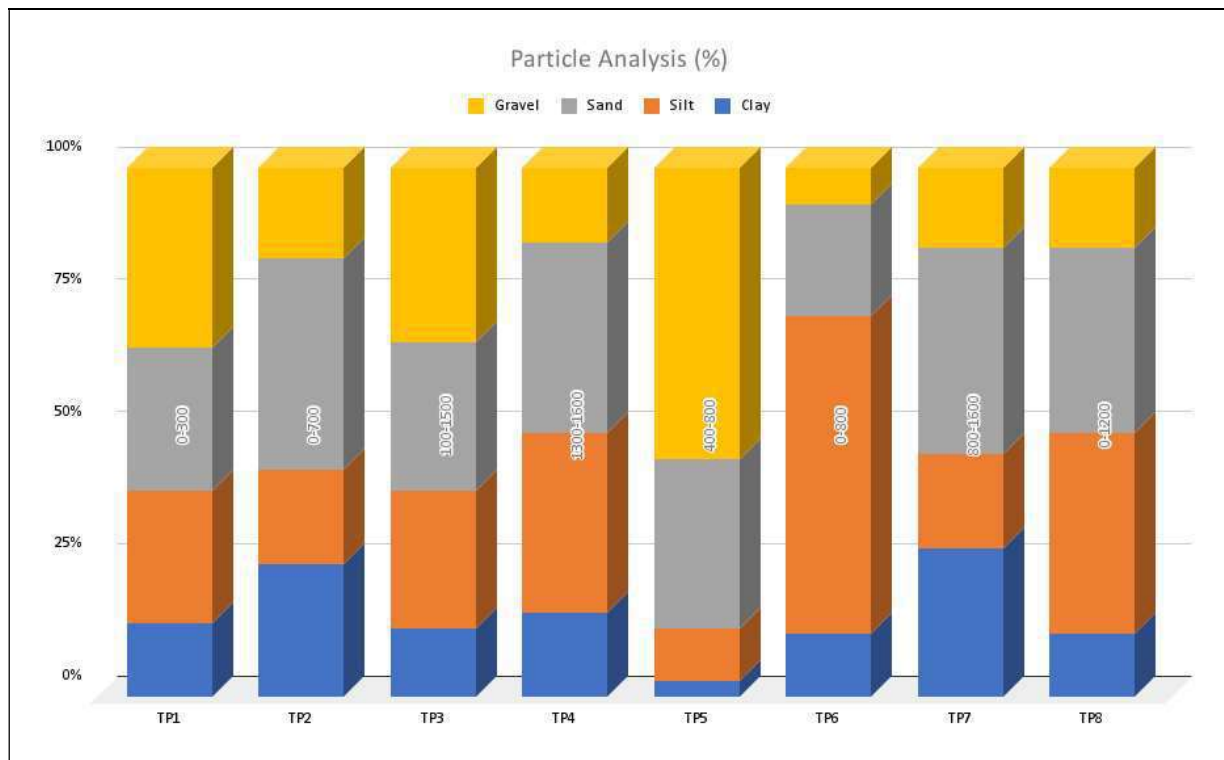
**Figure 19: Particle size distribution**

Representative samples of the insitu soil types were collected for Foundation Indicator tests to determine the particle size distribution (grading) and Atterberg limits. The results of the Foundation Indicator tests were shown in Table 2 and an analysis of the particle size distributions were presented in Figure 19.

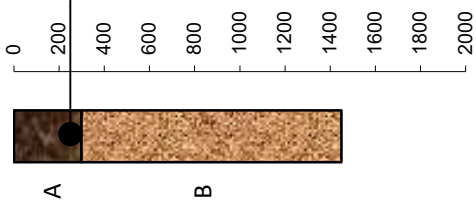
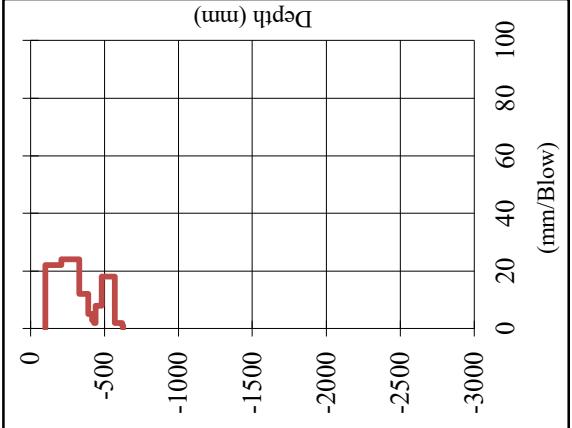
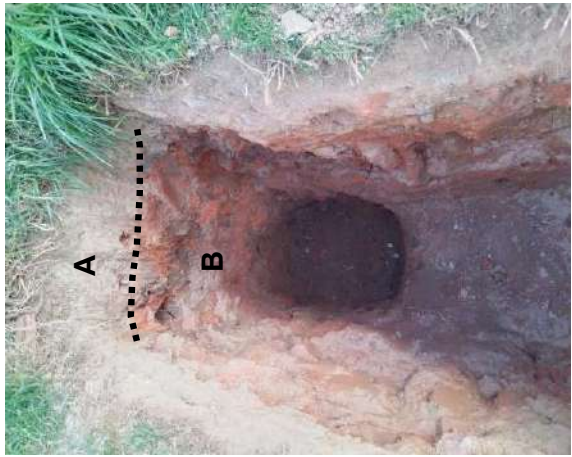
TP 1	Datum: NGL	Co-ords: 23 Y0047919 X3764737	Dynamic Cone Penetrometer (DCP)	Photo of Test Pit
<div style="display: flex; justify-content: space-between;"> <div style="width: 45%;">

</div> <div style="width: 50%;"> <p>Key to symbols: ● Sample taken</p> <p>○ Groundwater</p> <p>Slightly moist, dark reddish brown, medium dense, intact, <b>CLAYEY SILTY SANDY GRAVEL</b>, imported (fill made ground)</p> <p>Foundation Indicator &amp; MOD/CBR/Indicator</p> <p>Moist, dark red, dense, intact, <b>BRICK FILL RUBBLE</b>, imported (fill made ground)</p> </div> </div> <p style="text-align: center;"><b>TP Stopped</b> <b>No Water</b></p>

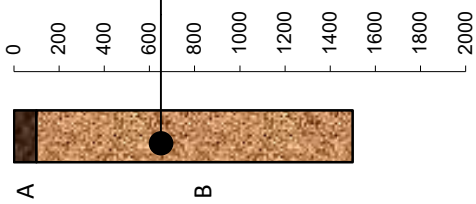
TP 3	Datum: NGL Key to symbols: ● Sample taken	Co-ords: 23 Y0048281 X3764924 Sample taken	Groundwater

<p style="font-size: small;">(0 to 100) (100 to 1500)</p>	<p>Moist, dark yellowish orange, dense, intact, <b>SANDY GRAVEL</b>, imported (fill made ground)          Moist, light yellowish orange, dense to very dense, intact, <b>CLAYEY SILTY SANDY GRAVEL</b>, residual.</p> <p style="text-align: center;"><b>Foundation Indicator &amp; MOD/CBR/Indicator</b></p>	<p>23 Y0048281 X3764924  <input checked="" type="checkbox"/> Sample taken</p>	<p>Groundwater</p>
<b>TP Stopped No Water</b>			
TP 4	Datum: NGL Key to symbols: ● Sample taken	Co-ords: 23 Y0048150 X3764459 Sample taken	Groundwater

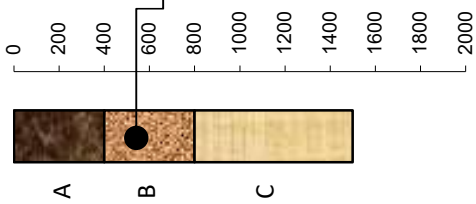
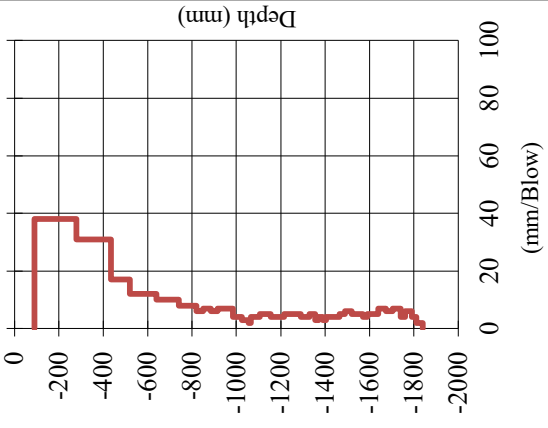
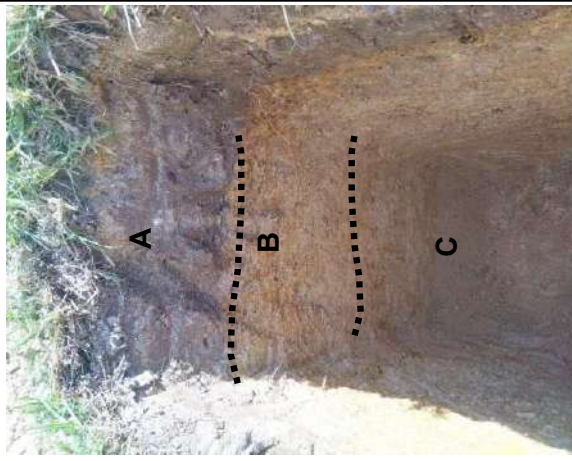
TP 5	Datum: NGL	Co-ords: 23 Y0048450 X3764597	Photo of Test Pit

<p style="text-align: center;">A      B      C</p>	Key to symbols: ● Sample taken Slightly moist, dark reddish brown, medium dense, intact, <b>SILTY SANDY GRAVEL</b> , imported (fill made ground)  Moist, dark yellowish orange, dense, intact, <b>SILTY SANDY GRAVEL</b> , imported (fill made ground) <b>Foundation Indicator &amp; MOD/CBR/Indicator</b> Moist, light yellowish orange, very dense, intact, <b>SILTY SANDY GRAVEL</b> , residual.	Dynamic Cone Penetrometer (DCP)

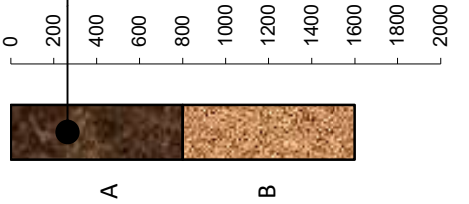
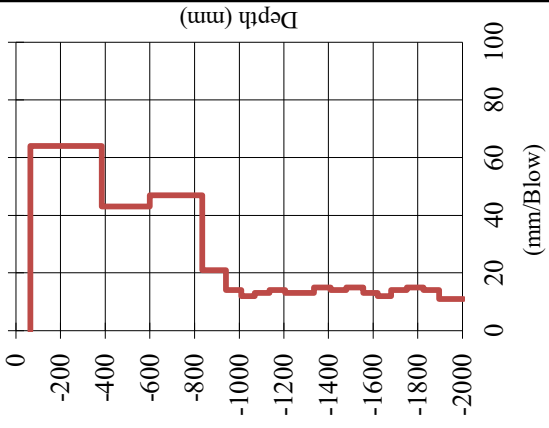
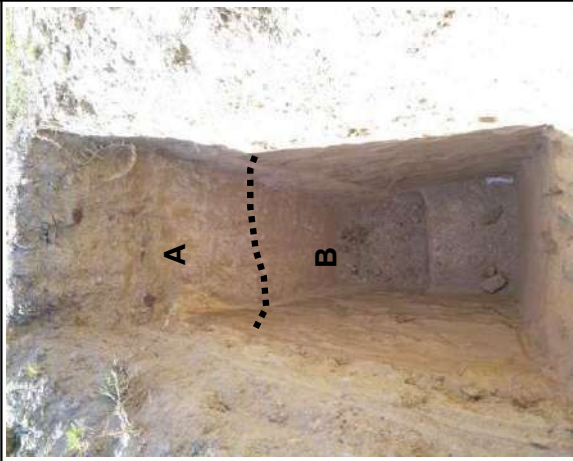
<b>TP Stopped No Water</b>			
TP 6	Datum: NGL	Co-ords: 23 Y0048351 X3764706	Photo of Test Pit

<p style="text-align: center;">A      B</p>	Key to symbols: ● Sample taken Moist, light brown, medium dense, intact, <b>CLAYEY SANDY SILT &amp; RUBBISH</b> , imported (fill made ground) <b>Foundation Indicator &amp; MOD/CBR/Indicator</b>  Moist, dark brown, stiff, slickensided, <b>CLAYEY GRAVELLY SAND GRAVEL</b> , residual.	Dynamic Cone Penetrometer (DCP)

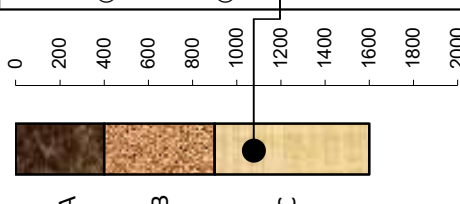
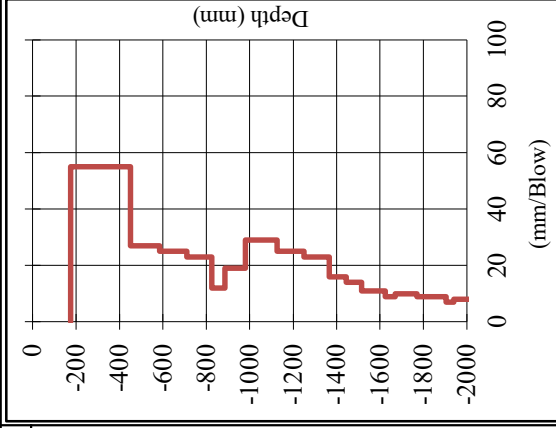
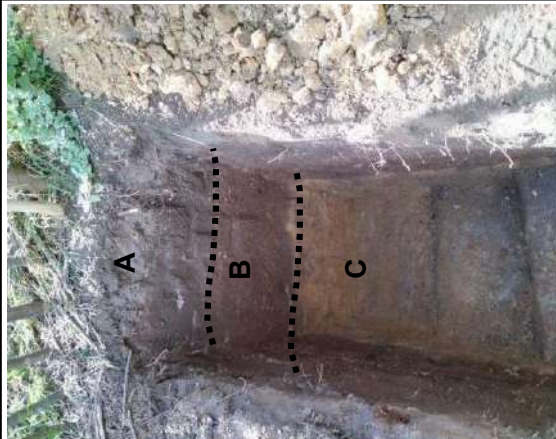
TP 7	Datum: NGL	Co-ords: 23 Y0048543 X3764947	Dynamic Cone Penetrometer (DCP)	Photo of Test Pit
<div style="display: flex; align-items: center;">

<div style="margin-left: 10px;"> <p>(0 to 400)</p> <p>(400 to 900)</p> <p>(900 to 1600)</p> </div> </div>	<p>Key to symbols: ● Sample taken</p> <p>Moist, dark grey, loose, intact, <b>SILTY SAND</b>, Transported</p> <p>Moist, dark reddish brown, medium dense, <b>SANDY GRAVEL</b>, transported.</p> <p>Moist, dark yellowish orange stained black, medium dense, <b>GRAVELLY CLAYEY SILTY SAND</b>, residual.</p> <p style="text-align: center;"><b>Foundation Indicator &amp; MOD/CBR/Indicator</b></p>
