Botanical and Terrestrial Biodiversity Compliance Statement for the Realignment and Extension of the Approved Thembalethu Sewer-Line to Accommodate Informal Human Settlement, George, Western Cape

Prepared For: Cape EAPrac
Author: Bianke Fouche
Confluent Environmental Pty (Ltd)
7 St. Johns Street,
Dormehls Drift,
George, 6529
SACNASP: No. 141757
Pr. Sci. Nat. (Botanical Science)
Cand.Sci.Nat (Ecological Science)
Reviewer: Dr. Jackie Dabrowski
Date: 13 May 2024
Version: Draft

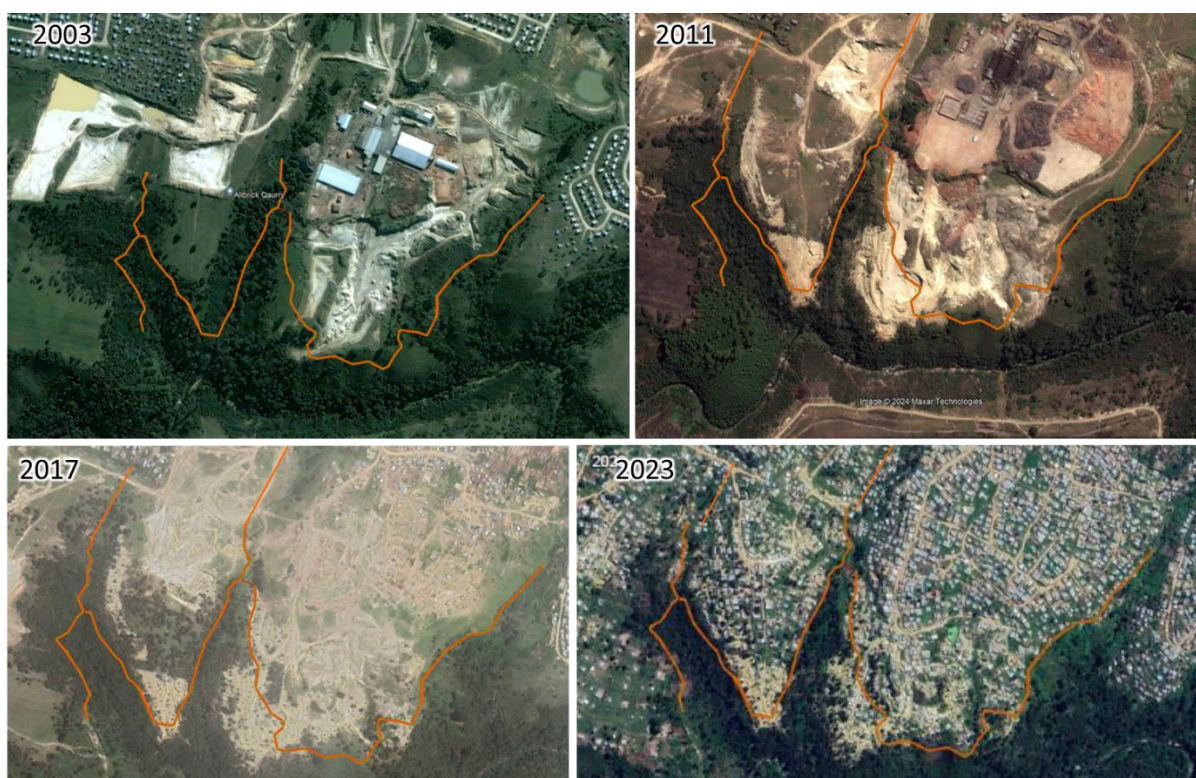
Figure 7: A series of historical imagery sourced from Google Earth.

“The realigned pipeline traverses the steep edge of land that was previously used as a quarry for brick-making. The quarry was active for approximately 2 decades appearing in the mid to late 1990s. Areas were alternately mined then rehabilitated, and the quarry was finally closed in around 2017. Following this, informal settlement of the area began which has progressed to high density settlement of the area in poorly suited areas including drainage lines and steep slopes (Fig. 7). It is clear from the series of satellite images presented that the realigned pipeline traverses areas of significant historical disturbance due to mass earthworks. More recent disturbances include sprawling informal settlement in close proximity to watercourses with associated informal waste disposal of solids and liquids.”

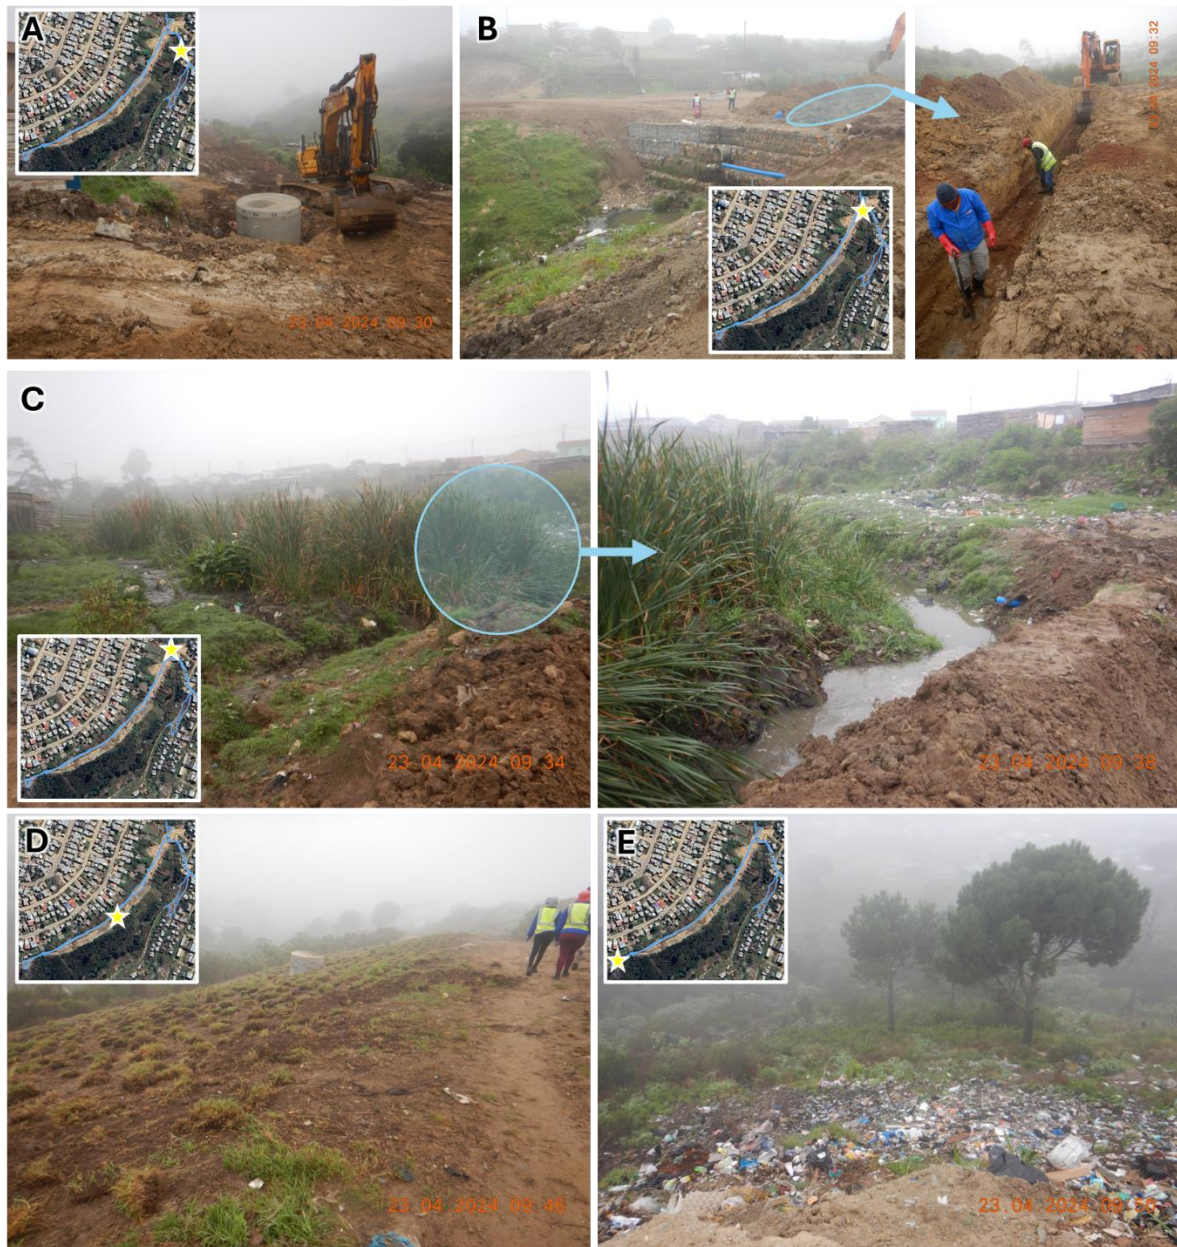
Figure 8: Images of the area where emergency repairs to the sewer line are taking place.

The current state of the vegetation across the entire site assessment area was severely transformed, with drainage lines containing severely eroded and incised banks, multiple dumping grounds, polluted water, and a host of almost exclusively invasive plants. Fig. 8 shows multiple images from the emergency repair area, located to the east of the proposed sewer realignment section. Fig. 8A is an image of one of the new, and larger manholes that have been installed in this area. Fig 8B illustrates the wall of supporting gabions and trench dug out behind the wall for connecting the sewer line. This emergency intervention in this section of the sewer line also requires a reno mattress at the toe of the gabion wall to prevent a repeated failure due to the creation of a “plunge pool”. Refer to the aquatic specialist report by Dr. Jackie Dabrowski for more detail on the plans and reasons for the infrastructure put in place here.

Fig. 8C illustrates the northern section of the crossing which is dominated by *Typha capensis*. This reed species has been used in artificial wetland settings to aid in the purification of water, however in order for that to work the reeds need to be periodically cut down (to preserve their ability to take up harmful chemicals and heavy metals). The water running through the stand of *Typha capensis* was evidently very polluted. Fig. 8D represents a section on the slope adjacent to the drainage line that is being revegetated with plants sourced in Thembaletu. Although the majority of the planted vegetation is invasive kikuyu (*Cenchrus clandestinus*), this is preferable over the erosion that could result if nothing was planted to stabilise the valley sides. Lastly, Fig. 8E is a large dump area along the westernmost section of the emergency sewage line repair area. This dump poses significant health threats and is surrounded by invasive and alien vegetation.

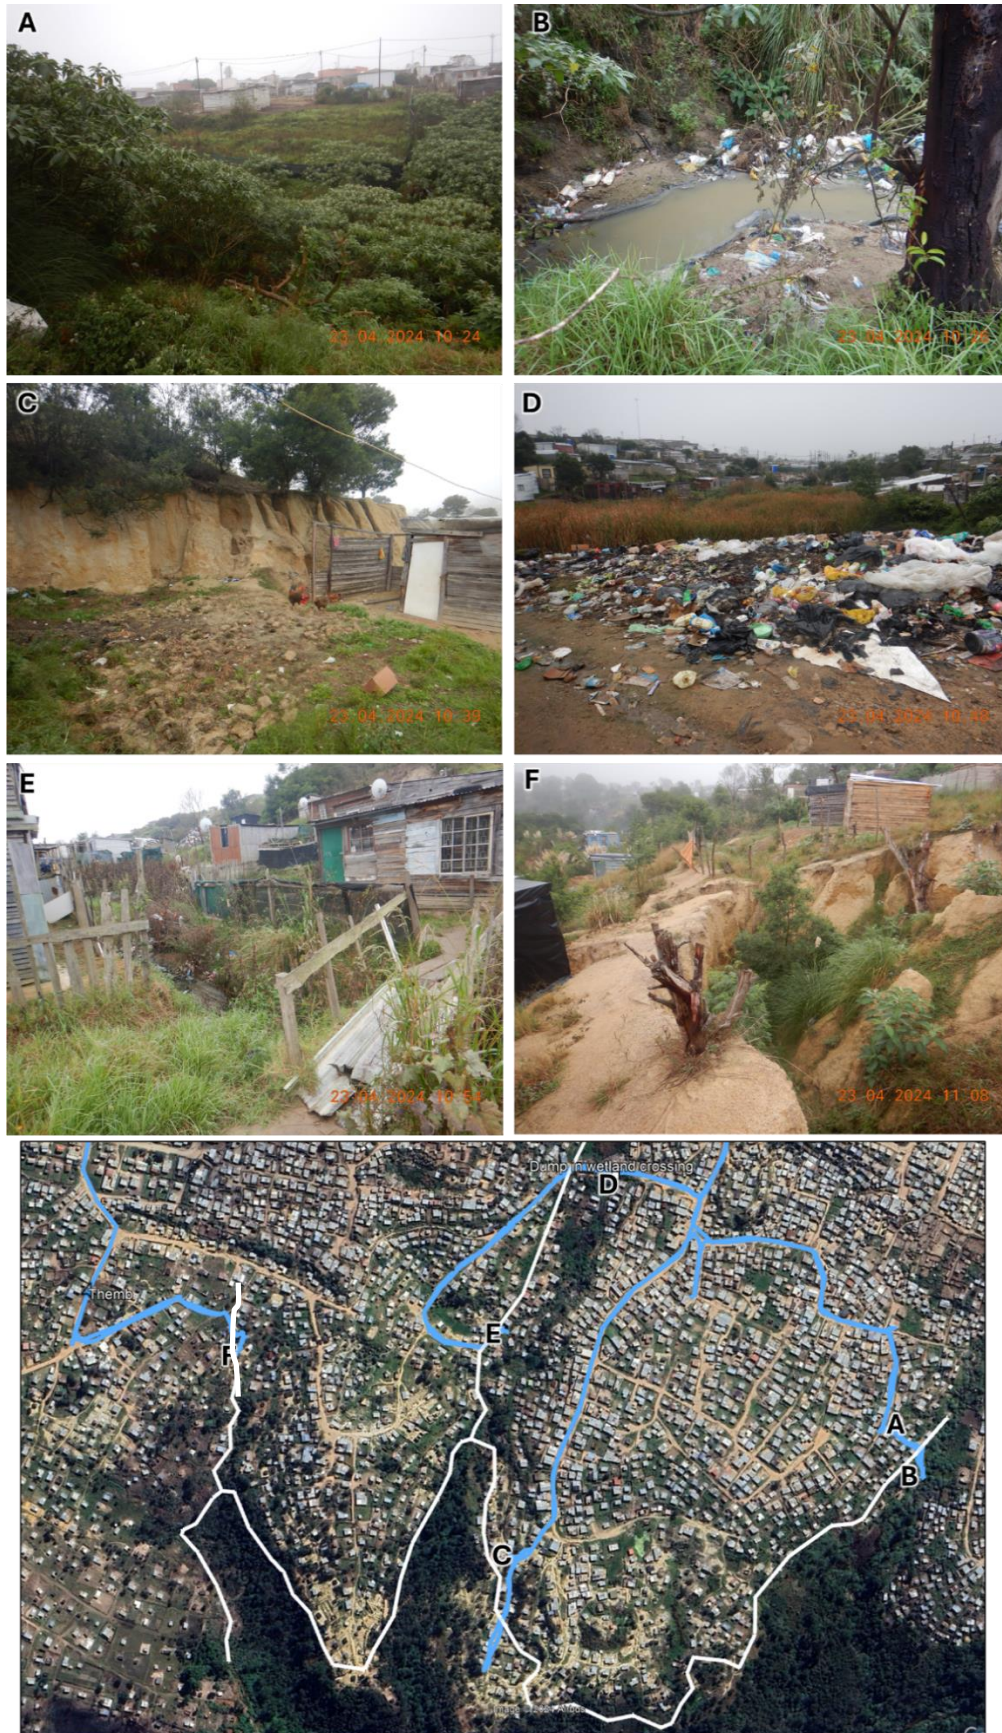
Figure 9: Images showing the landscape where the sewer line realignment is proposed. The blue line indicates the GPS track for the field assessment.

In addition to the emergency repairs, a section of the existing pipeline needs to be realigned, and this area is represented in the map in Fig. 9. Drainage lines are all very invaded, dominated either by black wattles (*Acacia mearnsii*) or by bugweed (*Solanum mauritianum*), like in Fig. 9A. The water quality along the entire proposed route is very poor, as illustrated in Fig. 9B. Fig. 9C shows a section where the new pipeline will cross between informal dwellings in an area that is severely eroded. Fig. 9D illustrates a point along the middle drainage line where a large informal dump is located in the middle of the drainage line. Fig. 9E represents an area where the proposed new sewer line crossed a narrow, eroded stream with numerous informal houses already established very near the stream. This section may prove a challenging area for the sewer line realignment project. Lastly, Fig. 9F was the closest point reached to the last sewer line connection section, and again the landscape was very eroded with numerous invasive plant species being dominant.

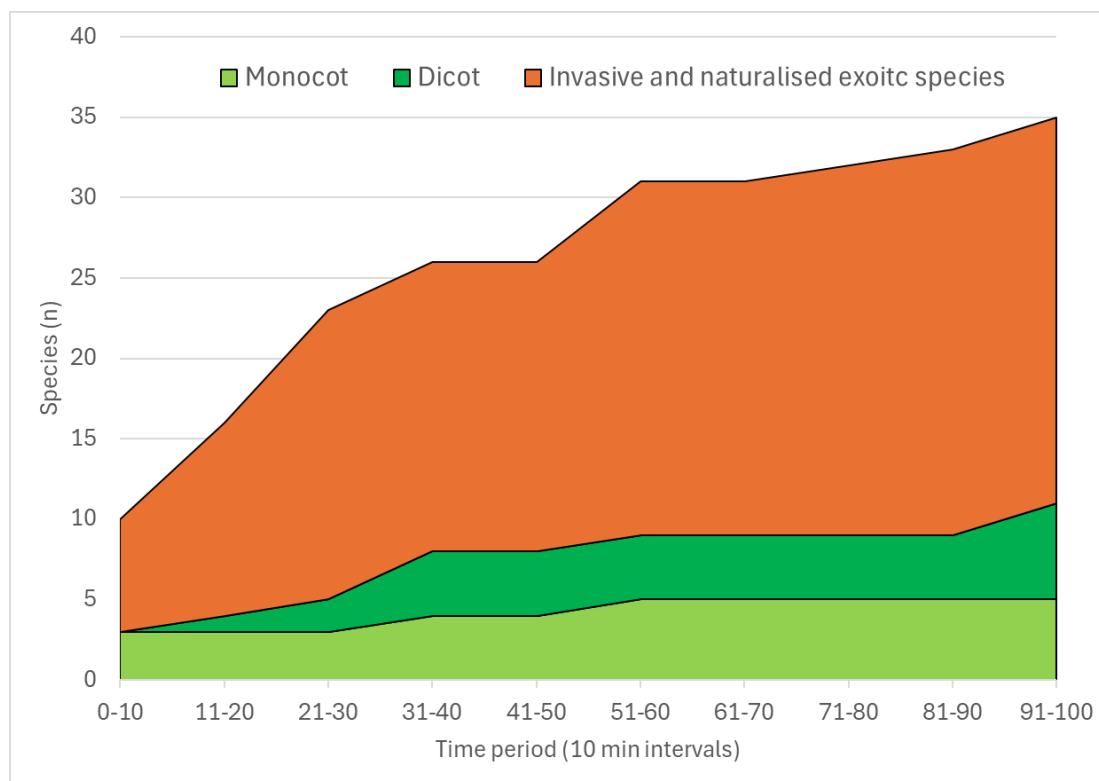
Figure 10: A plant species accumulation curve for the site assessment.

A species accumulation curve for all the species recorded on the site during the assessment is presented in Fig. 10. All species that were observed during the site visit are in Table 3. The site assessment species list is not exhaustive. No SCC were found during the site assessment, and it is confirmed that the presence of plant SCC are highly unlikely.

The plant species accumulation curve in Fig. 10 indicates that more species were likely present that were not recorded during the site assessment. However, they were more than likely additional invasive and naturalised exotic plants, or more native species that thrive in highly transformed and polluted environments. The species list below in Table 3 provides an explanation of each species in terms of its invasiveness and whether it is listed by the National Environmental Management: Biodiversity Act (NEMBA) and / or the Conservation of Agricultural Resources Act (CARA).
