GEOTECHNICAL SOIL TEST REPORT

Client: Stephan Coetzee

Project: Erf 2107, Wilderness, George

Date of test: 6.5.2020

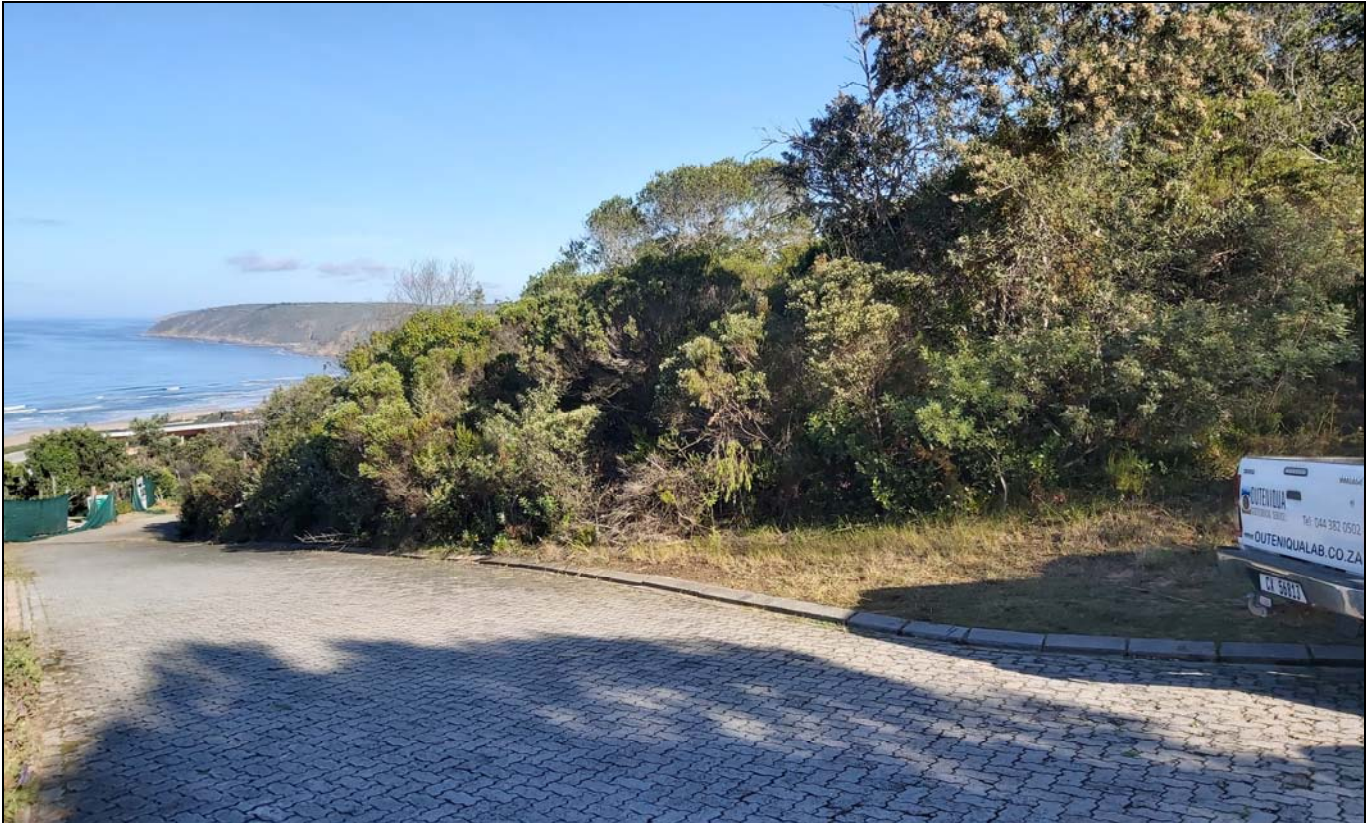
Fig 1: Photo of site looking west

The site is easily accessible via the existing municipal road (Fynbos Close) on the southern boundary of the site. The terrain slopes moderately (1:4) to the southwest (see Fig 1). The site is presently covered in thick fynbos vegetation and the surface conditions were generally dry with no signs of any slope instability or surface drainage problems, such as springs or marshes.

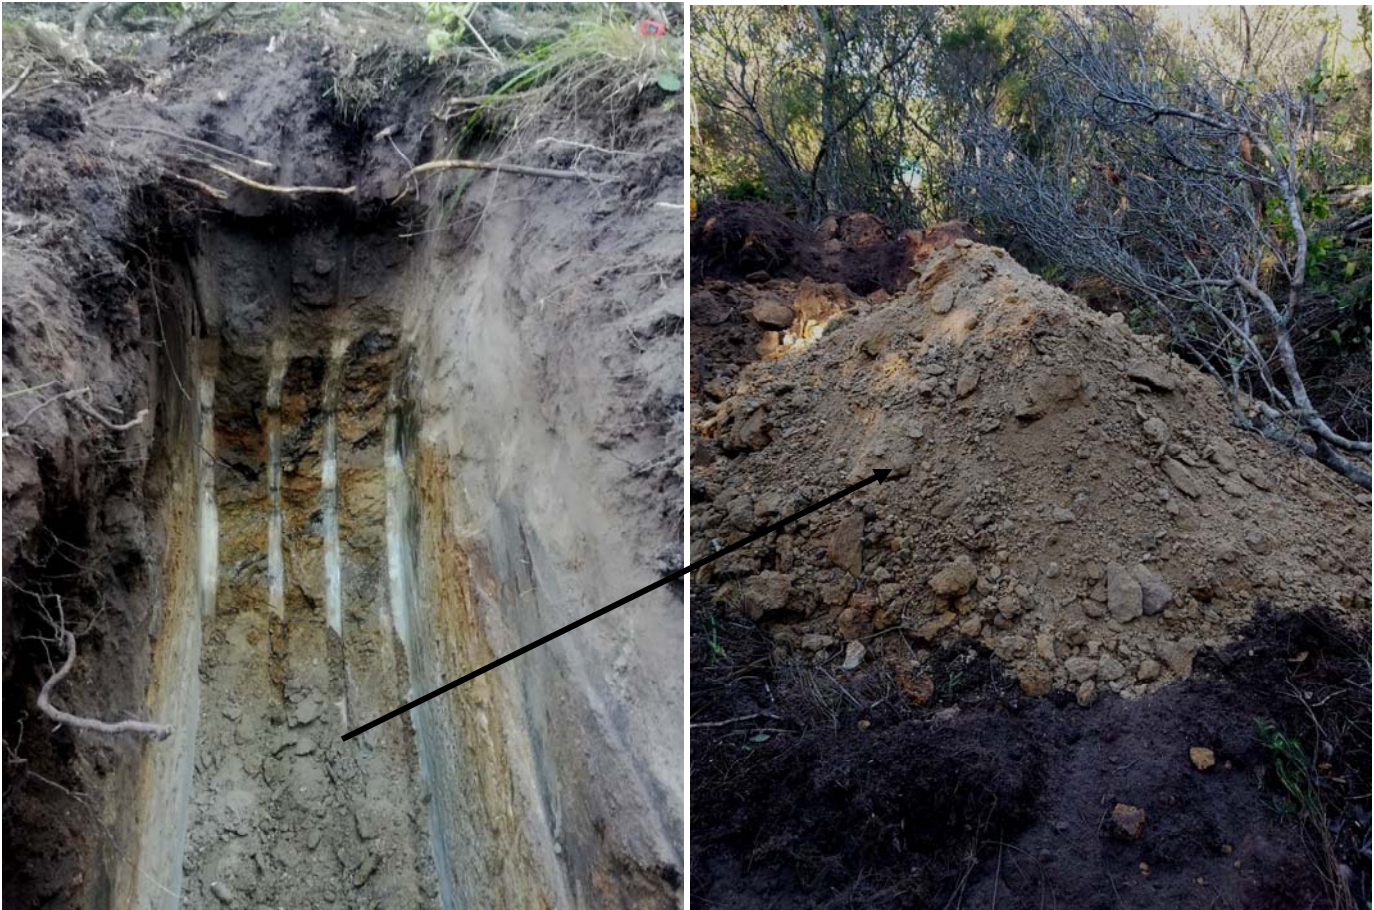
Fig 2: Typical soil profile and weathered granite gravel excavated from test pits

Test pits conducted on the site indicate that the soil profile is fairly consistent across the site, with the following general profile recorded:

- 0-0.65m: Moist, dark brown, loose- medium dense, SILTY FINE SAND (topsoil)
- 0.65-1.2m: Moist, dark red orange, dense, fissured, slightly gravelly CLAYEY SILTY SAND, residual
- 1.2-1.5m: Slightly moist, light yellow orange, very dense, intact, GRAVELLY SILTY SAND, residual completely weathered granite, becoming soft rock at base of pit.

Refusal of the excavator was recorded in both test pits at an average depth of 1.45m.

Earthworks: Significant bulk earthworks will be required to create a level platform due to the sloping terrain. Excavations below 1.5m will encounter soft rock (slow but just excavatable with TLB), becoming increasingly hard/difficult to excavate. Excavations beyond 2m may require a heavy excavator with rock bucket and/or hydraulic jack-hammer attachment for breaking rock (Hard excavation class).

Organic matter and organic-rich topsoil should be entirely stripped from the footprint of structures and stockpiled for landscaping purposes. Soil excavated from site (less any organic material) is potentially suitable for bulk filling purposes on platforms and under floors, assuming the required level of compaction can be achieved and with approval from the engineer. An allowance should be made for importation of some high-quality materials, such as G5 crushed rock, for final 150mm fill layers under floors and free-draining fill behind retaining walls. Bulk filling (from cut-to-fill operations) should be properly benched into the insitu and compacted at least 93%MDD to prevent sliding. Temporary excavation slopes less than 3m high will be generally stable at near-vertical angles for short periods of time, but the engineer should inspect deep excavations. Potentially unstable topsoil layers (upper 0.65m of profile) should be trimmed back to 45° on temporary slopes. Permanent slopes should be less than 1:2, or retained using suitable retaining methods as per the engineer's design. All fill material should be approved by the engineer.

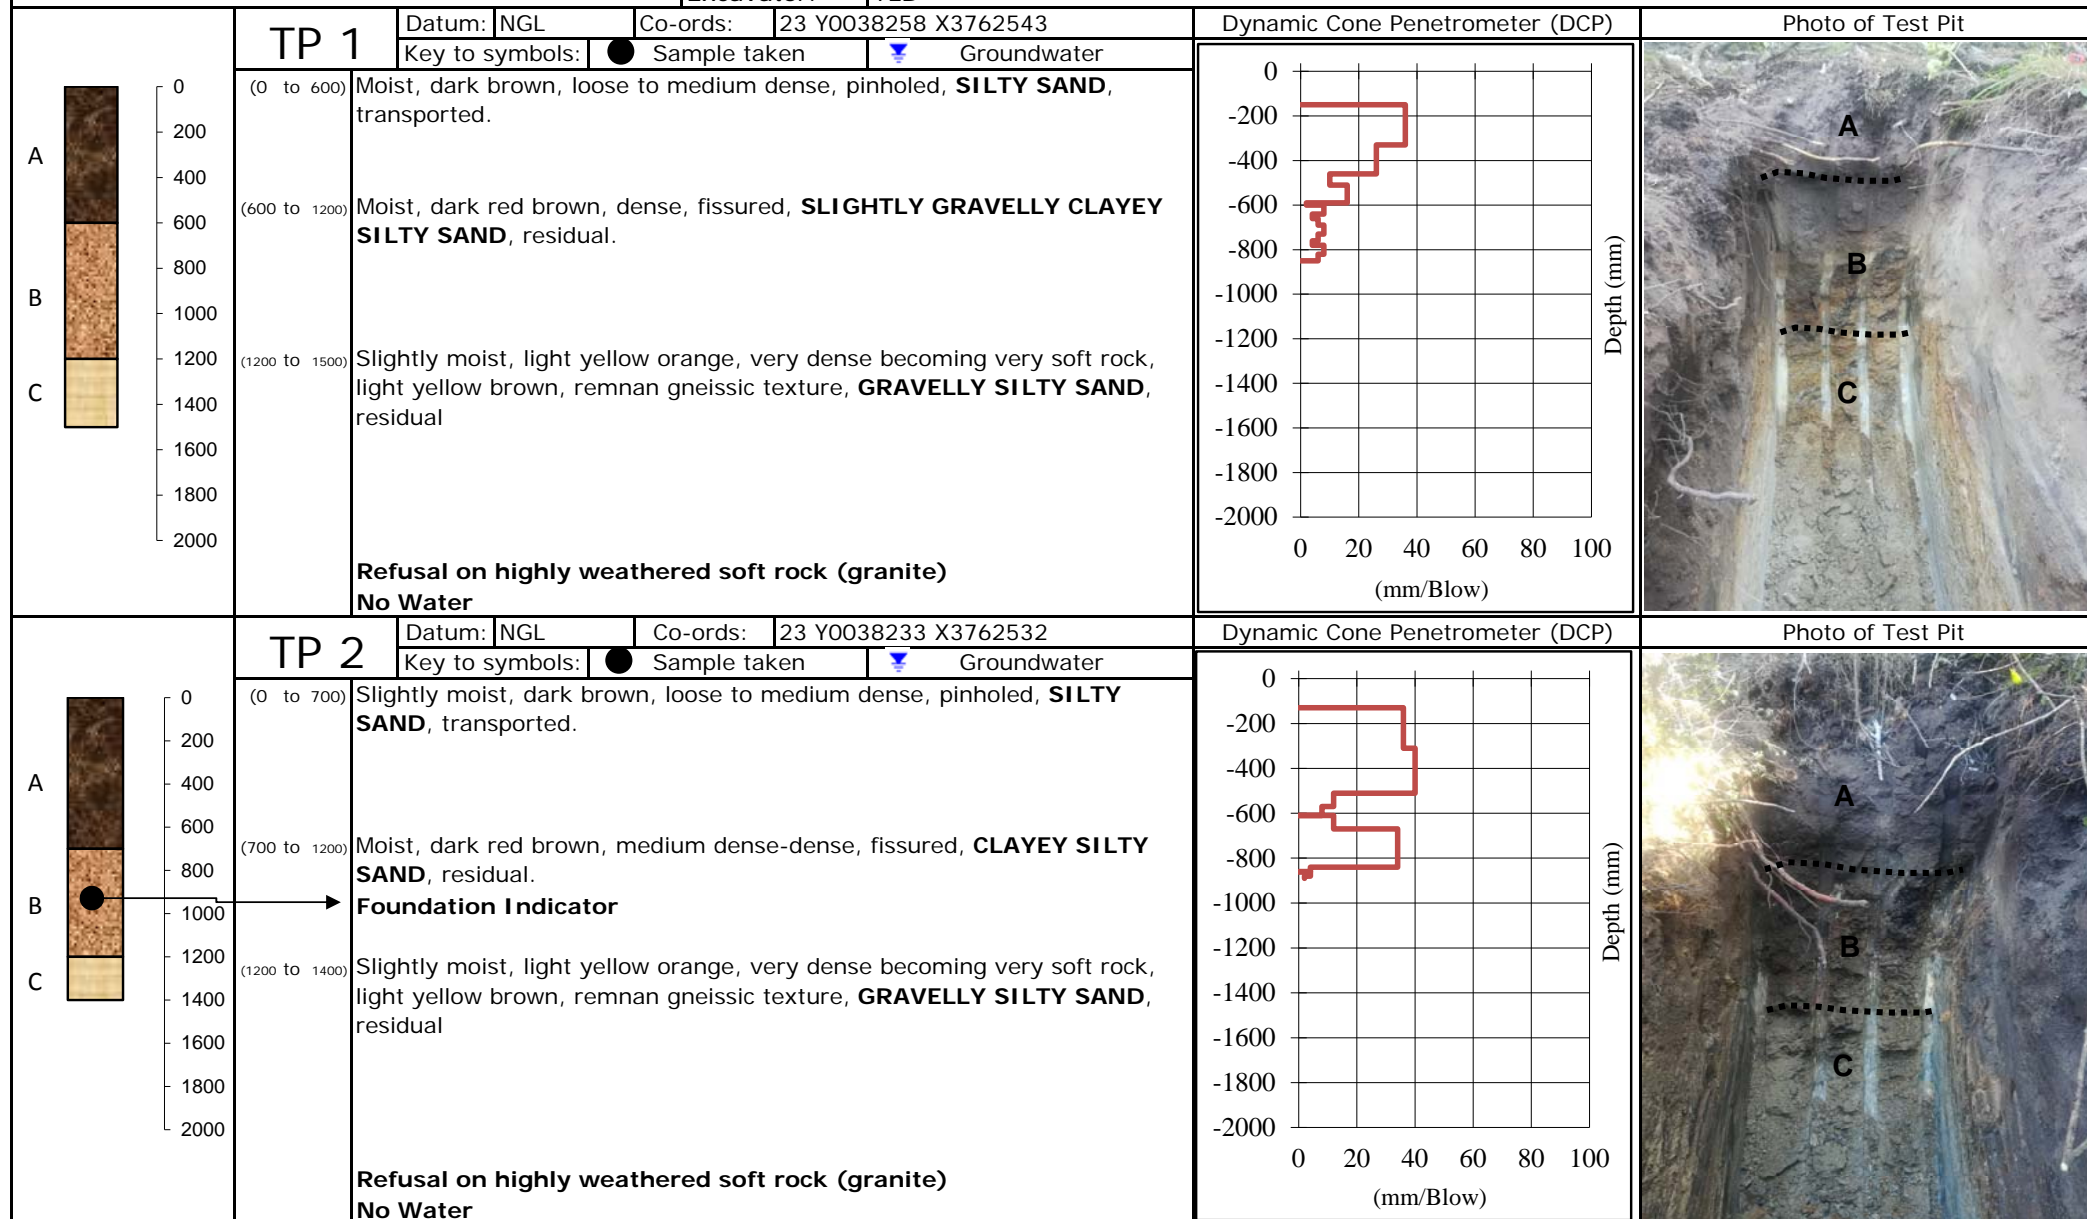
Geotechnical Soil Profile

Client: Stephan Coetzee
 Project: Erf 2107
 Area: Wilderness
 Date: 06.05.2020
 Excavator: TLB

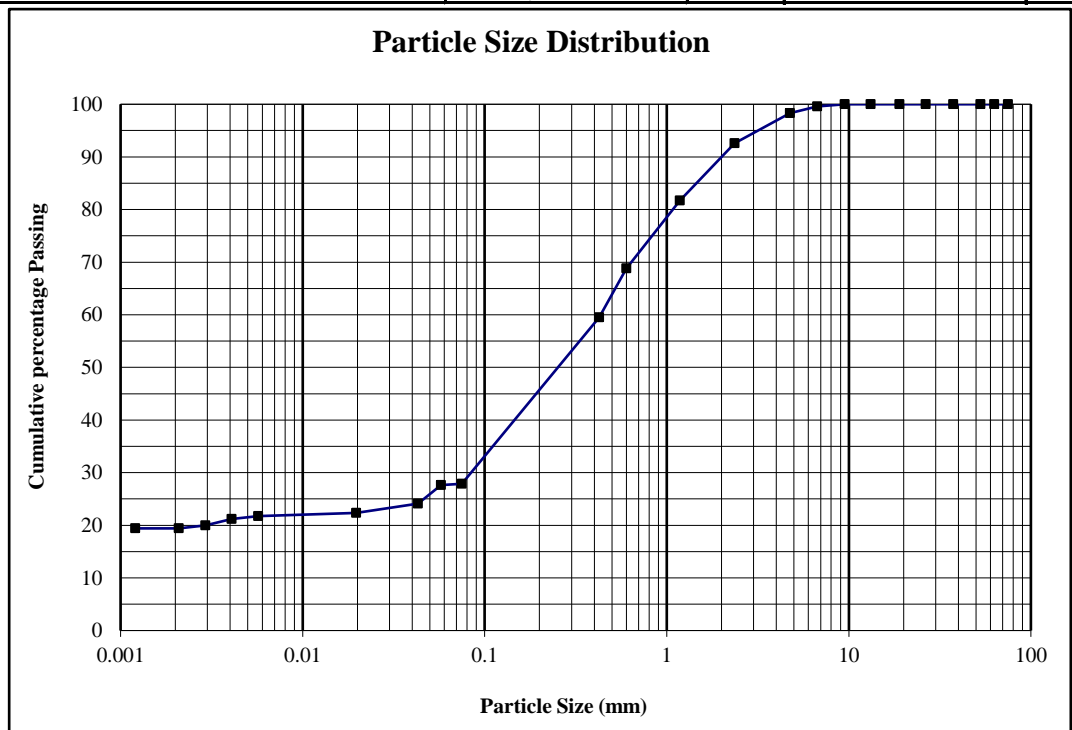
FOUNDATION INDICATOR - (TMH 1 Method A1(a),A2,A3,A4,A5) & (ASTM Method D422)

Material Description:	Light Yellowish Brown - Gravelly Clayey Sand	Sample Number:	78799		
Position:	TP2 - Layer 2	Liquid Limit	53	Linear Shrinkage	11
Depth:	700-1200	Plasticity Index	22	Insitu M/C%	12.8

Sieve Size(mm)	% Passing
75.0	100
63.0	100
53.0	100
37.5	100
26.5	100
19.0	100
13.2	100
9.5	100
6.7	100
4.75	98
2.36	93
1.18	82
0.600	69
0.425	60
0.075	28
0.0575	28
0.0429	24
0.0197	22
0.0057	22
0.0041	21
0.0029	20
0.0021	19
0.0012	19

% Clay	19	% Silt	9	% Sand	61	% Gravel	11
Unified Soil Classification		SM		PRA Soil Classification		A-2-7

The residual clayey sand below the topsoil (i.e. the second horizon) has a clay content of 19%, a plasticity index of 22 and an overall medium potential expansiveness, according to the Van der Merwe method, but due to the thin nature of this horizon it will have a low heave potential (<7.5mm – H category).

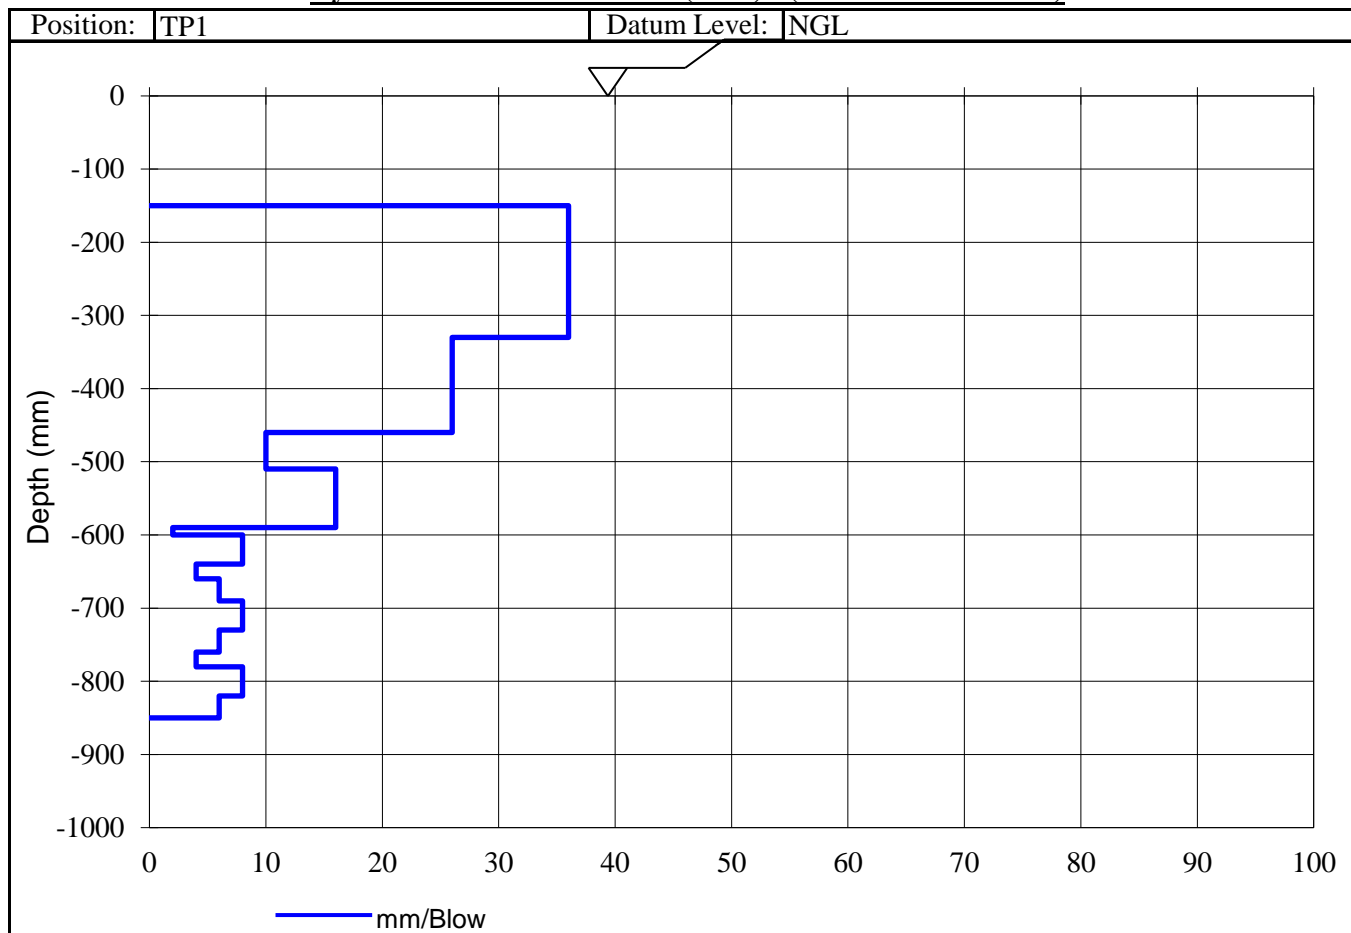
Dynamic Cone Penetrometer (DCP) - (TMH 6 Method ST6)

DCP test results indicate that the upper 0.85m of the soil profile is loose to medium dense (potentially compressible and collapsible) with low safe bearing capacity, but all tests show dense to very dense conditions with good bearing capacity below this depth. All tests refused within 1m of NGL. The estimated safe bearing capacity at a nominal founding depth of NGL-0.85m is 250kPa. The underlying soft bedrock below 1.2m is a highly favourable medium to carry heavy structural loads with bearing capacity in the order of 350-450kPa.

Foundations: The recommended foundation system for single/double storey masonry structures is lightly reinforced concrete strips and/or square bases. An estimate of safe design bearing pressure is 250kPa at a minimum founding depth of 0.85m below natural ground level or 0.6m below cut platform level, whichever is deeper. The engineer should inspect trenches before casting foundations to ensure suitable conditions.
