Rapid assessment and mitigation measures for watercourses on Erven 21028 and 21029, George

Prepared by Dr. Jackie Dabrowski of Confluent Environmental (Pty) Ltd

May 2021 (Updated June 2021)

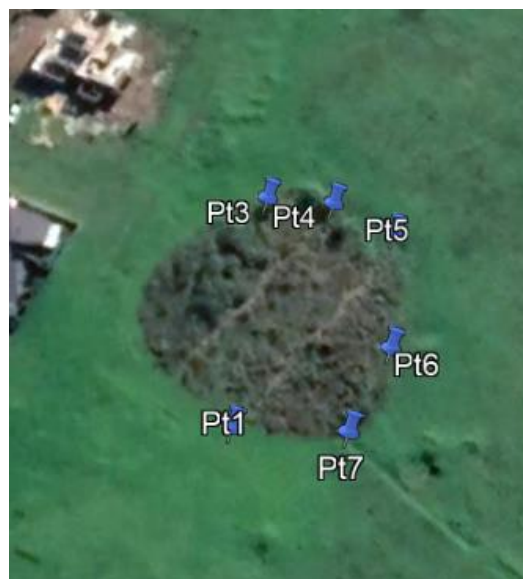
The wetland was demarcated by marking out 7 points along the circumference (edge; Figure 2). A 30 m measurement will be taken from these points outwards to mark out the buffer area by the contractor on Monday 31 May. One of the points (Pt2) did not save in the GPS and will be verified in the coming week. But there is good agreement between the points marked and the satellite imagery which still indicates the wetland (Figure 2).

Figure 2. Satellite image of the wetland with marked points made on 28 May 2021.

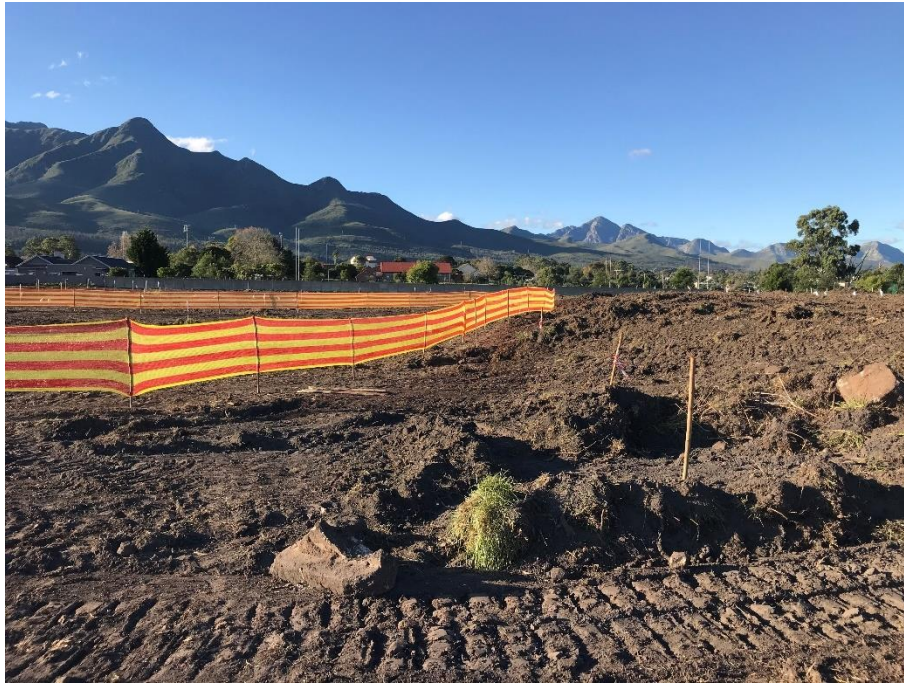
Approximately one third of the wetland has been covered with a large quantity of earth fill from the other two thirds of the wetland which has been excavated. Fill was also obtained from the cleared vegetation area on Erf 21029. No evidence of the wetland remains, and the site is now highly disturbed (Figure 3). It will be more thoroughly assessed during subsequent site visits to determine the feasibility of rehabilitation.

Figure 3. Photo of the present state of the wetland roughly demarcated by shadecloth, showing infilled area to the right.

On Monday 31 May 2021, the site was visited again to determine whether removal of the portion of fill that was placed over the wetland is a feasible option for rehabilitation. Two areas of fill were removed to the previous level of the wetland using the excavator on site. Roots of *Typha capensis* were still present that had not yet decomposed, although the leaves had already browned off. However, *T. capensis* is a resilient plant, and is known to be difficult to remove. It is the opinion of the author that if the fill is removed from the filled in area that many of the reeds will regrow creating the opportunity for rehabilitation. The rapid removal of fill from the wetland area with subsequent monitoring of re-establishment of the wetland vegetation is therefore recommended before the roots decompose and seedbank is lost.

The fill placed in the wetland flat (described above) was subsequently removed from the area on 15 June 2021.

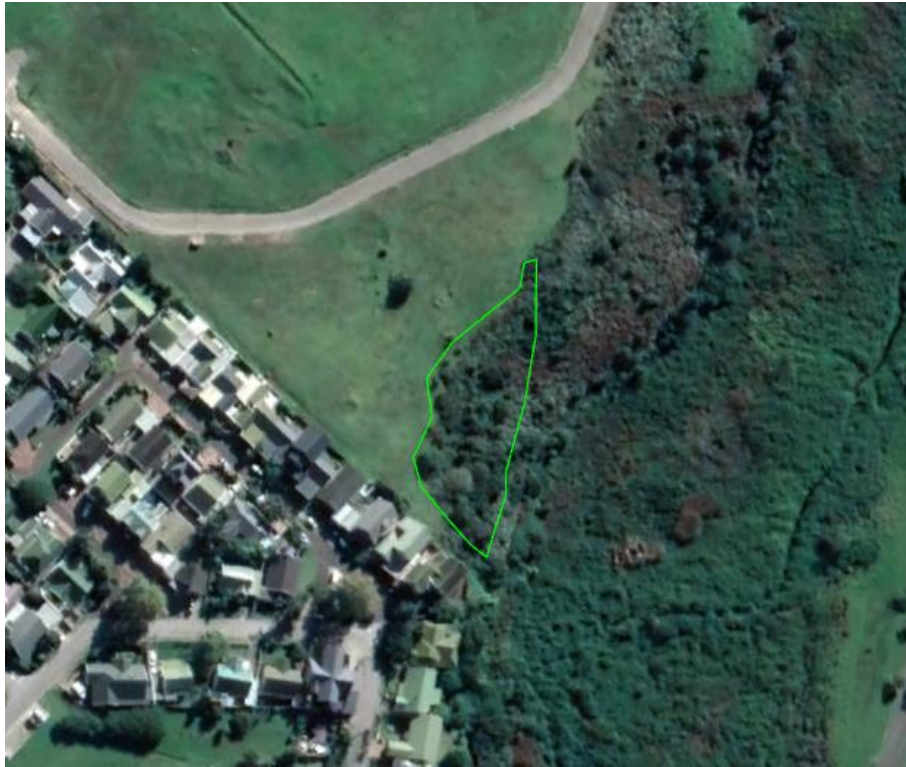
The Camfersdrift River flows in a south-westerly direction towards the south-east of Erf 21029. At this point the river has a broad valley-bottom wetland area confined by relatively steep slopes on the western bank. The area of vegetation cleared on Erf 21029 was mapped using a GPS on site and measures **1 928 m²** (Figure 4). The area was being cleared for construction of houses down the slope which were to be supported by a retaining wall towards the slope bottom.

The vegetation cleared served the important function of stabilising soil on the steep slopes and would be classified as riparian vegetation grading to wetland vegetation towards the bottom slope. Now it has been removed, and the soil disturbed, this creates a very high risk of soil erosion down the slope resulting in sedimentation of the Camfersdrift wetland (Figure 5). It is therefore recommended that urgent mitigation measures are taken to prevent further degradation of the environment.

Figure 4. Area of vegetation cleared adjacent to the Camfersdrift wetland.

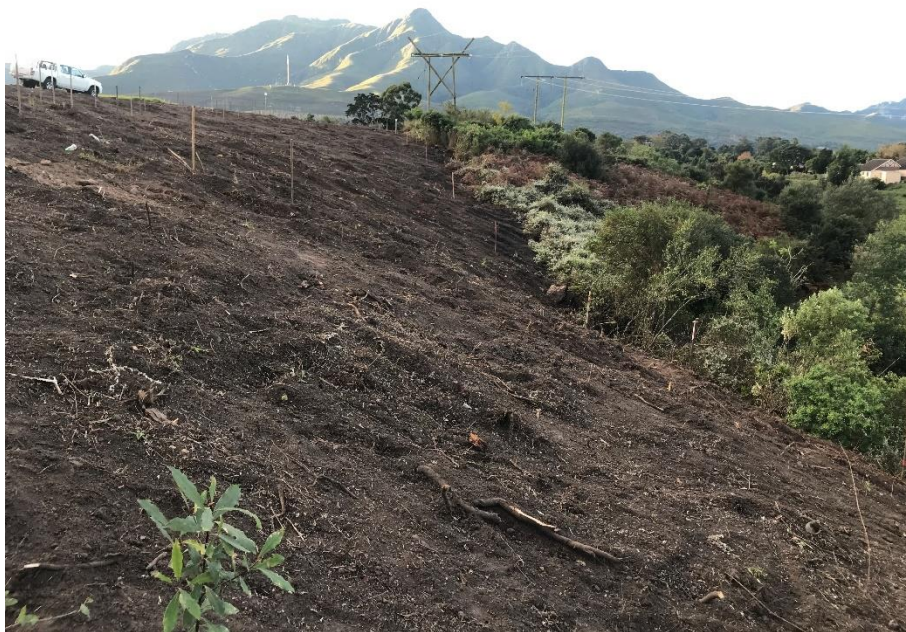
Figure 5. Photo of the cleared vegetation showing the steep slope on Erf 21029.

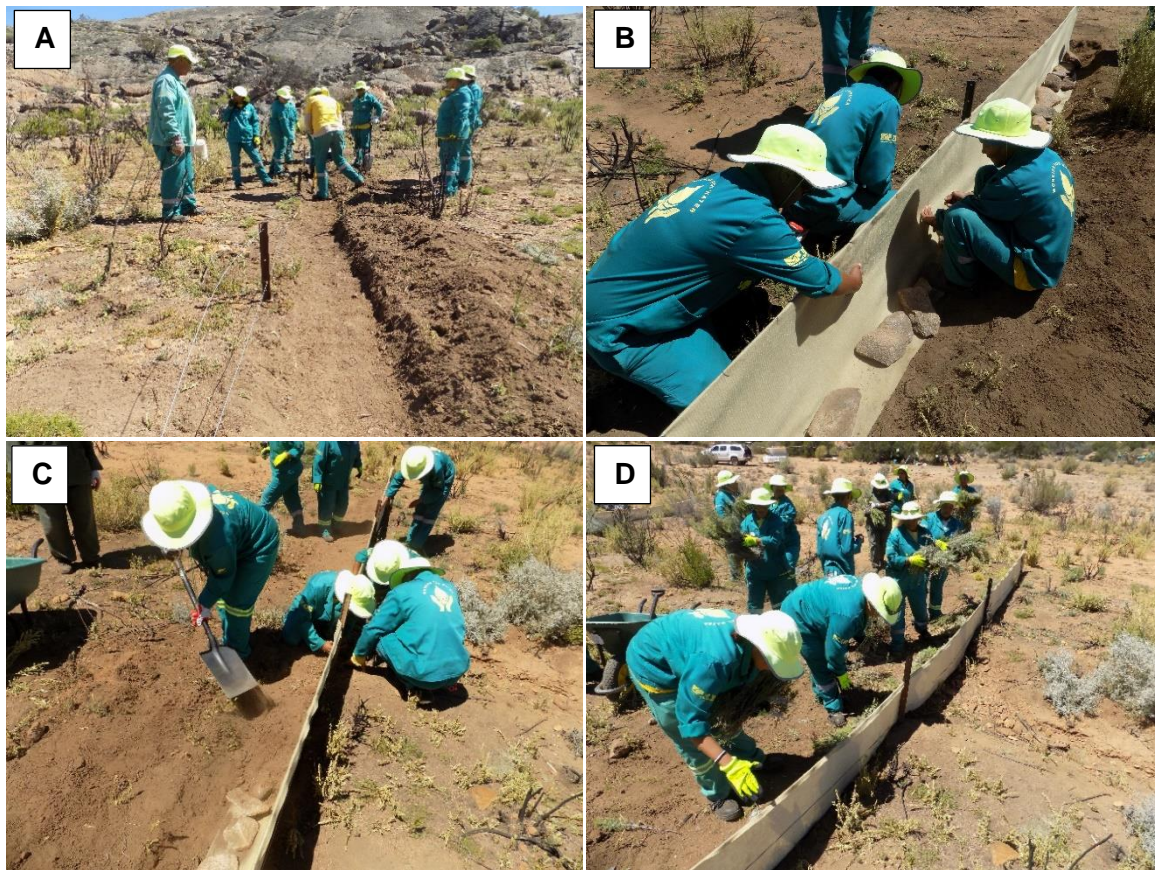
Figure 7. Installation of the soil erosion control fence. A: Installing the standards and wires and preparing the trench. B: Fitting the geotextile, tying it on with wire. C: Filling in the trench over the geotextile. D: Applying a mulch against the completed fence (Photos courtesy Ken Coetzee).

Proper installation of soil erosion control fences is necessary for them to be effective. 4 silt fences must be installed along the contours as indicated in Figure 6. Images demonstrating the installation of erosion control fences are shown in Figure 7. The following guidelines must be followed:

- Geotextile fences must be installed perpendicular to the direction of water flow and along a line of uniform elevation or contour. In other words they should not waiver up and down the slope, but should be in a straight line across the slope. If this guideline is not followed, water will flow along the fence to the lowest point creating stress and potential collapse at this point;

- Silt fences can be staked using wooden stakes. Metal droppers are preferable but will be stolen. The stakes should be arranged in straight lines across the area to be rehabilitated, at most 3m apart and firmly driven into the ground. A steel wire along the top of the stakes and also along the ground must then be secured and to which the geotextile is fastened, top and bottom;

- A 250 to 350 cm wide and 10 cm deep trench must be dug upslope of the location of the fence and the bottom half of the geotextile then laid into the trench;

- The trench must be backfilled and the soil compacted over the geotextile;
- The height of the silt fence should be between 20 and 30 cm;

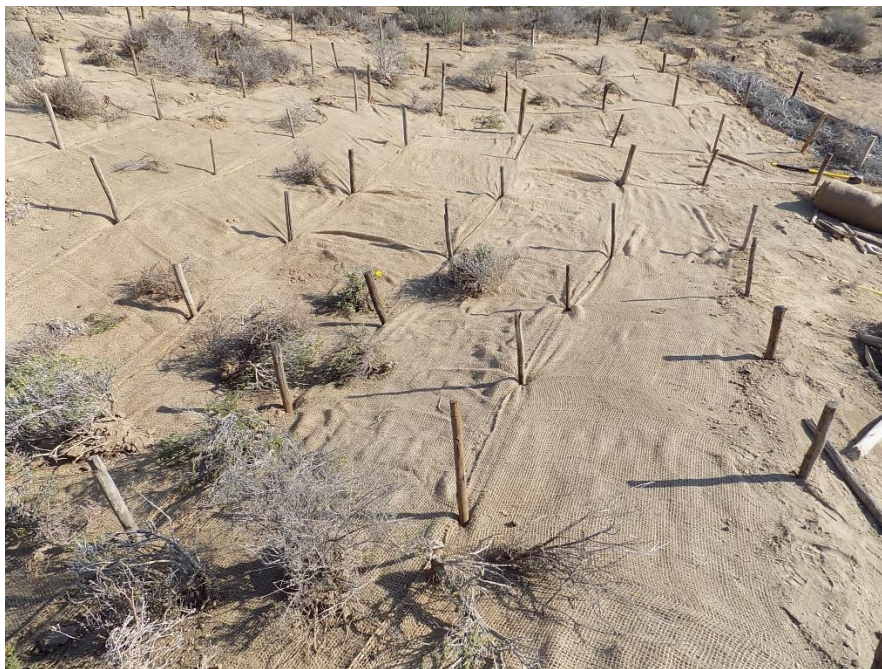
Figure 9. Example of how Soilsaver is fitted to the soil surface (Photo courtesy Ken Coetzee). Note holes to accommodate indigenous vegetation.

- Cover the seeded and mulched slopes with a rolled erosion control product (such as jute, coir or straw matting). Preferably a natural (vs. man-made), bio-degradable product should be used. The use of a jute geotextile called *Soilsaver* is recommended. It is also available from Kaytech in Port Elizabeth and in Cape Town.

The role of the erosion control matting is not to provide long-term protection for slopes from erosion, but to protect the soil surface until vegetation can establish and become the permanent stabilising feature. The slope should be seeded and mulched, and then covered with erosion control matting which will remain in place until the vegetation has established. Matting should be overlapped by about 10cm and secured using wooden stakes along the edges. Terminal ends of the matting can also be staked or buried in an anchor trench.

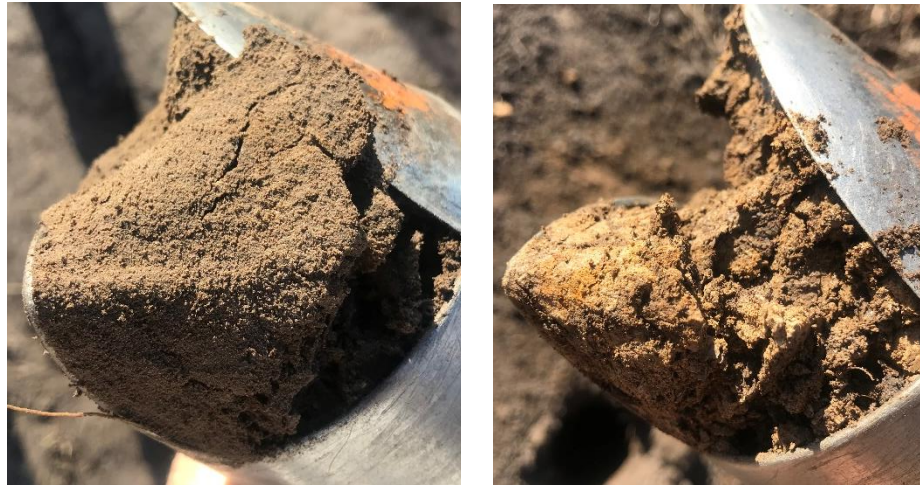
As vegetation was recently cleared on the slope above the Camphersdrift wetland, soil indicators were used to delineate the wetland in this area. A series of four transects perpendicular to the Camphersdrift wetland were augered up the slope where vegetation was

cleared. Augering was conducted approximately every 2 – 3 m along the transect. Soils were augered to a depth of 50 cm to search for evidence of permanent, seasonal or temporary wetness. The delineated edge of the wetland was determined as the line between auger points indicating temporary wetness and no wetness (Figure 12). Delineated wetland areas in the vicinity of the two erven to be developed are presented along with the revised buffer recommendation in Figure 13.

Figure 12. Example of augered soil down the slope towards Camphersdrift wetland showing soil with no wetland indicators (left) compared to soils with indicators of temporary wetness (right).

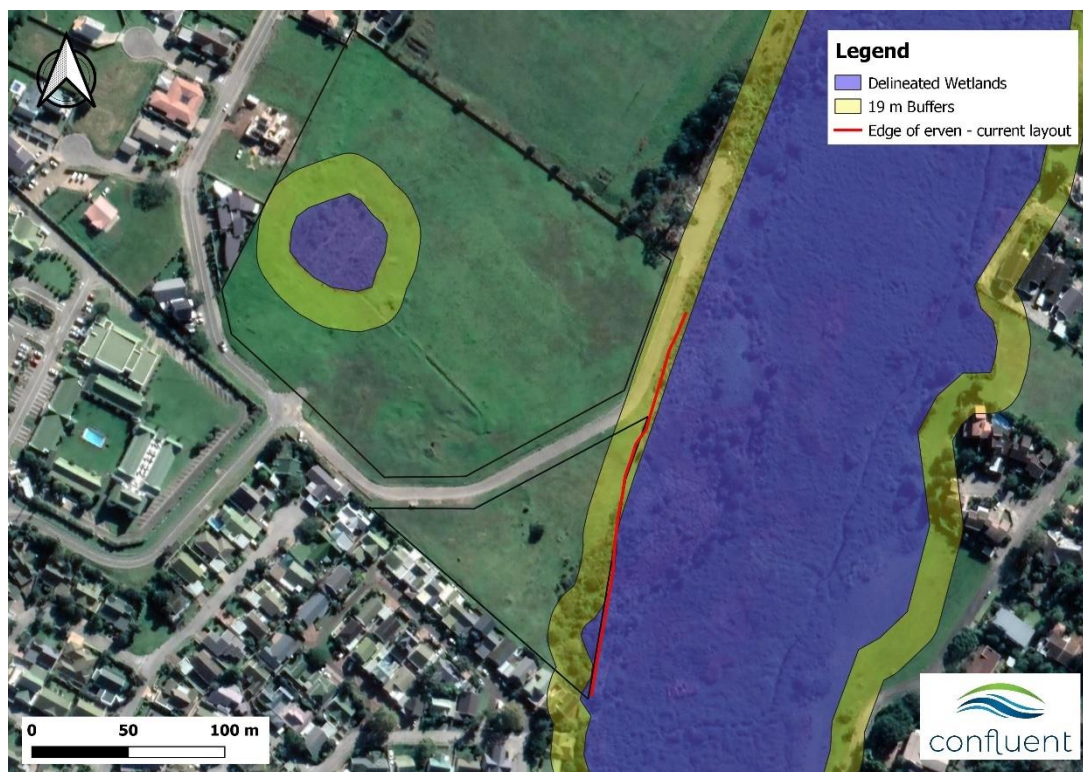
Wetland Flat Buffer: 19 m

Camphersdrift Wetland Buffer: 19 m

Figure 13. Delineated wetland areas and recommended buffers for Erven 21028 and 21029.

The resulting buffer was the same for both wetlands. The buffer areas would be completely out of bounds during the Section 24g process, and while any other environmental processes are initiated and authorised (e.g. Water Use License). The buffer areas would also need to be maintained and / or rehabilitated to provide sustained support to the watercourse. A point worth noting about watercourse buffers is that they primarily protect watercourses from diffuse sources of pollution, as opposed to point sources. Housing developments do not produce large amounts of diffuse pollution, unlike other land uses such as a feedlot for instance. Greater risks are posed by point sources such as stormwater outlets, which buffers are not able to mitigate. Buffers are also meant to conserve biodiversity, migration corridors, and reduce collective risks to the watercourse. These factors are accounted for in the buffer calculation.

The revised aquatic buffers will need to be overlaid with more detailed botanical specialist inputs. The updated buffers and sensitive areas can then be considered in possible revisions of the planned layout of the residential development.
