**Streambank Stabilisation of a Wetland in Rosemoor, George,
Western Cape.**

Freshwater Assessment Report

George Municipality

August 2022

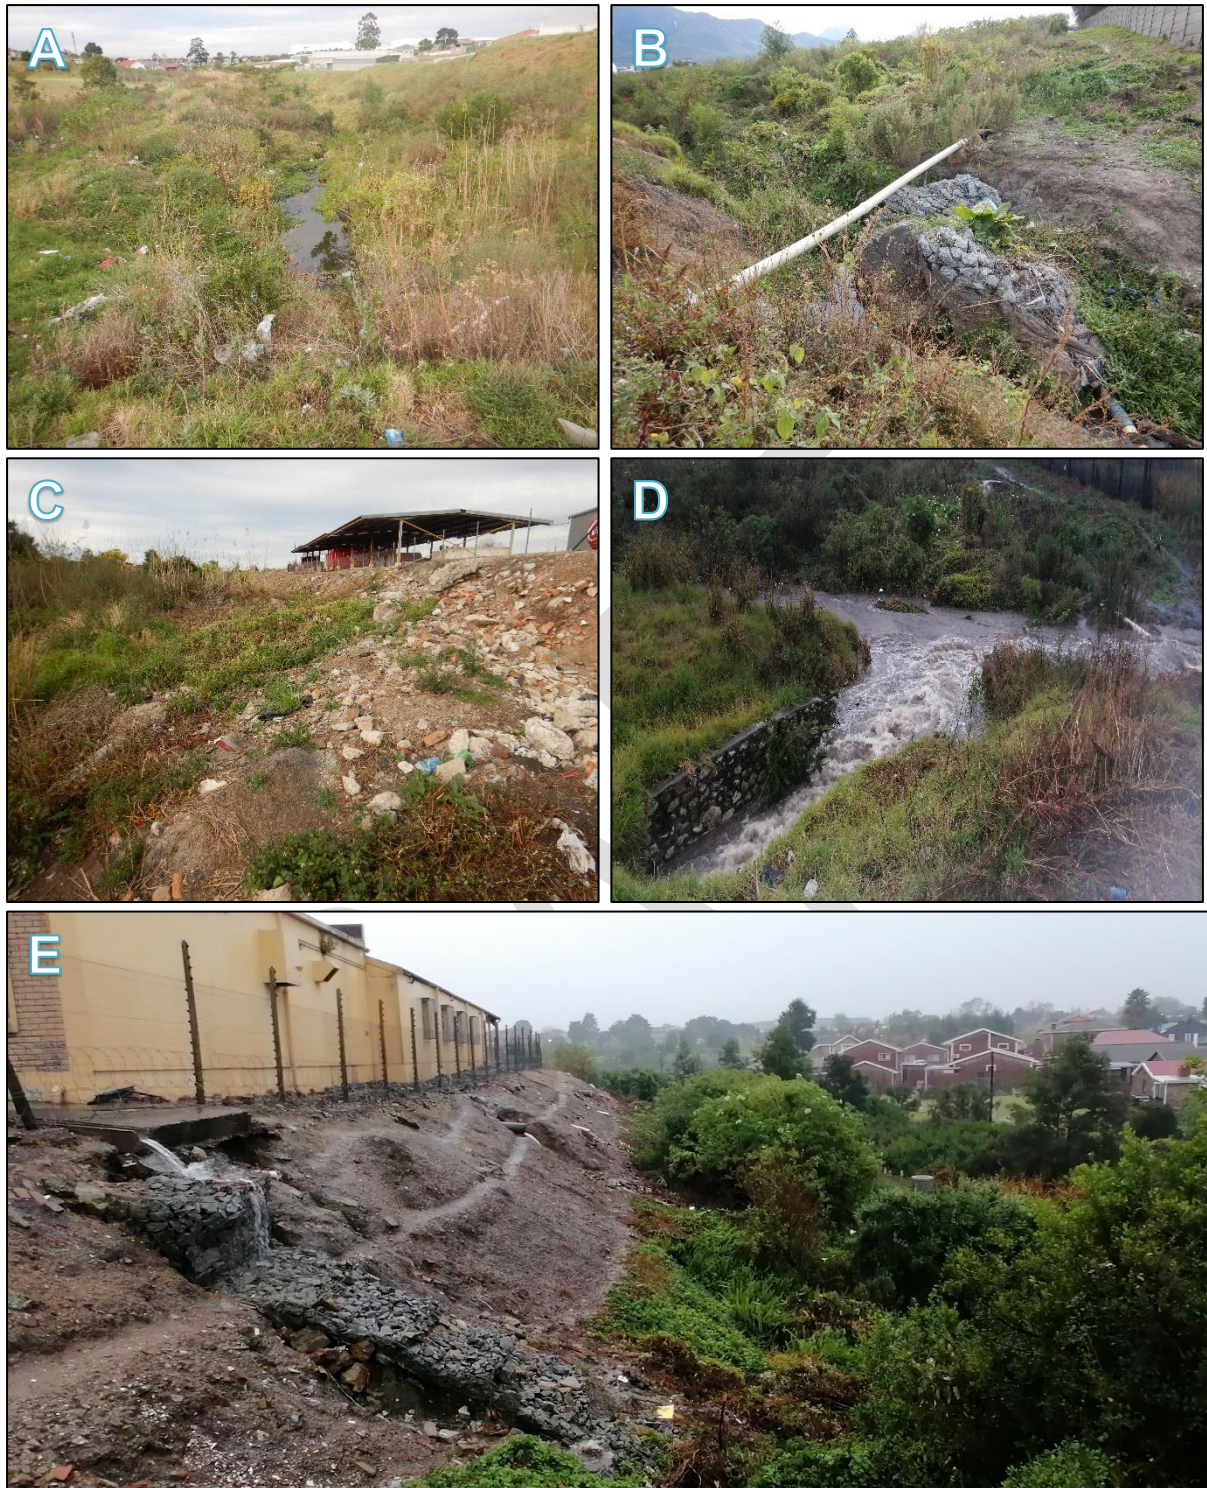
Figure 3: Photographs broader catchment impacts including litter in the wetland south of Grens Road (A); sewage pipeline crossing the wetland (B); infilling of rubble along western boundary of the wetland (C); high volumes of stormwater entering the wetland upstream of erven 21150 and 21151 (D); and stormwater inputs from industrial areas along the western boundary of the wetland (E).

The surrounding urban and industrial areas have significantly impacted the ecological condition of the wetland. As described above the wetland receives considerably higher volumes of water due to extensive hardened surfaces in the catchment area, numerous bulk stormwater discharges and numerous smaller discharges from adjacent industrial properties (Figure 3). This was confirmed during a site visit conducted shortly after a very heavy rainfall event, which led to extensive flooding across the city of George. High stormwater inputs have altered both the hydrological and geomorphological characteristics of the wetland area, resulting in almost riverine conditions, an incised channel and loss of sediment from the bed and banks (due to high velocity, high energy stormwater flows) (Figure 4). This has resulted in the loss of wetland habitat and alteration from what was most likely an unchannelled valley bottom wetland (with high flood and sediment attenuation capacity) to a more channelled system. A stormwater outlet that discharges into the river in between Erf 21150 and Erf 21151 also likely contributes to the bank destabilisation. There is a high drop-off and the plunging effect would most likely have scoured the toe of the embankment which would have contributed to the erosion of the embankment in this area. Large sections of the western extent of the wetland have been historically infilled for the establishment of industrial warehouses. Dumping of rubble is also evident.

Water quality has been compromised by input of stormwater originating from urban and industrial areas and most likely by sewage input from leaking infrastructure and a pump station located further upstream. Large amounts of solid waste and litter were observed within the channel of the wetland and it was evident that garden waste, litter and ash and burned out coals are frequently dumped into the wetland

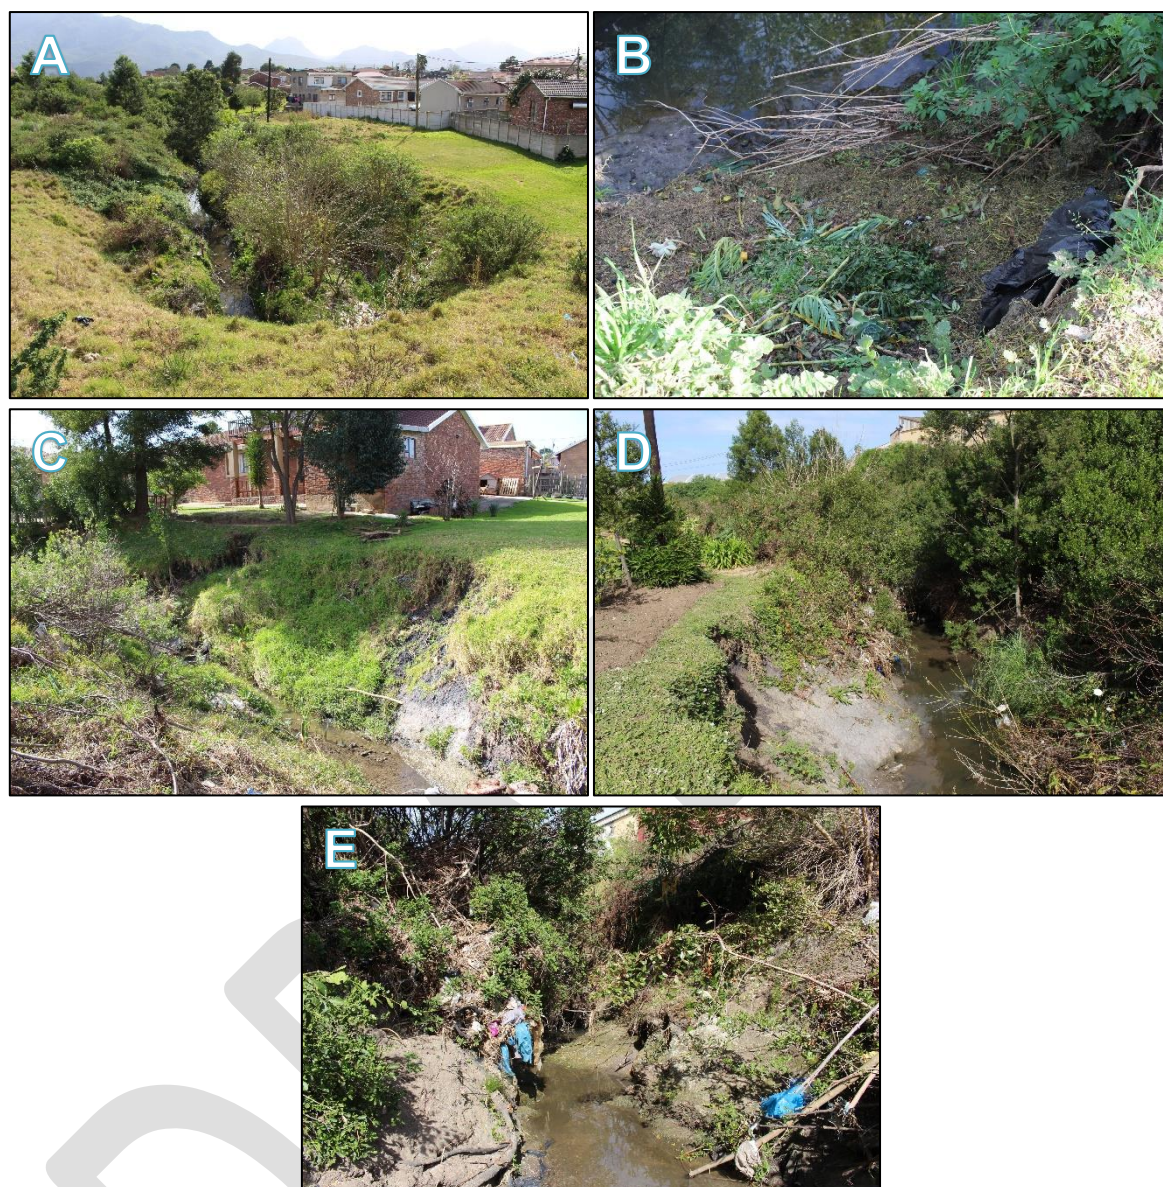
Figure 4: View of the wetland looking north from Grens Road (A); dumping of litter and garden waste into the wetland (B); eroded banks adjacent to Erf 21151 (C); erosion of banks in-stream habitat and eroded banks of the wetland (top) and eroded channel adjacent to erfven 21150 and 21151 (bottom).

The need for the stream bank stabilisation was initiated primarily as a result of risk posed to erven 21150 and 21151, the boundaries of which are located immediately adjacent to the eroded channel. Any further destabilisation of the bank therefore presents a risk to the residential buildings located on these properties. Alternative 1 therefore restricts gabions to the section of channel located adjacent to these properties (Figure 5). Alternative 2 proposes the placement of gabions along the entire length of the stream from Erf 21151 (starts at the same point as Alternative 1), all the way to Grens Road. The rationale for this alternative is that the entire length of this section of the channel is incised and eroded. Properties along this alternative are however set far back from the channel and are therefore not at imminent risk.

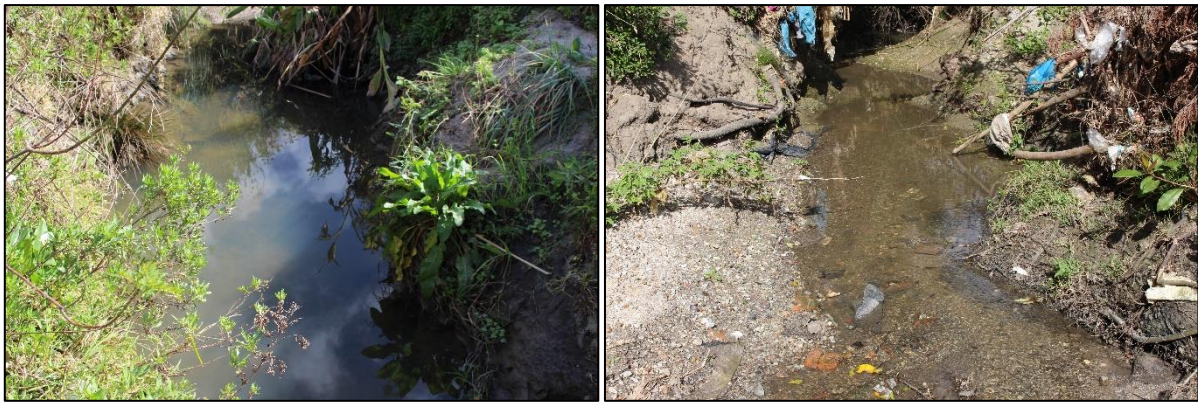
Figure 9: Photographs showing typical instream biotopes present along the stream delineation including occasional deeper pools (left) and predominantly shallow, flowing runs and riffles (right).

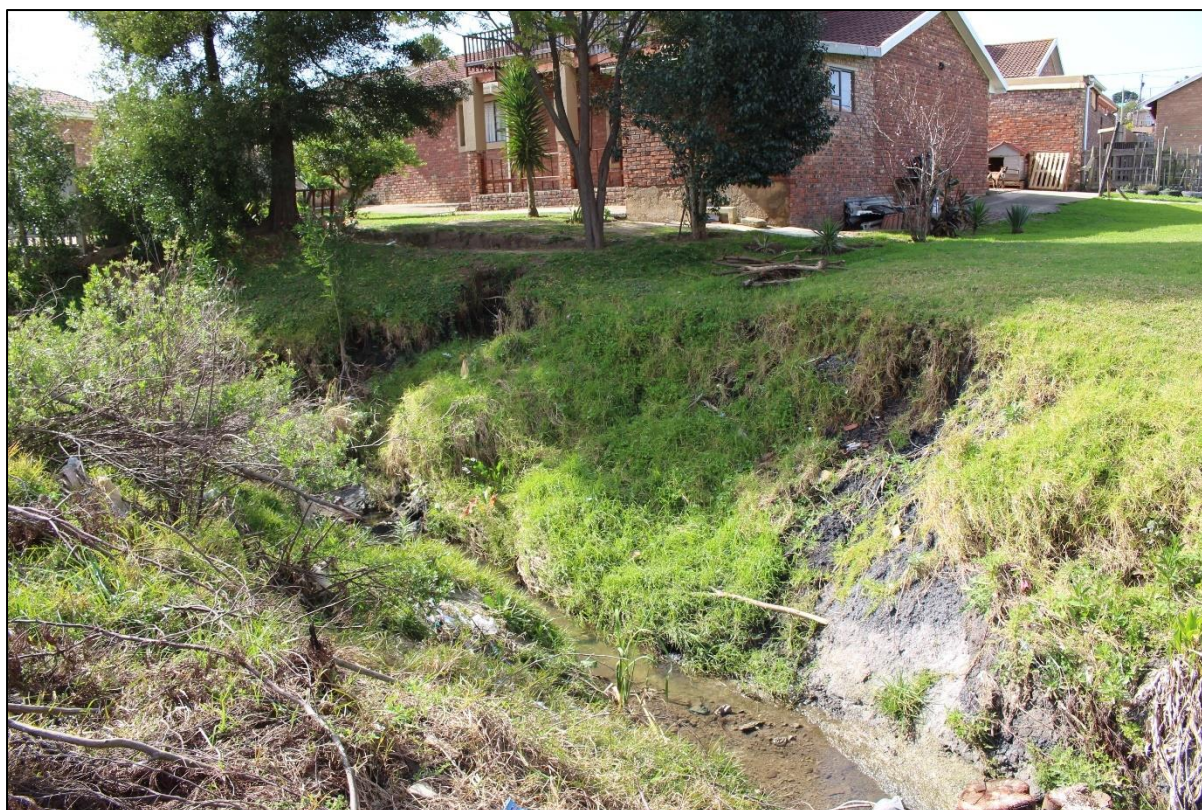
Figure 10: Photograph showing typical vegetation present along banks that require stabilisation.

The length of the embankment that will be stabilised is either bare (i.e. where erosion has exposed the embankment) or predominantly covered in *P. clandestinum* (Figure 10). Other species that were observed included the following (none of which are species of conservation concern):

- *Acacia mearnsii* (Black wattle – alien invasive)
- *Acacia melanoxylon* (Blackwood - alien invasive)
- *Cortaderia selloana* (Pampas Grass- alien invasive)
- *Typha capensis* (Cape bulrush)
- *Juncus effusus* (Soft rush)
- *Nidorella ivifolia* (Bakbesembossie)
- *Canna sp.* (common garden plant)

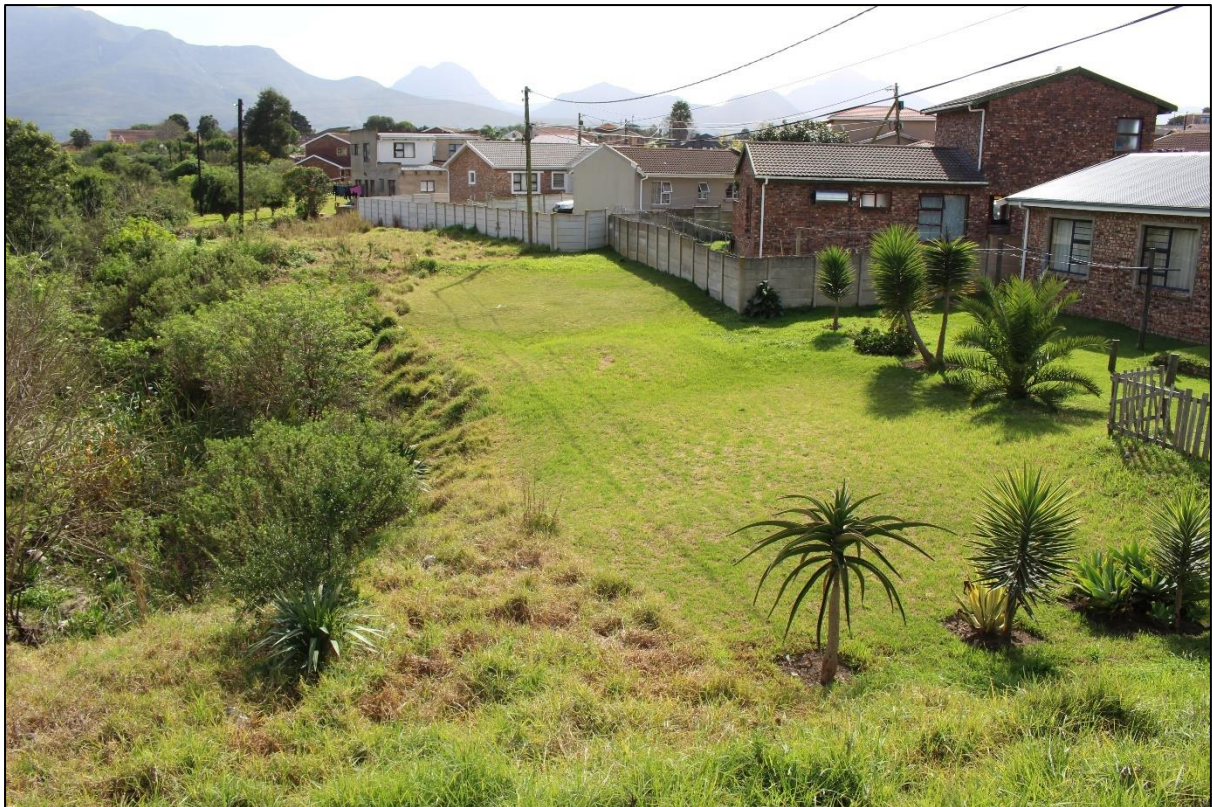
Figure 11: Photograph showing the presence of mowed and maintained lawns along the eastern extent of the wetland.

Sections of the embankment from Grens Street further upstream have had riparian vegetation removed and lawns cultivated right up to the edge of the bank. The roots of riparian vegetation play an important role in binding soil and help to stabilises stream banks. The removal of the vegetation therefore contributes to the de-stabilisation of the bank. While increased stormwater inputs are the main cause of the stream incision, the lack of riparian vegetation contributes to the problem.
