## **FRESHWATER COMPLIANCE STATEMENT**

**Tourist Accommodation on Portion 101/489 Jongensfontein, Hessequa,  
Western Cape.**

**Prepared for Cape EAPrac**

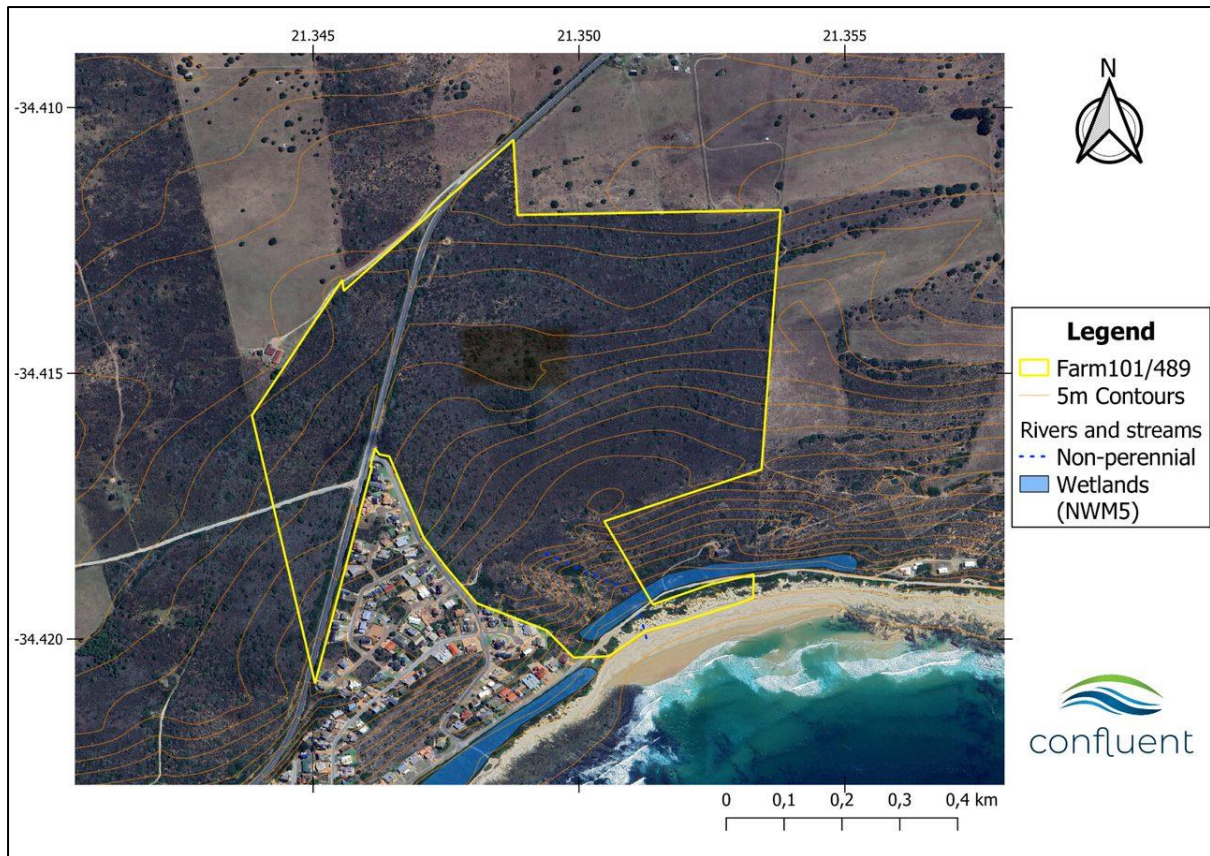
Figure 2: Location of the property in relation to mapped watercourses.

Ecosystem Priority Area (FEPA) or a Strategic Water Source Area (SWSA). According to geospatial data sources, one non-perennial stream flows on the property in a south-westerly direction and one seep wetland is located at the bottom of the southern slope of the property (Figure 2).

Natural areas of drainage characterised by a poorly defined channel that partly coincided with the mapped non-perennial drainage line were observed along the relatively steep slope of the coastal foredune (see Figure 2), however, they were well vegetated by terrestrial vegetation and there are no obvious bed or banks or any sign of aquatic habitat associated with these drainage lines. As the drainage line reaches lower elevation, the channel disappears completely. The drainage lines are natural areas of drainage but do not transmit high volumes of water and cannot be considered as watercourses on which aquatic biodiversity is dependent. A depression area was located on the plateau above the foredune, however no signs of hydrophilic wetland vegetation were observed. Given the very sandy soil it unlikely that water would accumulate for a long enough period to encourage the establishment of wetland vegetation and biota.

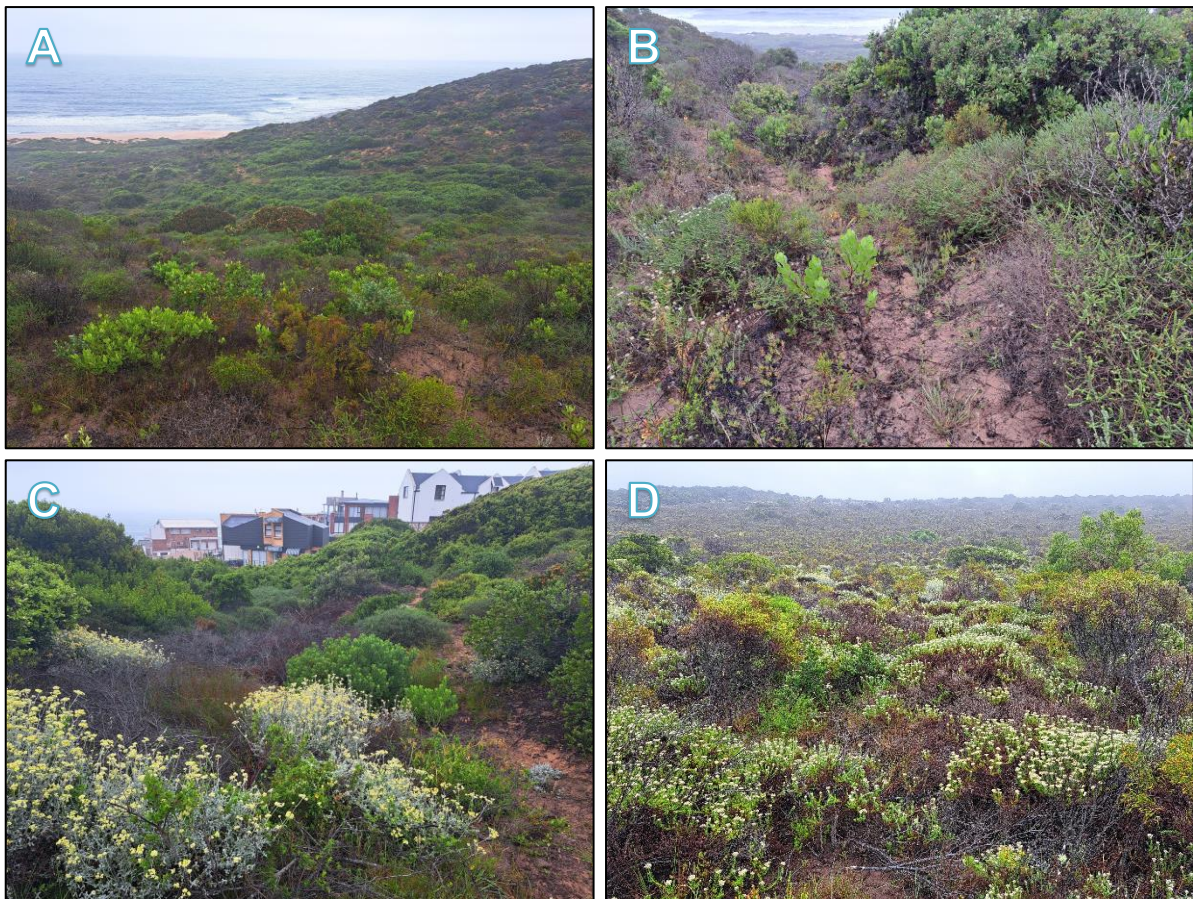
The entire area indicated as a seep wetland was traversed by foot. This area was covered with dune thicket vegetation (Figure 4) and there was no evidence of any seeping water or any obvious geological/lithological formations that would cause groundwater or rain-derived water to seep down-slope as subsurface interflow. In addition, soils are generally very sandy and well drained, with limited pedological development. All of these factors are not consistent with typical conditions under which one would expect seep wetlands to occur. Finally, there were no characteristic hydrophilic wetland plant species indicating saturated soil conditions throughout the extent of the mapped wetland area (Figure 5). As described above, soil is very sandy and well drained and there were no indications of seasonal, temporary or permanent soil saturation in soil profiles that were augered up to a depth of 50 cm. In conclusion, no sign of a wetland seep was observed on the property. Similarly, the wetland seep indicated to occur to the east of the property (see Figure 2) is also not a wetland. Both areas mapped as wetlands are characterised by dense terrestrial dune thicket vegetation, dominated by milkwood trees (*Sideroxylon inerme inerme*).

Figure 5: Photographs of the site including a view from the top of the foredune down to the coast line (A), well vegetated, topographical areas of drainage (B and C) and the depression at the top of the foredune (D).
