**PROPOSED CONSTRUCTION AND OPERATION OF  
HOTAZEL 2, NORTHERN CAPE**

**AGRICULTURAL IMPACT ASSESSMENT REPORT**

**FEBRUARY 2021**

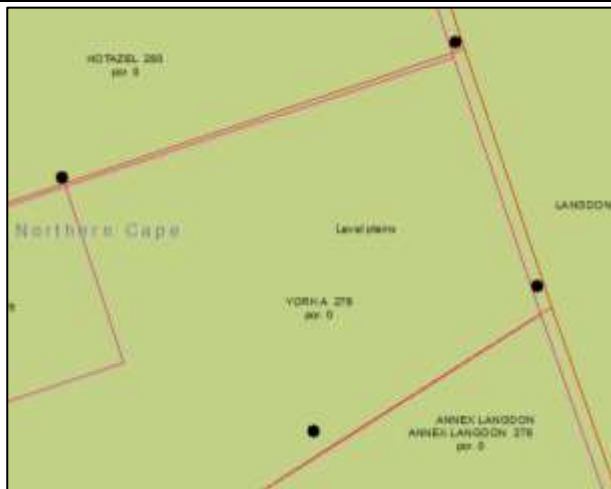
Figure 2: Natural resource data (AGIS)

The natural resource theme maps contained in Figure 2, give an overall view of the site.

Terrain type: Level plains

Slope: light green - <2%; dark green - 2.1-5%

Acocks veld type: Tropical Bush and Savanna type (Bushveld)

Vegetation type: Kathu Bushveld

Annual rain fall: 359 mm

Land capability class: VII

The Land Type map in Figure 2 shows that the pedosystem **Ah 9** was allocated to the Remaining Extent (Portion 0) of Farm York A 279. This refers to red or yellow high base status soils >300 mm deep. The pedosystem is predominately located on a Footslope (95%) which has a slope gradient of less than 1 %. The dominant soil type predicted is an apedal, fine sandy textured soil with effective soil depth in excess of 1200 mm. Very low mechanical limitations are predicted.

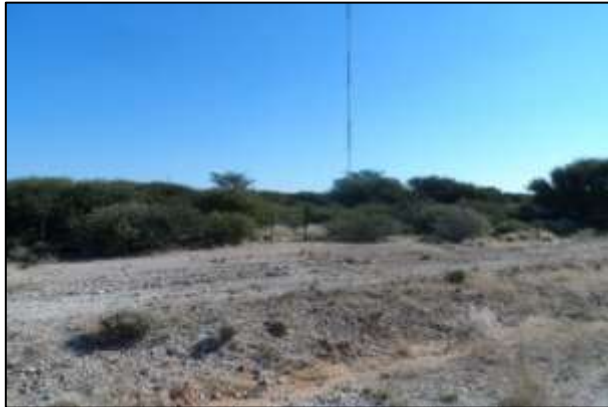
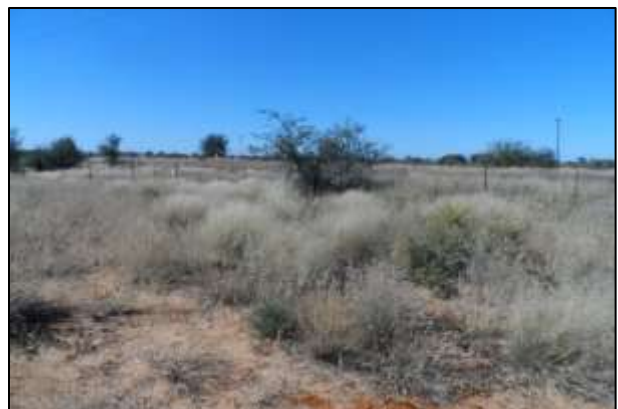
**Figure 4: Typical Vegetation and Existing Infrastructure**

A veld condition assessment, by visual acknowledgement, was conducted simultaneously with the soil survey. The photos in Figure 4 show the veld condition. The vegetation type is Kathu Bushveld (Savannah biome). The composition of the grazing varies from open grass with low to heavy encroachment of Black Thorn acacia (*Acacia mellifera*), as can be seen in Figure 4. Encroachment takes place when veld is over-grazed or where the soil has been disturbed.

**Outside site East of OBS 21**

**Fernwood OBS 23**

**Open savannah veld OBS 76**

**Savannah with medium acacia OBS 08**

**Borehole and pump OBS 05**

**South border OBS 18**

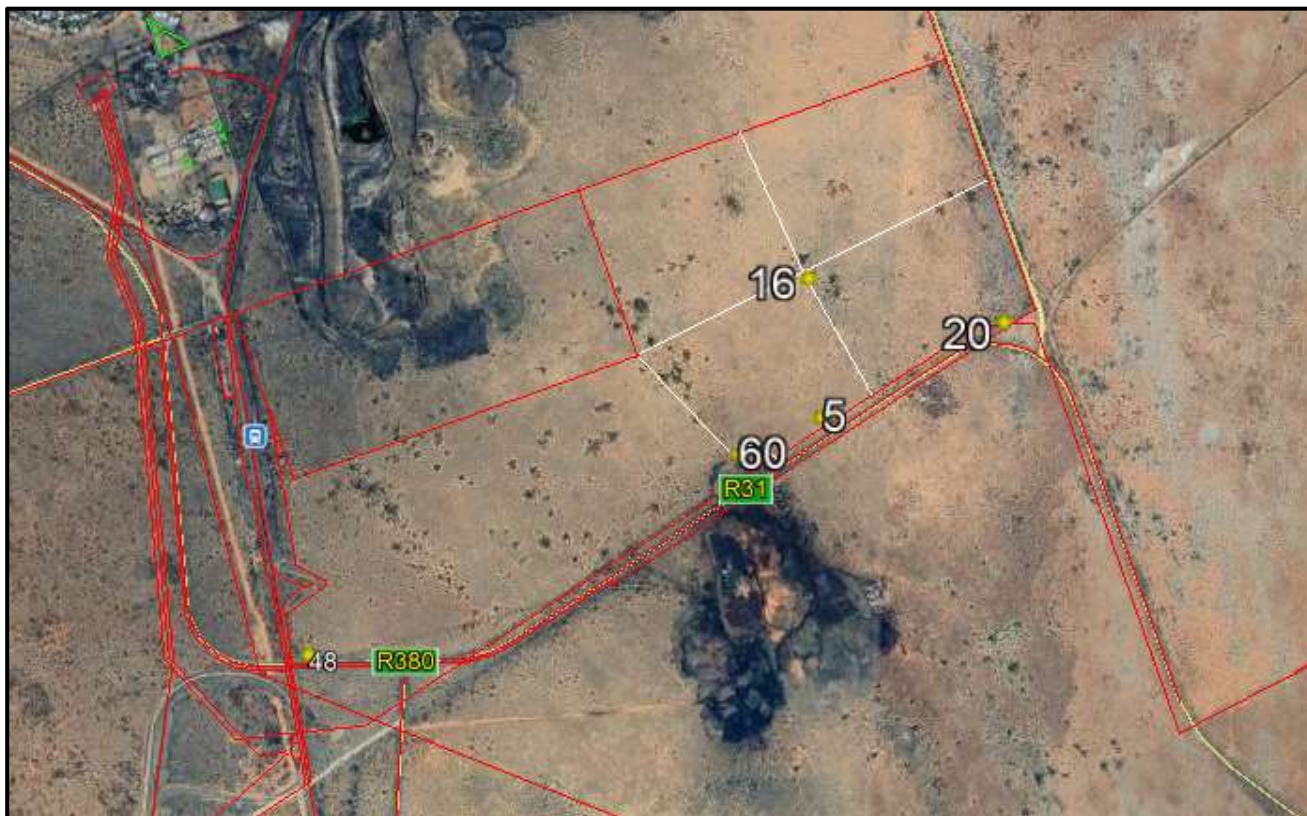
Figure 5: Infrastructure on Farm

The farm is used for extensive grazing with cattle. The infrastructure, demonstrated in Figure 5, consist of a cattle handling facility at point 16, house and handling facilities at point 60 (not inside footprint) and internal fencing, shown as white lines. Point 5 marks the position of a borehole and pump. Point 20 shows the position where an antenna is erected as well as a windpump (not inside footprint). Red lines on the map represent existing transmission and railway lines traversing the farm as well as the cadastral boundaries.

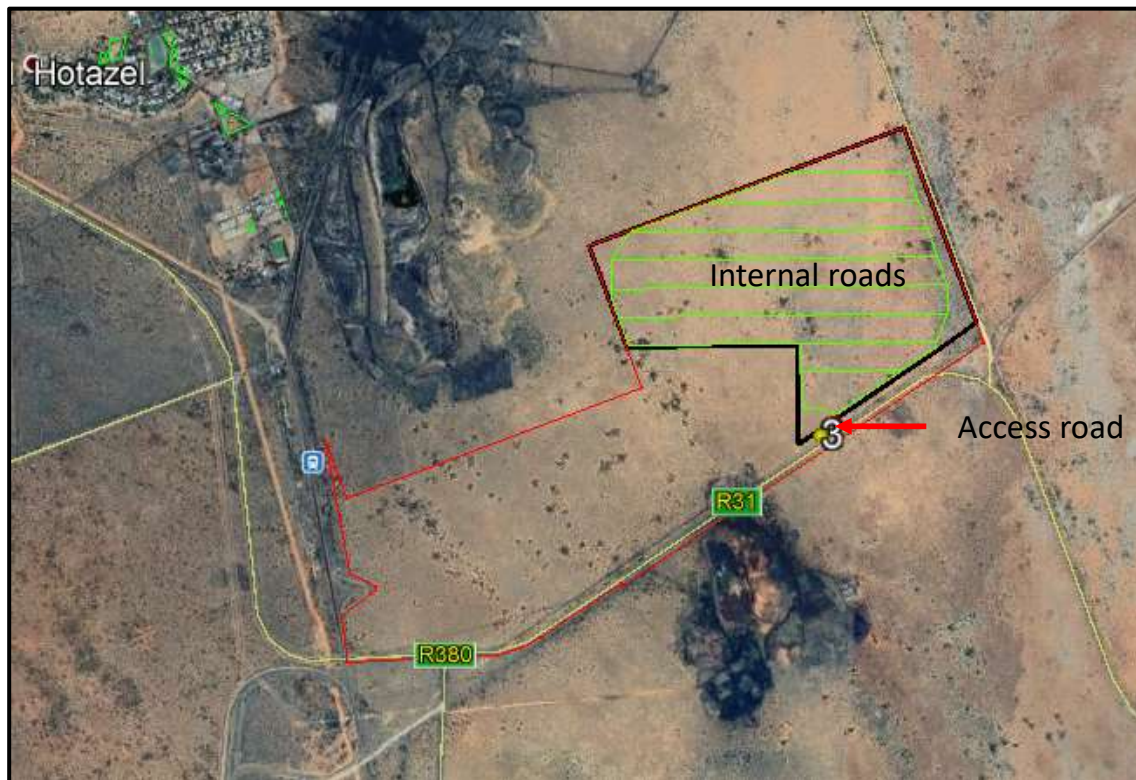
Figure 7: Access and internal roads

The dominant soil is a Clovelly 3100 with a soil depth of >1200 mm. The soil is valued as low potential, due to the low clay content (<10%), loose consistency of top and sub-soil and arid climate. Black thorn Acacia is prominent.

Precautionary measures must be taken to mitigate the risk of ground disturbances with the construction of the access roads. Attention should be given to drainage, water flow, erosion and the existence of *Acacia eriloba*.

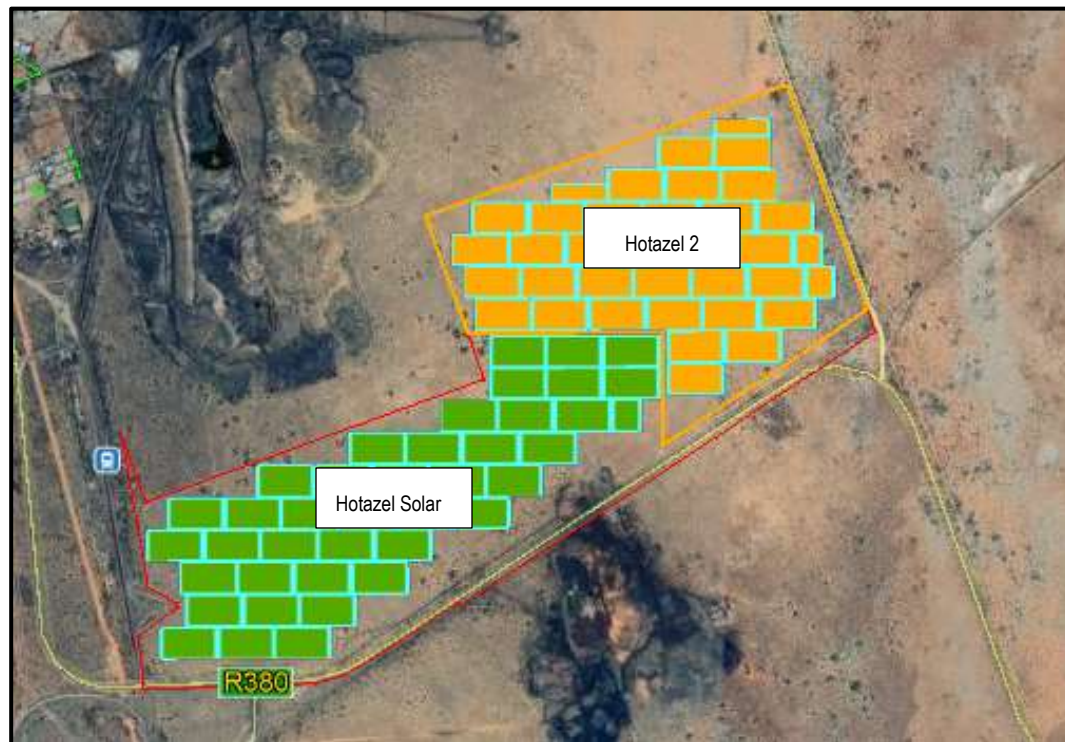
**Figure 10: Footprints of Hotazel Solar and Hotazel 2**

The loss of agricultural land has to be assessed with the knowledge that the entire farm (Remaining Extent of Farm York A 279) could be transformed, by the development of the proposed Hotazel 2 facility and the adjacent Hotazel Solar facility (Figure 10).
