**PROPOSED CONSTRUCTION AND OPERATION OF  
HOTAZEL 2, NORTHERN CAPE**

**AGRICULTURAL SCOPING REPORT**

**MAY 2020**

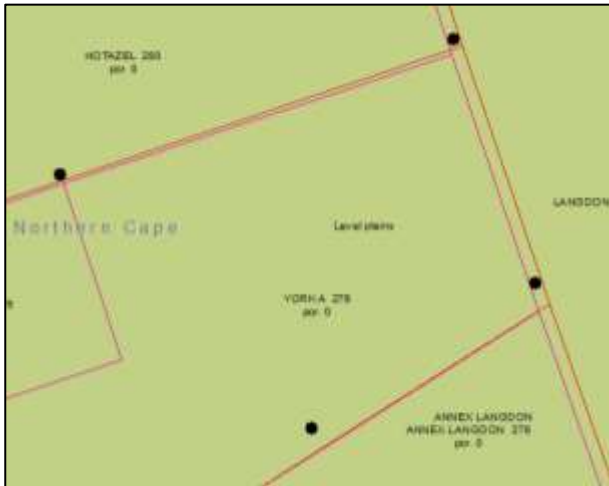
Terrain type: Level plains

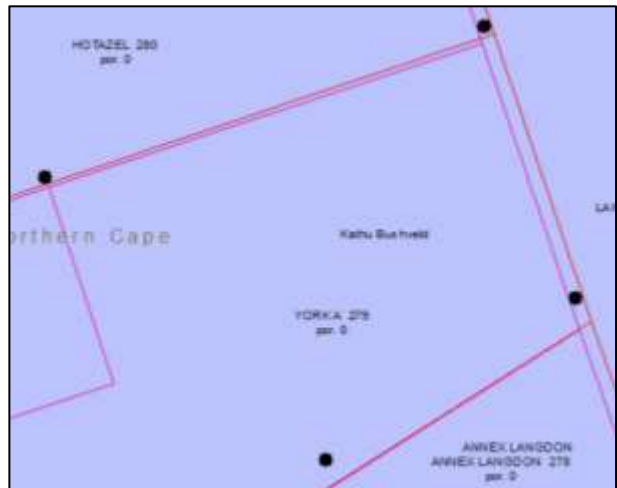
Vegetation type: Kathu Bushveld

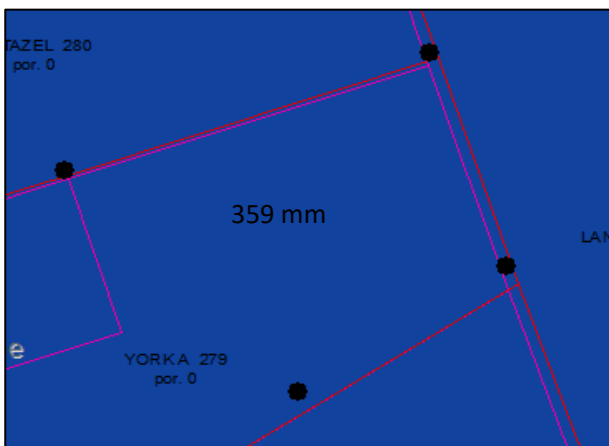
Annual rain fall: 359 mm

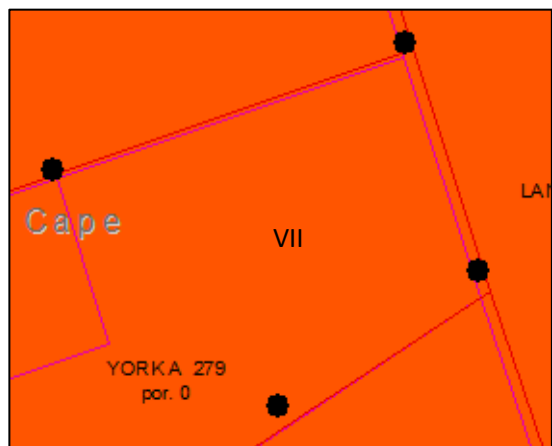
Land capability class: VII

The Land Type map in Figure 2 shows that the pedosystem **Ah 9** was allocated to the Remaining Extent (Portion 0) of Farm York A 279. This refers to red or yellow high base status soils >300 mm deep. The pedosystem is predominately located on a Footslope (95%) which has a slope gradient of less than 1 %. The dominant soil type predicted is an apedal, fine sandy textured soil with effective soil depth in excess of 1200 mm. Very low mechanical limitations are predicted.

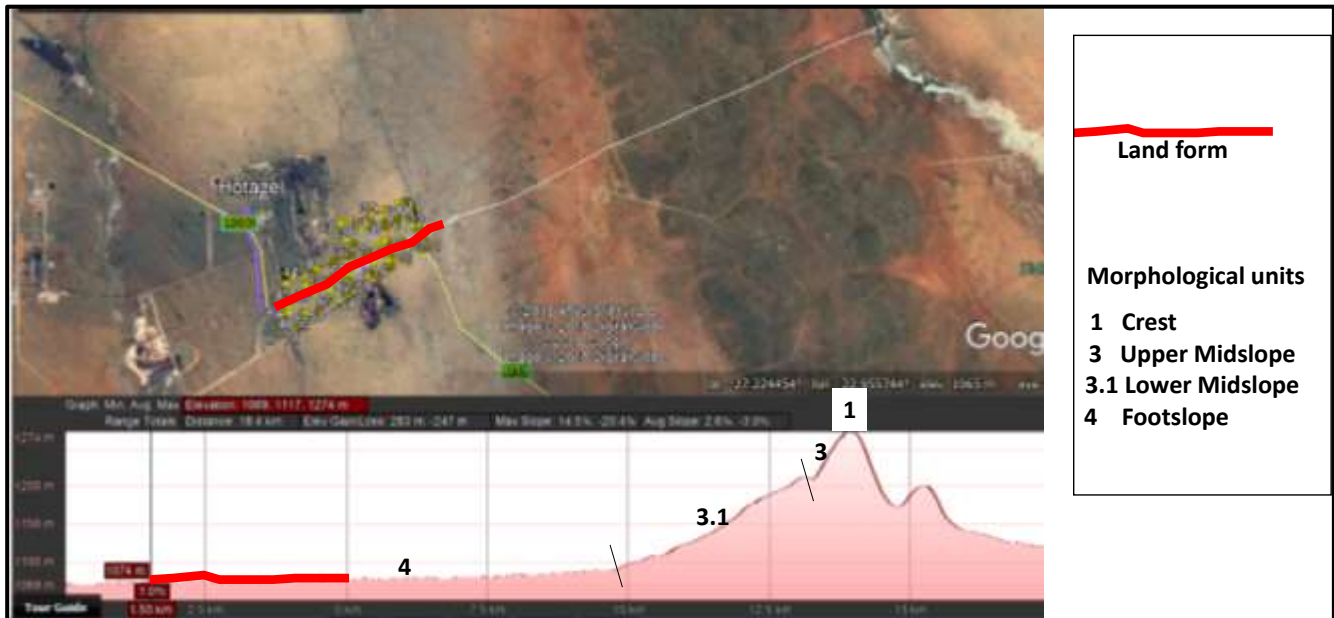
The cross section in Figure 3 provides information regarding the shape of the slope within the development footprint. It shows a straight shape for the foot slope (4).

Figure 3: Slope cross section.

This information is valuable when interpreting the land type data, as this will indicate what soil forms can be expected in each terrain unit. It is expected to find deeper soils on concave soils with water locked soils at foot slopes and valley bottoms.

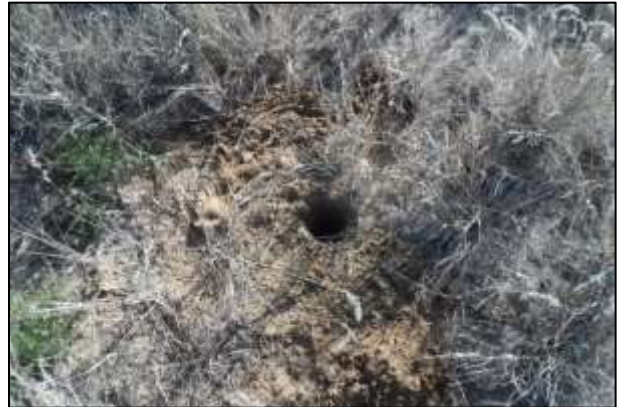
**Fernwood OBS 23**

A veld condition assessment, by visual acknowledgement, was conducted simultaneously with the soil survey. The photos in Figure 4 show the veld condition. The vegetation type is Kathu Bushveld (Savannah biome). The composition of the grazing varies from open grass with low to heavy encroachment of Black Thorn acacia (*Acacia mellifera*), as can be seen in Figure 4. Encroachment takes place when veld is over-grazed or where the soil has been disturbed.

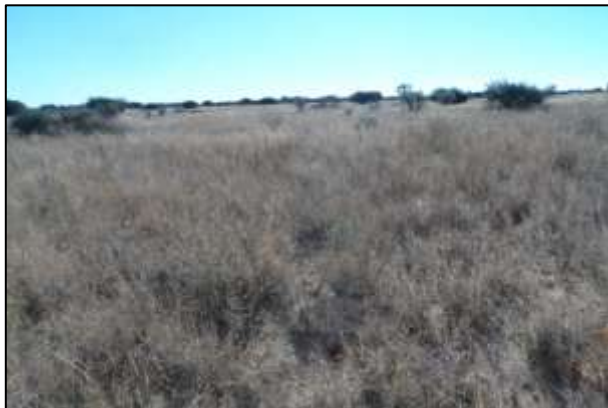
**Open savannah veld OBS 76**

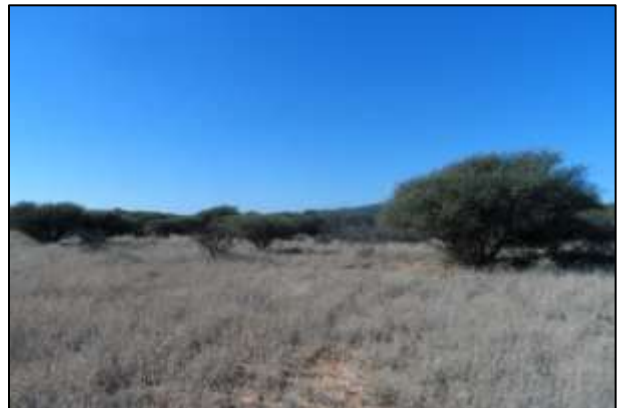
**Savannah with medium acacia OBS 08**

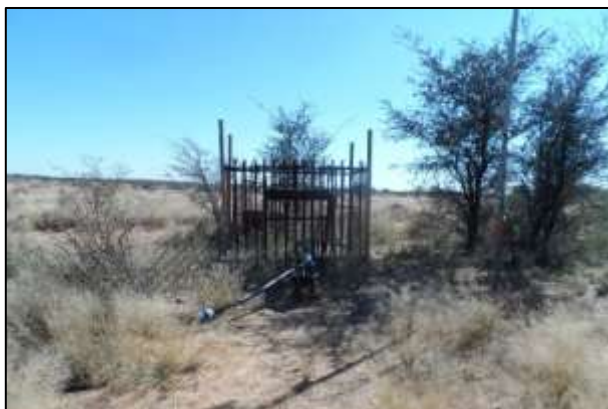
**Borehole and pump OBS 05**

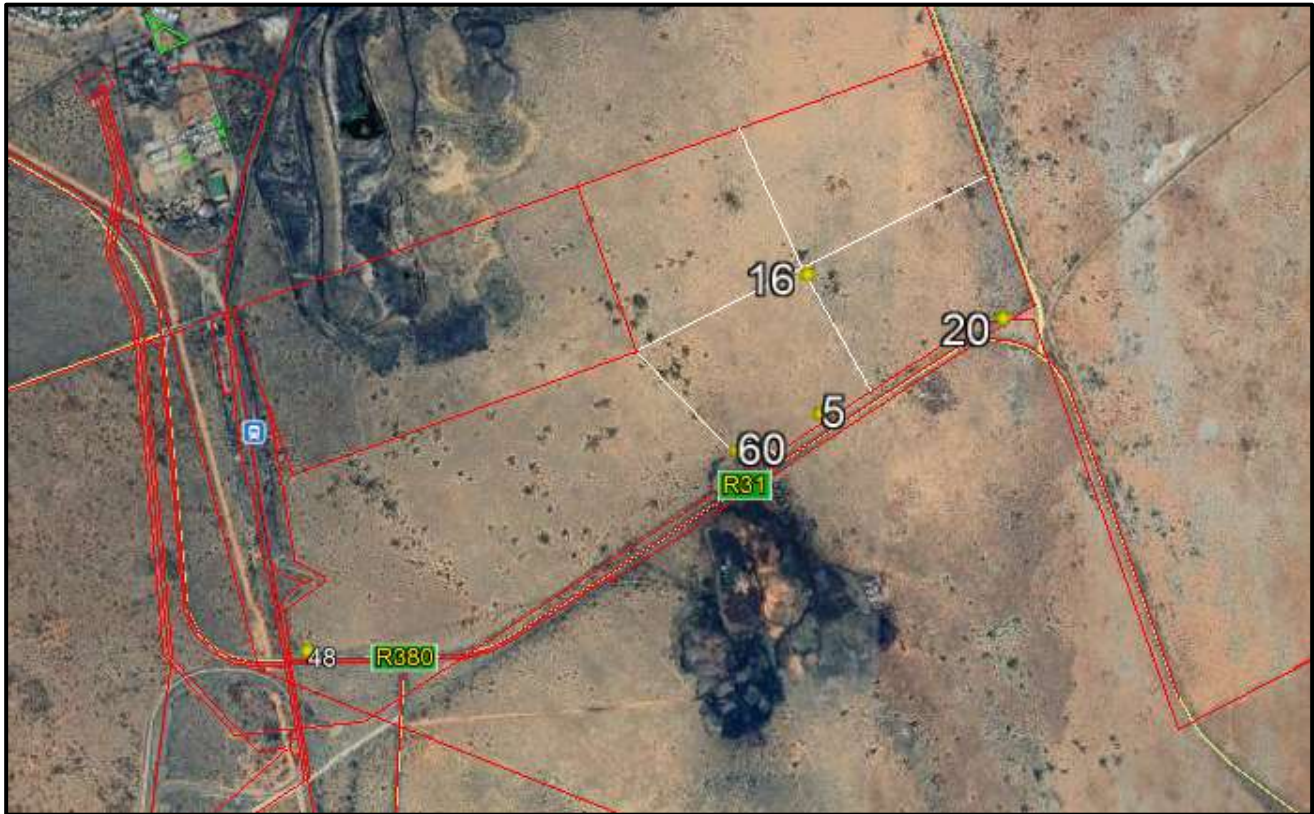
The farm is used for extensive grazing with cattle. The infrastructure, demonstrated in Figure 5, consist of a cattle handling facility at point 16, house and handling facilities at point 60 (not inside footprint) and internal fencing, shown as white lines. Point 5 marks the position of a borehole and pump. Point 20 shows the position where an antenna is erected as well as a windpump (not inside footprint). Red lines on the map represent existing transmission and railway lines traversing the farm as well as the cadastral boundaries.

Figure 5: Infrastructure on Farm

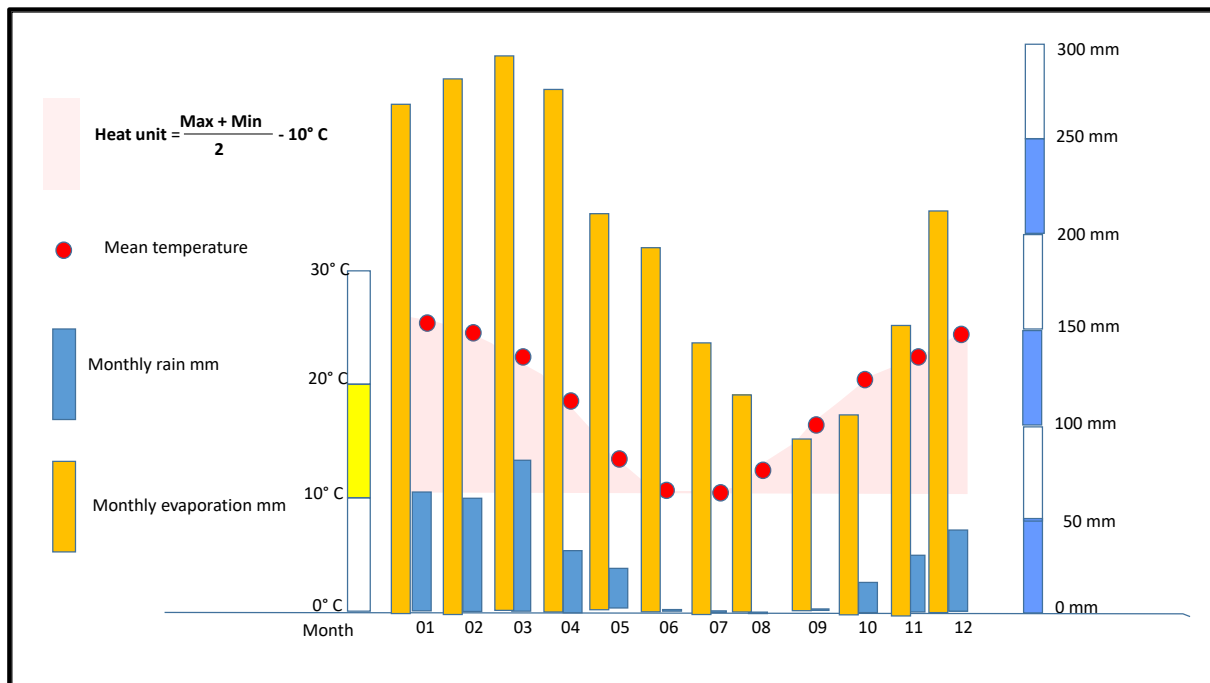
The climate conditions and their relation to soil properties and plant physiology, determine the agricultural capability of a specific land unit. The climatic conditions are shown in Figure 6.

Figure 6: Climatic conditions applicable on the proposed site

The growing season for a crop is determined by the available heat units and predicted rainfall.

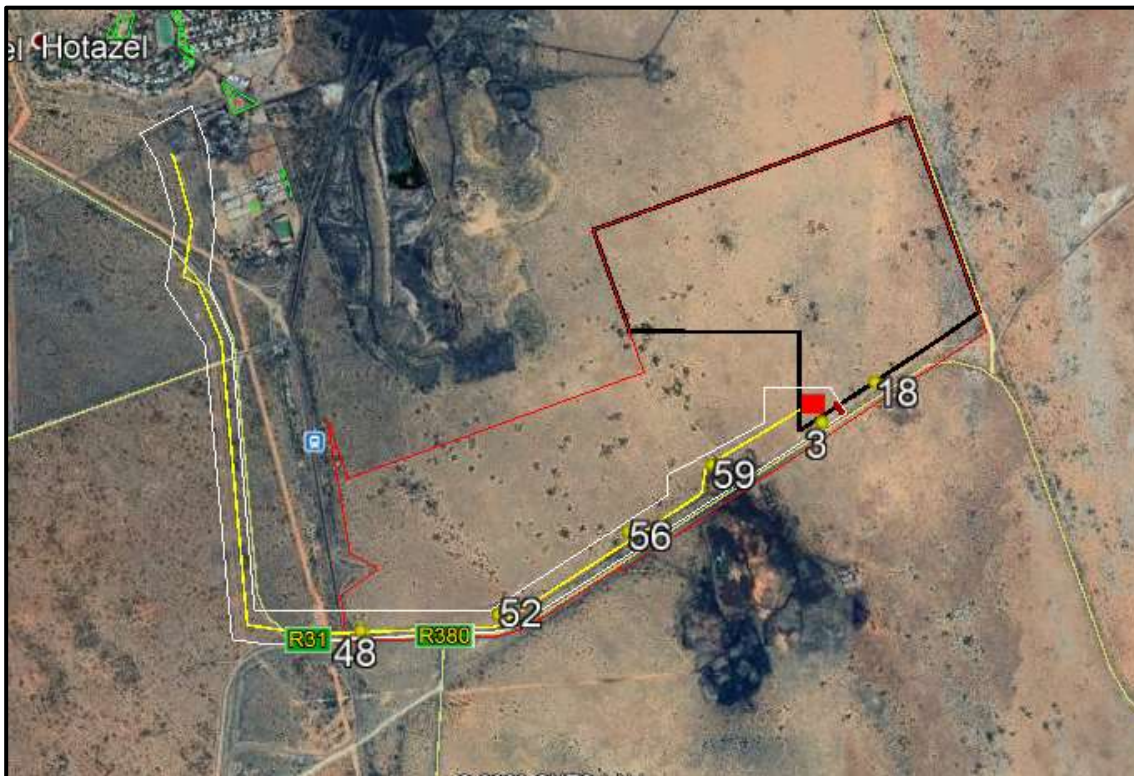
**Figure 8: Grid connection (with photo reference points) – The yellow line represents the indicative routing of option 1.**

**Option 3** is a ±1km overhead 132kV powerline from the Hotazel 2 on-site substation/ collector switching station to the Hotazel Solar collector switching station (which has undergone a Part 2 Amendment process). Option 3 follows the same corridor as Option 1, but only up until it reaches the Hotazel Solar collector switching station. The powerline will have a maximum height of 32m and a servitude width of between 31m and 36m.

All options of the overhead line will have a low impact on agricultural production, as grazing can continue and the lines are in a compact, narrow gauge.

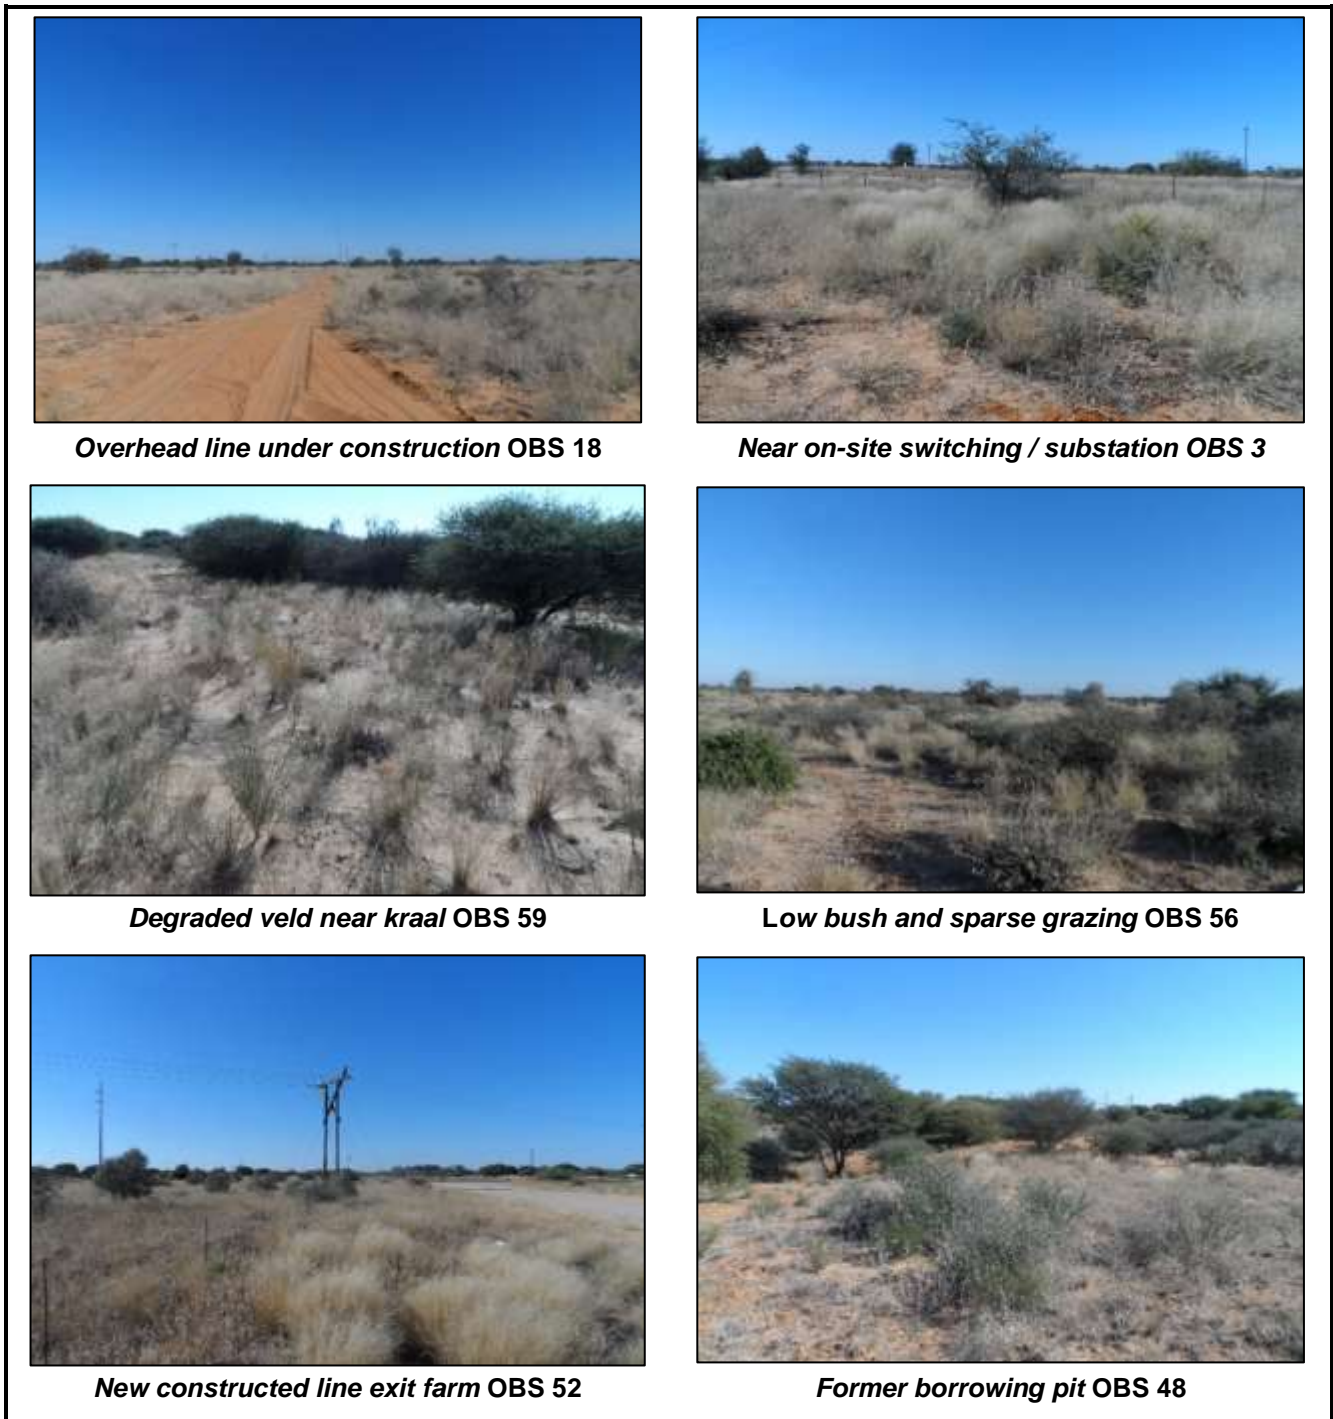
**Figure 9: Grid connection photos**

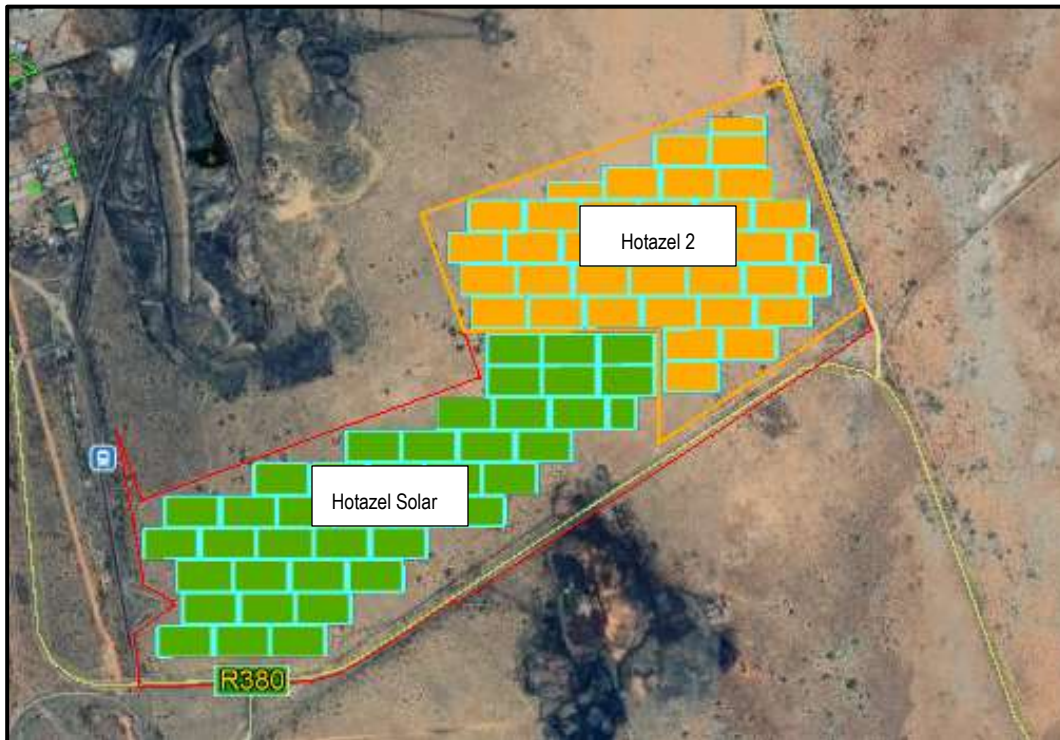
**Figure 10: Footprints of Hotazel Solar and Hotazel 2**

The loss of agricultural land has to be assessed with the knowledge that the entire farm (Remaining Extent of Farm York A 279) could be transformed, by the development of the proposed Hotazel 2 facility and the adjacent Hotazel Solar facility (Figure 10).

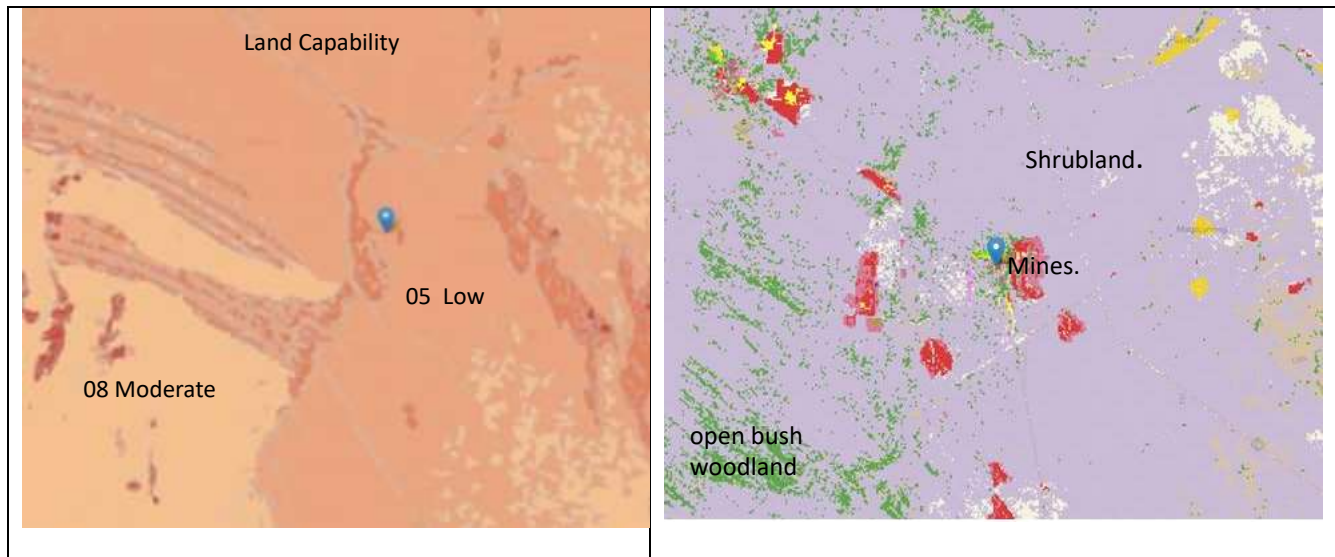
The two maps in Figure 11 show the land capability for agriculture and restrictions caused by mining activities and its supporting infrastructure in the immediate vicinity of the site.

**Figure 11: Land capability and landcover maps of the area (AGIS)**

The locality of the Remaining Extent (Portion 0) of Farm York A 279, fall in the Strategic Transmission Corridor Development zone. This is mainly because of the mining enterprises that surround it. The land capability is low with open bush, wood- and shrubland as the effective natural resources in an arid climate. There are no cultivated fields noted. The farm and its surrounding area are utilized as grazing for cattle. The Remaining Extent (Portion 0) of Farm York A 279, with a farm size of 636 ha and a carrying capacity of 13 ha /LSU, can only support 48 large stock units (LSU) with sustainable grazing, which does not qualify as an economical enterprise. The infrastructure associated with the mining activities, namely transmission and railway lines and roads confine the farm to a secluded entity.

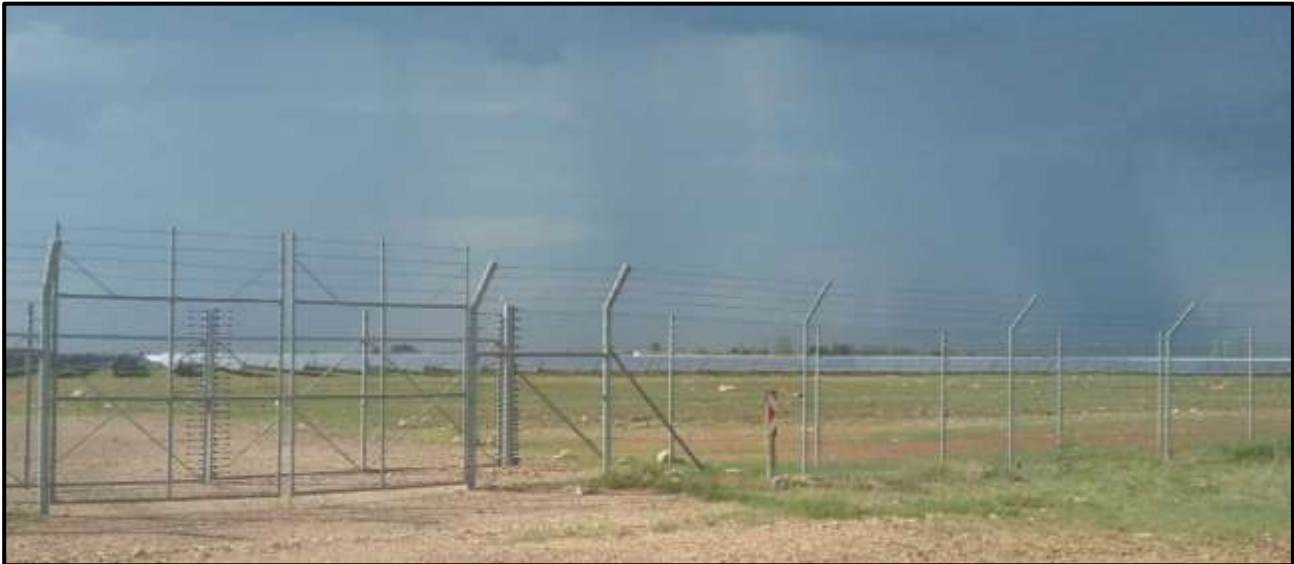
Figure 13: Completed facility

The region already has an industrial character because of the mining activities, railway infrastructure and electrical infrastructure. The increasing intensified farming methods influence the perspective on “agricultural character”. With their low height above soil level, the solar panels could be mistakenly perceived as a horticultural venture under shade net. If sheep were allowed to graze among the panels, the character would be close to agricultural.
