Municipal Approval

OSCAE APPLICATION FORM

New Primary Dwelling

Erf 222, Buffalo Bay, Knysna

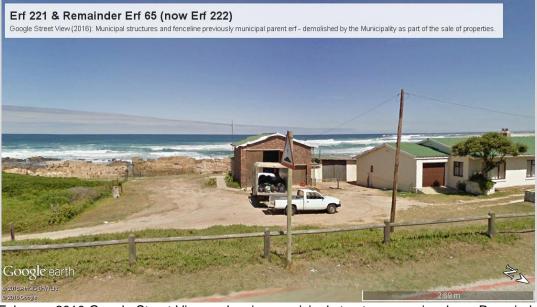
Figure 1: February 2010 Google Street View – showing municipal structures previously on Remainder of Erf 65 (middle) & Erf 221 (right) before properties were sold and buildings demolished by the Municipality. Driveway and disturbed area depicted to the left of the garage building aligns with the Encroachment Agreement area between the landowner of the Erf 222 and the Knysna Municipality.

The existing **gravel access driveway** off Main Road and parking, previously associated with the municipal infrastructure (visible on historical aerial image dated 2003 – see Figure 2 below), remain on the municipal property Erf 210 (neighbouring Erf 222) and it is the intention of the Applicant to drop (excavate) and **pave this existing area of driveway** to provide access to the proposed basement garage beneath the new dwelling on Erf 222, in terms of a signed / approved Encroachment Agreement with the Knysna Municipality. It is also the intention to re-instate a low bollard fence below this access driveway to reduce public vehicular access across the area considered under the Encroachment Agreement, directly adjacent to Erf 222 (see Area labelled ABCD in Appendix C) – for security and privacy purposes.

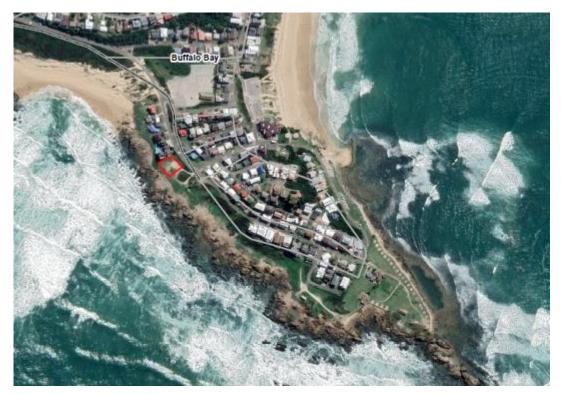
Figure 2: Aerial image of Buffalo Bay coastal headland, indicating location of Erf 222 (image courtesy of Google Earth Pro, 2021).

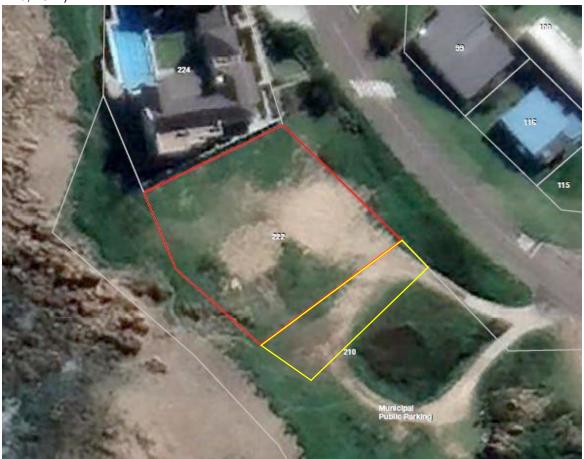
Figure 3: Aerial image indicating Erf 222 (red polygon) & neighbouring property cadastral boundaries (courtesy Google Earth Pro, 2021). Yellow polygon indicates approx. portion of Erf 210 under Encroachment Agreement.

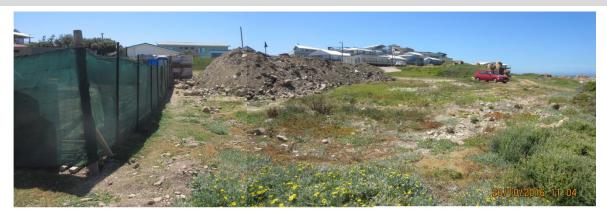
During October – December 2016, Erf 222 was used as a stockpile site for the neighbouring construction site on Erf 224. Erf 222 located between shade-net fence and red car in photo (Oct.2016).

Figure 4: Landscape view of Erf 222 from SW corner of property. Note Gazania sp.& Arctotis sp. in foreground and disturbed condition of remainder of property (photo dated October 2016).

Erf 222 is highly transformed due to previous & current landuse – Municipal storage & maintenance depot; followed by demolition of buildings and fenceline in early 2016; used as a stockpile site / material laydown area for neighbouring construction site (Erf 224) at the end of 2016; and most significantly, being traversed by the public and vehicle to access the coast. Therefore, very little Dune Fynbos or Thicket vegetation remains on the property. Ground creepers plants and grasses appear to be the dominant plant species noted on the property and include *Gazania sp., Falkia sp., Carpobrotus sp., Arctotis sp.* and small succulent plants.

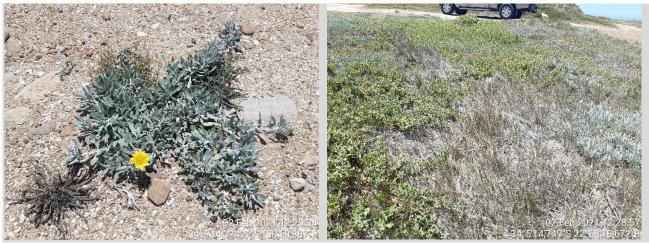
Figure 5: Gazania, grass & Arctotis groundcovers growing on periphery of erf.

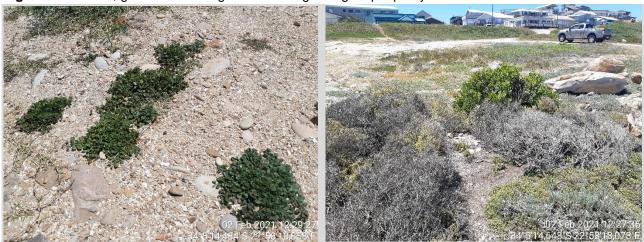
Figure 6: Falkia & dead brush growing on the coastal side of the erf. A single Cape Saffron bush (Cassine peragua) noted in 2m setbackline.

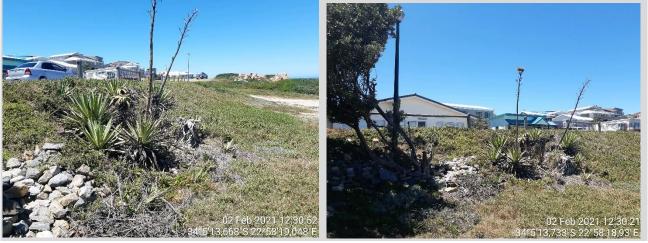
Figure 7: Stand of exotic Agave cactuses & a New Zealand Christmas tree within road reserve beyond northwestern corner of erf.

An exotic New Zealand Christmas Tree (*Metrosideros excelsa*) is located within the road reserve of Main Road beyond the north-western corner of the property. Much of this area of the road reserve above the property has been subject to illegal dumping of garden refuse, resulting in the establishment of a stand of *Agave sp.* cactuses, among the ground covers and grasses mentioned above.

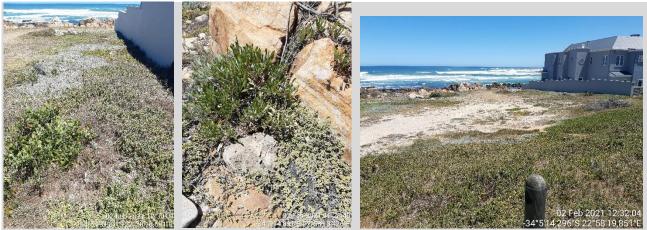
Figure 8: Groundcovers & small succulents growing on property.

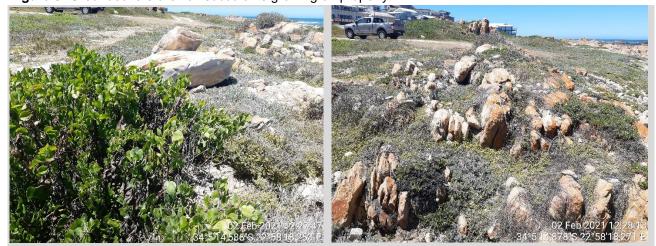
Figure 9: Cape Saffron & succulents growing among rocky outcrop within 2m building line / setback line on seaside of erf.

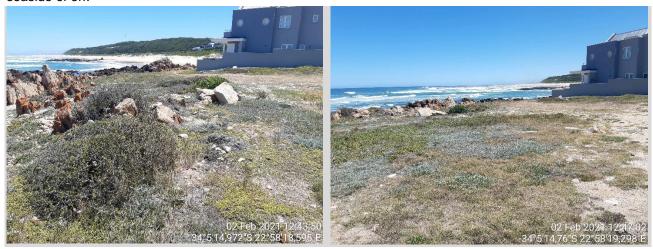
Figure 10: View west across 2m coastal building line / setback line. House on Erf 224 noted in background. A small island of remnant thicket vegetation occurs on the neighbouring municipal Erf 210 to the south-east of the Erf 222 *albeit* disturbed by vehicle and pedestrian trampling to gain access coastline and braai area.

This small island of Thicket contains wind-swept Rooikrans (*Acacia cyclops*), Milkwood (*Sideroxylon inerme*), Baboon Grape (*Rhoicissus digitata*), Cape Saffron (*Cassine peragua*), Cape Coastal Cabbage Tree (*Cussonia thyrsiflora*); Bitou (*Chysanthemoides monilifera*) etc.

None of this disturbed Thicket vegetation on Erf 210 will be removed or damage during the excavation and paving of the existing access road or construction of the house on Erf 222.
