AQUATIC BIODIVERSITY IMPACT ASSESSMENT
Proposed Establishment of the Diepwalle Tented Forest Camp

Prepared for Cape EAPrac

Updated in January 2024 to include revised and final Site Development Plan.

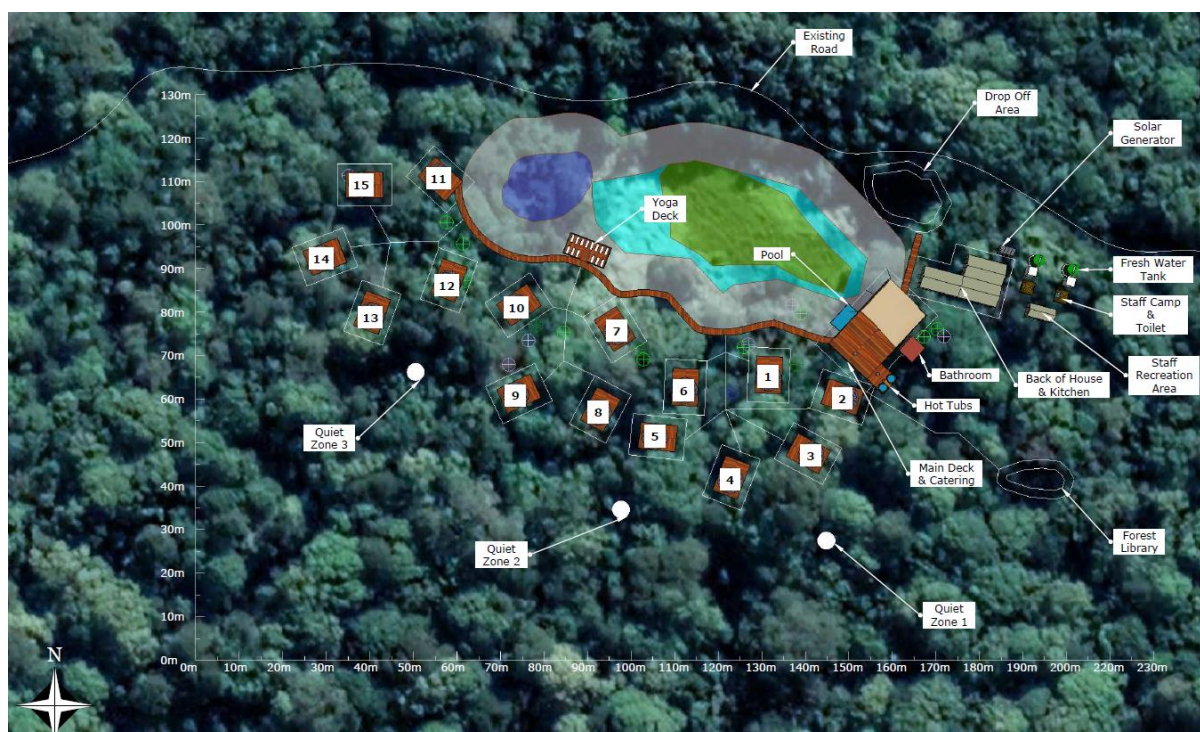
Figure 1. Conceptual layout of the camp at the clearing site.

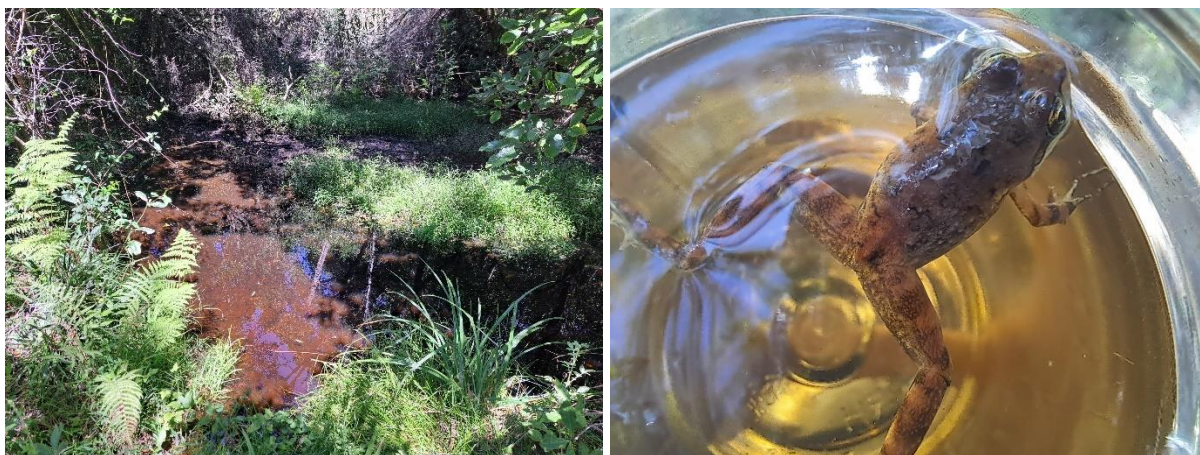
Figure 5. The excavated pool (left) and a Cape River Frog (*Amietia fuscigula*) found in the pool.

The pool has been excavated and is therefore considered artificial and is not classified as a watercourse in terms of the NWA. However, as it has been present at the site for many decades, possibly over a century, and has attracted a range of hydrophytic (water loving)

plants and a population of at least two frog species. These are Cape River Frogs (*Amietia fuscigula*) and Clicking Stream Frogs (*Strongylopus grayii*). Given its location in a National Park and priority conservation area these are features which contribute to biodiversity in the area and warrant protection from disturbance.

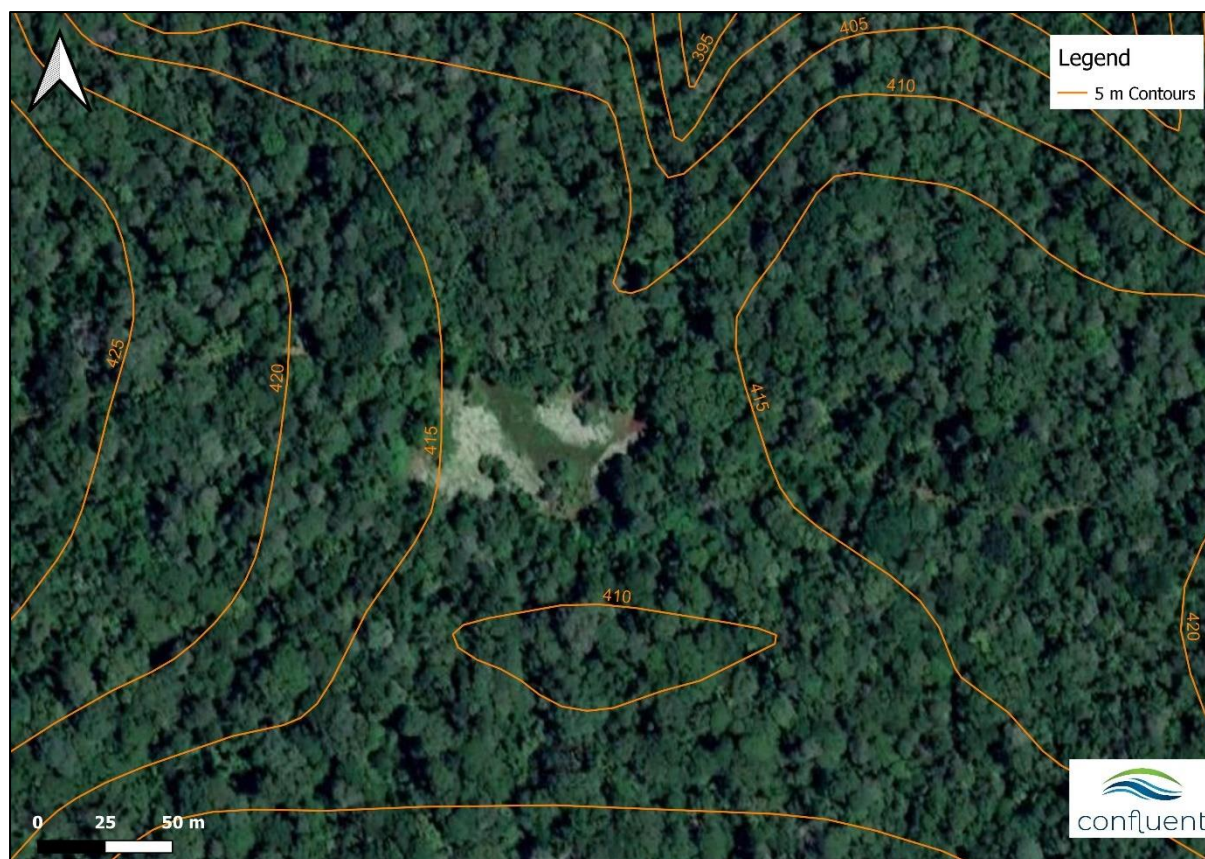
Figure 6. 5m contours at the site showing the clearing position described as a saddle.

Extensive soil augering along transects in the clearing resulted in a range of seasonal and temporary wetland features. No permanent wetland areas were found. There is no channelled inflow or outflow from the wetland. The site topography and soils mean the soil profile is easily saturated which is due to the B soil horizon demonstrates a distinct textural change, with extreme mottling and wetness below this zone. This is typical of duplex soils in the area. The topographic location of the seep wetland is a 'saddle' (Figure 6) which is defined by Ollis *et al.* (2016) as follows:

“Saddles are relatively flat, high-lying areas flanked by down-slopes on two opposite sides in one direction and up-slopes on two opposite sides in an approximately perpendicular direction. The gradient of the surrounding slopes may vary from gentle to steep.”

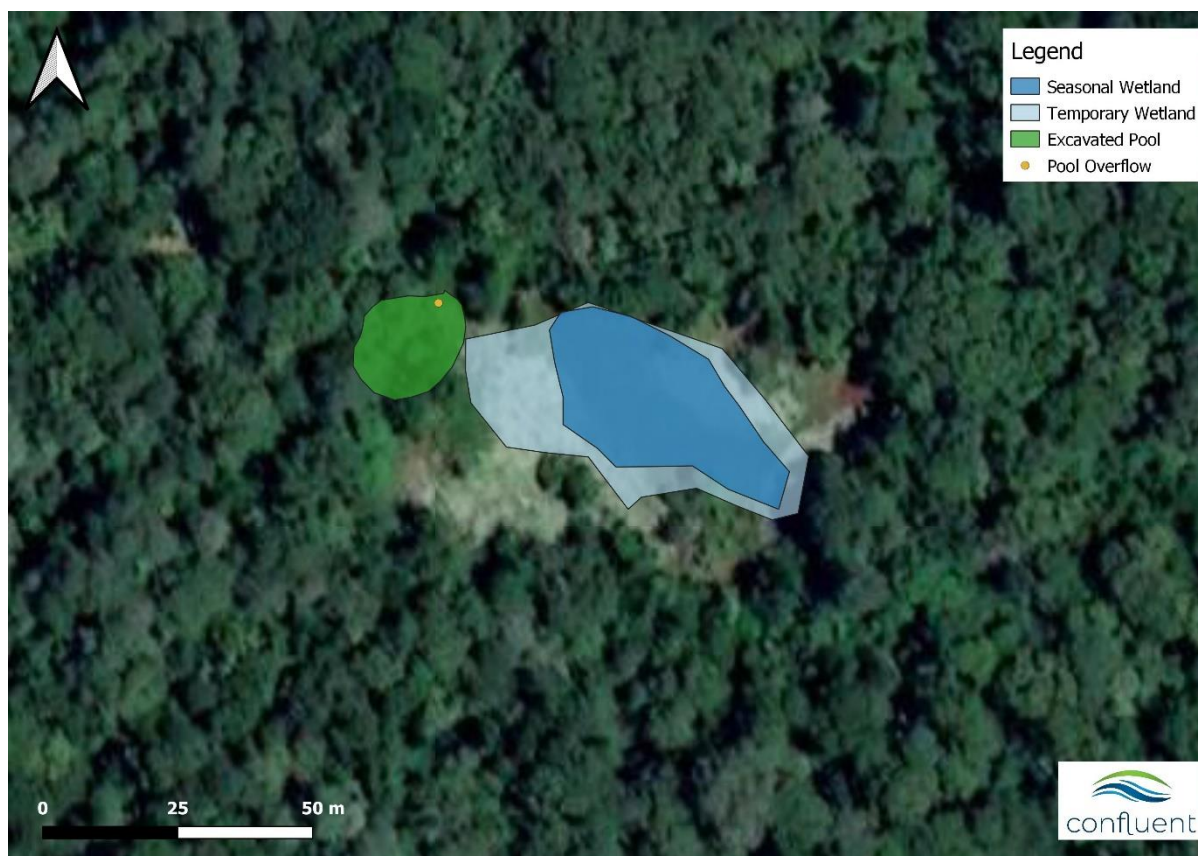
Figure 8. Delineated seasonal and temporary wetland areas, and excavated pool in the clearing area.

Soil augering across the clearing showed two distinct zones of wetness, being temporary and seasonal (Figure 8). These approximately corresponded with two zones of dominant vegetation being *H. petiolare* in the temporary zone and *H. cymosum* in the seasonal zone (Figure 9). However, these plants were interspersed throughout with alien invasive bramble (*Rubus* sp.) and bracken fern (*Pteridium aquilinum*). While these plants are not obligate or facultative wetland plant species, *H. cymosum* often grows in damp areas and is common in seasonal wetlands of the Southern Cape. Most plant species present in the clearing are considered pioneer species which grow rapidly following disturbance.

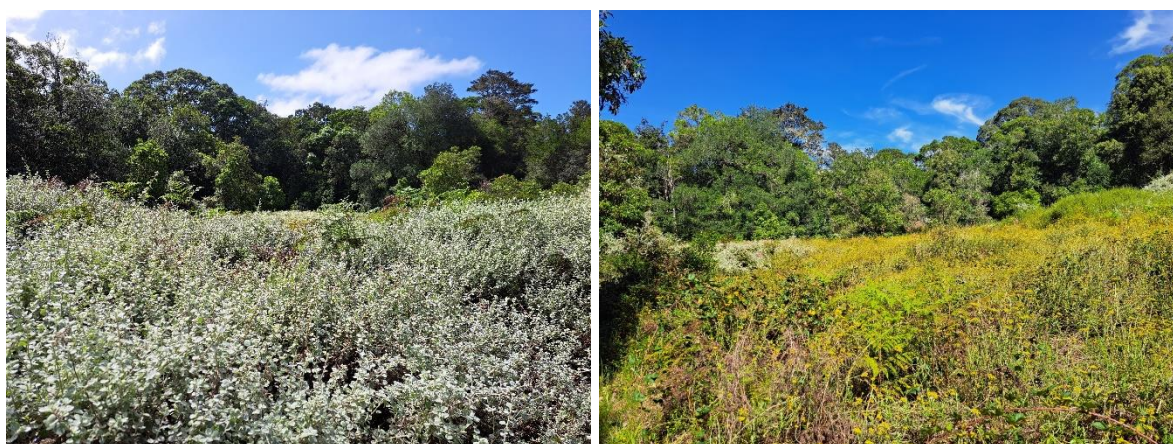
Figure 9. Two aspects of the clearing showing dominant *Helichrysum petiolare* (left) and *Helichrysum cymosum* (right).

Plants in the clearing have grown to such a high density that the process of succession appears to have been halted. In places the growth of *H. petiolare* is > 2 m high. Plants growing along the wetland's edge adjacent to the road are more diverse and typical of obligate wetland plants consisting of species such as *Juncus lomatophyllus*, *Persicaria decipiens*, and various *Cyperus* spp.

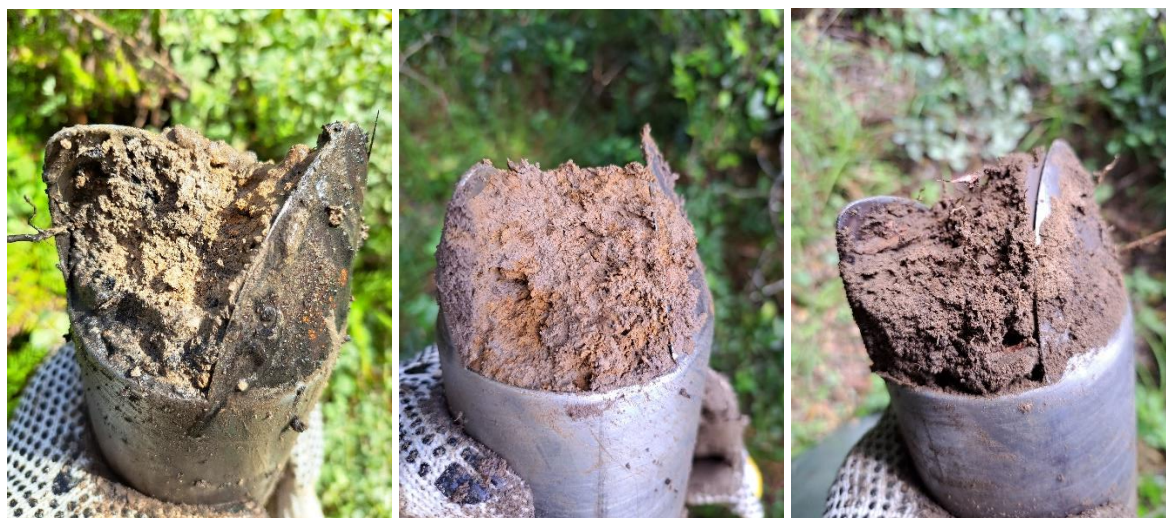
Figure 10. Typical soil auger samples from seasonal (left), temporary (middle) and non-wetland (right) areas of the clearing. All soils are collected within the upper 50 cm of the profile.

Soils in the wetland area had a thin layer of organic matter on the surface but were predominantly mineral (Figure 10). Soils in the temporary zone of the wetland showed few high chroma mottles within the brown soil matrix. The temporary zone is defined by short

periods of saturation for a duration of less than 3 months per year. The seasonal zone of the wetland showed grey-brown soil with many high chroma mottles and gleyed areas. The seasonal zone typically has a significant wet period for at least 3 months per year.

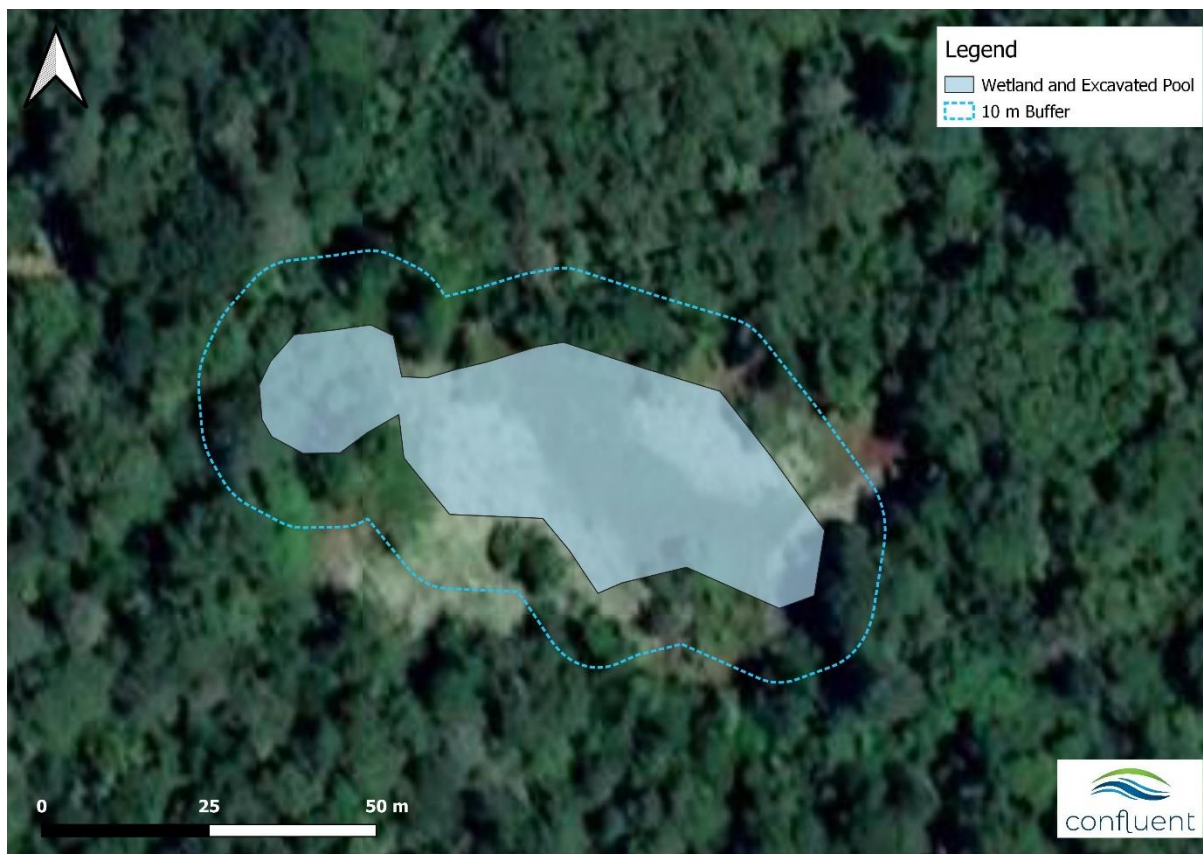
A buffer of **10 m** is recommended around the wetland area and excavated pool. This buffer is considered a management setback line within which various activities are either supported or discouraged. The proposed tented camp represents a very low risk to the wetland area and the access road already runs through the buffer area of the wetland. It is therefore not considered a complete no-go area.
