# **DRAFT Environmental Audit Report**

## **Gondwana Game Reserve**

In terms of the  
National Environmental Management Act (Act No. 107 of 1998, as  
amended) & 2014 Environmental Impact Regulations

**Date:** 12 November 2018

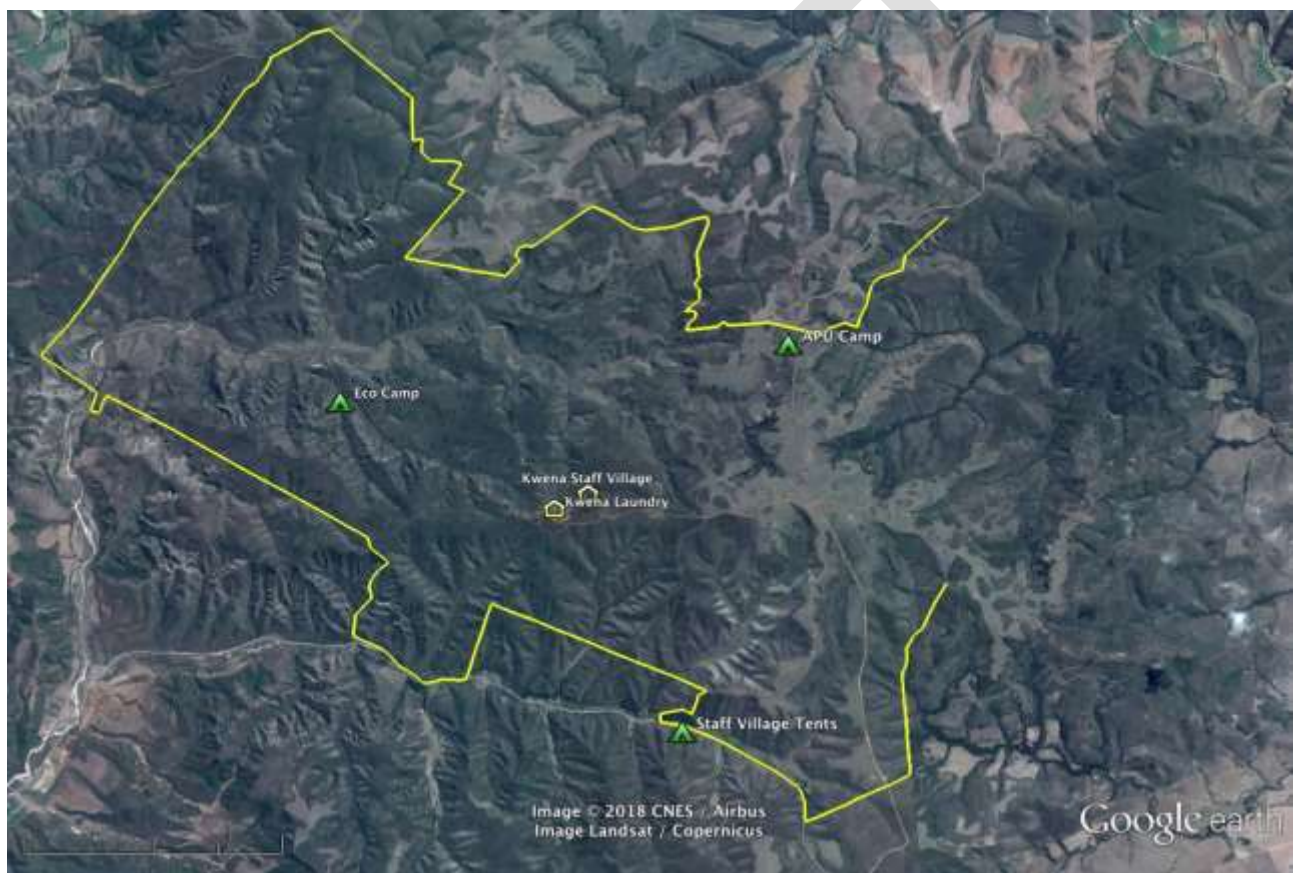
**Figure 2:** Showing structures built on Gondwana Game Reserve that are not reflected on the general plan for GGR.

A number of additional structures not reflected on the General plan for GGR were identified as part of this audit.

For the purposes of this environmental audit, only structures constructed on the areas zoned as open space IV are discussed as these have implications in terms of EA compliance.

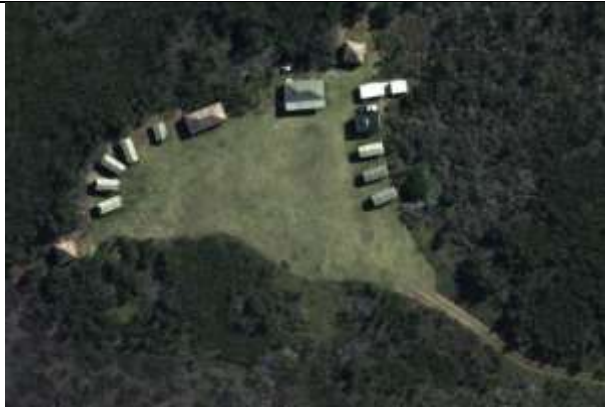
**Figure 3:** High resolution aerial image of the anti-poaching training facility on GGR.

The anti-poaching training camp is situated in an area surrounded by dense stands of alien invasive vegetation. It is situated on an area that was previously disturbed farm lands (not within one of the natural areas). The establishment thereof is not in contravention of condition 6 of the EA.

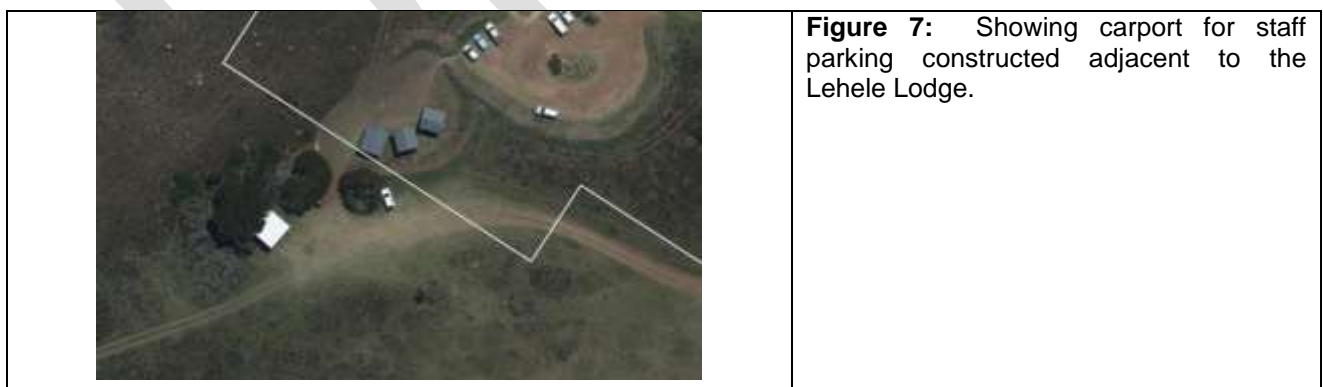
### 7.2.3 Carport - Lehele Lodge

A carport for staff parking associated with Lehele Lodge has been constructed. Although directly associated with the lodge, it has been constructed outside of the Resort Zone 1 erf (376/98).

The construction of this carport outside of the Resort Zone 1 Erf is thus in contradiction to condition 17 of the EA. It is recommended that GGR move the carport to within the Resort Zone erf (33m to the East).

The position of this carport is however situated on one of the previously fallow lands and as such is not in contravention with condition 6 of the EA.

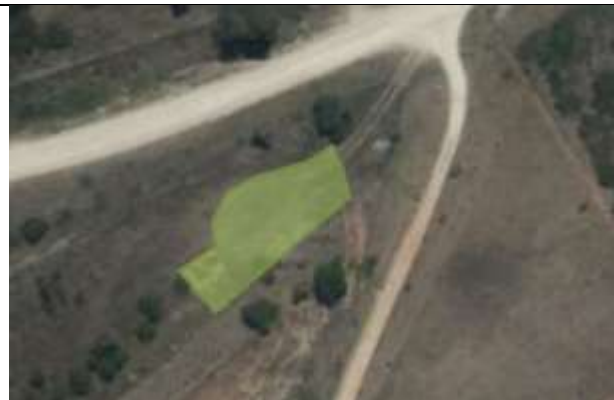
**Figure 10:** Showing area outside the Reserve, where GGR commenced with the establishment of a vegetable garden.

GGR began to establish a vegetable garden on an area outside of the Reserve, but on an area still zoned for Open Space IV. This project was however abandoned when a neighbouring landowner lodged a complaint with DEA&DP compliance and enforcement.

The intent of this vegetable garden was to provide opportunities of unemployed family members of GGR employees to contribute towards their own food security and to possibly generate an income into the future.

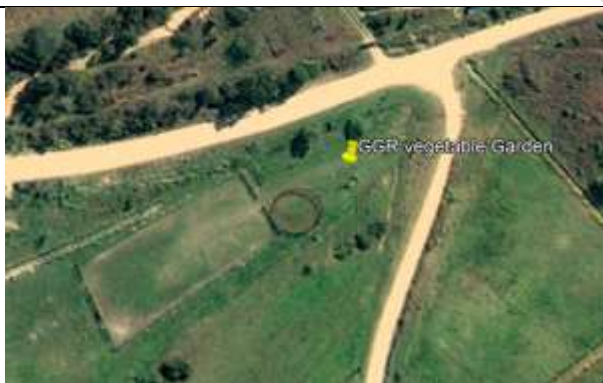
**Figure 11:** 2009 Aerial imagery showing agricultural infrastructure at the position of the vegetable garden

This area was historically used for agricultural purposes as can be seen from paddocks present on historical aerial imagery as well as the the presence of irrigation piping and terracing on the area.

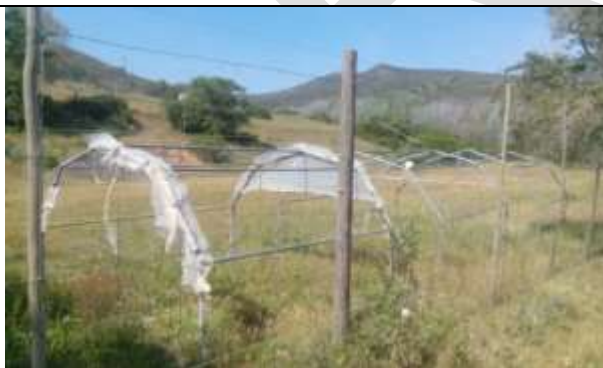
**Figure 12:** Showing current state of the area where GGR commenced with the establishment of a vegetable garden

The establishment of a vegetable garden at this position is not in contravention of conditions 6 or 17 of the EA. The affected area is approximately 500 square metres and does not contain indigenous vegetation as defined in regulation 324. Activities 12 and 15 in listing notice 3 are not triggered by the establishment of this vegetable garden. It is therefore the finding of this Audit report that GGR be allowed to continue to establish this vegetable garden at its current position on condition that removal of indigenous vegetation does not take place.

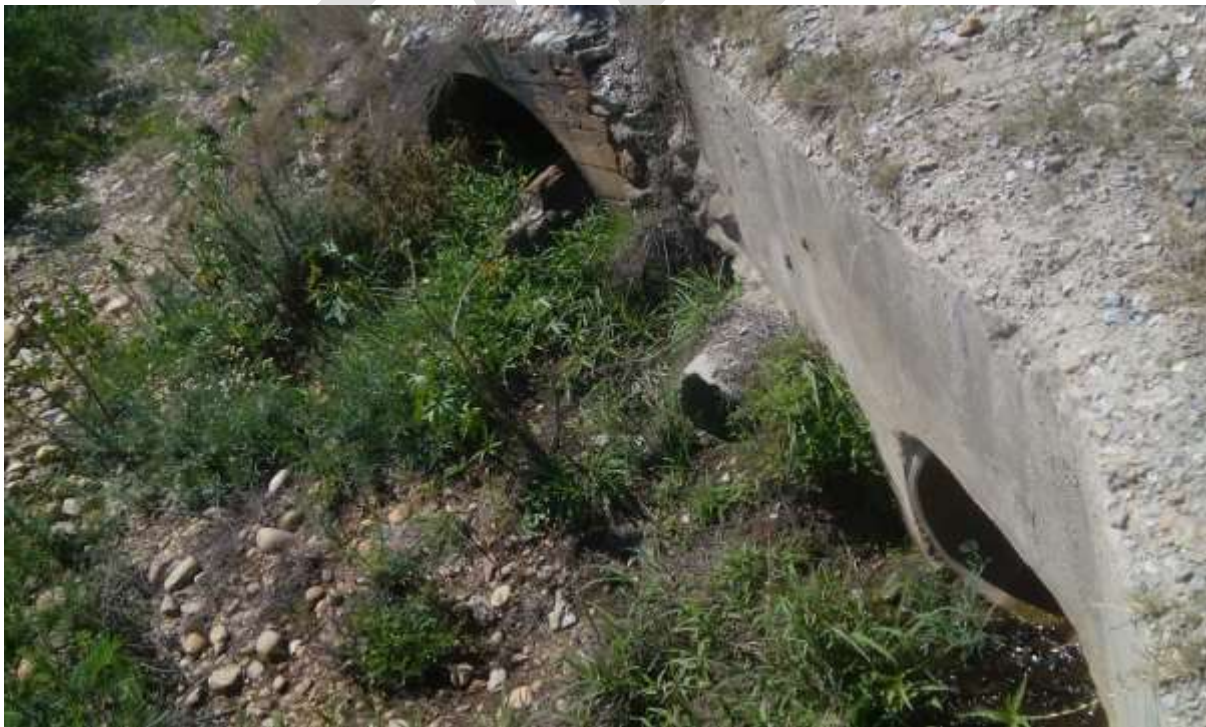
**Figure 13:** Showing culvert (1x Armco and 2 x concrete pipes) that blocked and caused flooding of adjacent land on GGR.

During the floods of 2006, a blocked culvert along the Provincial Road caused water to overtop the road and flood an adjacent field on the GGR and other properties. This resulted in the formation of a significant erosion gulley across this portion of property.

During these flood conditions, the water moved as overland flow and started to form an erosion gulley approximately 97m from the edge of this unnamed watercourse.

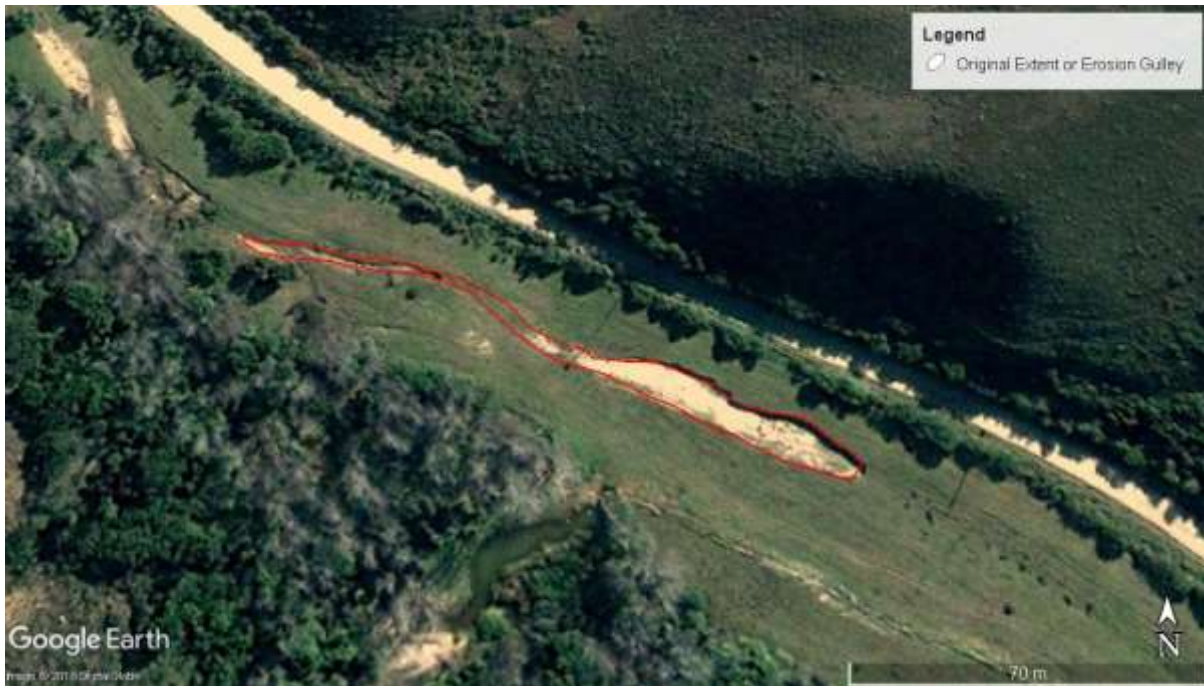
**Figure 14:** Showing original extent of erosion gulley on GGR (Aerial Image 2009)

The original extent of the erosion gulley is clearly visible on the 2009 Aerial Image.

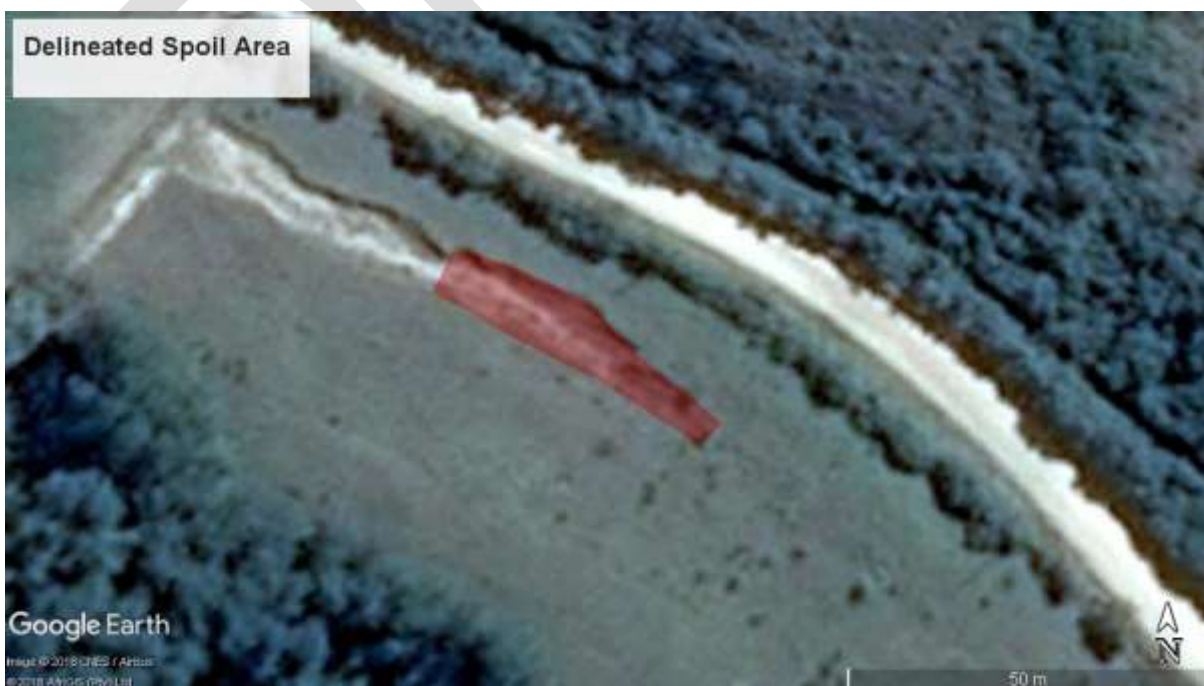
**Figure 15:** Delineated spoil area on 2016 Aerial Image

The area where waste (and other material) was disposed to land was delineated by Cape EAPrac. The delineated area is approximately 45m long and approximately 7m wide at its widest point. The depth of infill is approximately 1.1m deep at its deepest (although this depth tapers shallower relatively quickly from the center point of the original erosion channel. The measured delineation is 331m<sup>2</sup>.

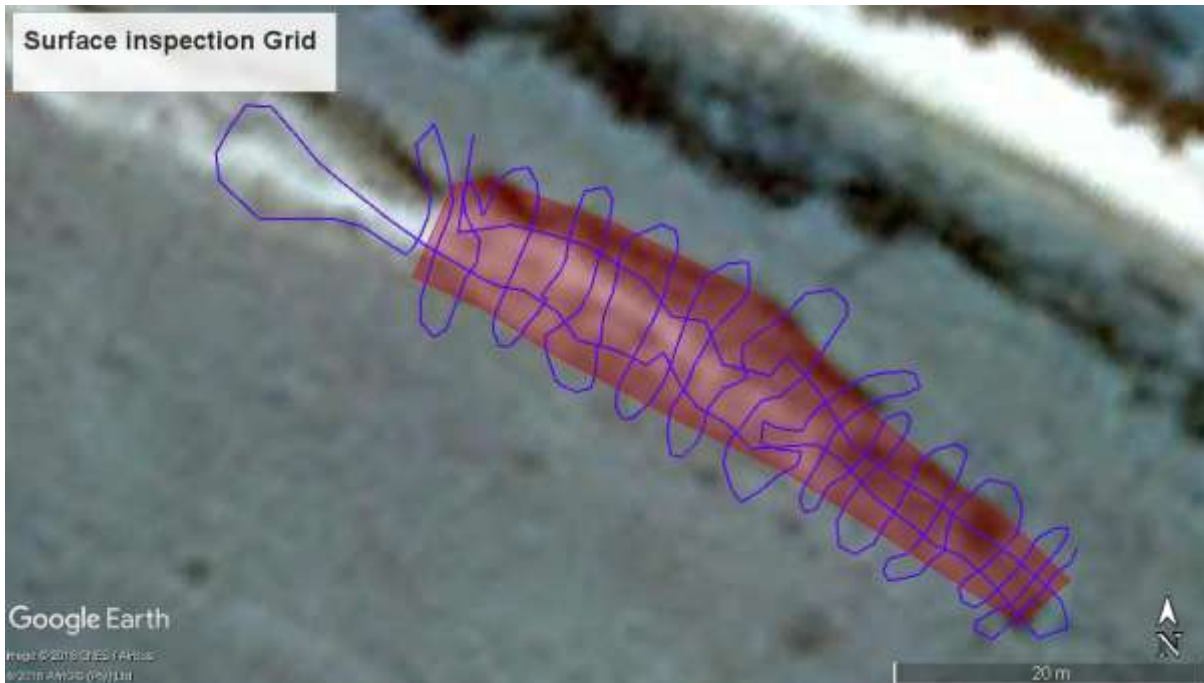
**Figure 16:** Showing grid walked to determine the presence of any waste on the surface of the delineated spoil area.

In order to determine the presence of any remaining asbestos contaminated building rubble (as GGR had already removed the asbestos containing waste from this area), Cape EAPrac undertook a surface inspection of the delineated area and surrounds. A grid of the total delineated area was walked to ensure the entire area was covered.

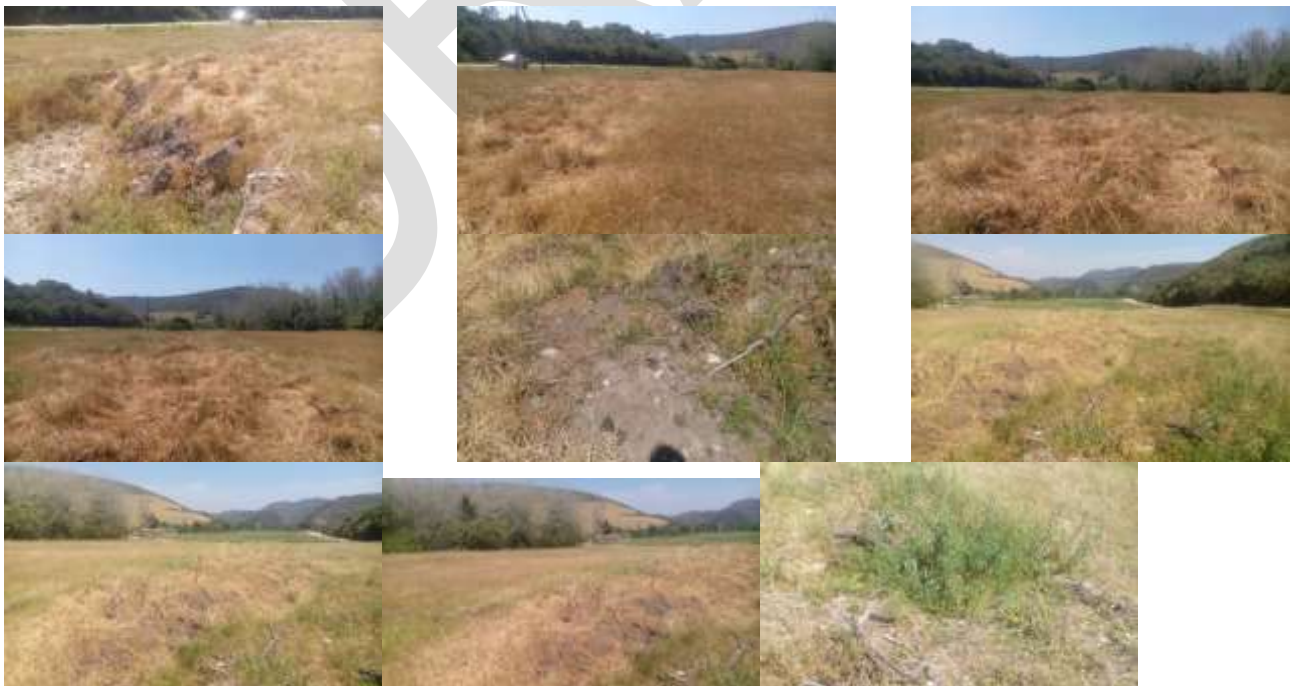
**Figure 17:** Photographic examples of typical surface conditions of delineated spoil area.

During the surface inspection, no building rubble, nor asbestos waste was observed on the surface as can be seen in the typical photos of the current condition of the delineated area.

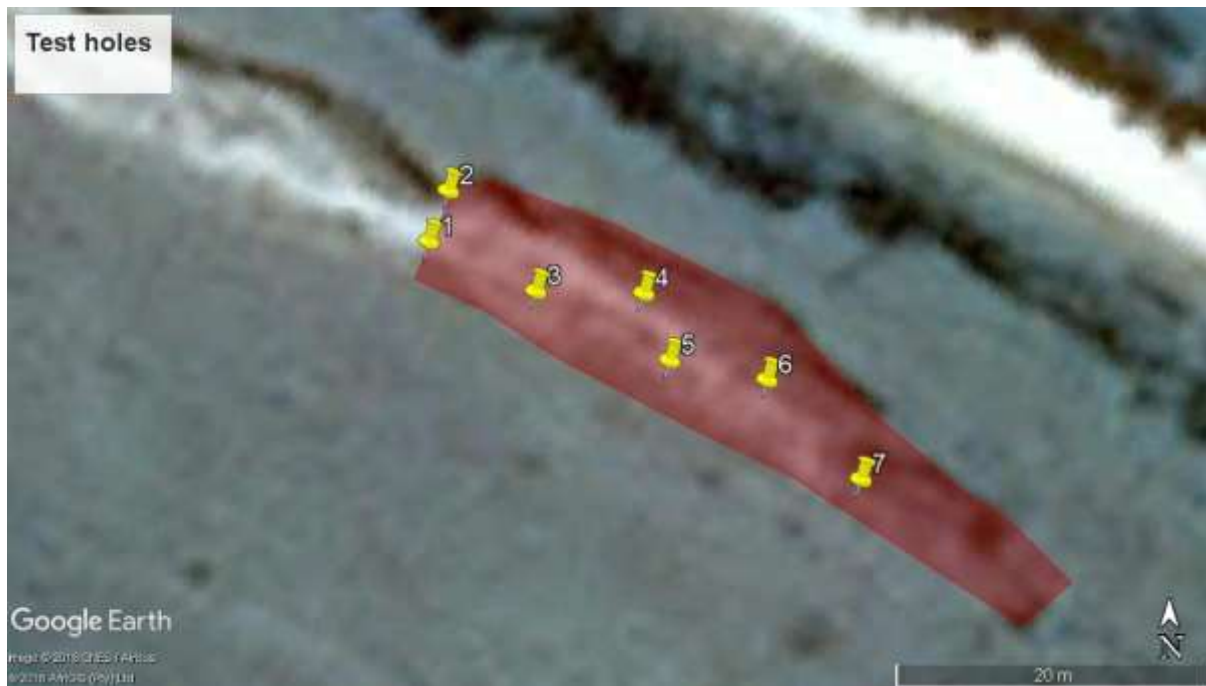
**Figure 18:** Position of trial holes dug to determine the presence of sub-surface waste.

Further to the surface inspection the existing fill profiles were inspected and a number of trial holes were dug to determine the presence of subsurface waste.

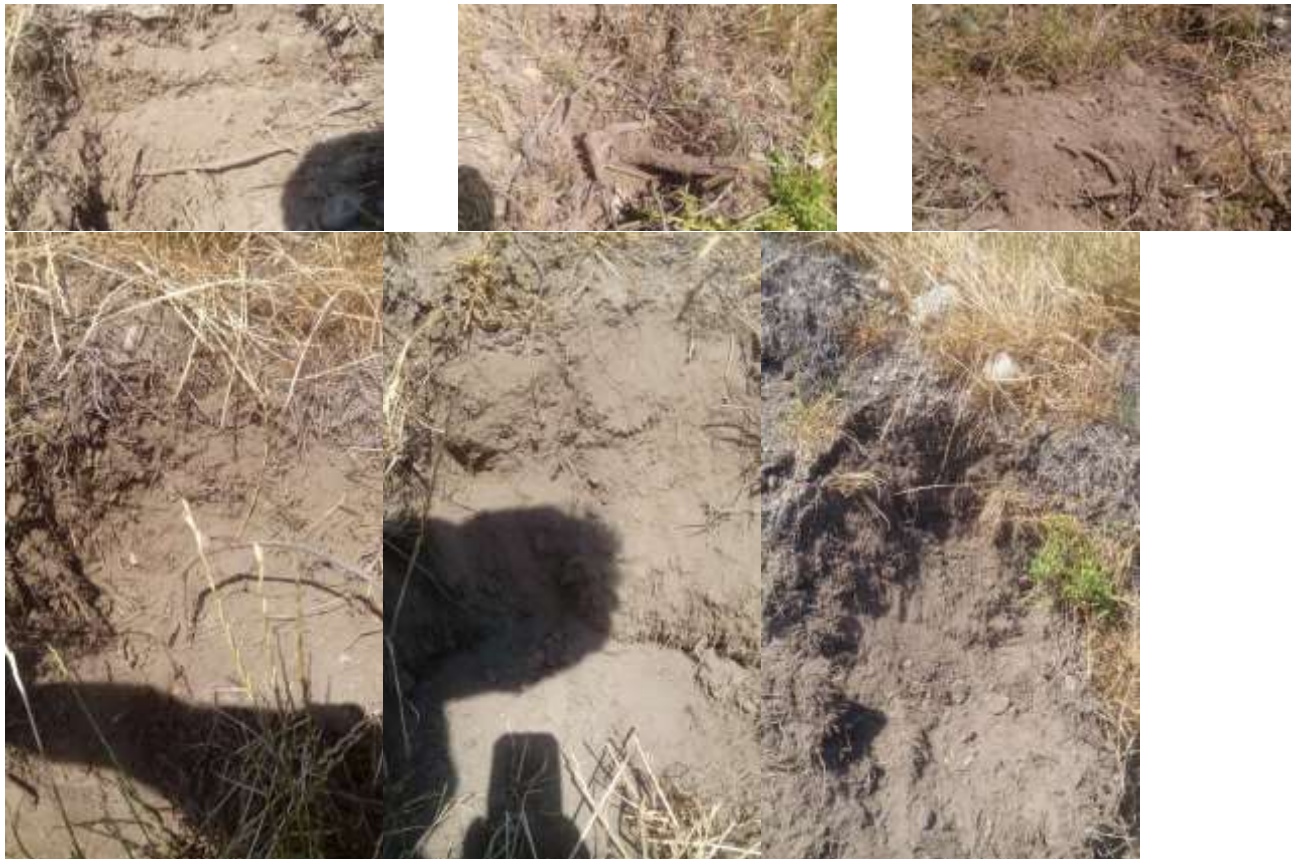
**Figure 19:** Typical examples of subsurface contents of spoil material within delineated area.

The photo plates below show typical examples of the subsurface contents of the delineated spoil area.

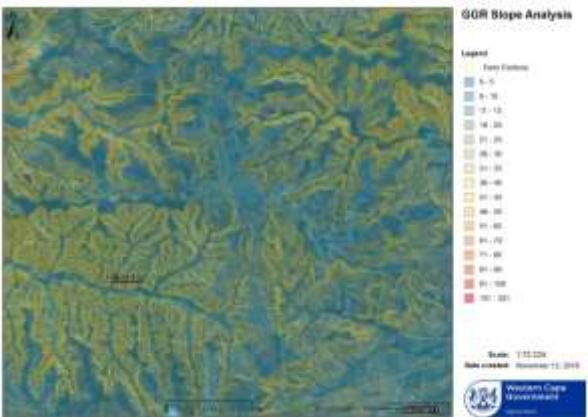
**GRR Slope Analysis**

**Figure 37:** Slope analysis of GRR showing that all Resort units are situated outside of areas containing 1:4 slopes.

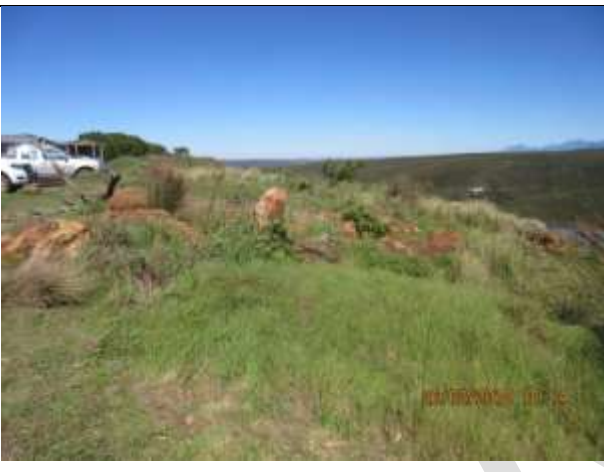
<p><b>Figure 50:</b> Showing Indigenous landscaping around the parking area at Lehele Lodge</p>
 	<p><b>Figure 51:</b> Energy efficient LED lighting at Lehele lodge</p>
 	<p><b>Figure 52:</b> Energy efficient CF lighting at Kwena Lodge</p>

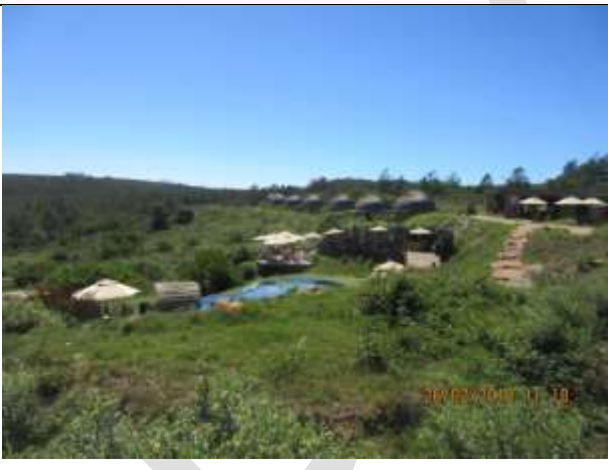
<p><b>Figure 66:</b> Overview of Kwena lodge showing the nearly completed invasive vegetation removal in this previously heavily infested area.</p>

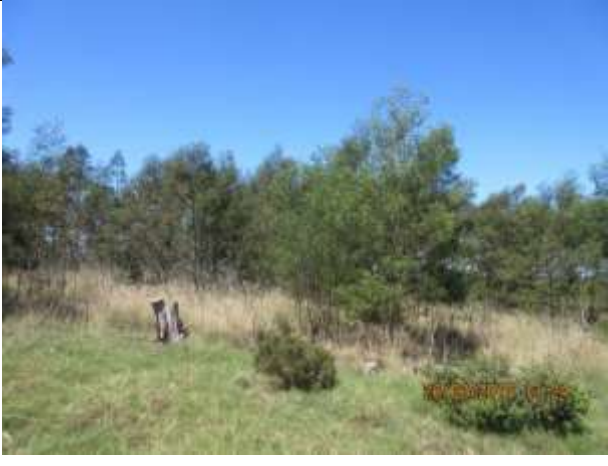
<p><b>Figure 77:</b> Showing young stand of invasive species at Red Rocks Housing Area</p>

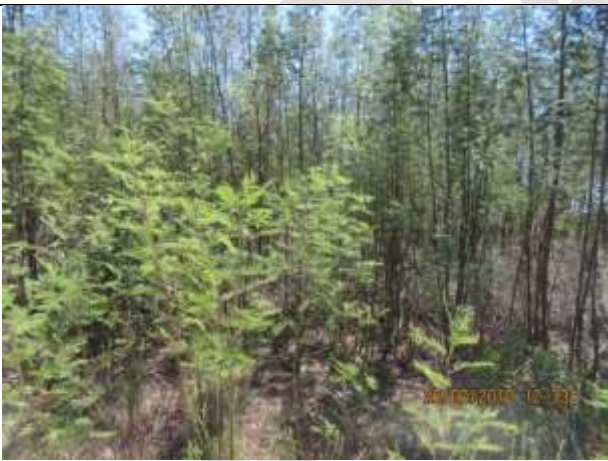
<p><b>Figure 85:</b> Dense invasive vegetation surrounding the Anti Poaching training facility</p>

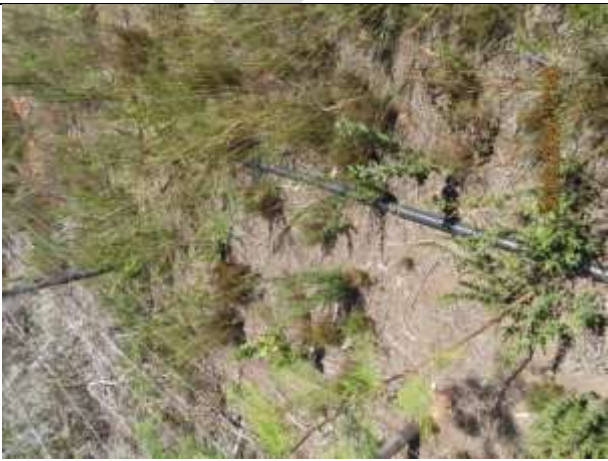
<p><b>Figure 86:</b> Water to anti-poaching training facility provided by HDPE pipe laid on surface.</p>

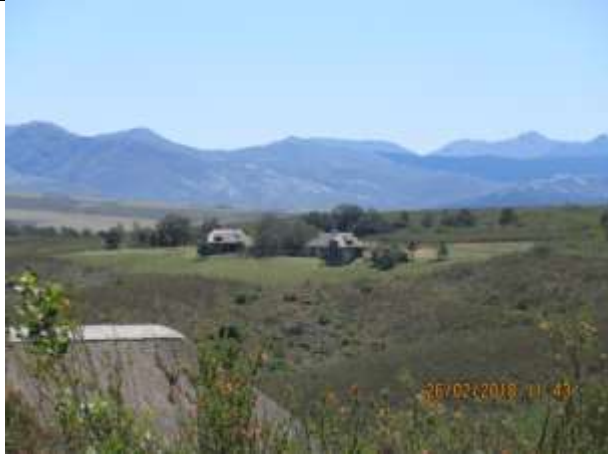
<p><b>Figure 89:</b> Two of the completed houses in Fynbos Camp showing setback from the historic fynbos areas as well as the indigenous landscaping surrounding the unit.</p>
---	--
