ENVIRONMENTAL AUDIT # 7

AFRO FISHING (PTY) LTD MOSSEL BAY

Report Reference: MOS009/07

Date: 30 April 2014

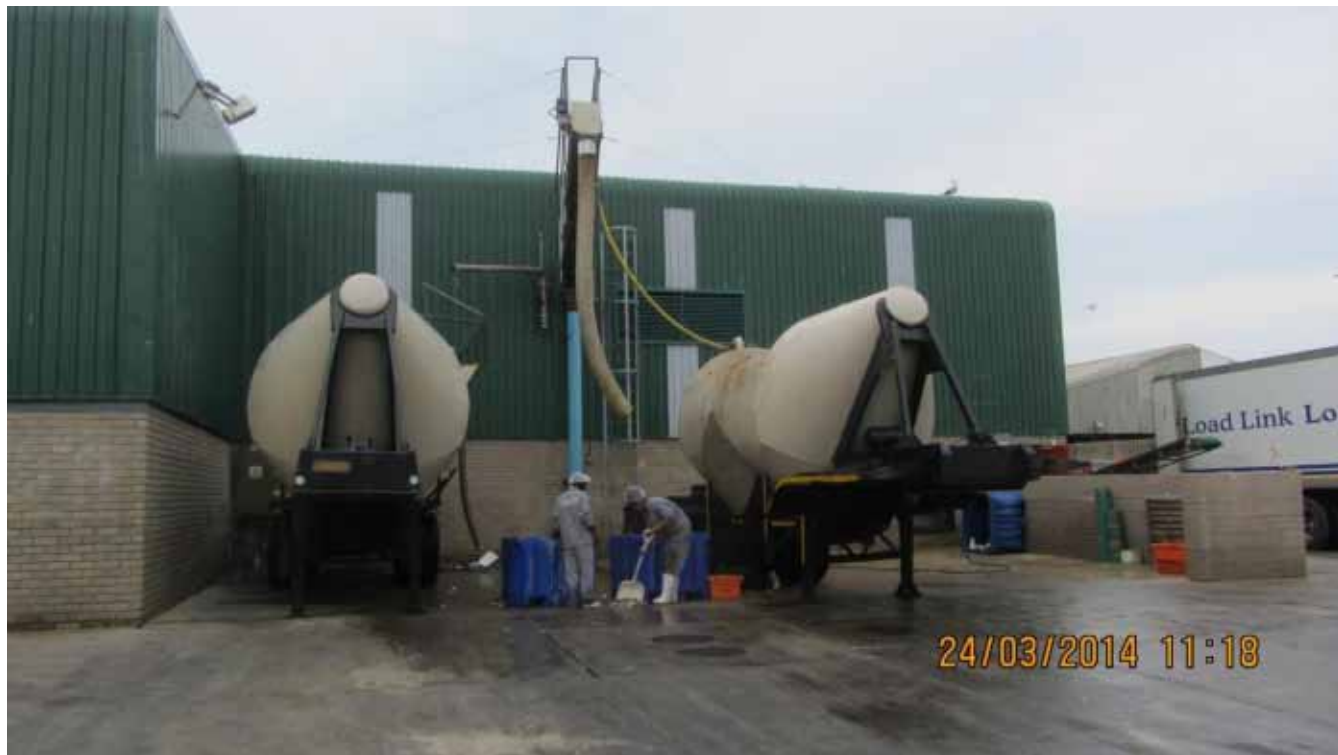
Photo 3: Offal tanks collecting fish waste

The waste material from the processing of the fish is known as offal and is made up of the head, tails, broken fish and blood. This is removed from the processing floor by means of a conveyor belt and removed from the premises in sealed tankers.

Included in this is the waste material from the boats and the offloading process which include scales and broken fish. These are screened out before entering the building, caught in skips and transferred into the offal containers for fish meal.

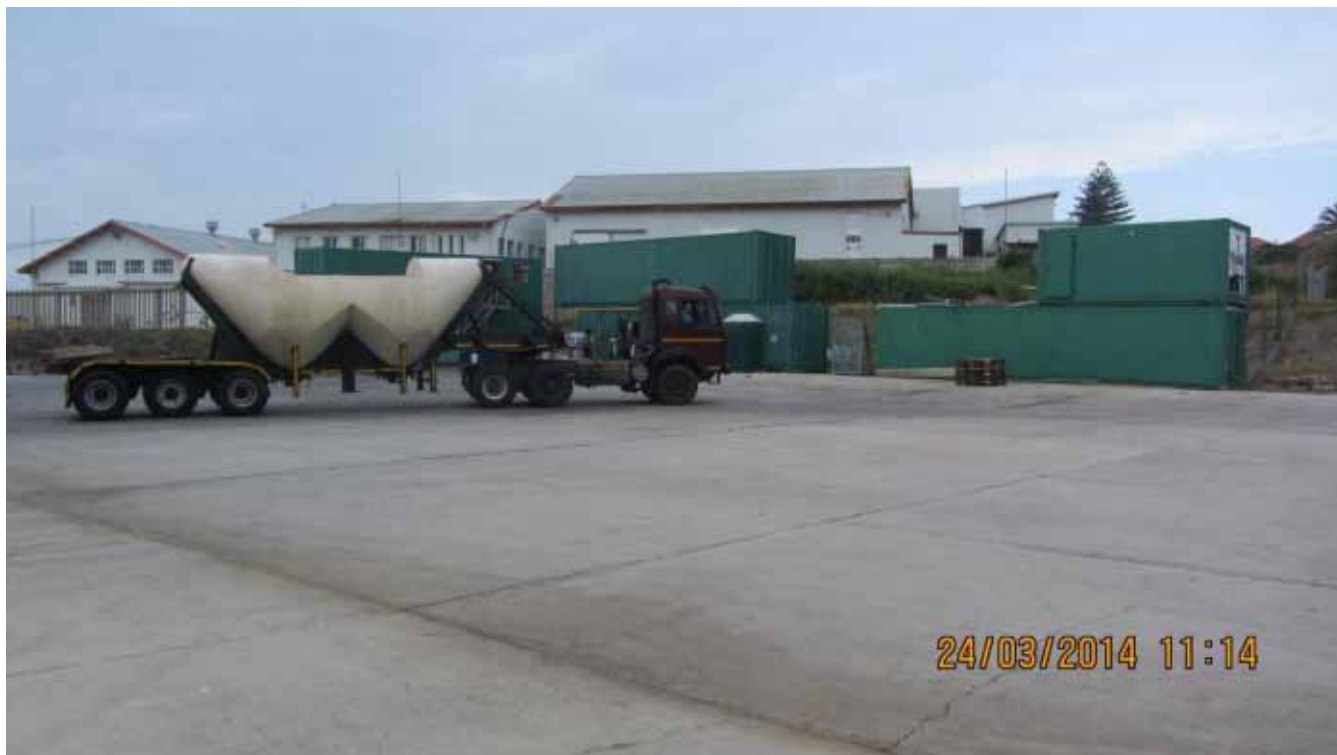
Photo 4: Offal tanking leaving the premises with a full tank

At the time of the site visit, the cannery was in full production and one of the trailers had left to offload its product. The cannery has an agreement with the South Cape Fish Meal (SCFM) plant located in the industrial area outside of Mossel Bay, for the receipt of the offal produced during processing.

The offal is made up of all waste products associated with the fish i.e. scales, blood, heads, tails, broken pieces etc.

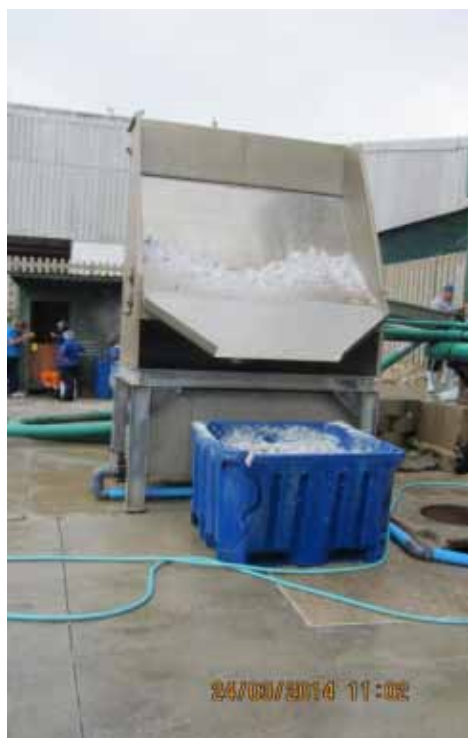
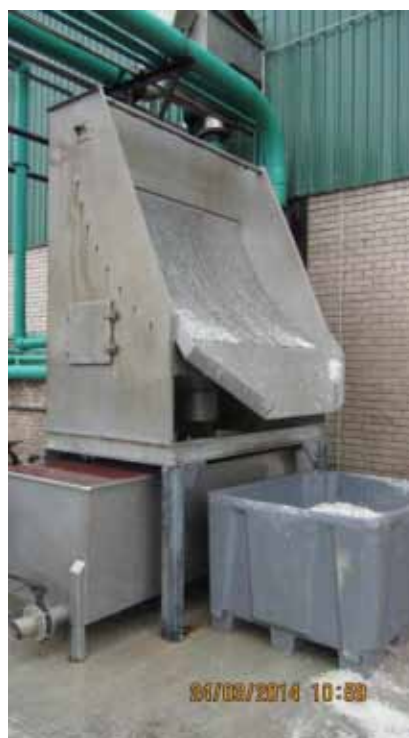
Photo 5: Screens between boats and factory and **Photo 6:** Screens with skimmer tank below

The outside skimmer tank is located on the quay which provides a secondary separation of any oils before the cooled water is discharged into the harbour. Once the water from the cooking process and general discharge water off the floor of the cannery is processed through this skimmer tank, the water is discharged into the harbour via the stormwater system.

When the cannery is in operation, the water from the boat holds, which is screened to remove solid proteins such as scales and flesh, enters the harbour via the stormwater outlet point as per the OEMP. The screens are located adjacent to the outside skimmer tank on the quay. The cannery and NPA management monitor this area daily, when in operation. This is done by visual inspections as well as the SAEON water sample analyses.

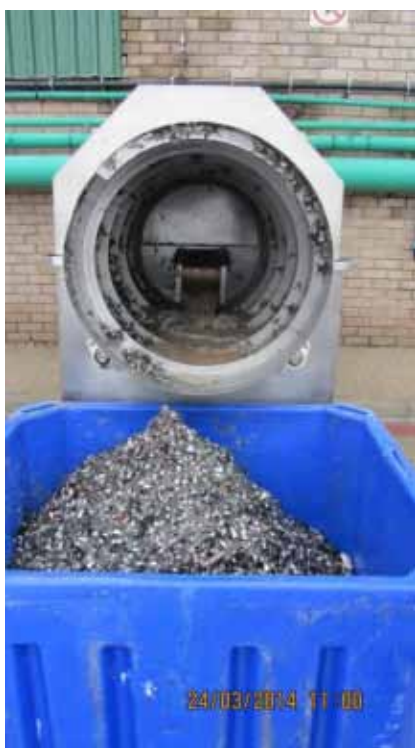
Photo 8: Drum screen

An additional screen has been included in the form of a drum filter which removes particles that may have fallen on the factory floor and washed into the drainage pipes. These pieces are generally small pieces of broken fish, some heads and tails. The pieces are removed as the drum turn and expelled into a skip. The water is diverted into the skimmer tank from where it is discharged into the harbour.

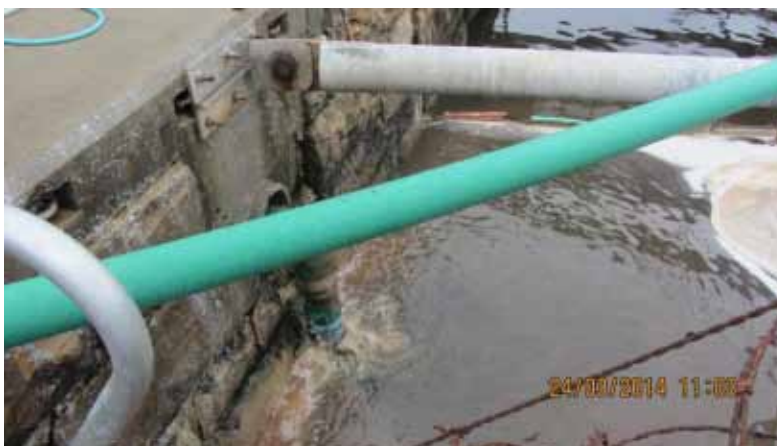
Photo 7: Discharge into the harbour with floating booms retaining oils

The water that enters the harbour is quickly dissipated. Any oils or proteins are retained by means of floating booms to contain any foam produced. These are quickly eaten by shoals of small fish.

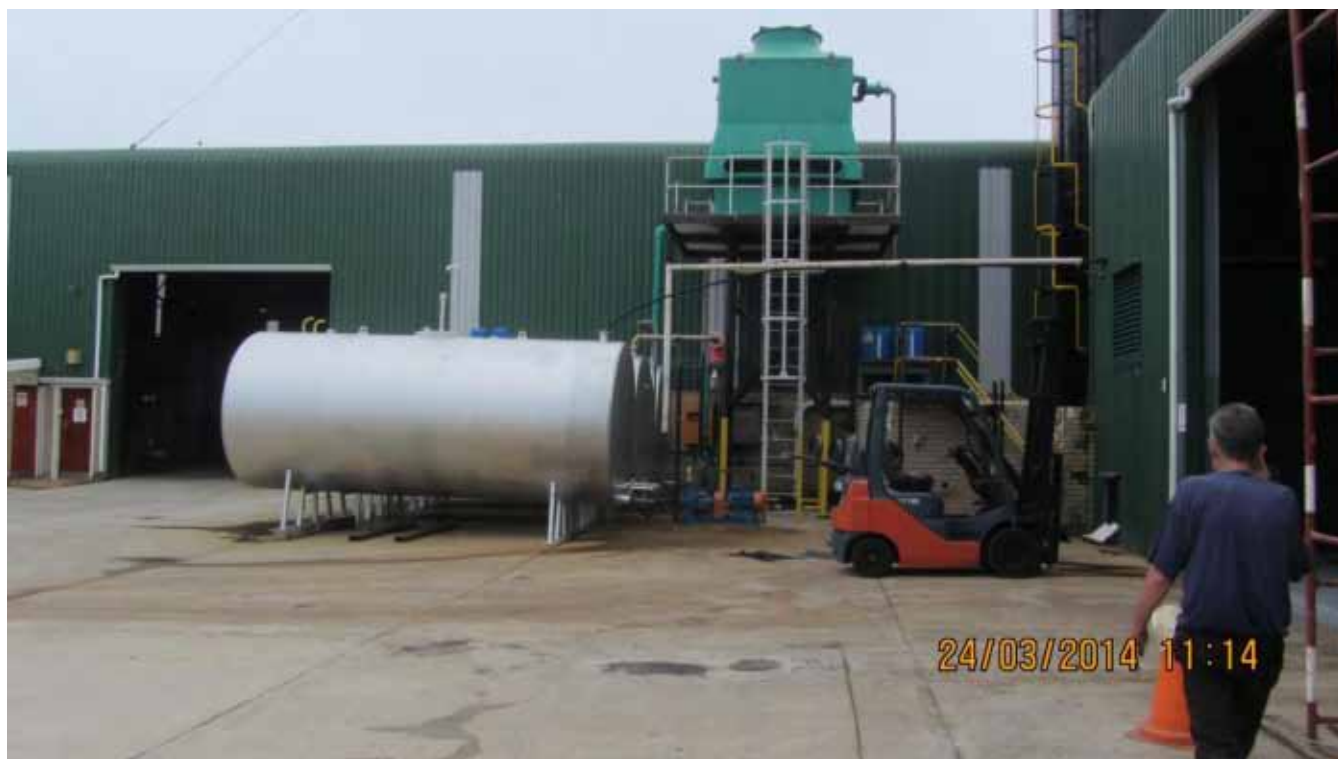
Photo 9: Water cooling tower and recycling system

The cannery has implemented several mechanisms to recycle water used in the cannery. This water is made up mostly of seawater from the boat holds and cleaning water used on the cannery floors. A filtration system has been setup next to the hopper and filtered sea water is re-used on the cannery floor for wetting blades and for further cleaning. Some of the filtered cooking water is pumped to an exterior tank and is used to irrigate the gardens around the cannery.

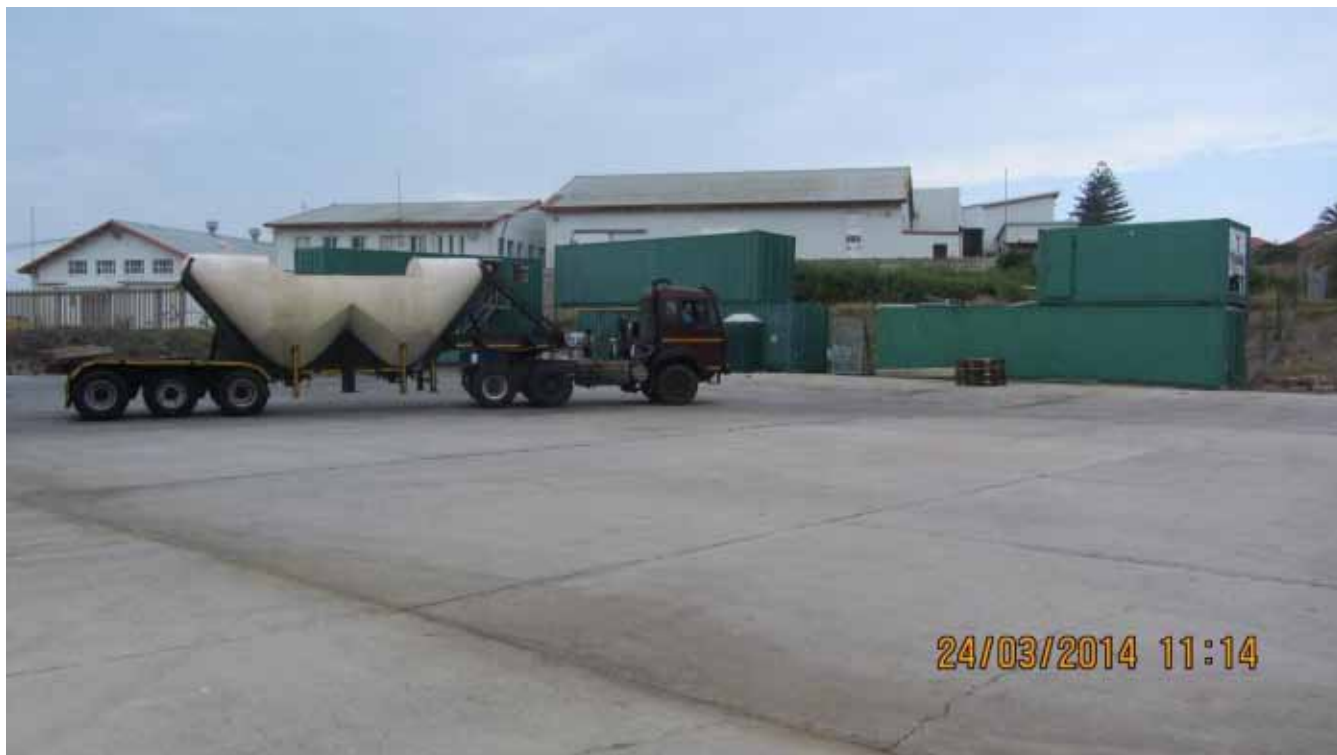
Photo 10: The yard and loading area is kept clean and neat

The cannery premises are kept very tidy and litter is not seen anywhere. Due to the very strict rules regarding food preparation and hygiene, the cannery is very conscious of its obligations, both in terms of the Environmental Authorisation and the NRCS (National Regulatory Compliance Services) regulations. Solid Waste is temporarily stored outside of the premises and removed to the relevant waste disposal site. Recycling within the cannery is encouraged at all times.

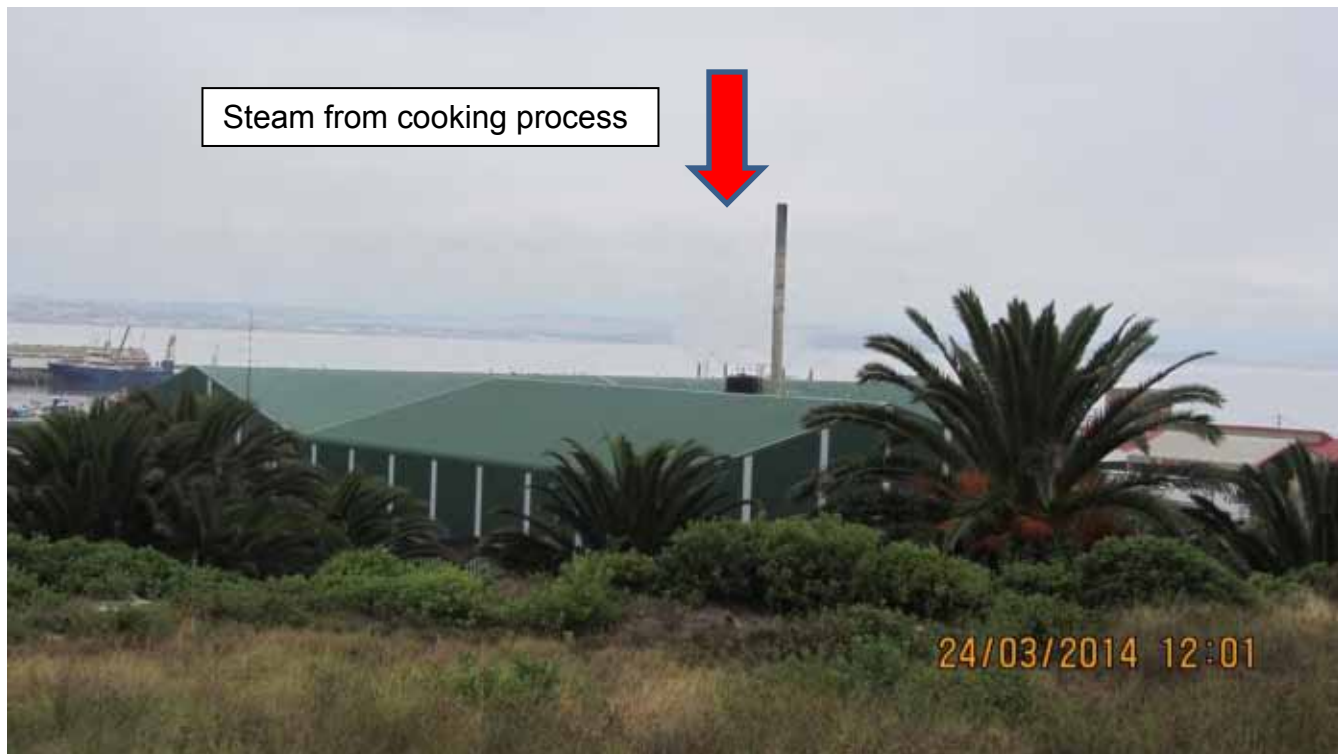
Photo 11: Only steam emissions observed at the audit inspection

The cannery runs its cooking and vacuum equipment with a fuel driven boiler. The boiler emits limited smoke on start-up and, depending on the quality of the available fuel, very little emissions are visible to the eye, nor is there any obvious smell of burnt fuel. In order to manage emissions it is important that all machinery is correctly maintained in order to reduce

Only steam from the cooking process was observed at the time of the audit.

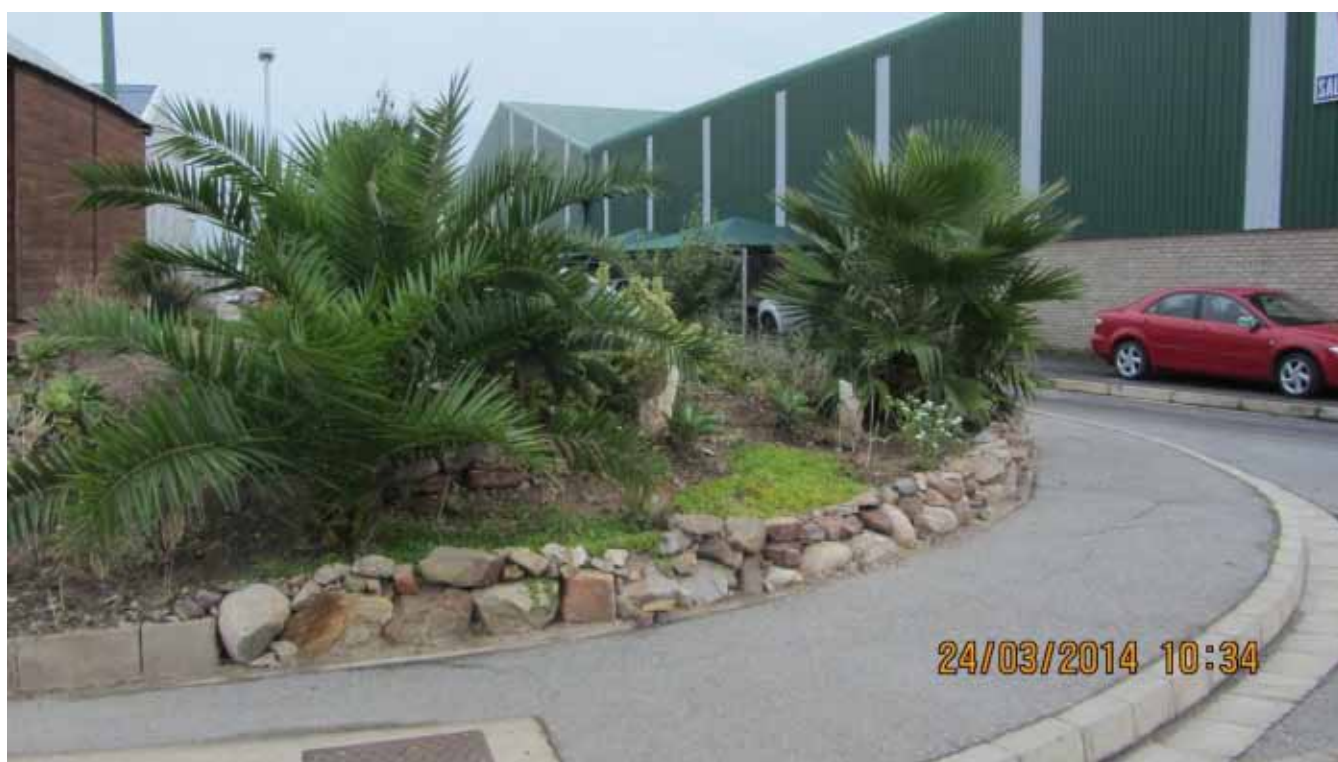
Photo 12: Gardens at the entrance to the plant

The premises of the cannery are being kept very neat and tidy and effort has been made at maintaining the gardens and landscaping the area. The embankments made along the road been built up with retention blocs and vegetated using *Aloe* and *Carpobrotus* spp (Suurvygie), effective erosion control and water wise plants. The plants are being watered by capturing some of the recycled water leaving the building in the stormwater drains. Furthermore the small entrance garden is predominantly populated using succulents that are water wise while creating a pleasing environment.

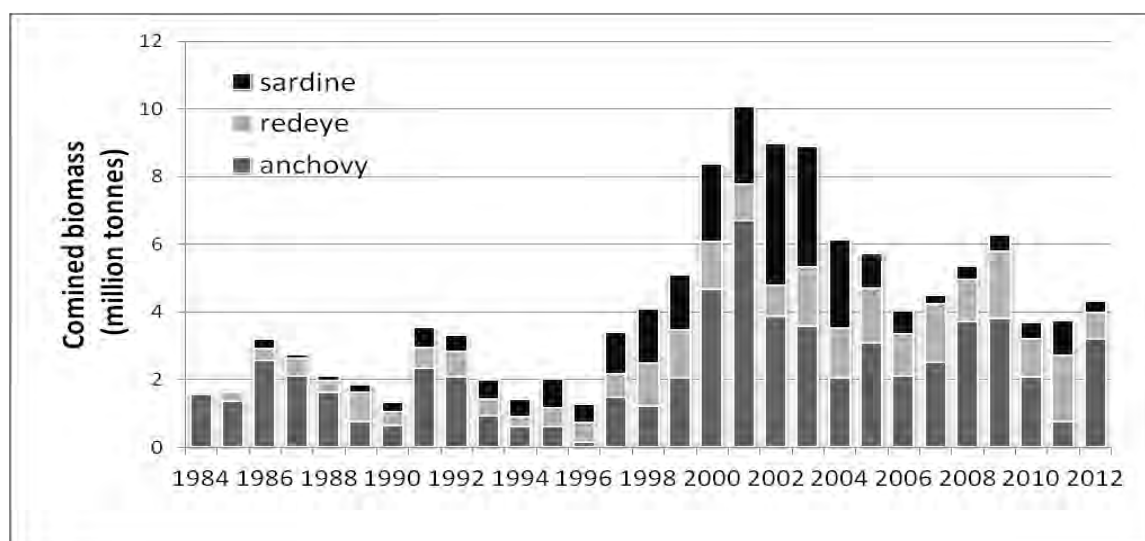
The anchovy spawner biomass was estimated at approximately 3.2 million tonnes, substantially higher than that estimated in 2011, and well above the long-term (1984–2011) average of 2.2 million tonnes. The sardine biomass of 345 000 tonnes was

considerably lower than the 1.04 million tonnes estimated in 2011 and similarly lower than the long-term (1984–2011) average of 1.02 million tonnes for this stock. The estimate of redeye round herring biomass had decreased by more than half from the previous level of approximately 1.96 million tonnes in 2011 to just 795 000 tonnes in 2012 year. This biomass was also lower than the long-term (1984–2011) average of 961 000 tonnes.

The combined biomass of 4.3 million tonnes for anchovy, sardine, and redeye round herring was slightly higher than that observed in 2011, with the sharp decrease in sardine and redeye biomass being countered by a large increase in the biomass of anchovy.
