GEOTECHNICAL SITE SENSITIVITY VERIFICATION & COMPLIANCE STATEMENT

THE PROPOSED VEGETATED LANDING STRIP ON PORTION 1 OF
FARM 172, NEAR HERBERTSDALE.

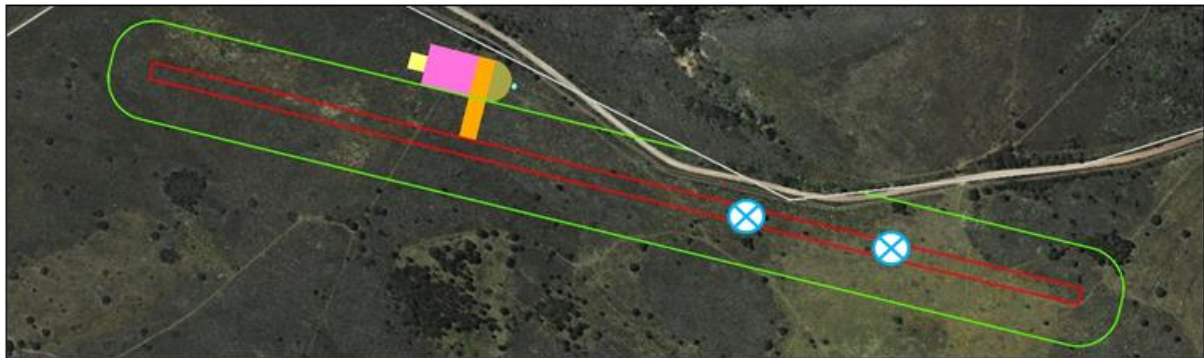
Figure 3: Approximate localities of the two test pits (TP1 & TP2).

The site was visited on 19 March 2023 by Mariska and Francois Byleveld. Two test pits (TP1 & 2) were excavated by hand in order to get a sense of the geology (Figure 3). Since the two soil profiles shared the same soil and geology (refer to Section 3 for a detailed explanation of the geology on-site) and the entire landing strip is contained inside the same geological formation, additional test pits were deemed unnecessary (Figure 1).

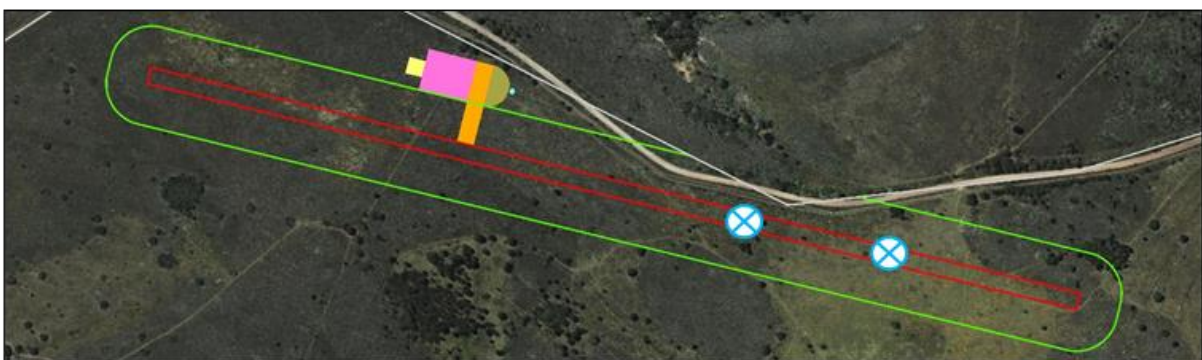
Figure 6: Approximate localities of the two test pits (TP1 & TP2).

As previously mentioned, the site was visited on 19 May 2023 by Mariska (SACNASP # 131589) and Francois Byleveld. Two test pits were excavated by hand.

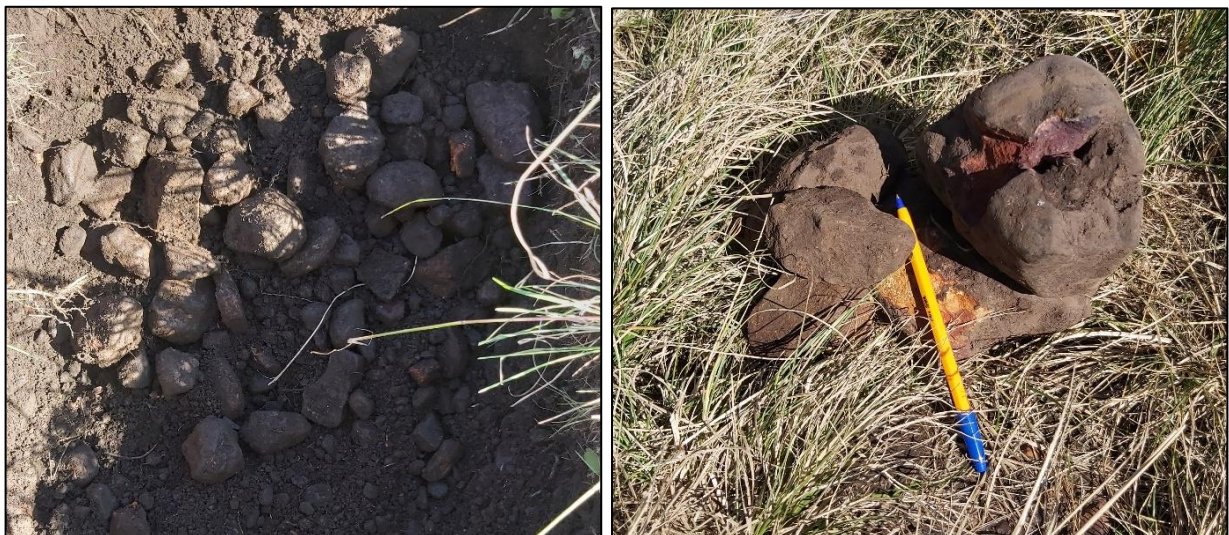
Figure 8: 100 – 400 mm layer consisting of quartzitic pebbles, cobbles & boulders.

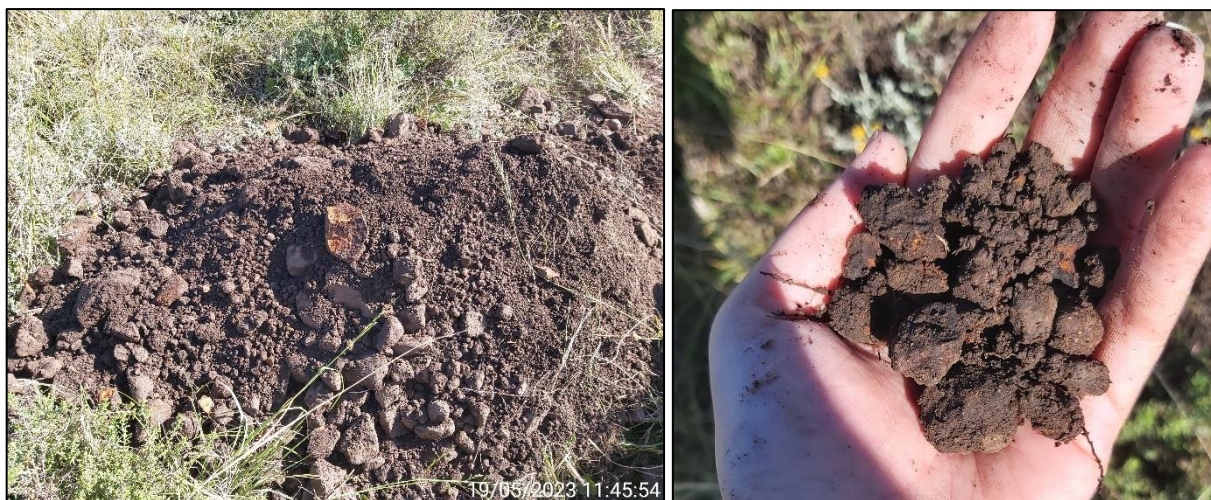
Figure 10: Stockpile of Test Pit 2 (left) and Ferricrete nodules found in Test Pit 2 (right).
