AQUATIC BIODIVERSITY COMPLIANCE STATEMENT

Erf RE/2833, Groot Brak, Western Cape.

Prepared for Cape EAPrac

Dr. James M. Dabrowski

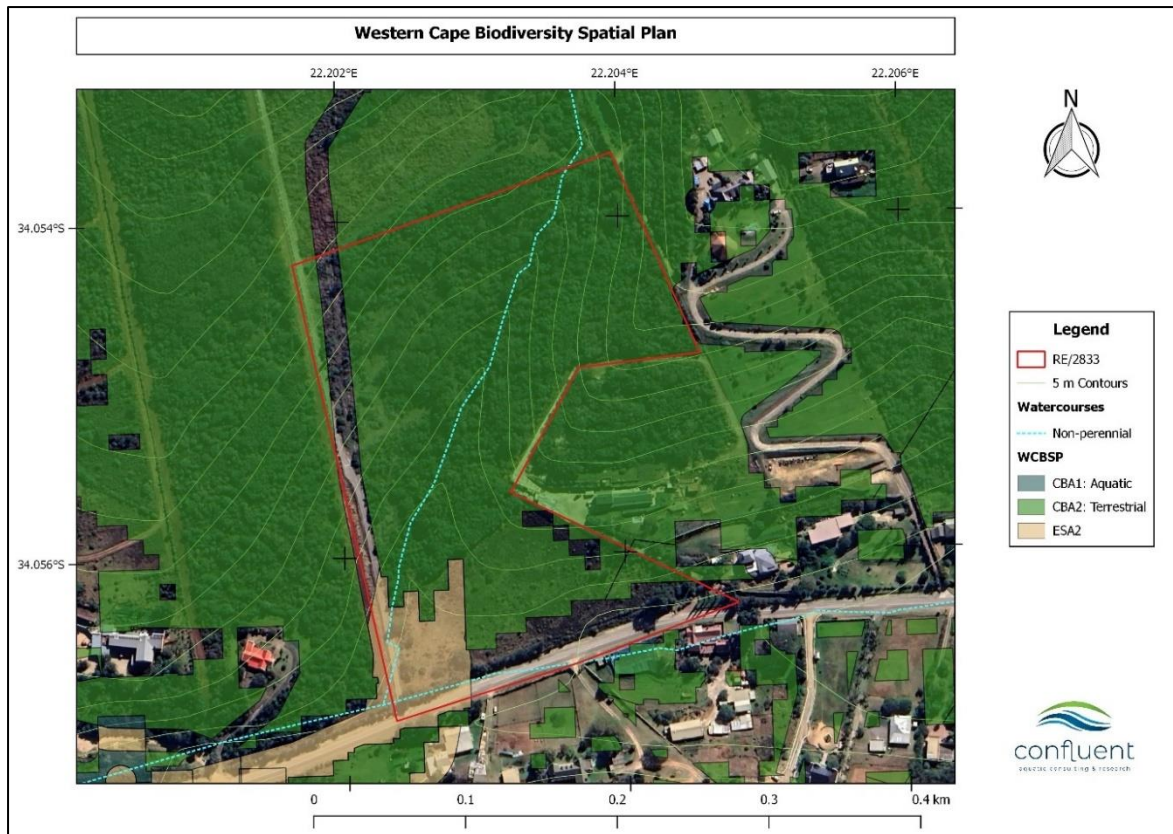
According to the Western Cape Biodiversity Spatial Plan the south-western most corner of the property is mapped as an aquatic ESA2 (Figure 3). These are considered as areas that are not essential for meeting biodiversity targets, but that play an important role in supporting the functioning of Critical Biodiversity Areas (CBAs) and are often vital for delivering ecosystem services.

Figure 3: Western Cape Biodiversity Spatial Plan

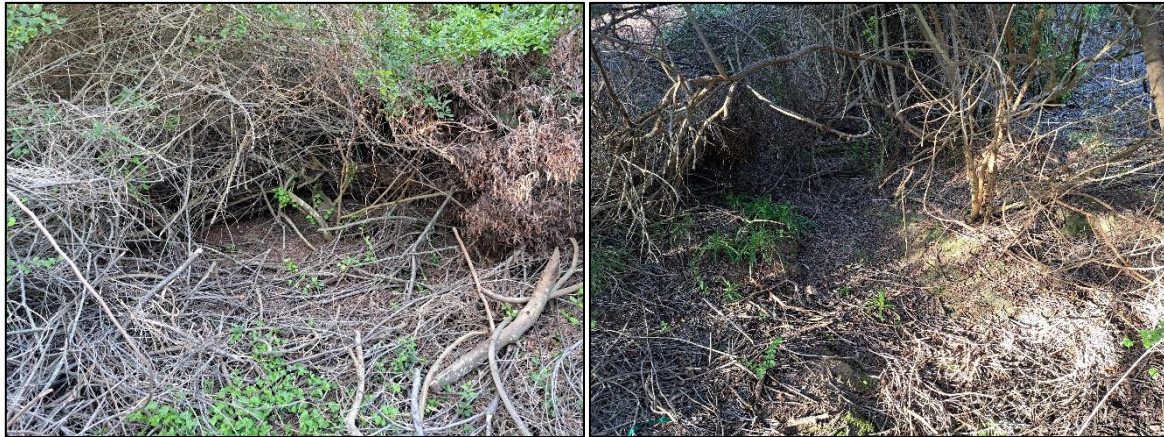
The valley was heavily invaded by *Acacia mearnsii* dominated thicket on the northern slope and less invaded Hartenbos Dune Thicket on the southern slope (Fouche, 2023). Vegetation along the valley bottom is very dense and almost impenetrable in places. While the valley is a low point in the landscape and therefore a natural area of drainage, no discernible bed and banks were observed along the valley bottom, indicating that water does not regularly flow through the valley (Figure 5). When water does flow, the volume and energy of flow is not sufficient to form a bed and banks and any associated permanent or temporary aquatic habitat. The lack of hydrophilic plant species, together with the lack of any seasonal, temporary or permanent soil saturation indicators shows that water does not tend to stand or accumulate along the drainage area.

Given the lack of any defined bed, banks or channel, and according to the classification system developed by Ollis et al. (2013), the feature indicated as a non-perennial drainage line in Figure 2 is not defined as a watercourse and is not associated with any aquatic habitat or aquatic biodiversity.

Figure 5: Photographs taken along low point of the valley floor indicating dense thicket vegetation with no discernible signs of bed, banks or a channel that would indicate the presence of a watercourse.

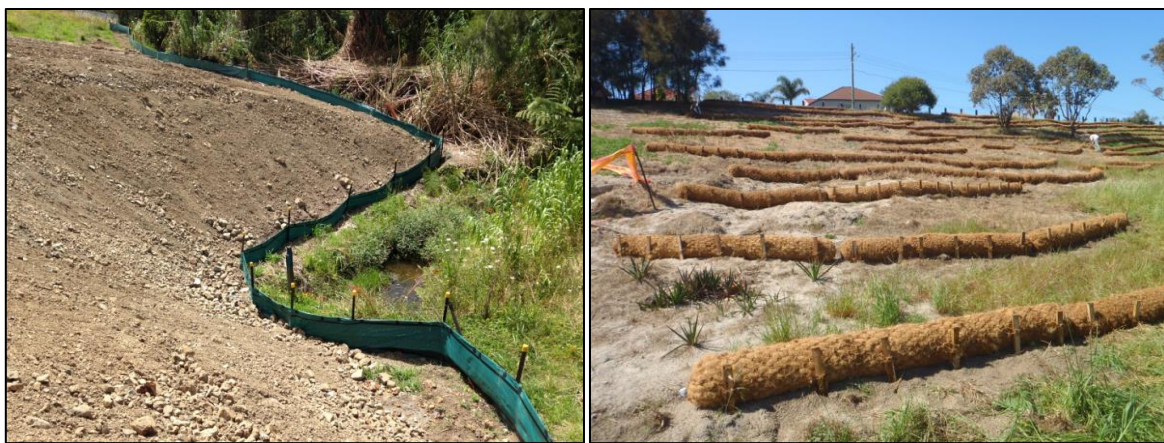
Figure 7: Examples of silt fences (left) and coir logs (right) used to trap sediment mobilised from steep slopes.

- Ensure that construction activities do not cause any preferential flow paths and concentrated surface runoff during rainfall events.
- Clearly demarcate the construction area and ensure that heavy machinery does not compact soil or disturb vegetation outside of these demarcated areas.
- Reduce transport of sediment through use of structures such as silt fences and biodegradable coir logs placed along a contour below the development footprint (Figure 7).
