Appendix C – Site Photographs.

Stephen Stead – VRMA, 2023.

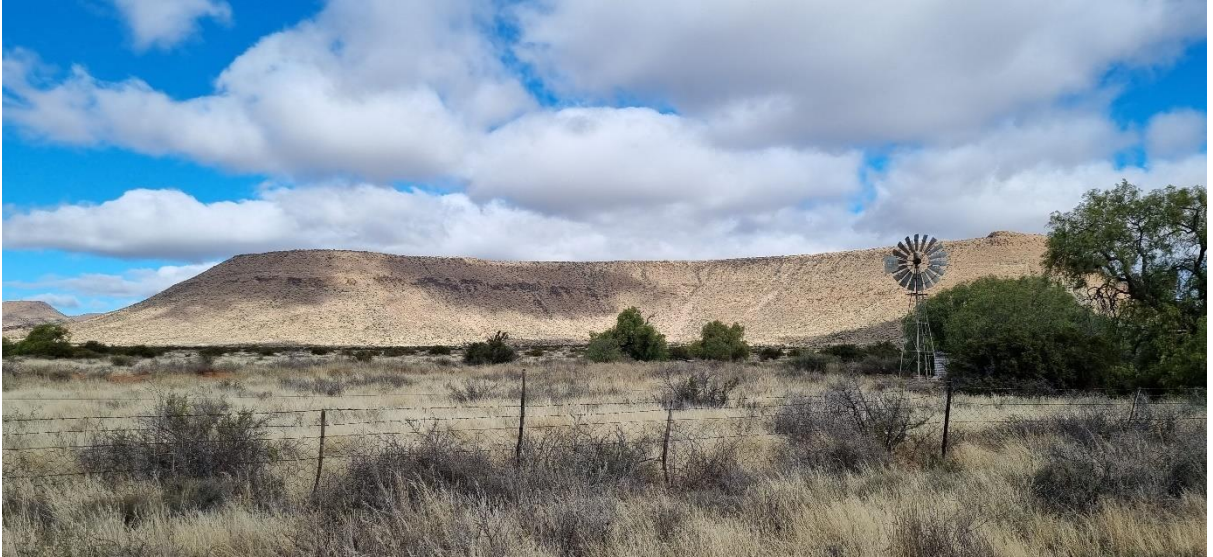
ID	1
PHOTO	Inselberg hill feature
RISK	Medium
DIRECTION	S
COMMENT	No proposed PV in close proximity to the hill feature as this is the key landform element in the landscape contrasting to the flat plains to the north where the PV is proposed.

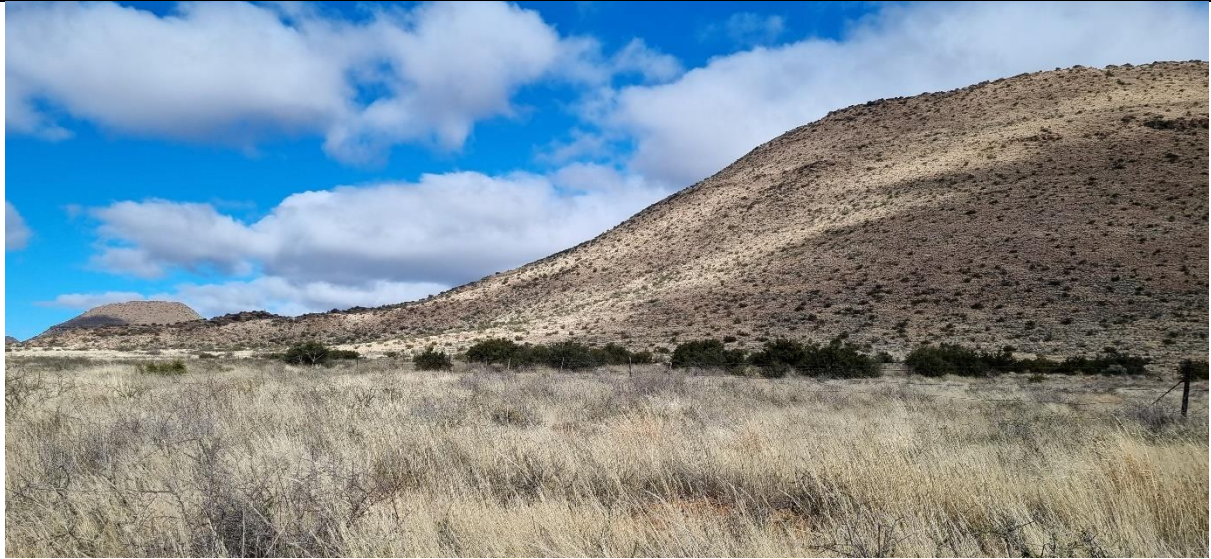
ID	2
PHOTO	Site PV
RISK	High
DIRECTION	S
COMMENT	Risk to hill landscape with PV located at the base of the slopes. Setback 200m buffer for Low Visual Impact.

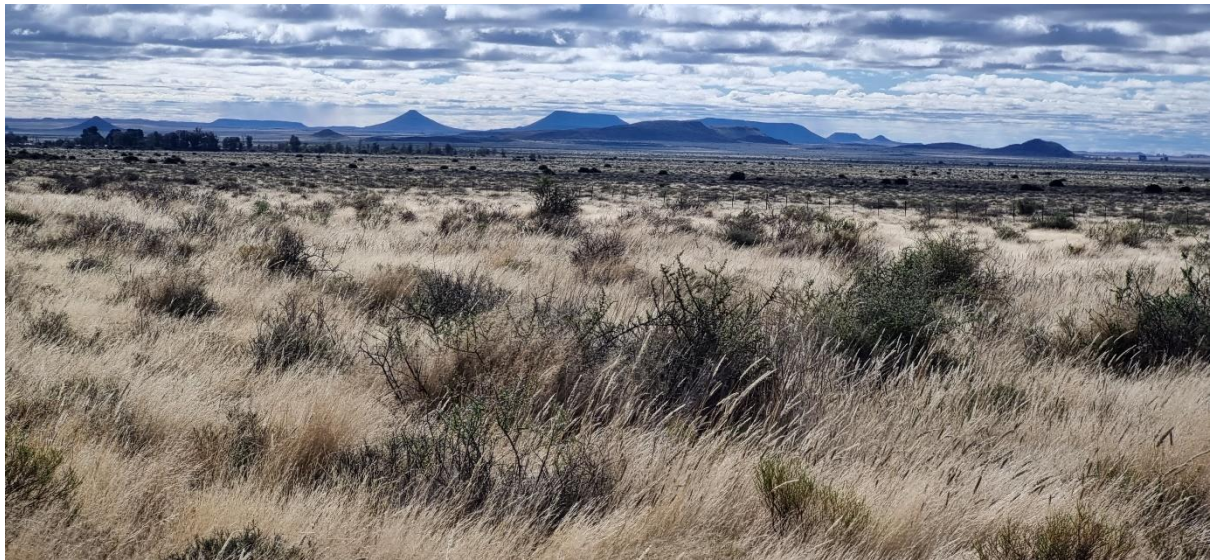
ID	3
PHOTO	Site PV
RISK	Medium
DIRECTION	N
COMMENT	Suitable north of road retaining south as agriculture with potential for future agricultural tourism.

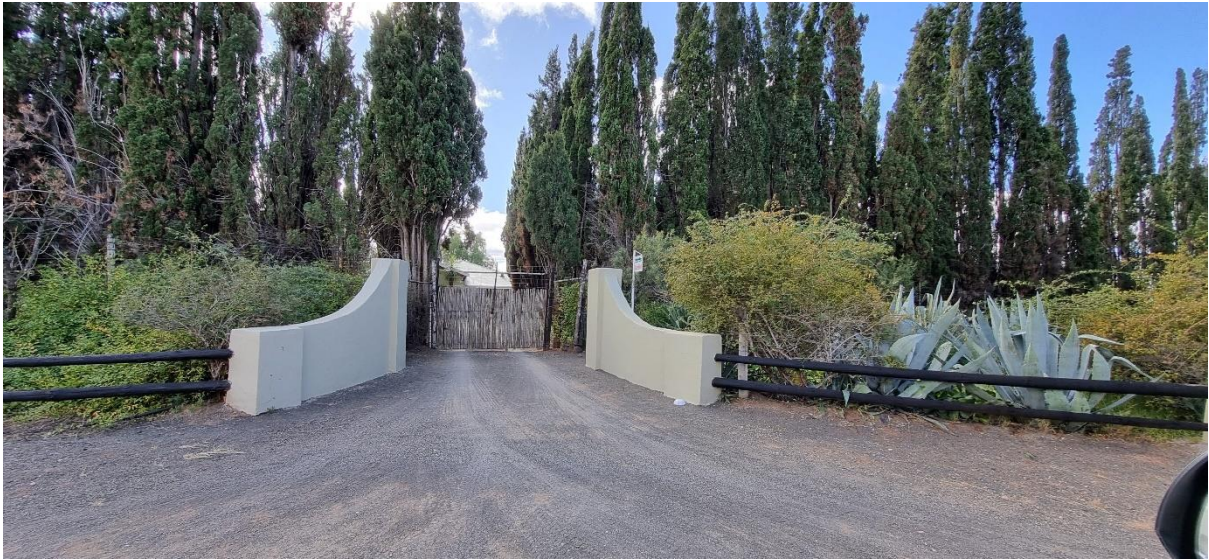
ID	4
PHOTO	Kareekloof farmstead
RISK	Low
DIRECTION	N

COMMENT	Suitable buffer from PV and well vegetation screened.
----------------	---

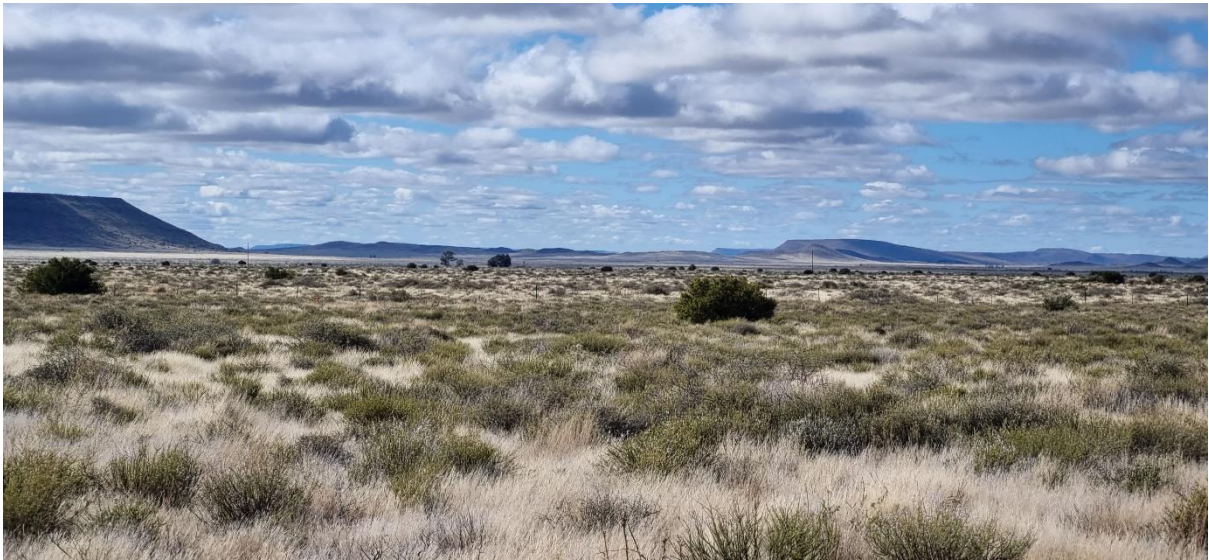
ID	5
PHOTO	Site PV
RISK	Low
DIRECTION	N
COMMENT	Low prominence and well set back from the southern hills.

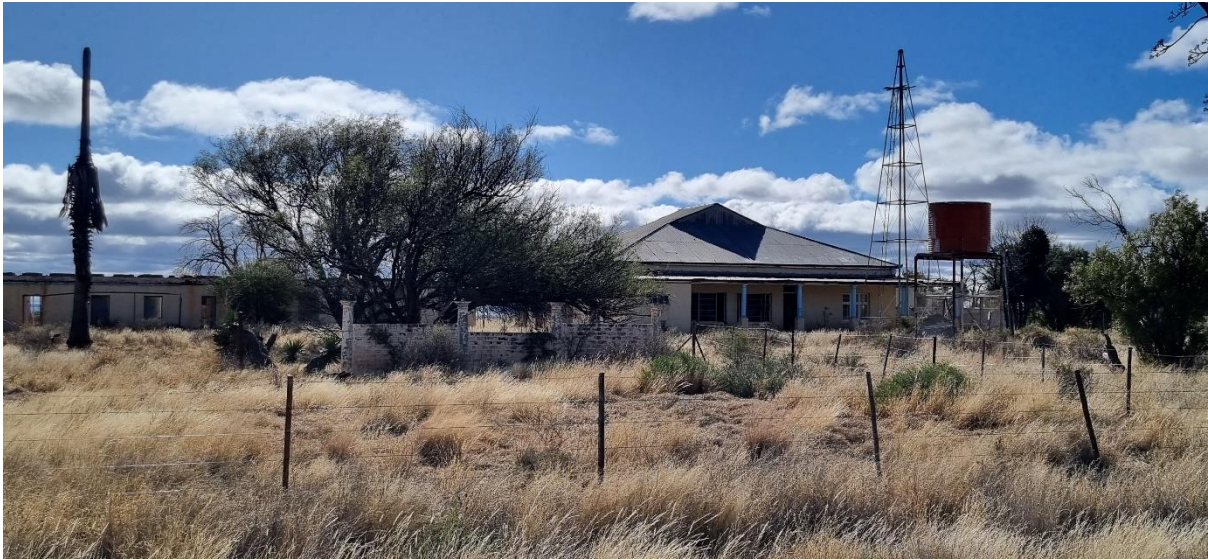
ID	6
PHOTO	Site abandoned farmhouse
RISK	Low
DIRECTION	NW

COMMENT	Abandoned and in disrepair with no resident
----------------	---

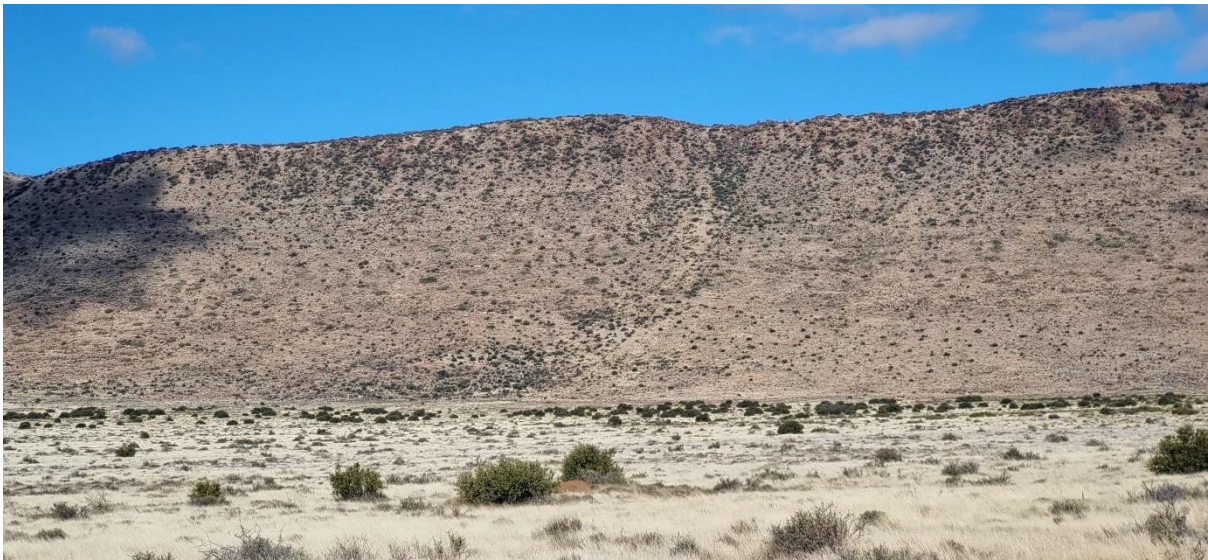
ID	7
PHOTO	Steep slopes and foothills
RISK	High
DIRECTION	S
COMMENT	Landscape degradation. Mitigation no-go for steep slopes and 300m buffer from foothills.

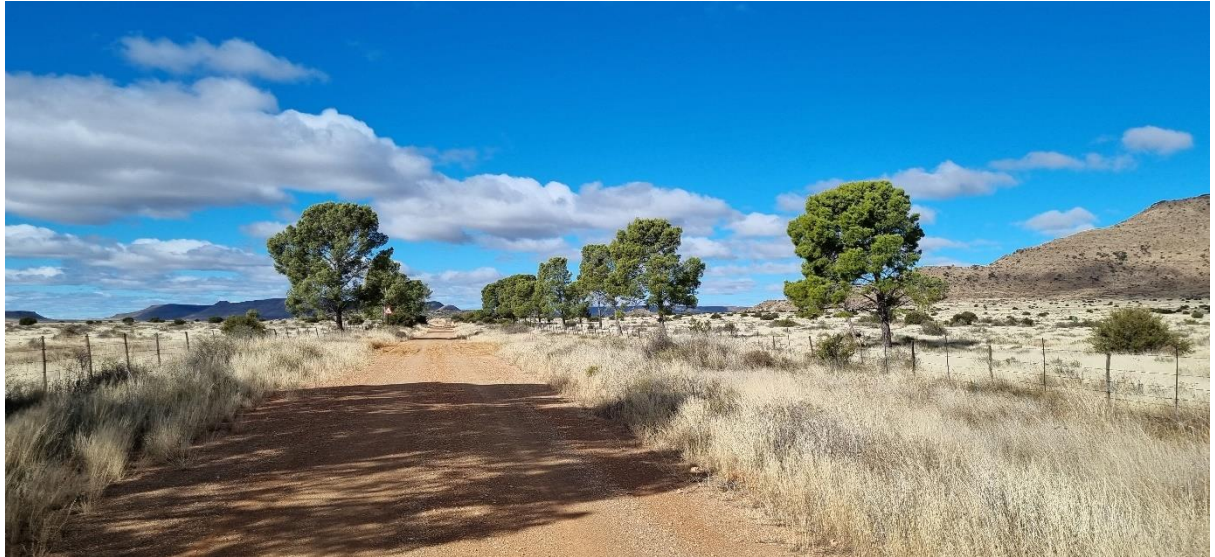
ID	8
PHOTO	Site PV
RISK	Medium

DIRECTION	E
COMMENT	Private farm access with fir tree plantings. Limited landscape value so can be felled and replaced with PV.

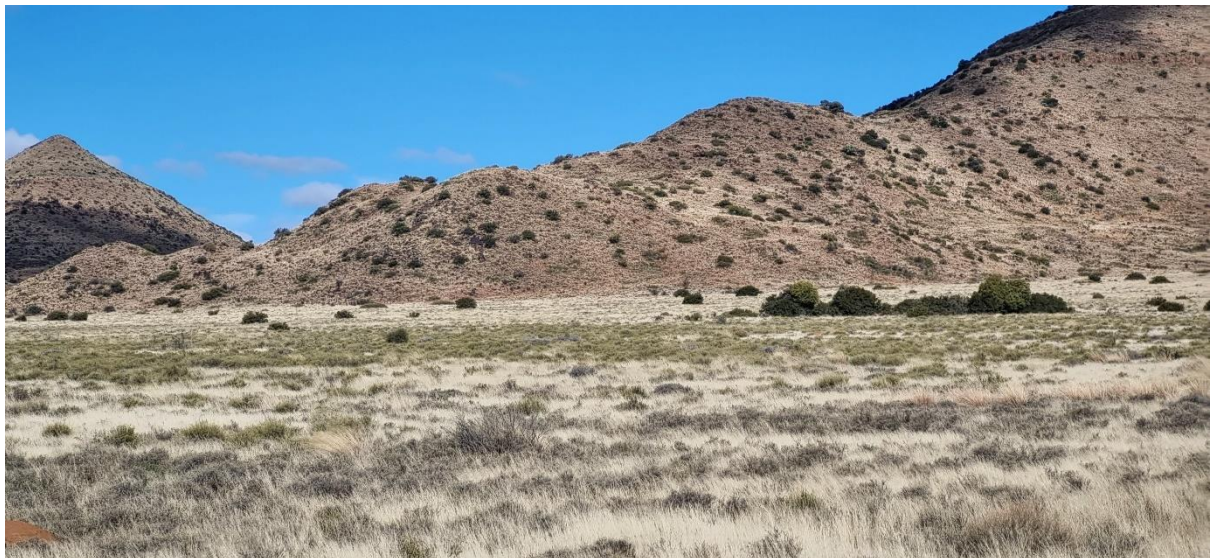
ID	9
PHOTO	Hill feature
RISK	High
DIRECTION	SE
COMMENT	No-go for steep slopes with 300m buffer around hill base.

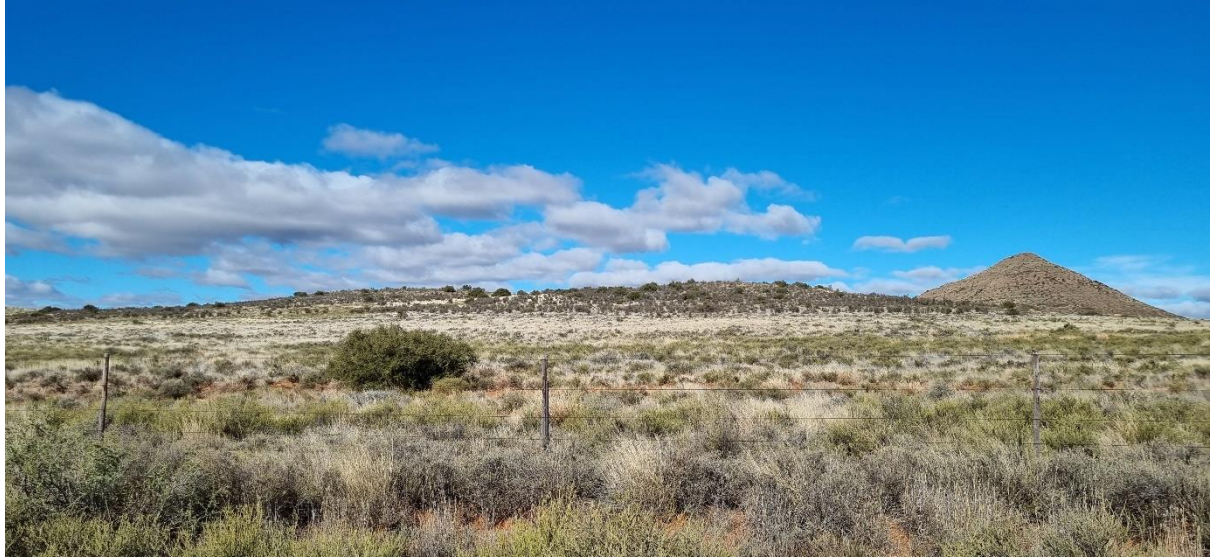
ID	10
PHOTO	Prominent steep slope area

RISK	High
DIRECTION	N
COMMENT	No-go with low impact north of road.

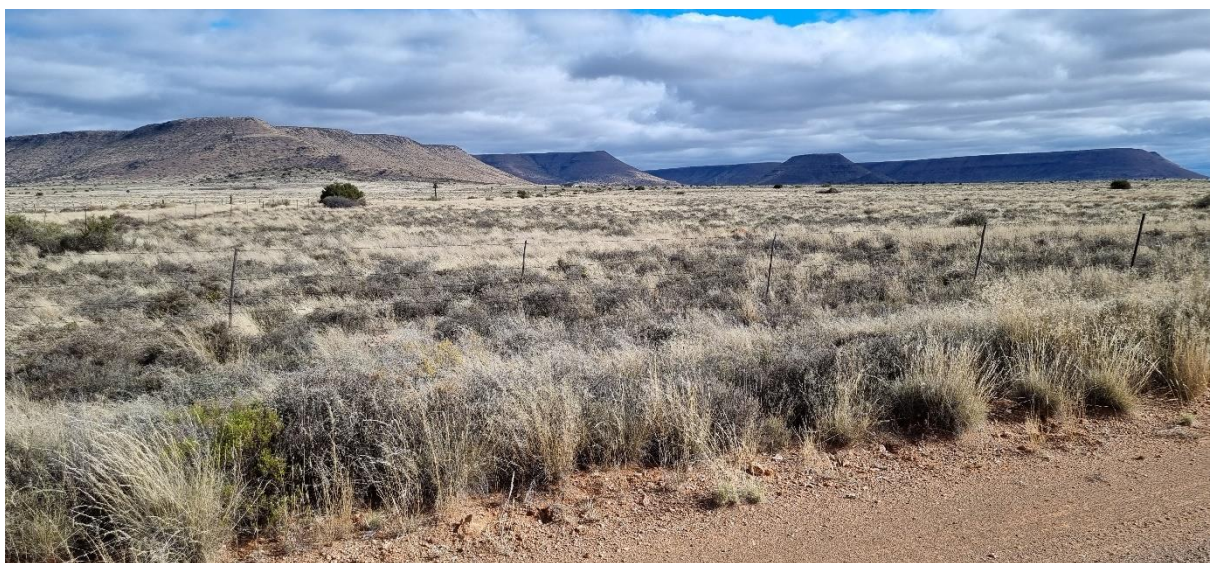
ID	11
PHOTO	KOP rural farm access road Northbound 1
RISK	Medium
DIRECTION	SW
COMMENT	Medium exposure and remote but prominent areas on foothills detracting from hill scenic quality. Mitigation remove PV from slopes for low Visual Impact outcomes.

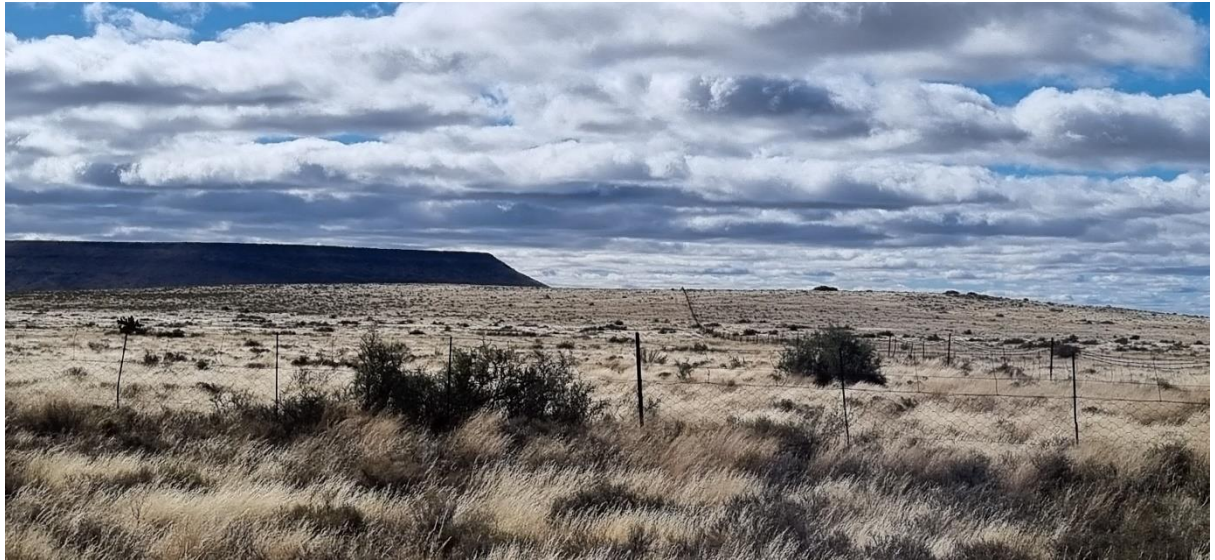
ID	12
-----------	----

PHOTO	Site PV
RISK	High
DIRECTION	N
COMMENT	Steep slope area for exclusion No-go.

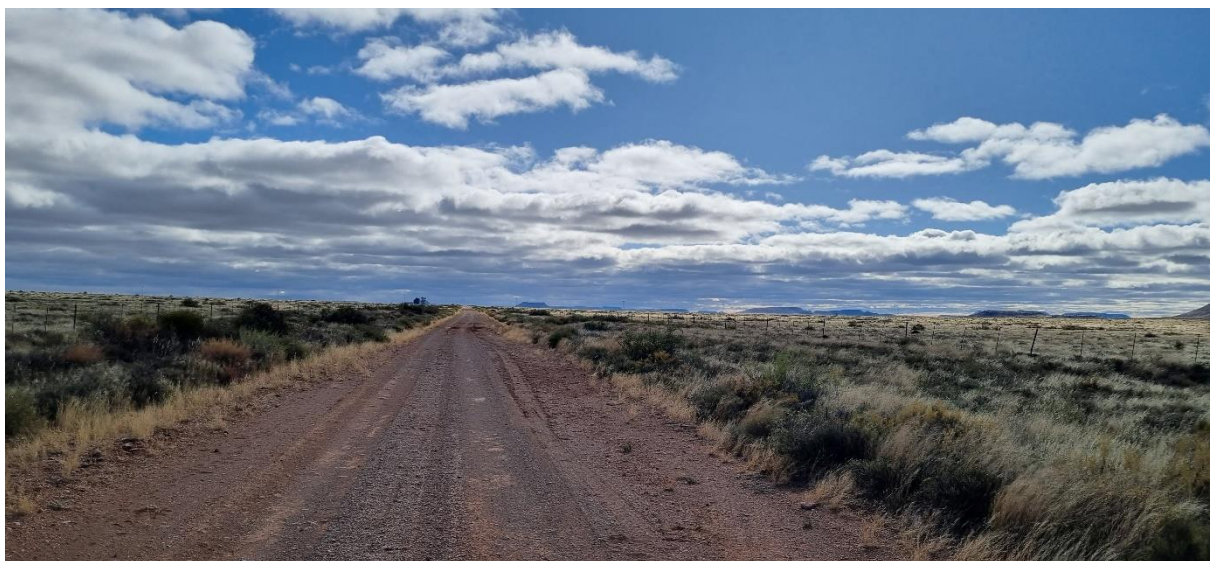
ID	13
PHOTO	KOP Rural access Northbound 2
RISK	Medium
DIRECTION	NE
COMMENT	Walling of PV on either side of road. Setback 50m on either side if road for low Visual Impact. Moderated by remote locality.

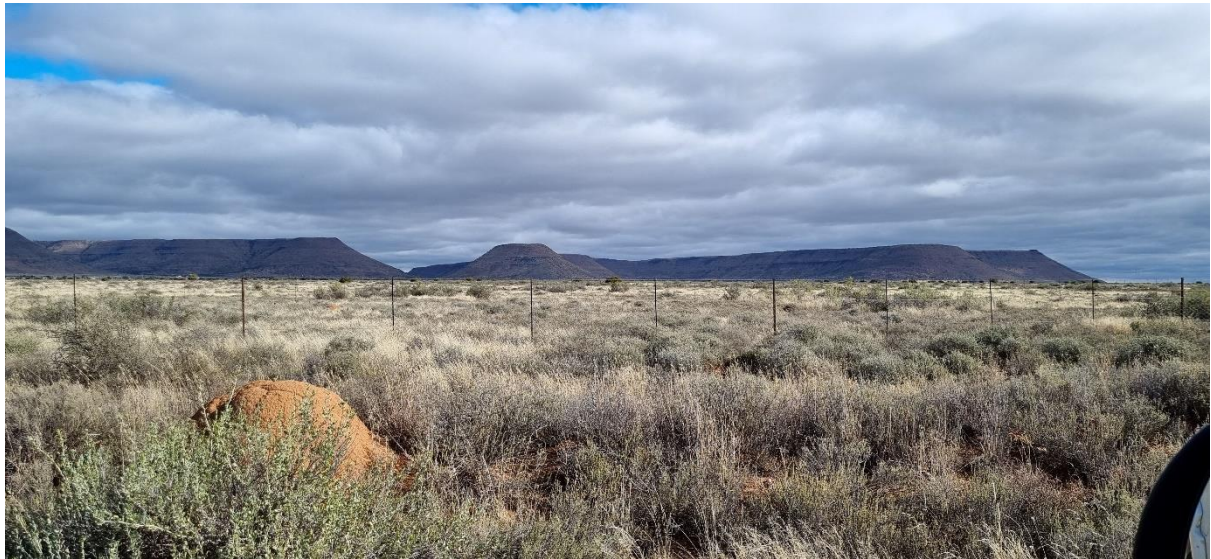
ID	14
PHOTO	Site PV
RISK	Low
DIRECTION	SE
COMMENT	Flat lands well set back from hill landforms. Suitable for 50m setback? on road.

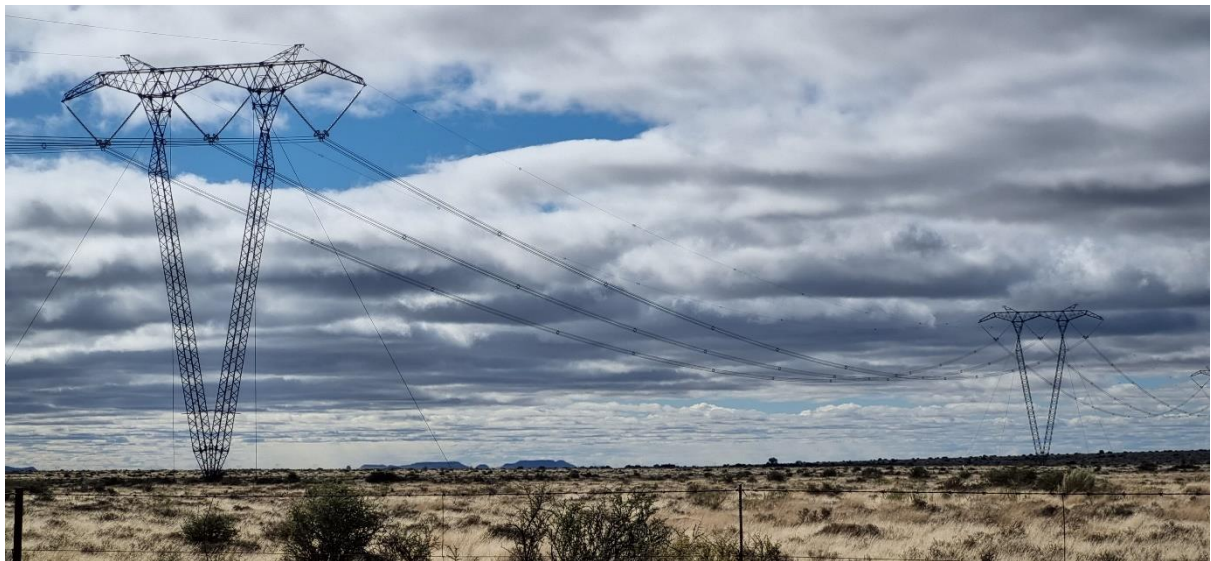
ID	15
PHOTO	Sense of Place existing OHPL 400kV
RISK	Medium
DIRECTION	NE
COMMENT	Local landscape degradation

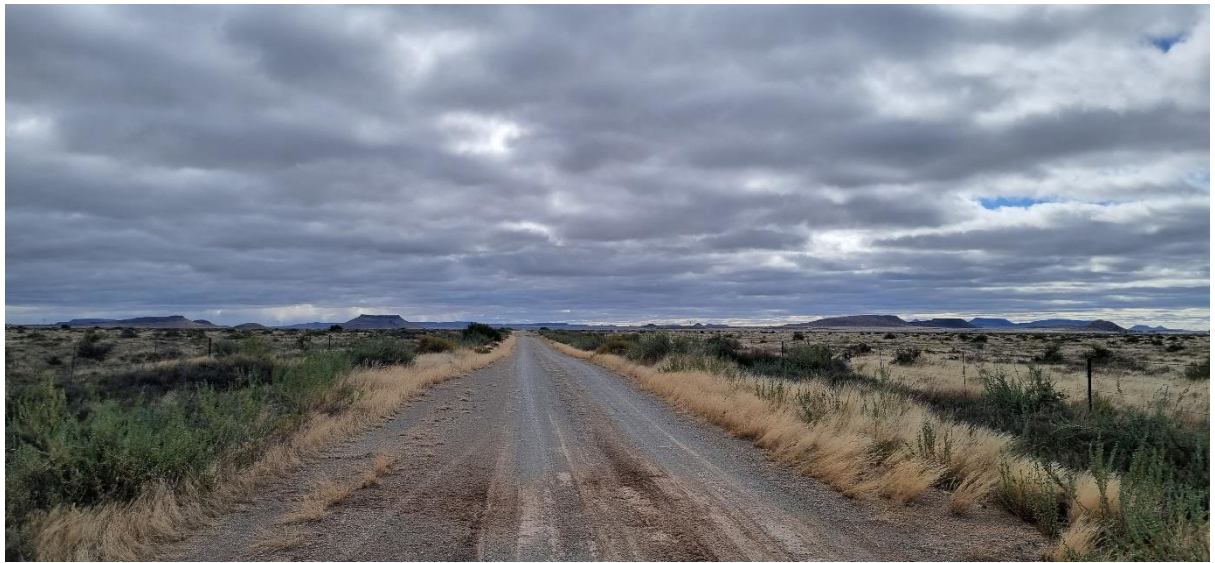
ID	16
PHOTO	KOP Rural farm access Northbound 3
RISK	High
DIRECTION	NW
COMMENT	visual exposure to PV with walling on either side. Setback PV 50m either side of the road for Medium Visual Impact.

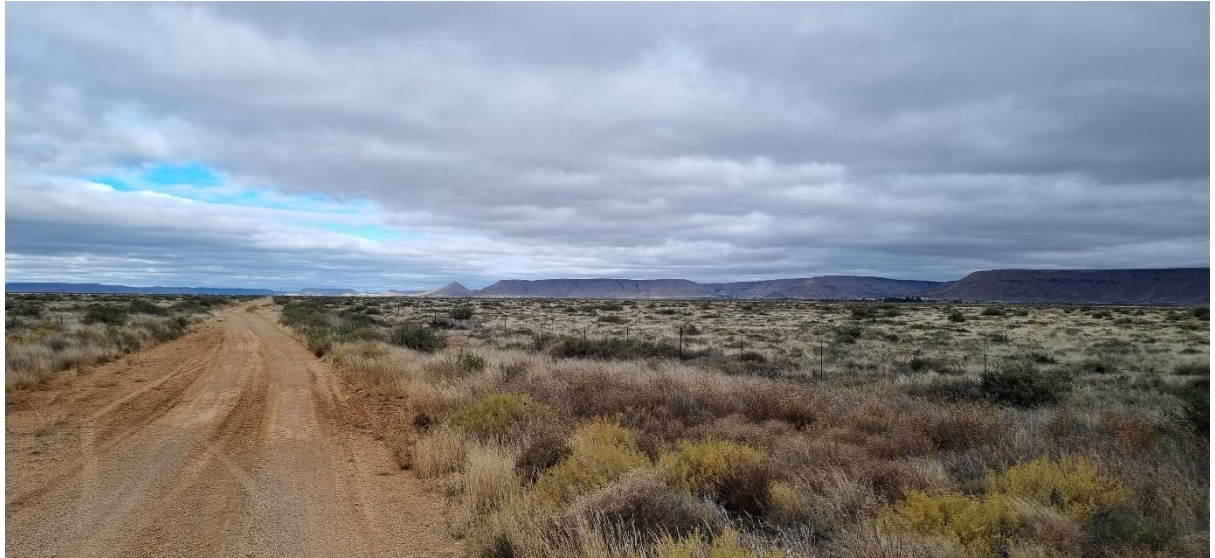
ID	17
PHOTO	KOP Rural access Southbound
RISK	Medium
DIRECTION	SE
COMMENT	PV to south side of road. Setback 50m for reduced intrusion and Low Visual Impact.

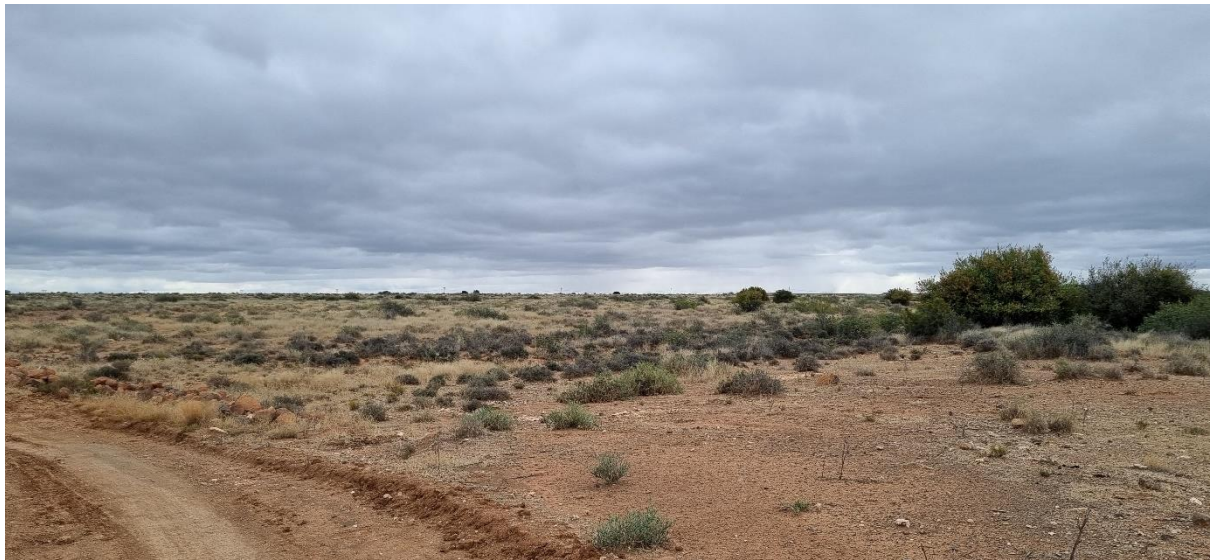
ID	18
PHOTO	Site drainage line
RISK	High
DIRECTION	E
COMMENT	No-go exclusion as per surface water hydrologist recommendations.

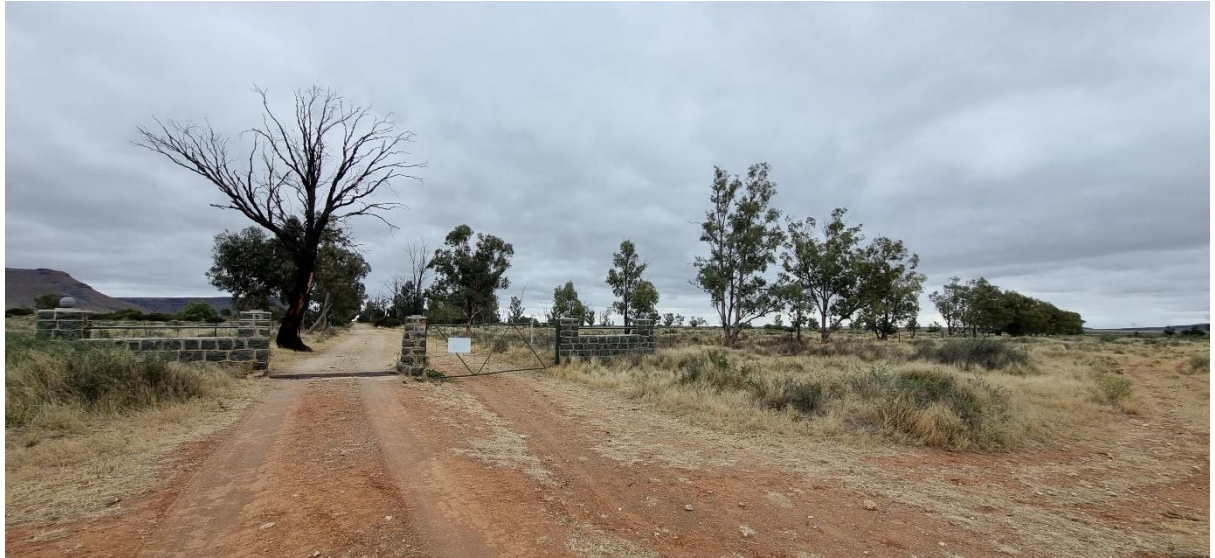
ID	19
PHOTO	Farmstead
RISK	High
DIRECTION	SE
COMMENT	No-go for farmstead with 50m buffer around cultural landscape areas.

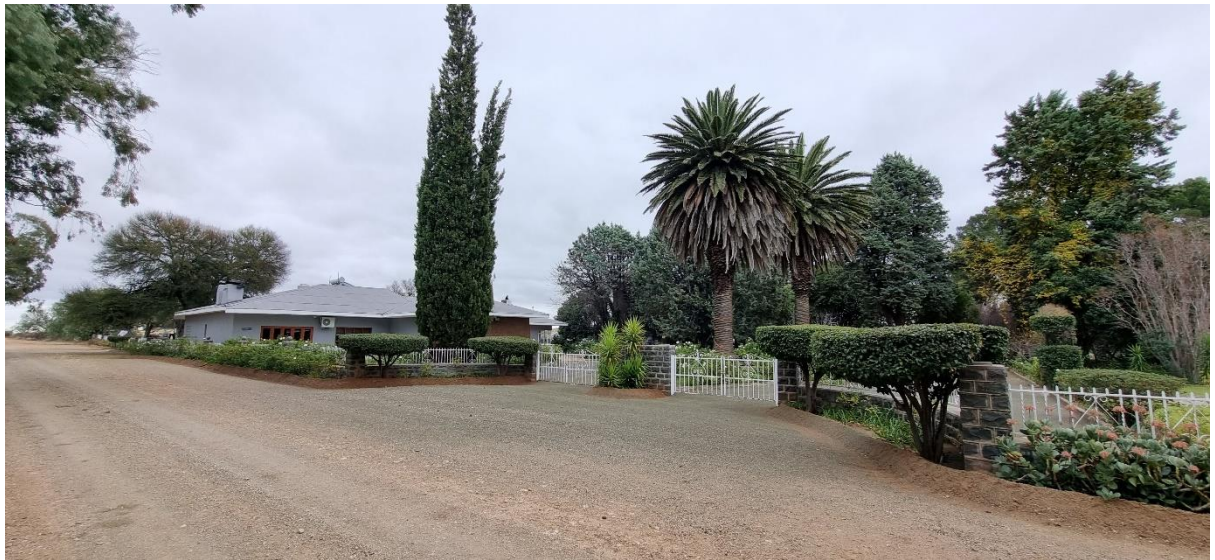
ID	20
PHOTO	Farmstead
RISK	High
DIRECTION	SE
COMMENT	No-go for cultural landscape

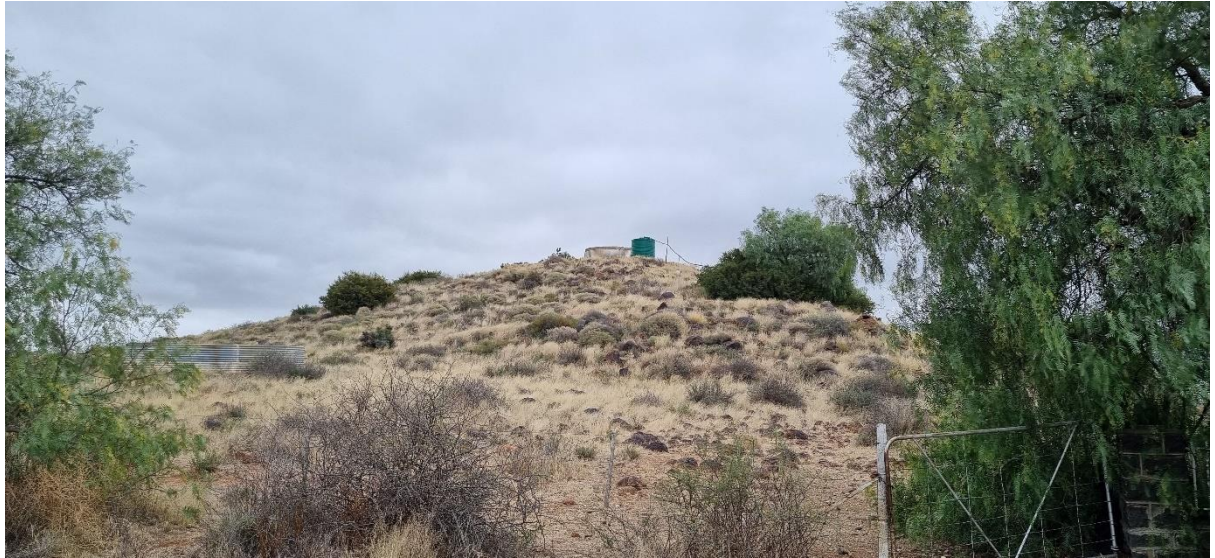
ID	21
PHOTO	Small hill
RISK	High
DIRECTION	E
COMMENT	Exclusion as part of farmstead cultural landscape.

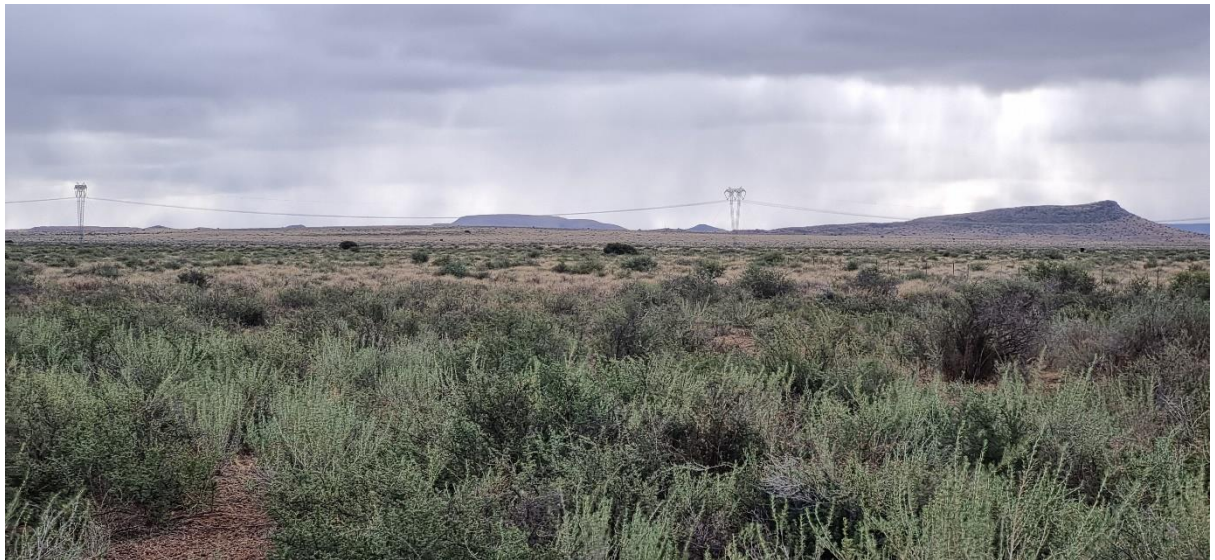
ID	22
PHOTO	Site PV
RISK	Low
DIRECTION	SE
COMMENT	Low prominence and exposure. Existing OHPL in the background.

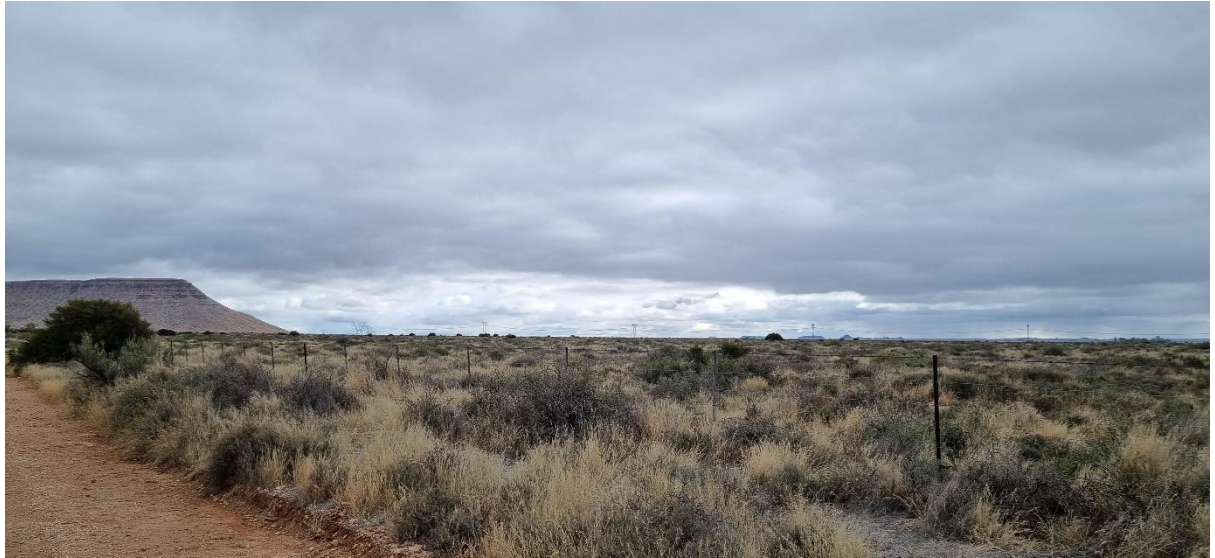
ID	23
PHOTO	Site PV
RISK	Low
DIRECTION	W
COMMENT	Low prominence and exposure.

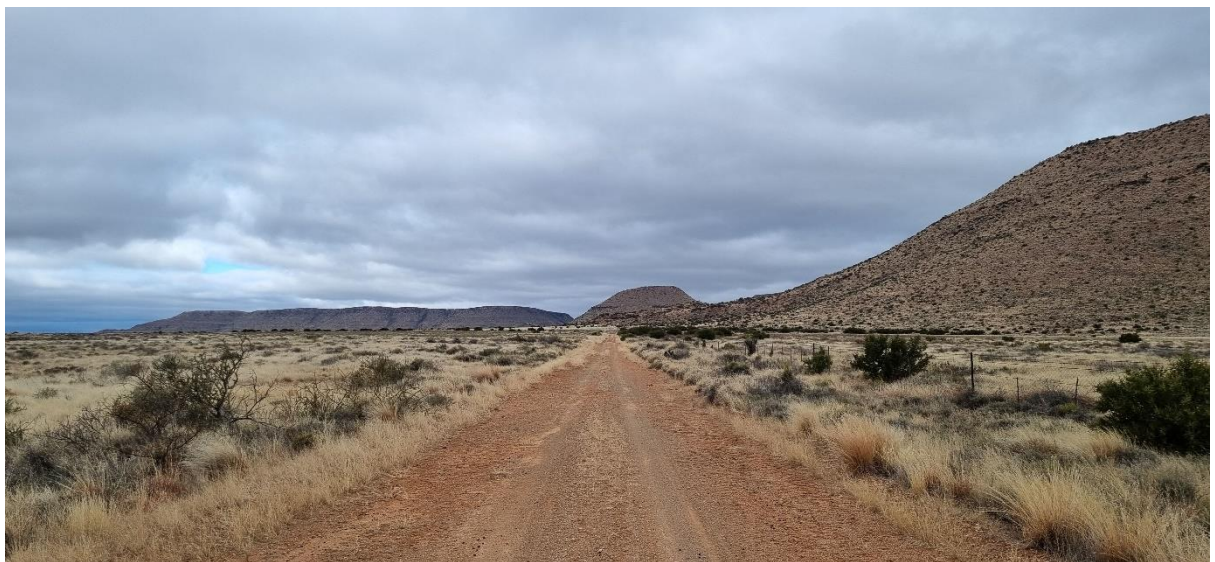
ID	24
PHOTO	Hill landforms setback point
RISK	Medium
DIRECTION	SE
COMMENT	Flat topped inselberg features unique in landscape. Setback buffer 500m to point for suitable development.

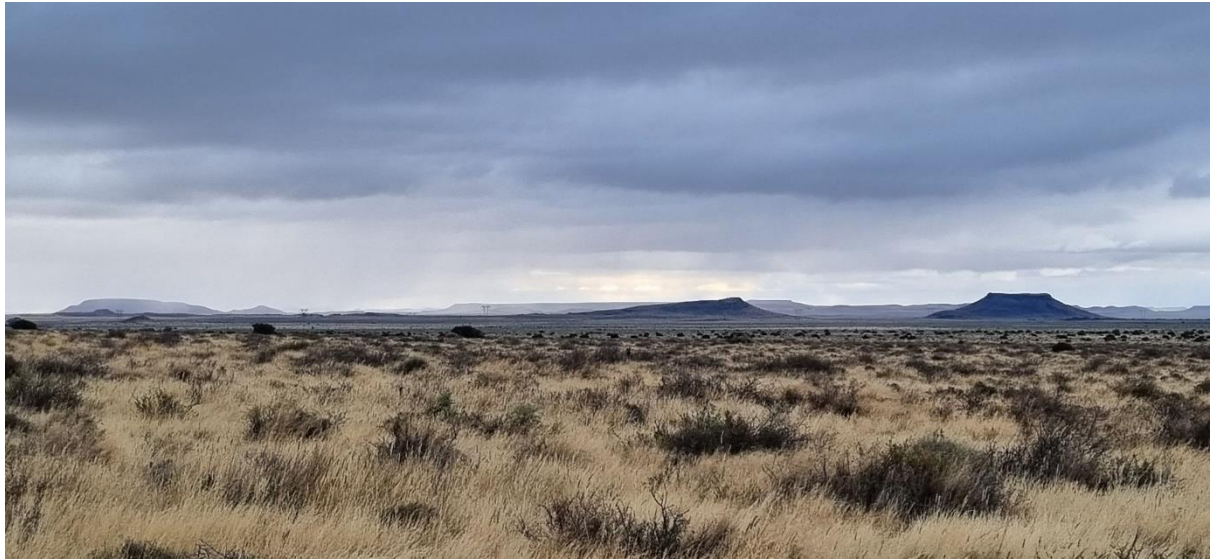
ID	25
PHOTO	Sense of Place Nama Karoo
RISK	High
DIRECTION	NW

COMMENT	Inselberg mountain features contrasting with surrounding flat plains.
----------------	---

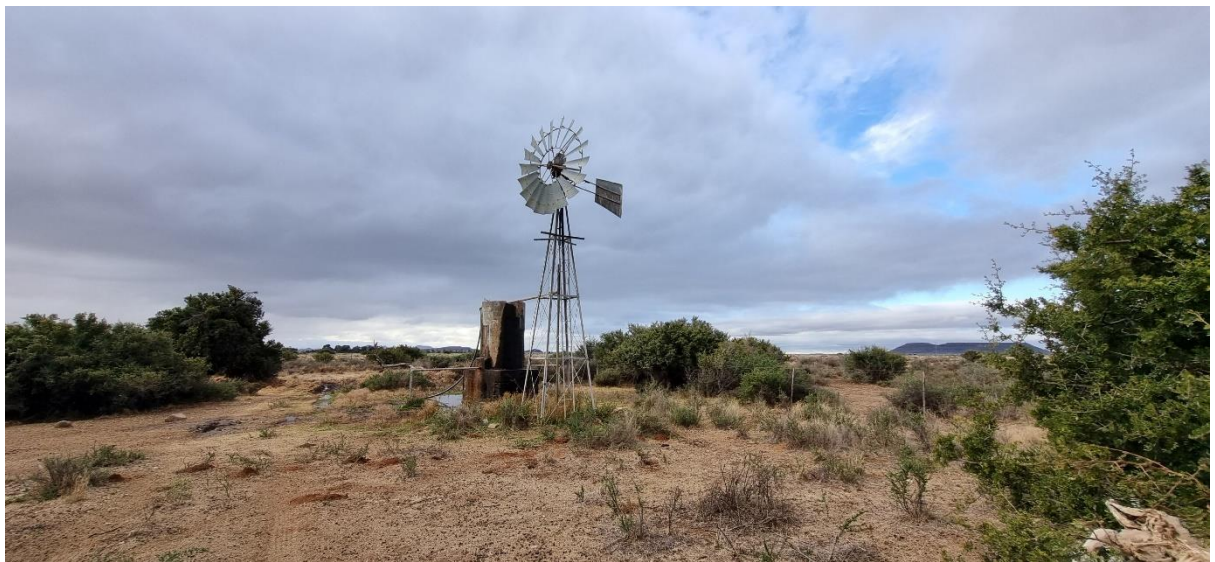
ID	26
PHOTO	Site agricultural farming
RISK	Medium
DIRECTION	N
COMMENT	Some landscape value from karoo farm. Not so significant that loss would constitute a fatal flaw. Mitigation requires agriculture continuation. Water holes have value.
