Geotechnical Desktop Study Report

Mogobe Battery Energy Storage System (BESS) Grid Corridor, Northern Cape

Client Reference No. PA984
Prepared for Mogobe EGI (Pty) Ltd.
26 April 2024

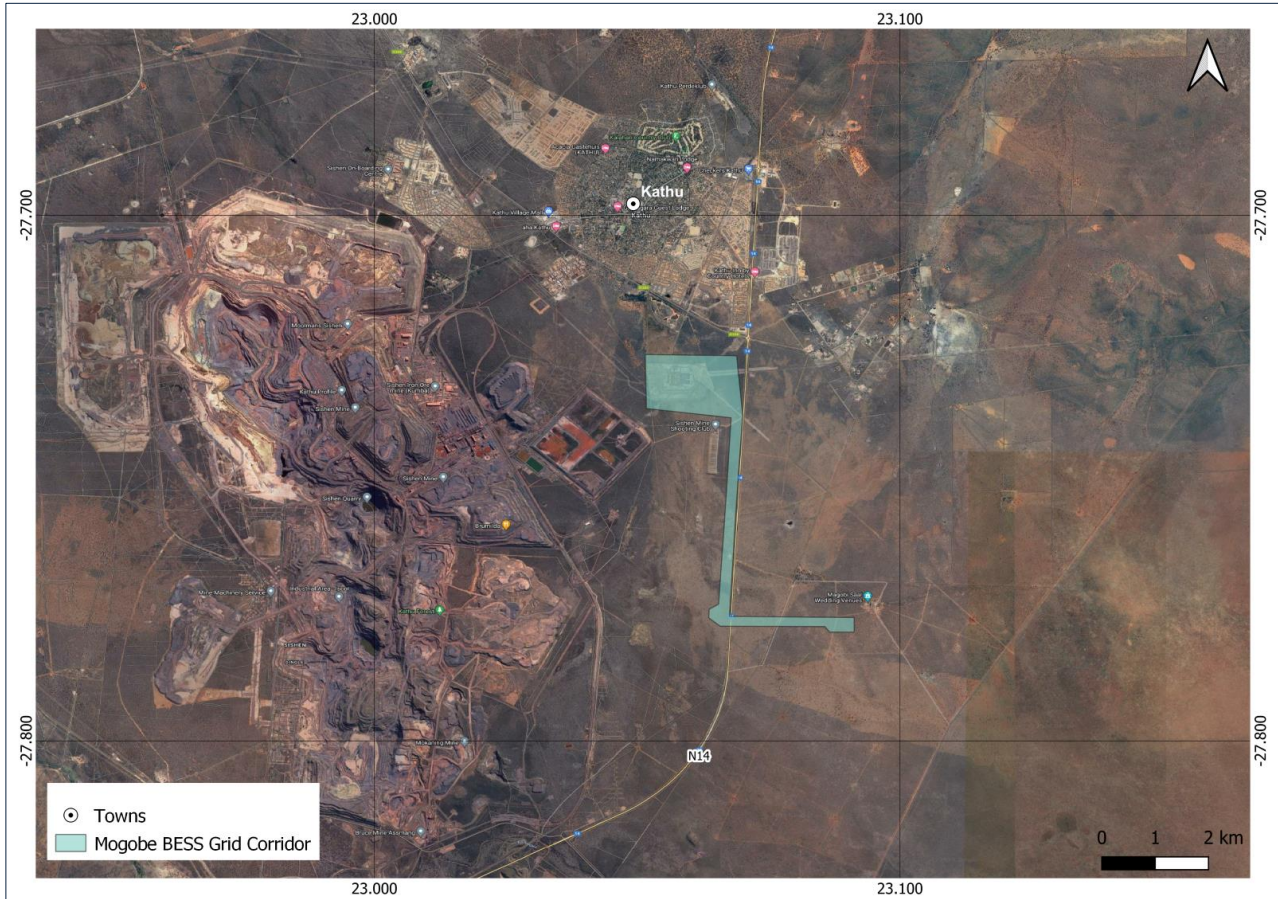
Figure 1-1: Site Layout Plan

Mogobe EGI (Pty) Ltd. ("Client") is in the process of developing a Battery Energy Storage System (BESS) grid corridor near Kathu in the Northern Cape Province, South Africa. The proposed grid corridor extends for a distance of approximately 9 km north of the BESS site (Figure 1-1).

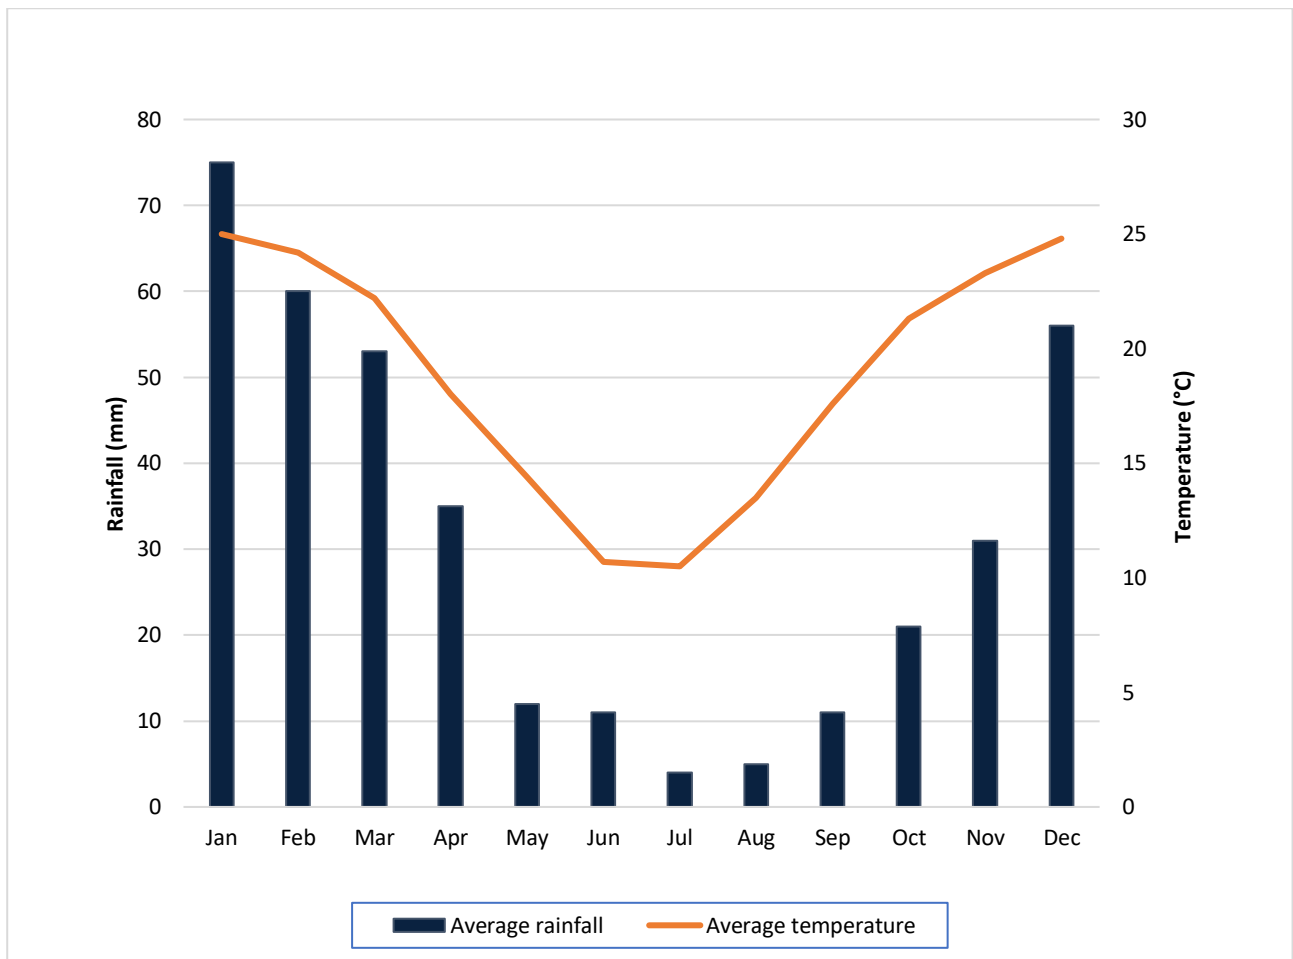
Figure 2-2: Summary of Climatic Data in the Site Region (after World Weather Online, 2024)

This region experiences local steppe climates, with Thornthwaite's moisture index between -40 and -20. Climatic data (World Weather Online, 2024) indicates that the mean annual temperature in this region is 18.8°C. The average maximum daily temperatures vary from 32.2°C in December to 18.8°C in June-July. Corresponding minimum temperatures for these months are 16.4°C and 2.5°C, respectively. The mean annual precipitation is approximately 374 mm, falling mainly during summer. Precipitation is the lowest in July, with an average of 4 mm. The greatest amount of precipitation occurs in January, with an average of 75 mm. The average monthly temperature and rainfall distribution are illustrated in Figure 2-2.

The climate is a pivotal factor for geotechnical considerations as it determines the mode and rate of rock mass weathering and, thus, the formation of soils. Weinert (1980) developed the N-Value to differentiate between regions of similar weathering characteristics. The N-value for this region is around 9, indicating that mechanical disintegration will be the dominant type of weathering, resulting in thin residual soils and weathered profiles.
