# HERITAGE IMPACT ASSESSMENT

## **Proposed Development of the Salsola PV Facility and Associated Infrastructure on Remaining Extent (Portion 0) of Farm 423 near Beaufort West, Western Cape**

Prepared by CTS Heritage

**November 2021**

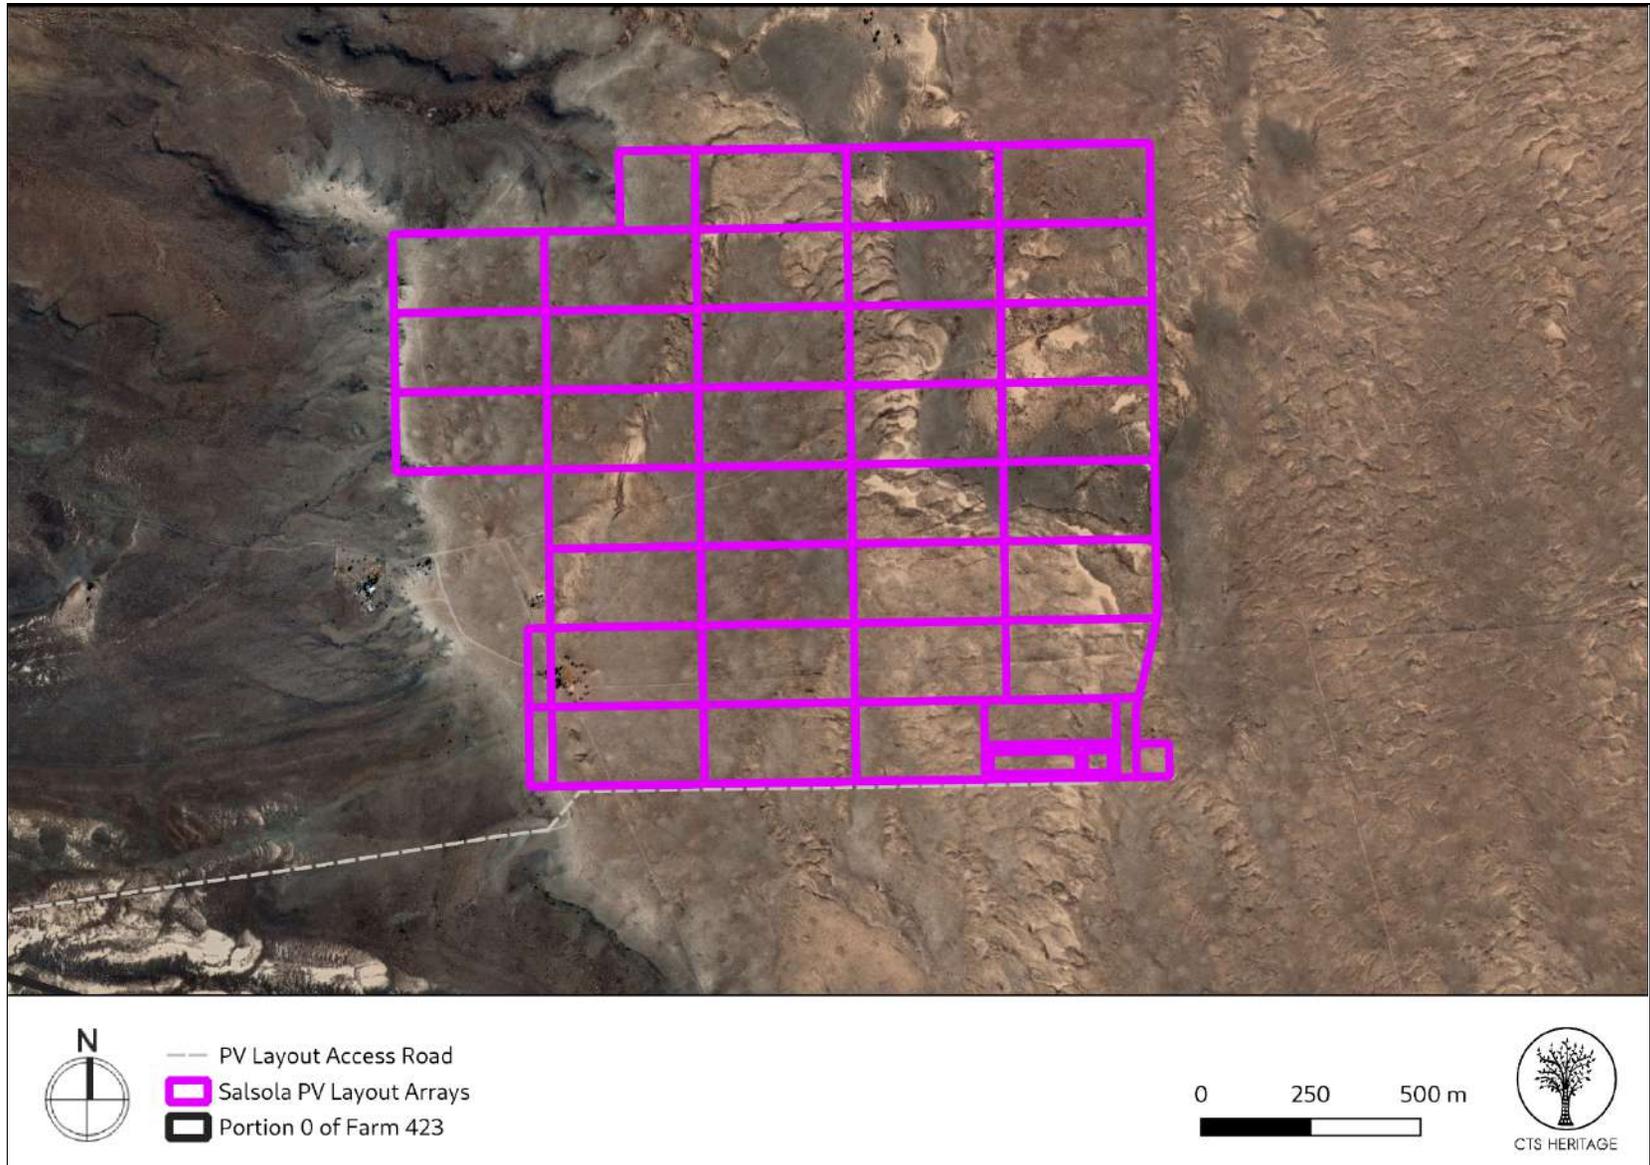
Figure 1.3: The proposed development layout of the Salsola PV Facility

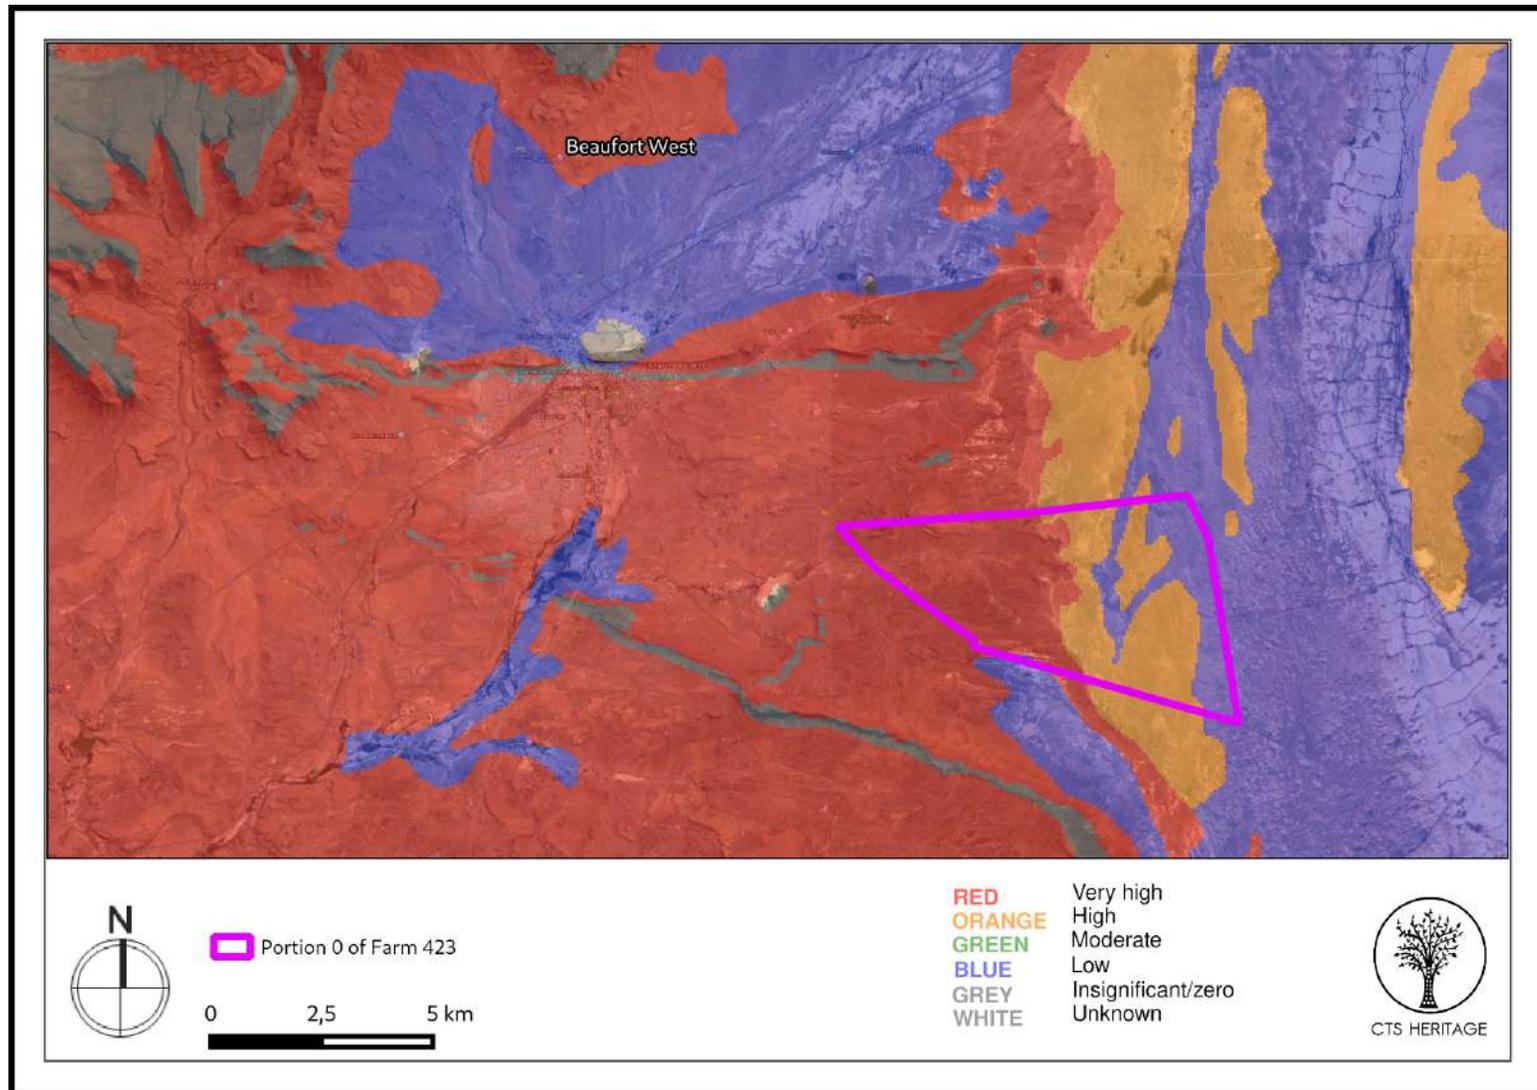
Figure 3.1: Palaeontological sensitivity of the proposed development area

It is concluded that the Salsola PV facility is of LOW palaeosensitivity and no impact to significant palaeontological heritage resources is anticipated. There are no fatal flaws or objections to authorisation of the proposed projects on palaeontological heritage grounds. No further specialist palaeontological studies or mitigation are recommended for these renewable energy projects. The Chance Fossil Finds Protocol appended to this report should be included in the EMPr for the developments.

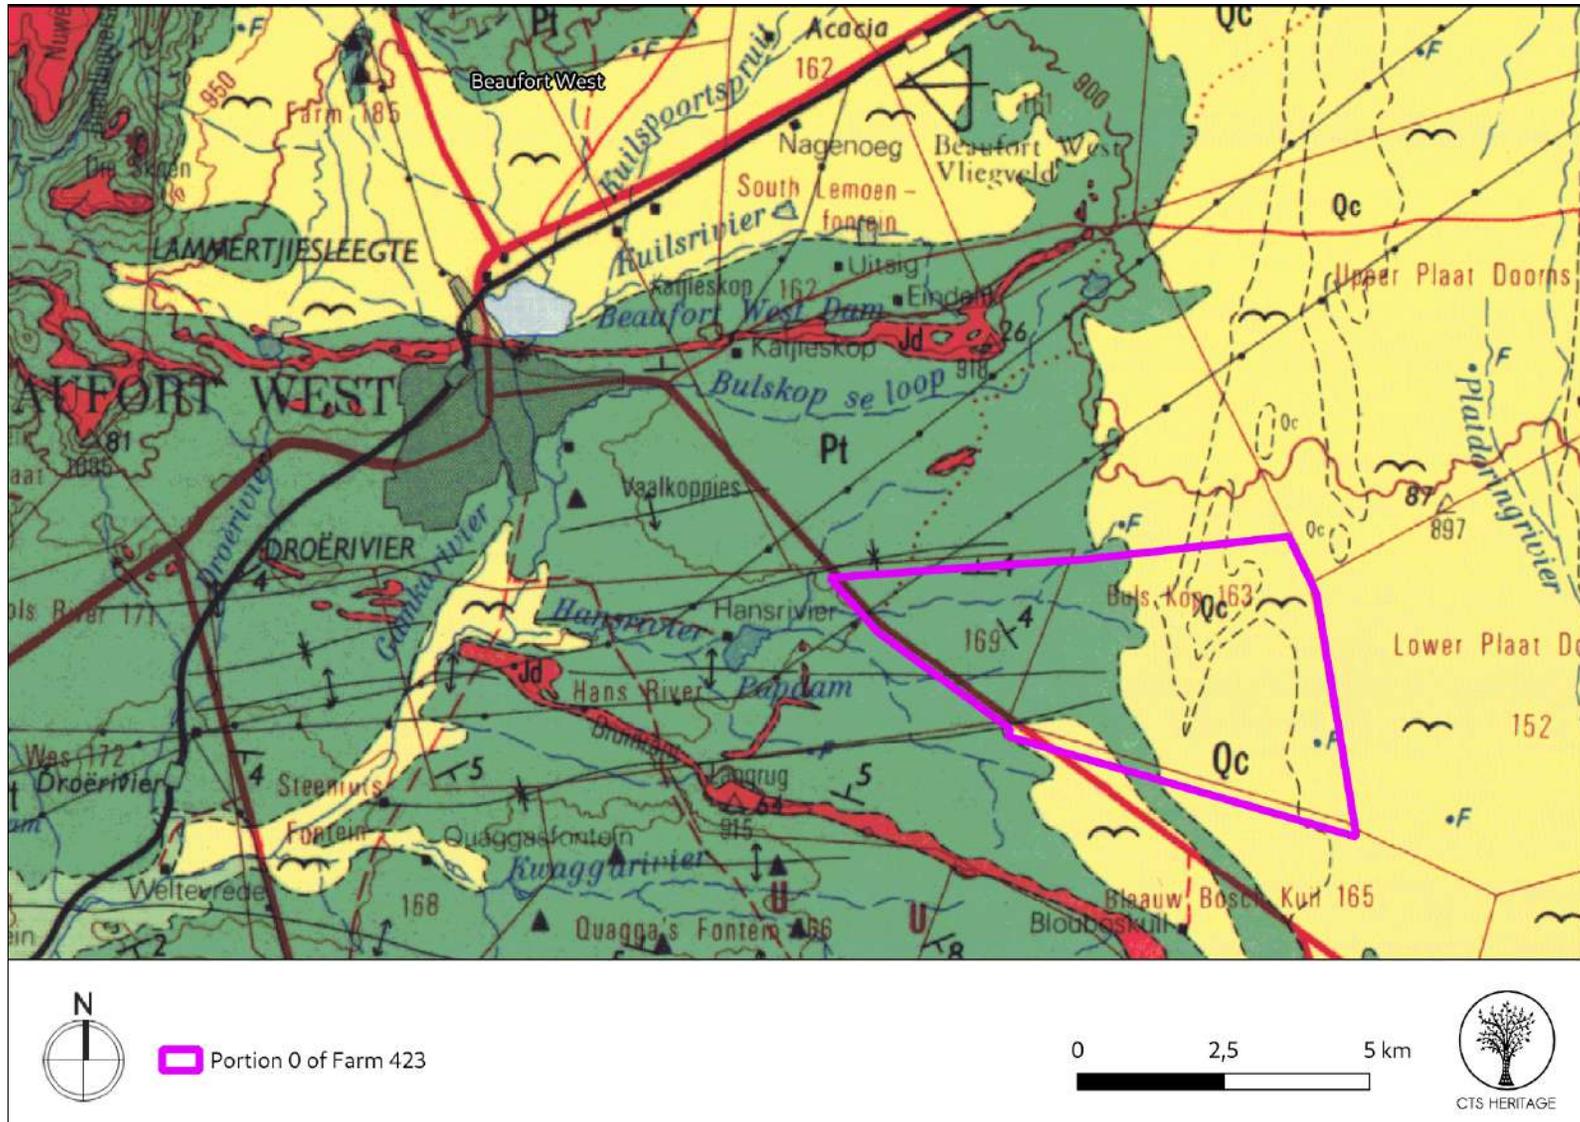
Figure 3.2: Geology Map. Extracted from the Council for GeoSciences Map 3222 for Beaufort West indicating that the development area is underlain by Pa: Abrahamskraal Formation and Pt: Teekloof Formation, both of the Adelaide Subgroup of the Beaufort Group of sediments

diversity invertebrate trace fossil assemblages within channel sandstones. The only fossils recorded within the Late Caenozoic alluvial deposits are occasional calcretised termaria of possible Pleistocene or Holocene age. The Palaeozoic and Caenozoic fossil sites all lie approximately 1.5 km west of development area (See satellite map A1 in Appendix 1 of the PIA), most are of modest scientific or conservation value and no mitigation in their regard is recommended here (Table 4).

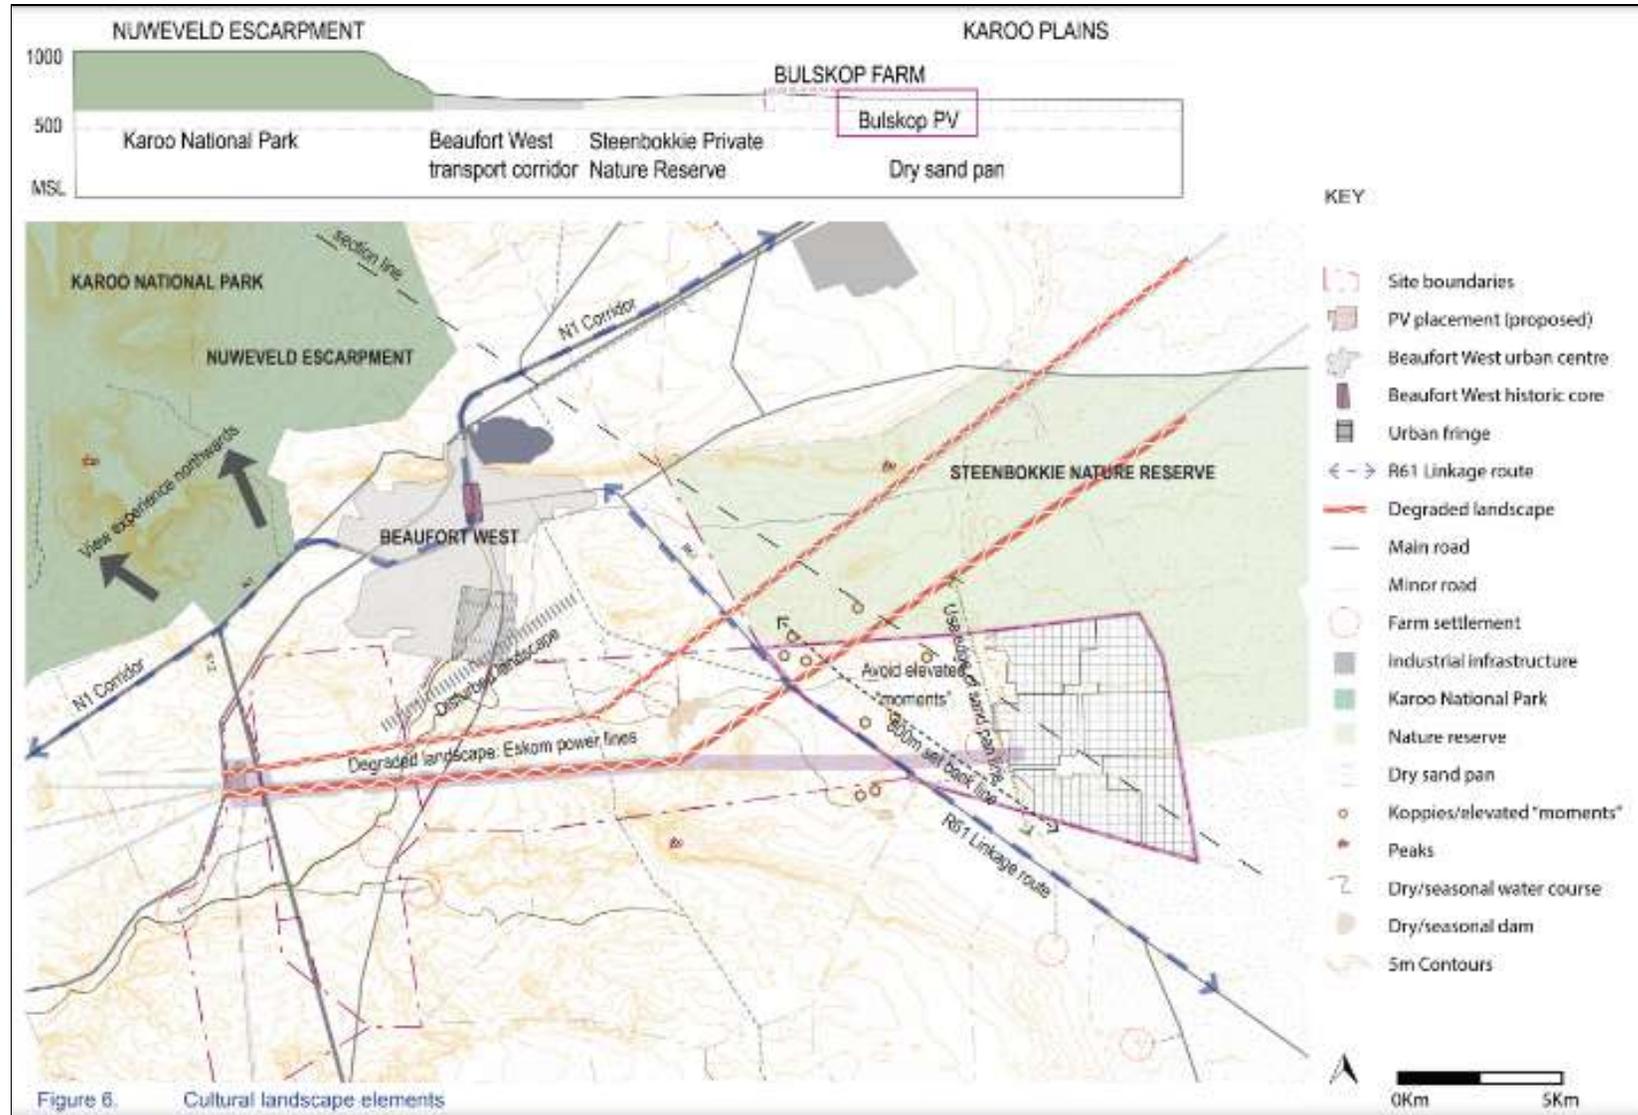
The Cultural Landscape Assessment identified low levels of significance of the study area and its landscape context. Only one aspect of the broader study area was identified to have some cultural significance – it was noted that the R61 could be considered as an important linkage route and in traversing a representative karoo landscape of what is colloquially known as ‘Die Vlakte’. The proposed development of the Salsola PV Facility may negatively impact on how this linkage route is experienced (Figure 4). While considered a heritage resource, the Karoo National Park is located sufficiently far from the proposed development to warrant no further analysis in this assessment.

Figure 4: Cultural Landscape Elements Map from Winter et al. 2021 (Appendix 3)

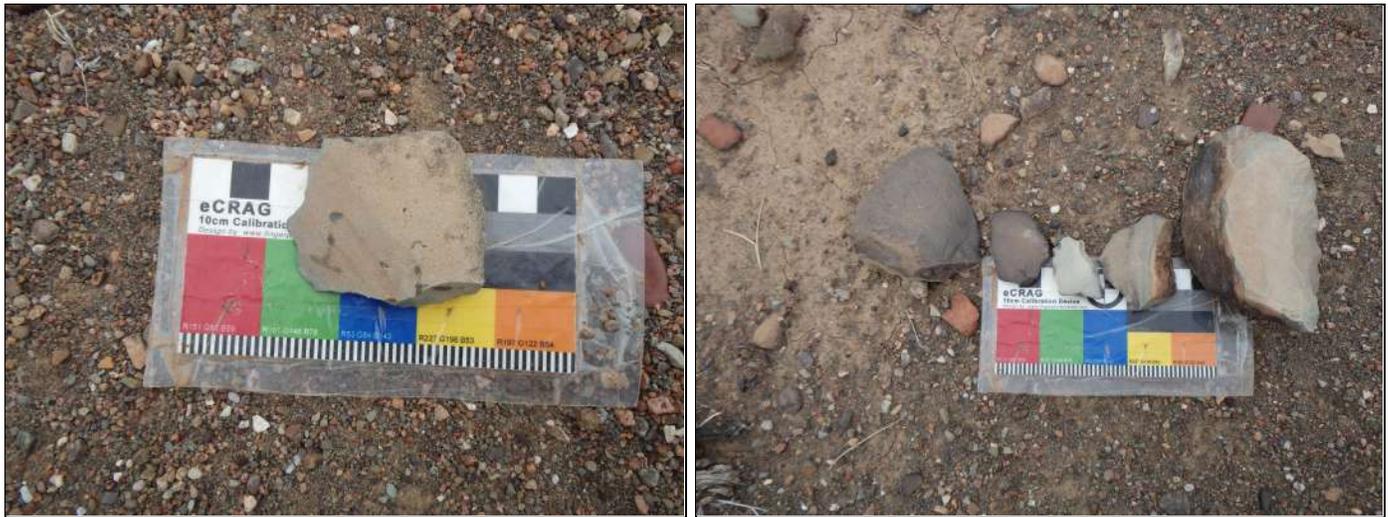
**Figure 5. Observation BLK030 (Grade IIIC)**

POINT ID	Site Name	Period	Description	Co-ordinates		Grading	Mitigation
BLK 030	Bulskop 030	MSA	Open site with mixed raw materials, flakes, cores, siltstone, hornfels. Floodplain, vegetation slightly better condition here due to groundwater	-32.40809	22.69982	IIIC	None required
BLK 055	Bulskop 055	Modern, Historic	Hansrivier farmhouse complex. Currently abandoned – consists of main farmhouse painted yellow with green corrugated roof and outbuildings as well as vandalised/ruined labourers cottages.	-32.39148	22.62556	IIIC	50m Buffer

Only one archaeological resource of contextual significance was identified (BLK030). This site has been sufficiently recorded and no further mitigation is recommended. Furthermore, based on the available layout, no impact to this site is anticipated as it is located well away from the Salsola PV development footprint.
