“House Maritz”

Erf 390 & Rem 141 Keurboomstrand

Coastal Engineer's Report

WML Coast Pty (Ltd)

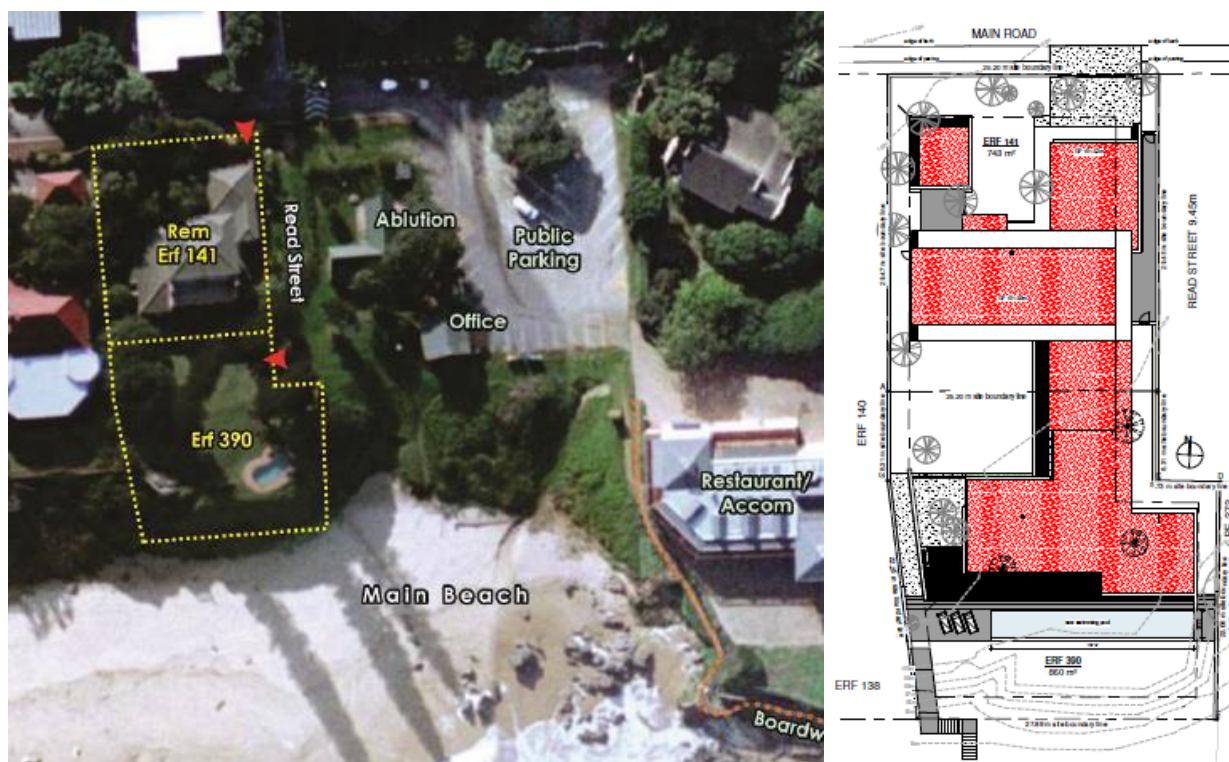
Figure 3: Setting and current layout of Rem Erf 141 and Erf 390 (left, Perception Planning) and new dwelling site plan (right, CLD Architects)

WML Coast was appointed to prepare a coastal engineer's assessment for the remainder of Erf 141 and Erf 390 (Main Street, Keurboomstrand). The applicant is proposing the consolidation of these two erven back into their original erf, breaking down the existing dwelling and building a new dwelling. Figures 1 and 2 below show the location and Figure 3 shows the current and future layout plans.

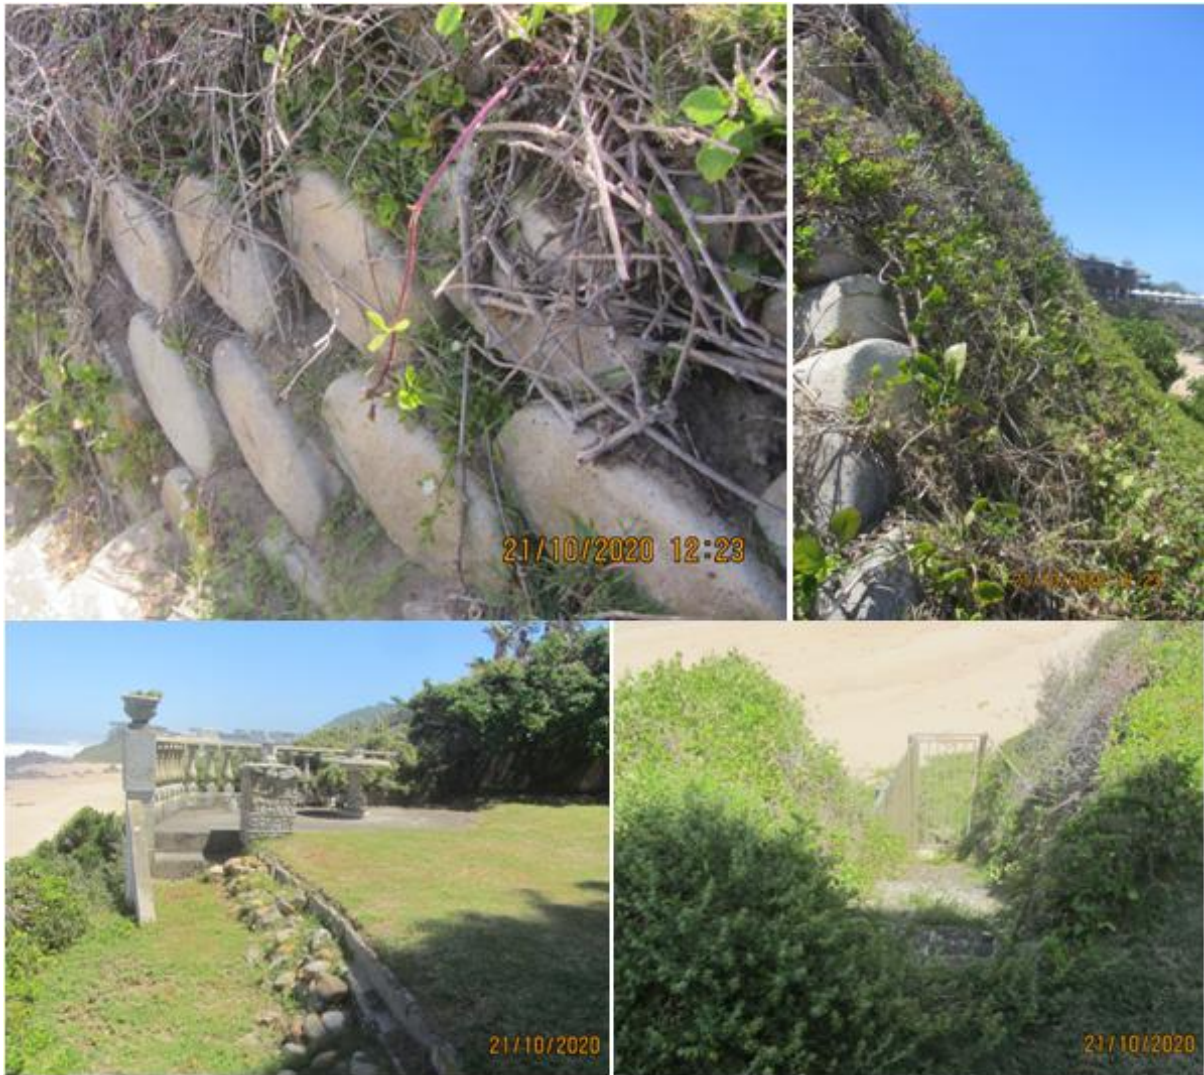
Figure 6: Photographs showing the interlocking concrete block retaining wall, stairway and upper concrete retaining wall / viewing deck (Melissa Mackay, CapeEAPrac)

The contour levels on the seaward side of Erf 390 on the mean sea level (MSL) datum are shown in Figure 4 (extracted from the surveyors drawing provided). 0 m MSL appears to be at approximately 90 m on the arbitrary architect's datum (AD) used for the SDP layout (CLD Architects). There is currently an interlocking concrete block retaining wall at a slope of 4:3 (vertical: horizontal) on the

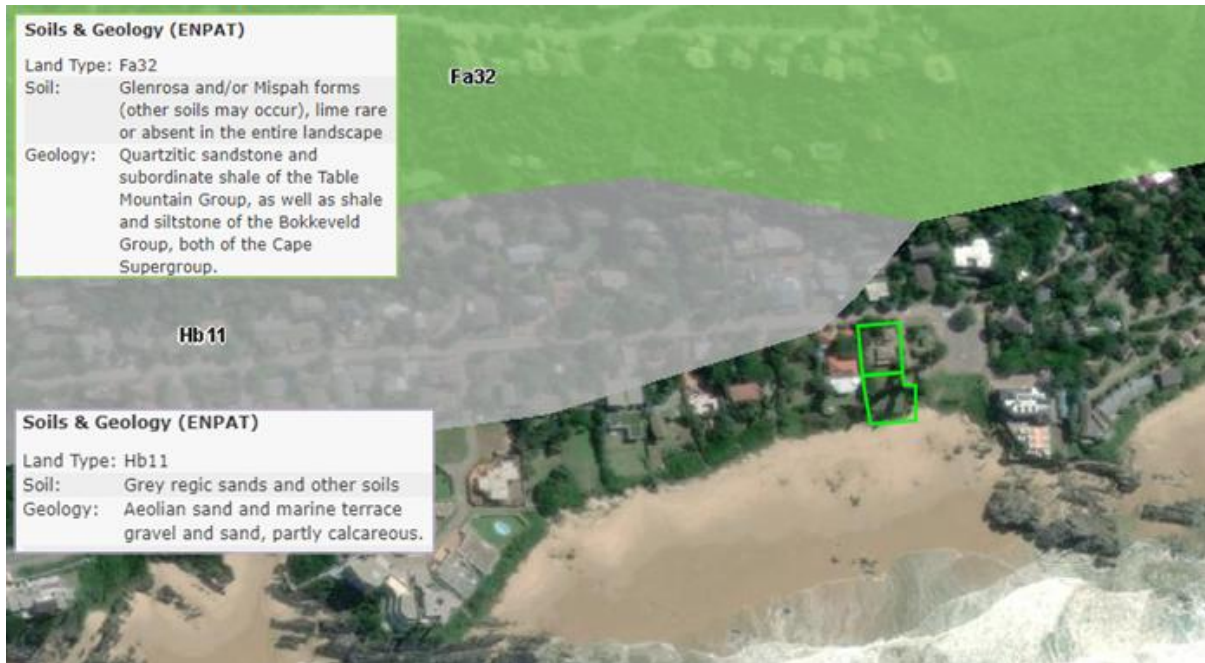
Figure 9: Soils & Geology near the site from Environmental Potential Atlas of South Africa (CFM, 2021)

No geotechnical reports for the site have been provided. It is assumed that the site is a retained sand dune with rock below at approximately sea level. The soil and geology description closest to the site from the Environmental Potential Atlas of South Africa (see Figure 9 below) is “grey regic sands and other soils; Aeolian sands and marine terrace gravel and sand, partly calcareous”.

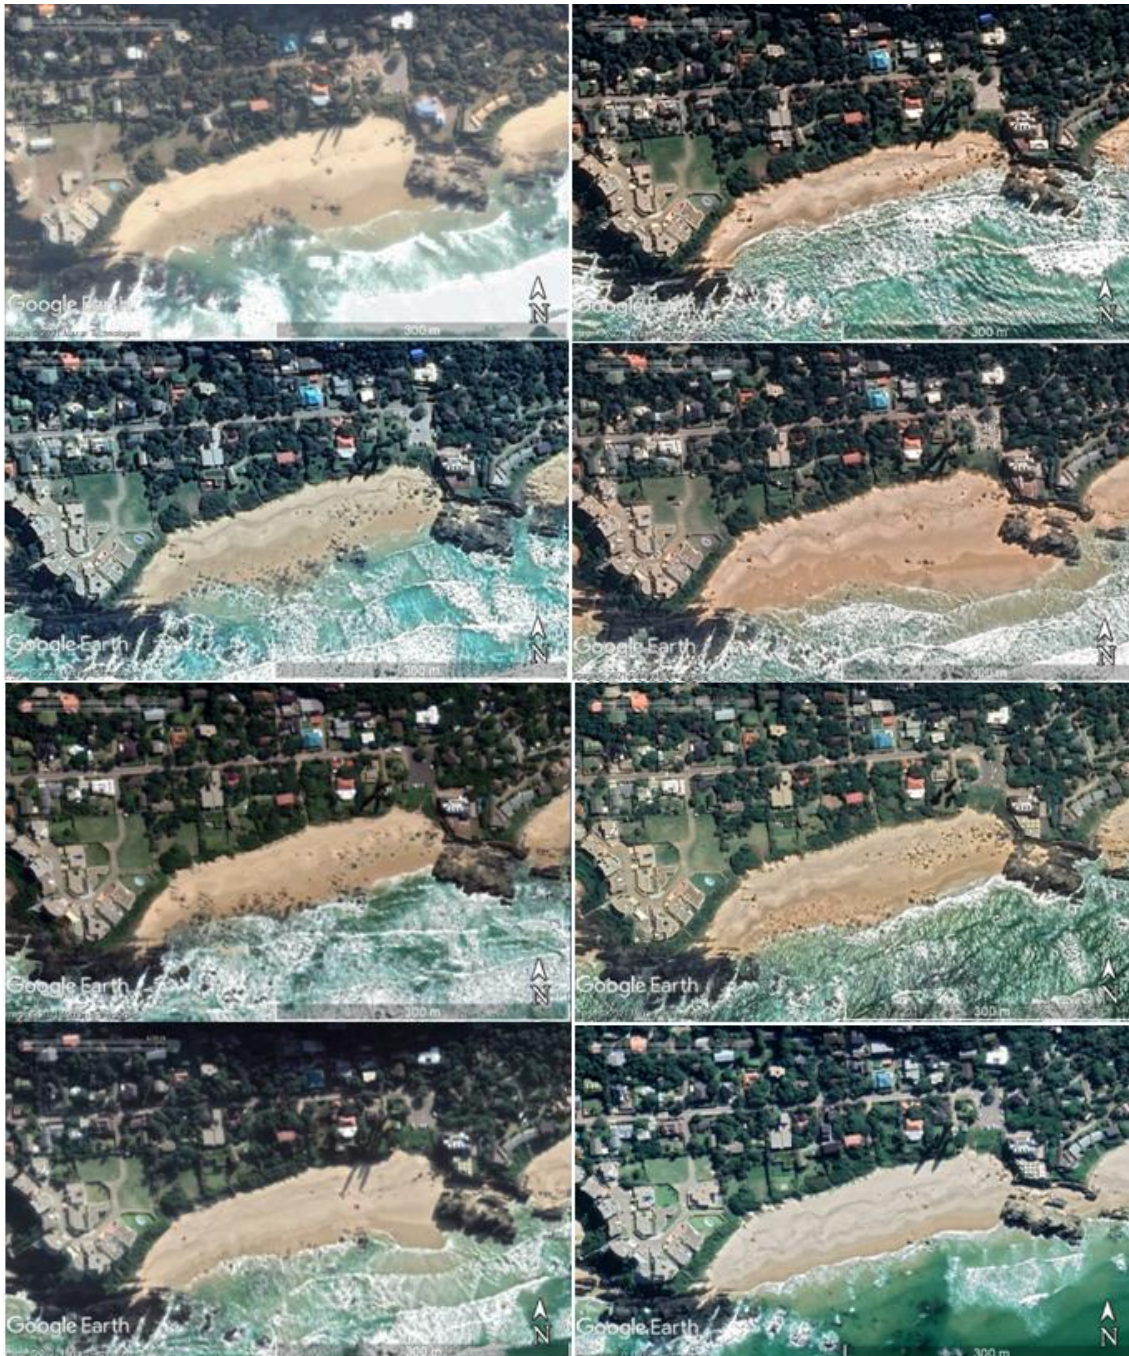
Figure 10: Selected satellite images of Keurboomstrand Beach between 2004 and 2021 (Google Earth)

The Keurboomstrand Beach sand erodes and accretes intermittently over time and appears to be currently “dynamically stable”. Selected historical aerial photographs over the past 17 years are shown in Figure 10. West of Erf 390 thin dune vegetation appears to have grown further seaward over the past decade whereas the vegetation line in front of the public parking to the east shows some erosion (see Figure 11). These minor trends are probably primarily due to pedestrian traffic rather than coastal processes. The effects of climate change (including sea level rise and increased storm intensity) can nonetheless be expected to pose increasing risk to the beachfront properties in this area.

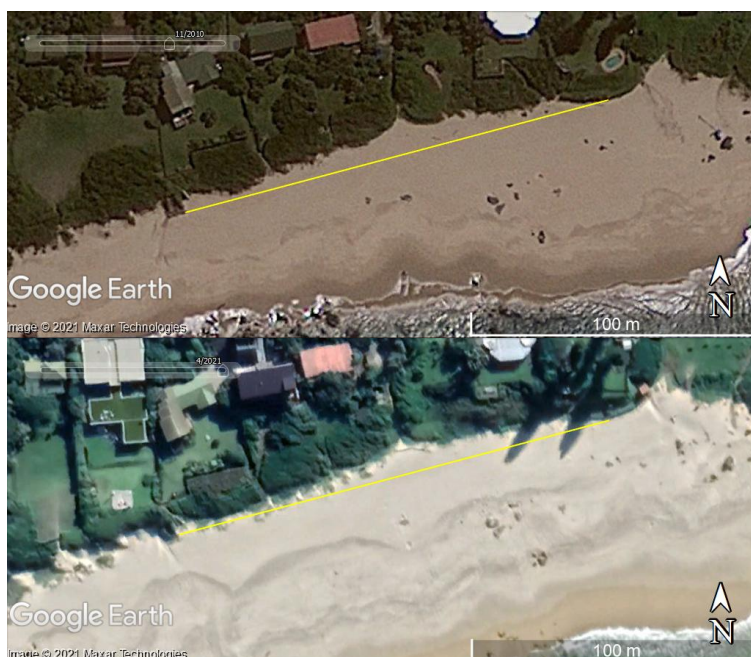
Figure 11: Satellite images taken 2010 (top) and 2021 (bottom) of Keurboomstrand in front of Erf 390

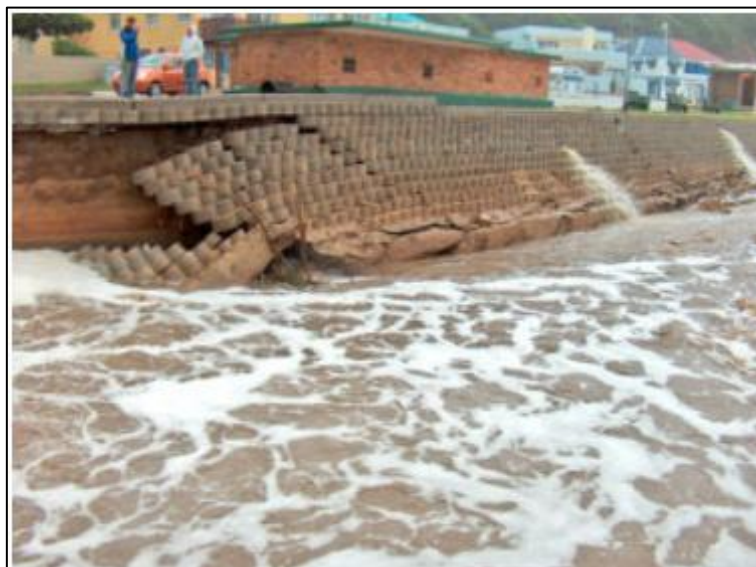
Figure 13: Failure of an interlocking concrete block wall at Herolds Bay in 2006 (terraforce.com, 2019)

While no physical inspections were made and no structural details have been reviewed, we consider the retaining wall on the beachfront edge of Keurboomstrand Erf 390 to be at risk from coastal attack. Interlocking concrete block retaining walls are typically highly susceptible to complete failure (via a “domino effect”) when undermined and are not suitable as seawalls when the structures behind are reliant on them. The photograph below shows failure of such a seawall in Herolds Bay in 2006.
