Water Use Assessment Form

Lower Schoonberg Farm 1/108, Quaternary Catchment J34E

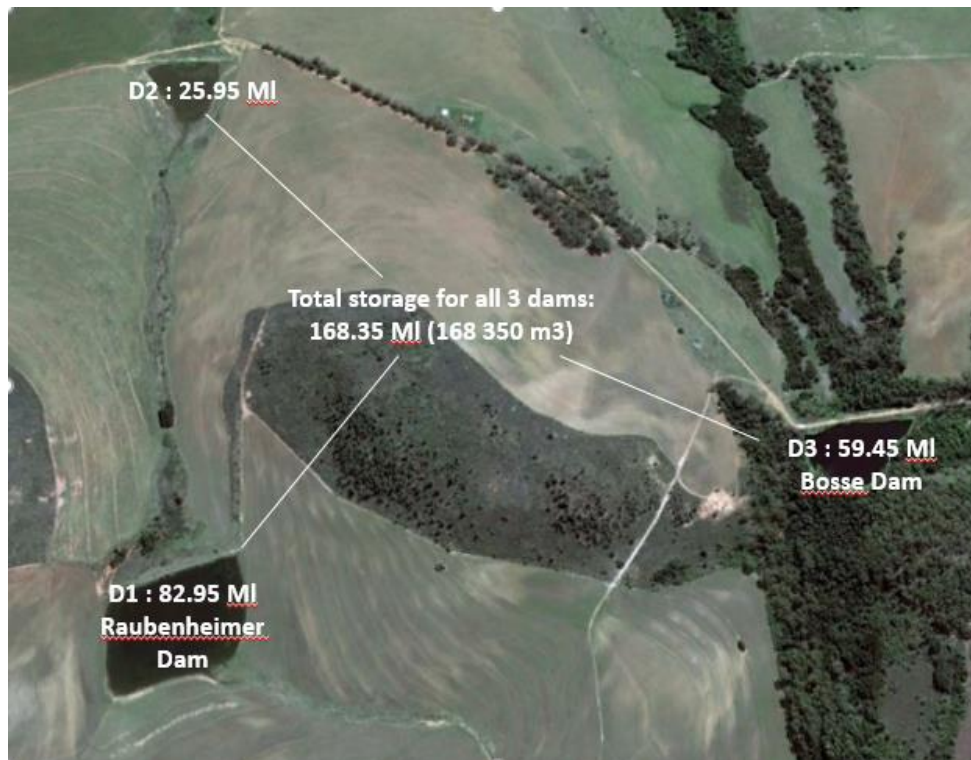
Figure 4. Contour survey volumes from water affairs document (D3 = Bosse Dam)

The same document provides volumes for all three dams on 1/108 which are shown in Figure 4 together with a total combined volume of 168 350 m³. This is close to what was determined in the V & V.

The difference between the historical volume of 59 450 m³ and the current volume of 163 500 m³ is **104 050 m³**, which is the amount to be applied for in the WULA.
