SENSITIVE WATERCOURSE CROSSINGS BY THE WATER PIPELINE TO BE UPGRADED (SOURCE: CONFLUENT)

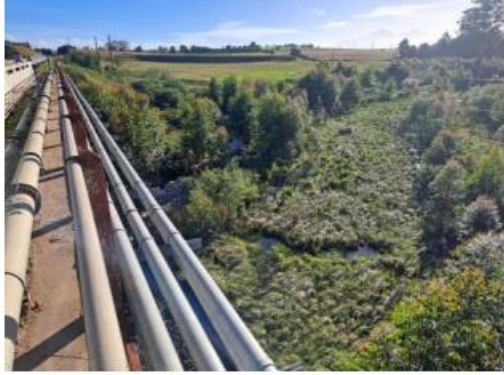
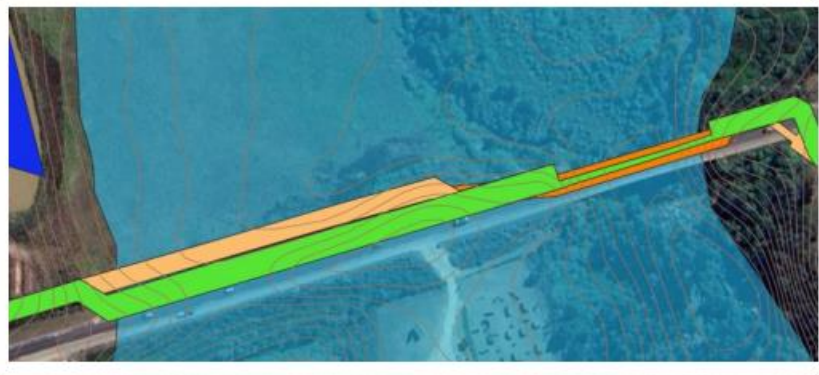
<p>Gwaing River Channelled Valley Bottom Wetland and associated enhanced wetland due to stormwater runoff to the west. Existing pipeline route above river on bridge and above wetland along road embankment.</p>

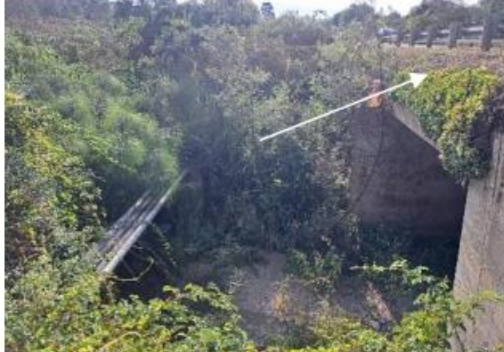
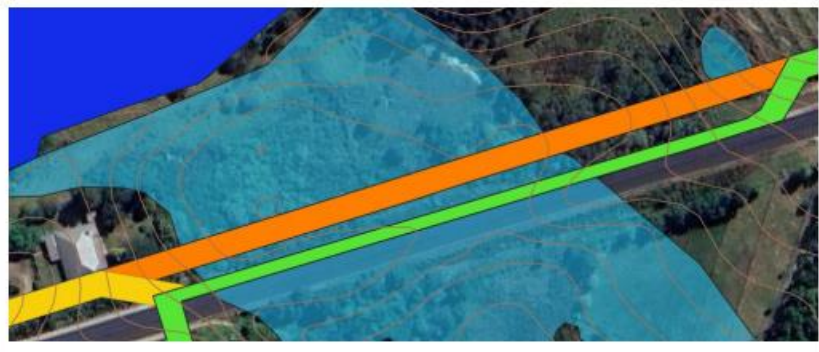
B

<p>Norga River Channelled Valley Bottom Wetland dammed upstream of the road. Major interception of flow by dam. Channelled spillway from dam leads to culvert under road. The preferred option crossing would be mounting the pipeline on top of the existing culvert (see arrow).</p>

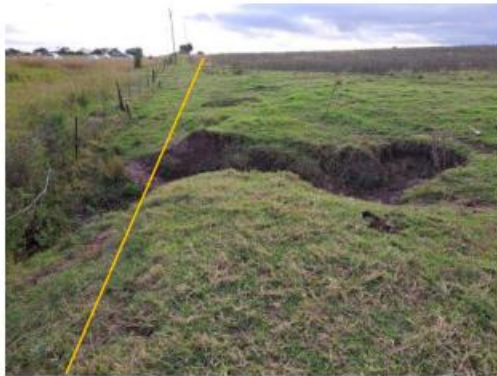
C

Possible Wetland

Historic temporary seep significantly disturbed due to intensive grazing road construction and subsequent erosion and slumping of soil.

Pipeline installed using Horizontal Directional Drilling at this point. This represents a precautionary approach.

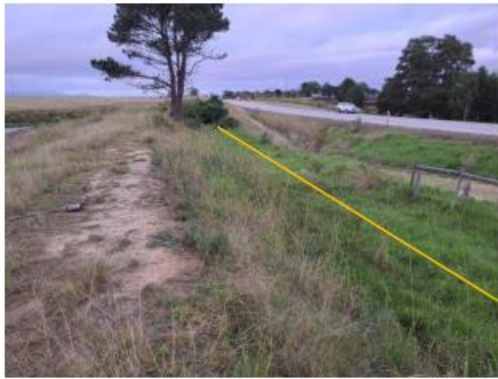
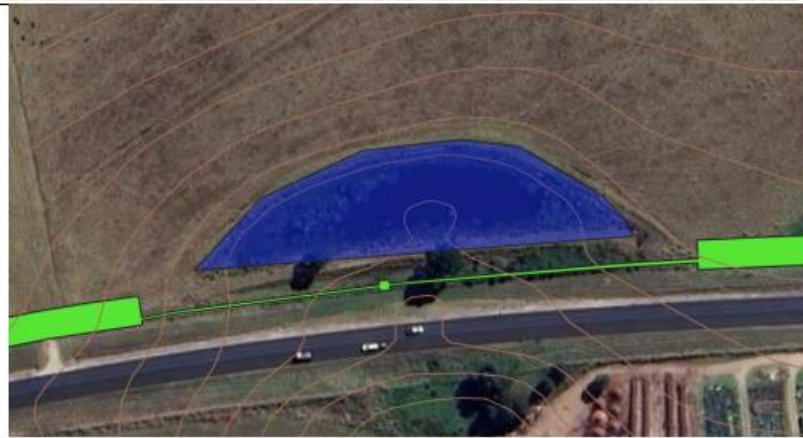
D

Dam

Probably old seep which was excavated for a dam. New pipeline route through highly disturbed vegetation impacted by existing road, dam embankment and alien vegetation. Pipeline installed using Horizontal Directional Drilling at this point.
