# Construction of Stormwater Infrastructure for Erosion Control – Erf 326, 318 and 139, Herolds Bay, Western Cape.

## Aquatic Compliance Statement

**Prepared For:** Cape EAPrac  
**Author:** Dr. J.M. Dabrowski (PhD)  
Confluent Environmental Pty (Ltd)  
7 St. Johns Street,  
Dormehlsdrift,  
George, 6529  
**SACNASP:** Pr. Sci. Nat. (Water Resources) – 113456  
**Reviewer:** Dr. J. Dabrowski (PhD)  
**Date:** 16 January 2024  
**Version:** Draft Final

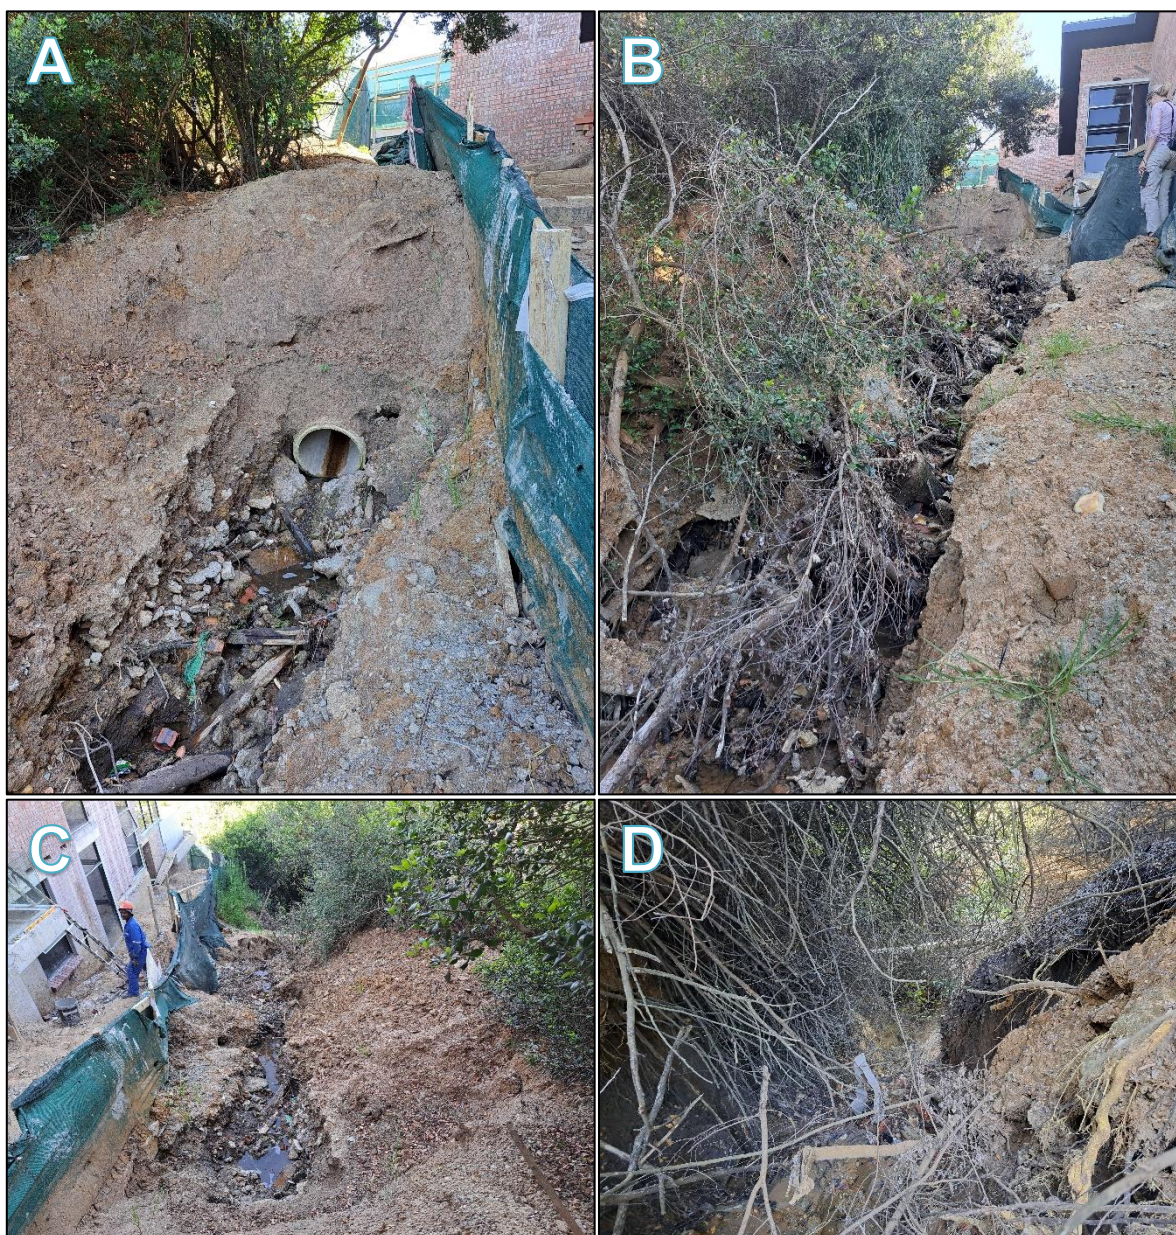
The site visit was conducted on the 26<sup>th</sup> of January 2024. Significant erosion was observed to the south of Voëlklip Road resulting in a very steep, narrow, deeply incised channel (Figure 5). This erosion has most definitely been caused by stormwater originating from a culvert beneath Voëlklip Road. It was not possible to walk the entire length of the eroded channel due to very steep drop-offs along its length, but a clear view of the channel up to the sewer line crossing the watercourse was visible. From this view it was evident that the erosion extended far down the slope and is likely to have reached the non-perennial watercourse that runs just to the west of the channel. Given the inaccessibility of the length of the erosion channel it is uncertain to what extent the stormwater runoff has impacted on the watercourse further down the slope – but based on observations made at the site it is quite likely that stormwater from

Voëlklip Road does most likely reach the watercourse. There was no clear indication of any channel or erosion upstream of Voëlklip Road.

*Figure 5: Photographs of the eroded channel below Voëlklip Road including the stormwater outlet discharging into the channel (A); a view of the eroded channel to the north (B); view of the eroded channel to the south (C); and the heavily eroded banks of the channel (with the sewer pipe crossing in the background (D)).*

The site visit revealed a highly eroded channel that extends relatively far down the steep slope to the south of Voëlklip Road towards the direction of a non-perennial watercourse that originates further to the west. This has been caused by stormwater flows originating from a culvert beneath Voëlklip Road. Given the extensive nature of the erosion it was not possible to determine whether the erosion channel eventually reaches the watercourse, but based on the gradient of the area and the extent of the erosion it is likely that it does. It is therefore

essential that this stormwater infrastructure be constructed with the aim of reducing the energy of stormwater discharge and reducing impacts to the watercourse further down the slope. No aquatic biodiversity will be impacted as a result of the construction of the gabion channel (or the sub-soil drainage and gabion wall upstream of Voëlklip Road). The proposal is aligned with the management objectives of SWSAs and will result in improved protection of the natural, watercourse further down the slope. With respect to the WCBSP, while the construction footprint falls within an aquatic ESA2, it does not fall within the watercourse for which this ESA has been assigned. Construction of the gabion channel will reduce the current impact on water-related services by allowing for the continued delivery of surface runoff without causing further degradation to CBA habitat further down the slope. For this reason, the sensitivity of the site is considered to be **Low**.

Given a watercourse is located further down the slope from the eroded channel it is however important that several management recommendations are implemented to avoid unnecessary impacts. These include the following:

- A construction schedule must be developed and clearly defined so as to avoid multiple sites being exposed and unattended to at any moment in time. The completion date for each phase of the construction must be indicated and all clearing, excavation, and stabilisation operations must be completed before moving onto the next phase;

- Dry working conditions must be established in the channel. Stormwater originating from the outlet on Voëlklip Road must be temporarily diverted around the construction site and safely discharged into the channel below;

- A temporary straw-bale check dam must be placed across the channel, immediately downstream of the construction area as a back-up to trap high levels of sediment in the event of a high rainfall event. The check dam and any accumulated sediment must be removed by hand as soon as construction is complete;

- No construction materials or topsoil must be stockpiled within the eroded channel. Stockpiles of construction materials must be placed outside of the channel (on as flat an area as possible) and protected (e.g. through use of sandbags and/or tarpaulins) to prevent materials being washed into the channel.

- Construction of a stilling basin at the outlet of the gabion channel should be considered so as further reduce stormwater energy and minimise erosion of the slope and watercourse downstream of the channel.
