Specialist terrestrial and botanical report for the stormwater infrastructure proposed on erven 139, 318, and 326 of Herolds Bay, in George local municipality.

Terrestrial Biodiversity & Terrestrial Plant Species Report

Prepared For: Cape EAPrac
Author: Miss Bianke Fouche (MSc)
Confluent Environmental Pty (Ltd)
7 St. Johns Street,
Dormehls Drift,
George, 6529
SACNASP: Cand. Sci. Nat. (Botanical Science) – 141757
Reviewer: NA
Date: 30 January 2024
Version: Draft

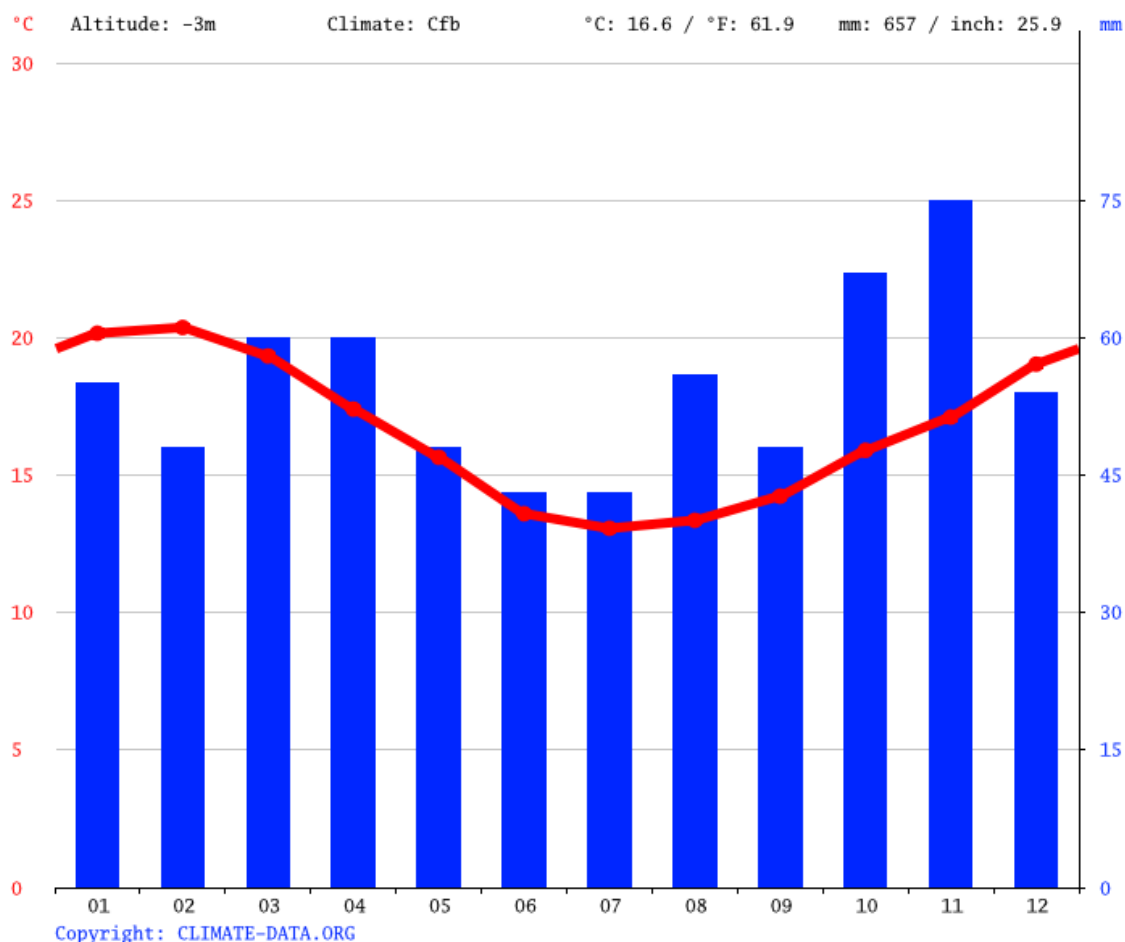
Figure 4: Climate data for Herold's Bay, where month 01 is January and 12 is December. Average Temperature per month is indicated by the red dots, and blue bars indicate average rainfall per month.

The proposed development is in Herold’s Bay. The temperature is highest in February, averaging a daytime temperature of around 20.4 °C (Fig. 4). The coldest month is July, averaging 13.1 °C. Decembers generally have the most rainy days (ca. 10 days), while May has the fewest (7 days). Rainfall in Herold’s Bay follows a little more erratic pattern, with no striking differences between different seasons of the year (Fig. 4). Relative humidity is highest in February (ca. 76%) and lowest in July (ca. 68%).

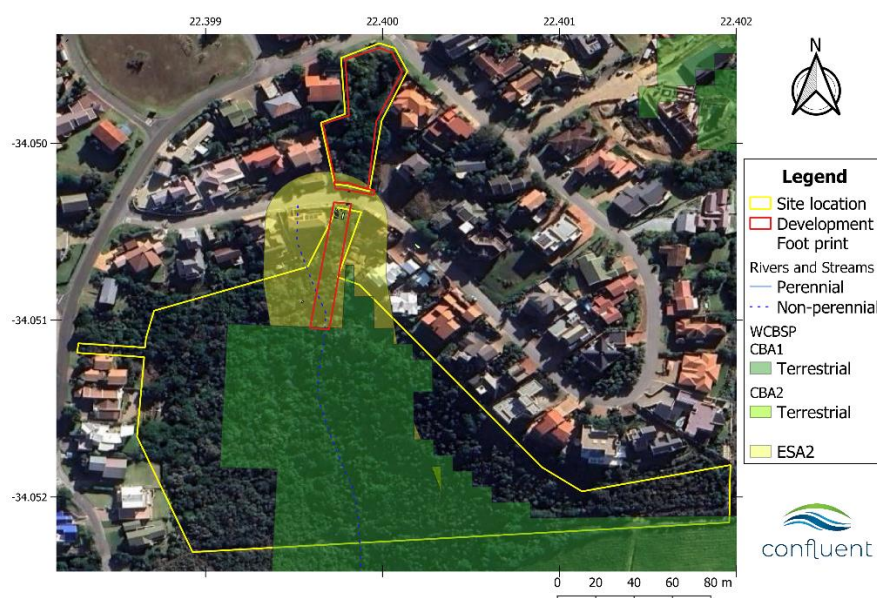
Figure 6: The mapped Western Cape Biodiversity Spatial Plan (WC BSP) categories that have been mapped for Brakfontein (Farm RE/236) and adjacent surrounding landscape.

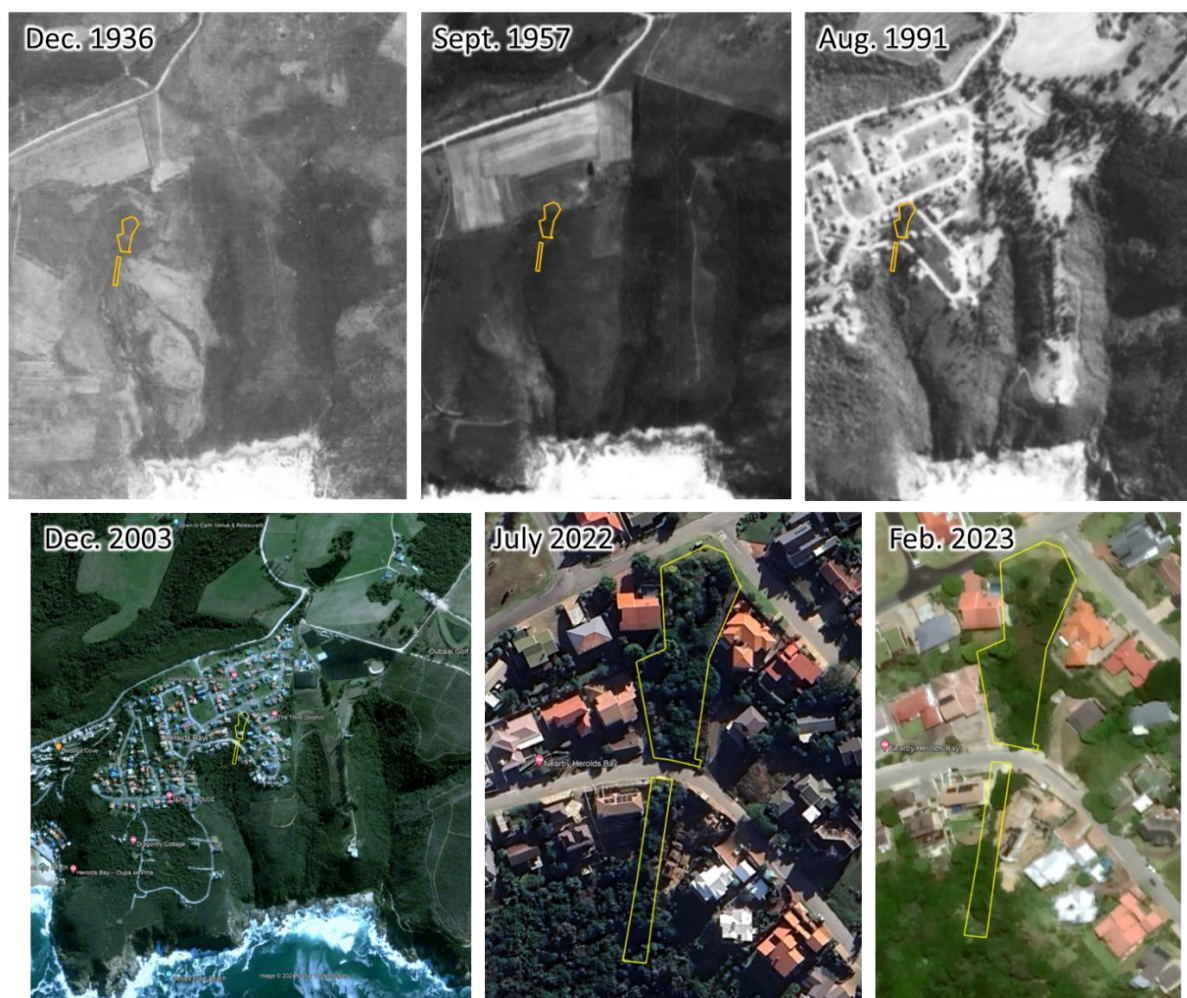
Figure 7: A series of historical imagery sourced from the CD: NGI geospatial portal (top row) and Google Earth (bottom row). The yellow polygons highlight the outlines of erven 318 and 326.

High resolution historical imagery (Fig. 7) can be sourced upon request from the CD: NGI Geospatial portal, or from their offices in Mowbray, Cape Town. Google Earth is also a repository of more recent historical images. The oldest historical image from 1936 illustrates a landscape with minimal disturbance. The site is located at the top of one of the valleys that extends towards the ocean to the south. In 1957 disturbance is still minimal, however there is a more pronounced presence of agriculture in the northern section of the site. However, by 1991 the residential development of the area had already isolated the site between houses. Development of this part of Herolds Bay continued, with even more houses visible in 2003. Clearance for the house currently under construction east of Erf 218 is visible for the first time in the July 2022 imagery for the site. The 2023 imagery illustrates how material from the development of the large house is spilling over into Erf 318, where the site is also experiencing bad erosion.

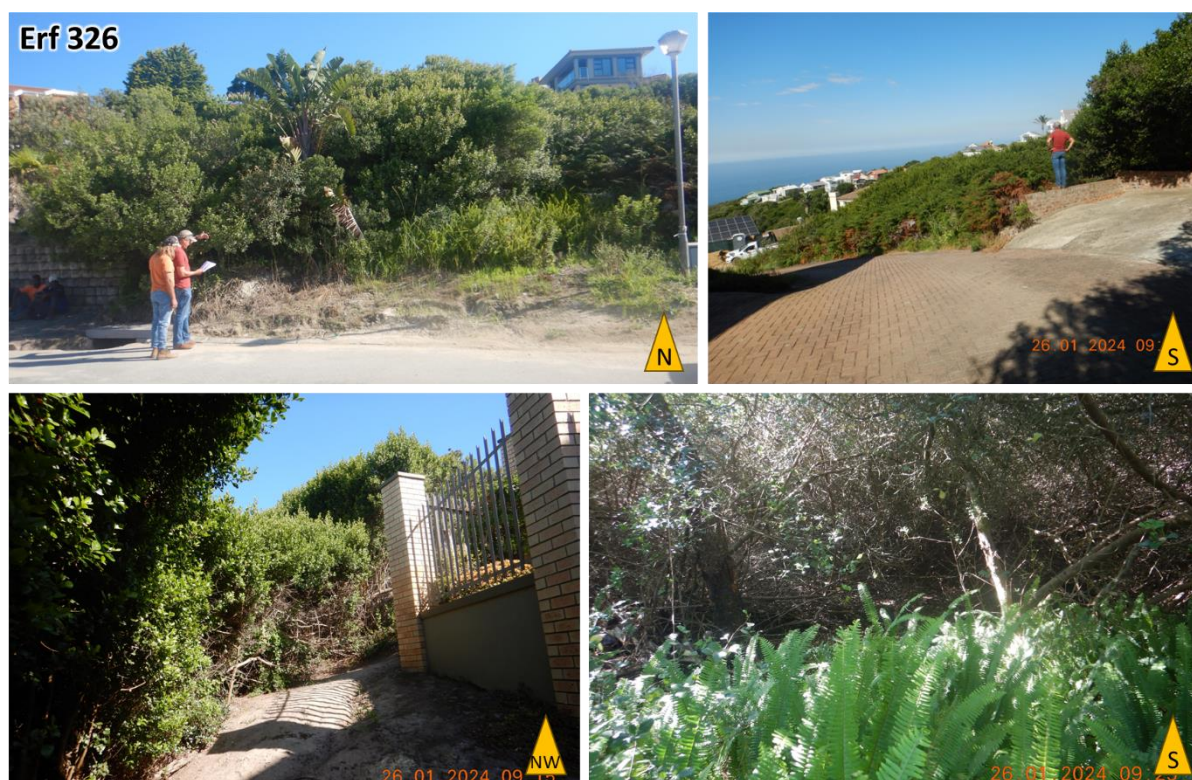
Figure 8: Photos of the site taken on Erf 326. The top left photo shows the open vegetation north of the existing road, top right is the view of the vegetation from the driveway along the western boundary of the erf. The bottom left image illustrates the thicket edge along the residential boundary, and the bottom right image illustrates the invasive fishbone fern (*Nephrolepis cordifolia*) in the understory of the thicket.

The vegetation on the site was more consistent with a thicket than with fynbos. The only fynbos elements on the site was found north of the existing road in the road verge. This is because the vegetation here is exposed and fynbos species can persist in the conditions available along the road verge. Large sections of Erf 326 was occupied by garden escapee plants and was no longer a natural thicket (Fig. 8). The thicket vegetation, apart from the road verges and eroded section of Erf 318, was relatively uniform and is likely Groot Brak Dune Strandveld. The vegetation on erf 318 is undergoing unnatural disturbance, with severe erosion on the site, and building material dumped in sections of the erf (Fig. 9). The erosion on the erf is the reason this stormwater management project was initiated, before more damage is done, including damage to the habitats that remain here.

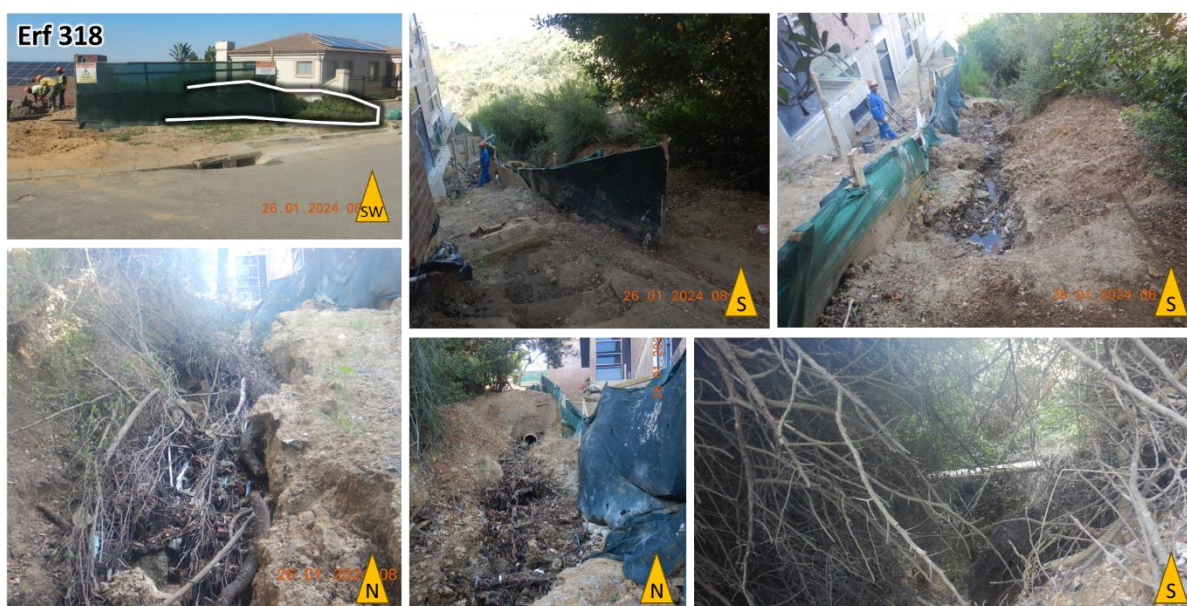
Figure 9: Photos of the site taken on Erf 318. This site is being eroded, and a large house is being constructed east of the erosion on the site.

- The erosion on erf 318 is causing an ongoing loss of habitat and hazard on the site.
- The construction of a large house directly east of the eroded section on erf 318 is causing additional damage to the vegetation and integrity of the substrate of erf 318.
- Invasive and naturalised plant species on the erven have caused diversity loss on the erven and have resulted in patched of vegetation that is transformed.
- The habitats on erven 326 and 318 are surrounded by an urban residential area which impacts on their connectivity with the wider natural space on erf 139 and surrounds to the south.

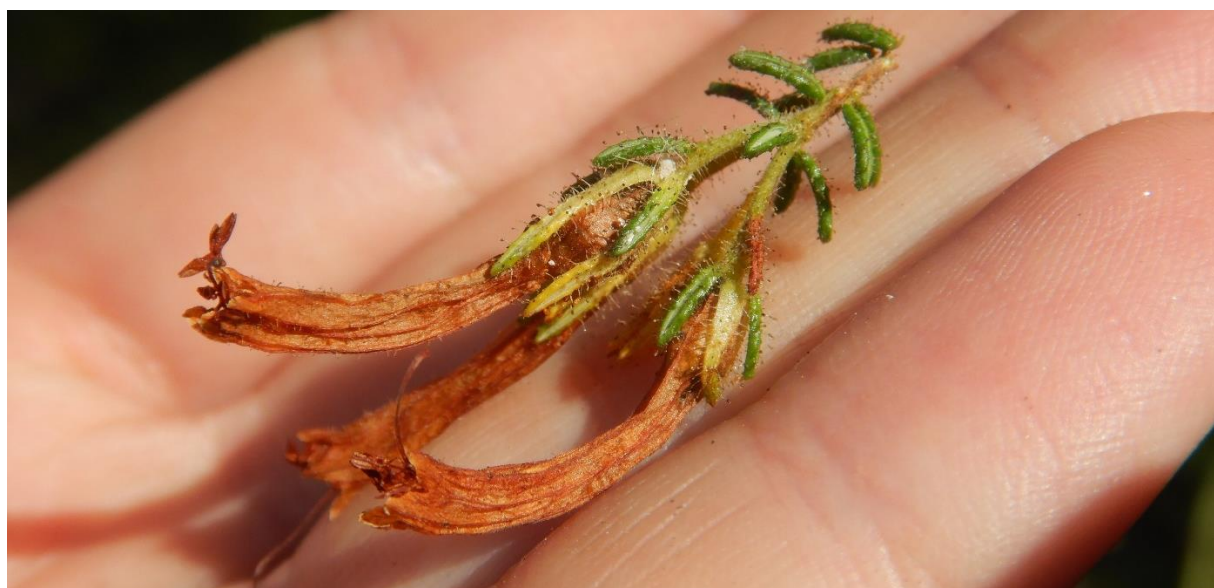
Figure 10: An image of *Erica glandulosa fourcadei* that was found north of the existing road along the boundary of Erf 326.

No protected tree species were observed, but the Red Listed *Erica glandulosa fourcadei* (Vulnerable) was observed in a small stand north of the existing road on the site. At the time of the site assessment the flowers were already spent, as illustrated in Fig. 10. Many listed invasive species were observed on the erven (see the list in Appendix 10.1), such as black wattles (*Acacia mearnsii*), bugweed (*Solanum mauritianum*), and the fishbone fern (*Nephrolepis cordifolia*). An explanation of the requirements for various NEMBA invasive species listings is provided in BOX 2.

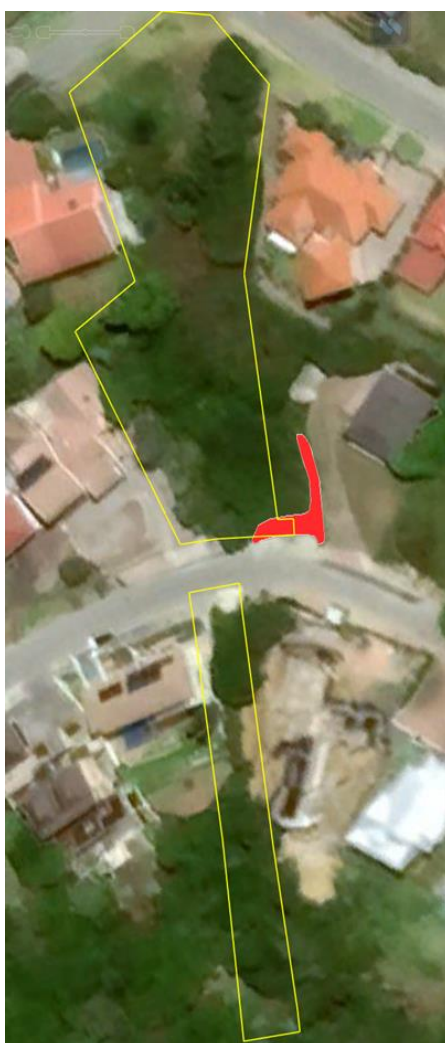
Figure 11: The red polygon on the map represents the area with a confirmed *Erica glandulosa fourcadei* population. This polygon is the only area on the site with a High botanical sensitivity. The rest of Erf 326 and 318 has a Low plant species theme sensitivity.

Although natural thicket remains on the erven, no protected tree species (e.g., Milkwood trees, *Sideroxylon inerme inerme*, and Cheesewood trees, *Pittosporum viridiflorum*) were observed on the site. However, one SCC was observed in the open canopy vegetation immediately north of the existing road, *Erica glandulosa fourcadei* (VU). The site does not contain a significant population of this species; however, its presence means that the section above the road where the gabion wall is proposed is a **High** botanical sensitivity (Fig. 11). The rest of the closed canopy thicket vegetation has a **Low** plant species sensitivity as the vegetation is modified, no SCC were recorded there (Fig. 11), and no SCC are likely to occur within the project area of influence apart from *Hermannia lavandulifolia* (which is a threatened species that thrives in slightly disturbed areas, is widespread, and which will be downgraded in status during the next Red List revision).

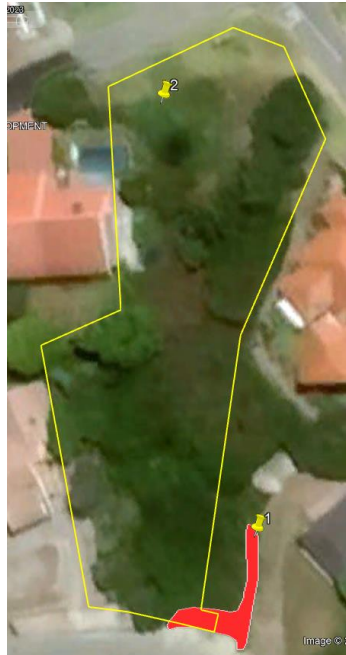
Figure 13: The yellow pin locations are potentially acceptable transplant locations for *Erica glandulosa fourcadei* on Erf 326. If the southern location is chosen, care must be taken not to damage existing *Ericas* that may already be present. The red area roughly indicated the existing population.

1. Conduct a search and rescue of the *Erica glandulosa fourcadei* population north of the existing road only where they will be impacted by the proposed development.
 - A. A permit may need to be applied for from CapeNature in order to conduct the Erica search and rescue operation.
 - B. Ensure that the plants are watered about an hour before rescuing them.
 - C. Find an area outside of the project area of influence, in an open canopy area somewhere on the erven, and dig holes large enough to support the Ericas using an excavator. Soil dug out of these holes must be kept in a pile next to the holes. The soil piles must either be on driveways or elsewhere in an already disturbed area. The potential replanting spots on the site include around Erf 326 are illustrated in Fig. 13 below:

- D. When rescuing the *Ericas*, it is imperative that the soil be removed with the roots. For this reason, an excavator must carefully dig up *Ericas* where they fall within the proposed gabion wall or pipeline footprint.

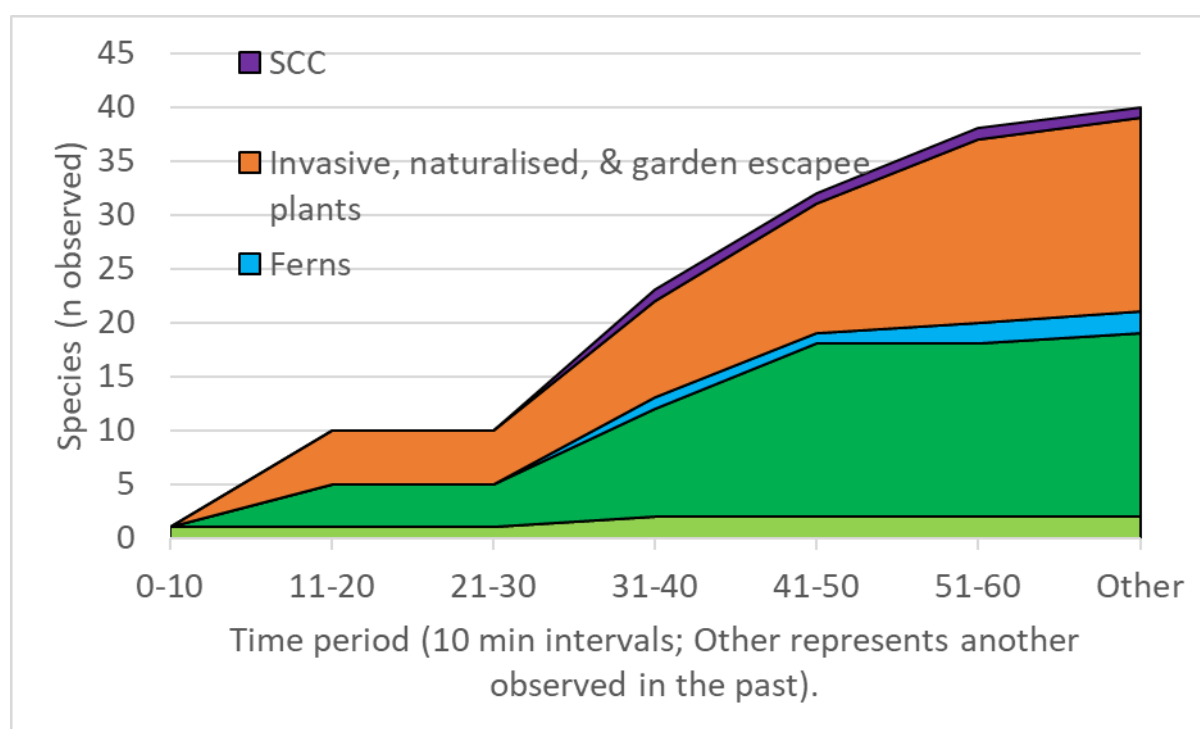
Figure 14: A plant species accumulation curve for the site assessment.

A species accumulation curve for all the species recorded on the site during the assessment are presented in Fig. 14. All species that were observed during the site visit are in Table 5. The site assessment species list is not exhaustive.
