# **24G and Future Development for the George Municipality Water Depot on Erf RE/464, George, Western Cape.**

Aquatic Biodiversity Site Sensitivity Verification and Impact Assessment.

**Prepared For:** Cape EAPrac Environmental Consultants  
**Author:** Mr. F de Ridder (MSc)  
Confluent Environmental Pty (Ltd)  
7 St. Johns Street,  
Dormehls Drift,  
George, 6529  
**SACNASP:** Candidate Natural Scientist. (Aquatic Science  
– 166398)  
**Reviewer:** Dr. J.M. Dabrowski (Pr. Sci. Nat. Water  
Resources - 114084)  
**Date:** 03 March 2026  
**Version:** Draft Final

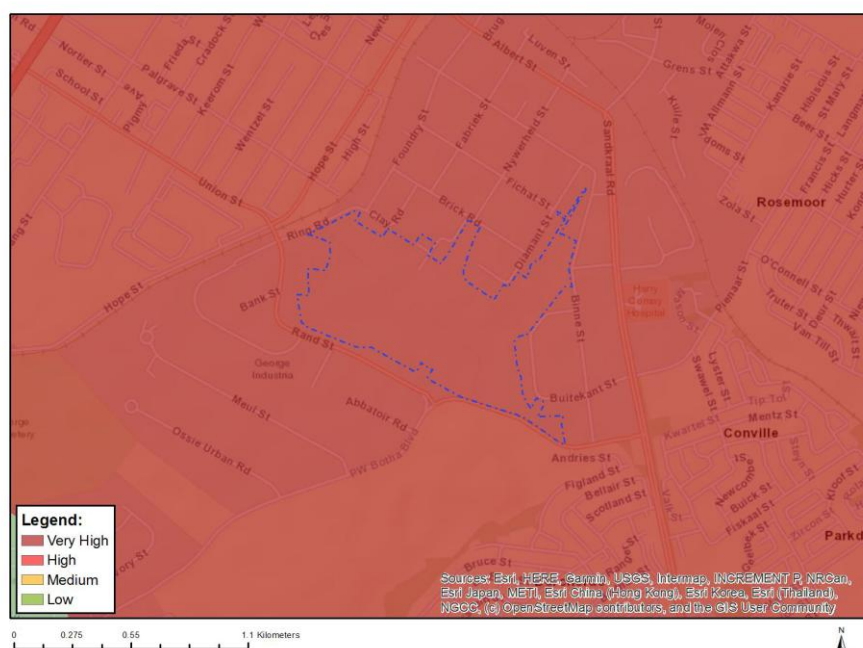
Figure 2: Results of the DFFE Screening Tool which indicate Very High Sensitivity for the Aquatic Biodiversity theme for the 24G area and further developments for the George Municipality Water Depot.

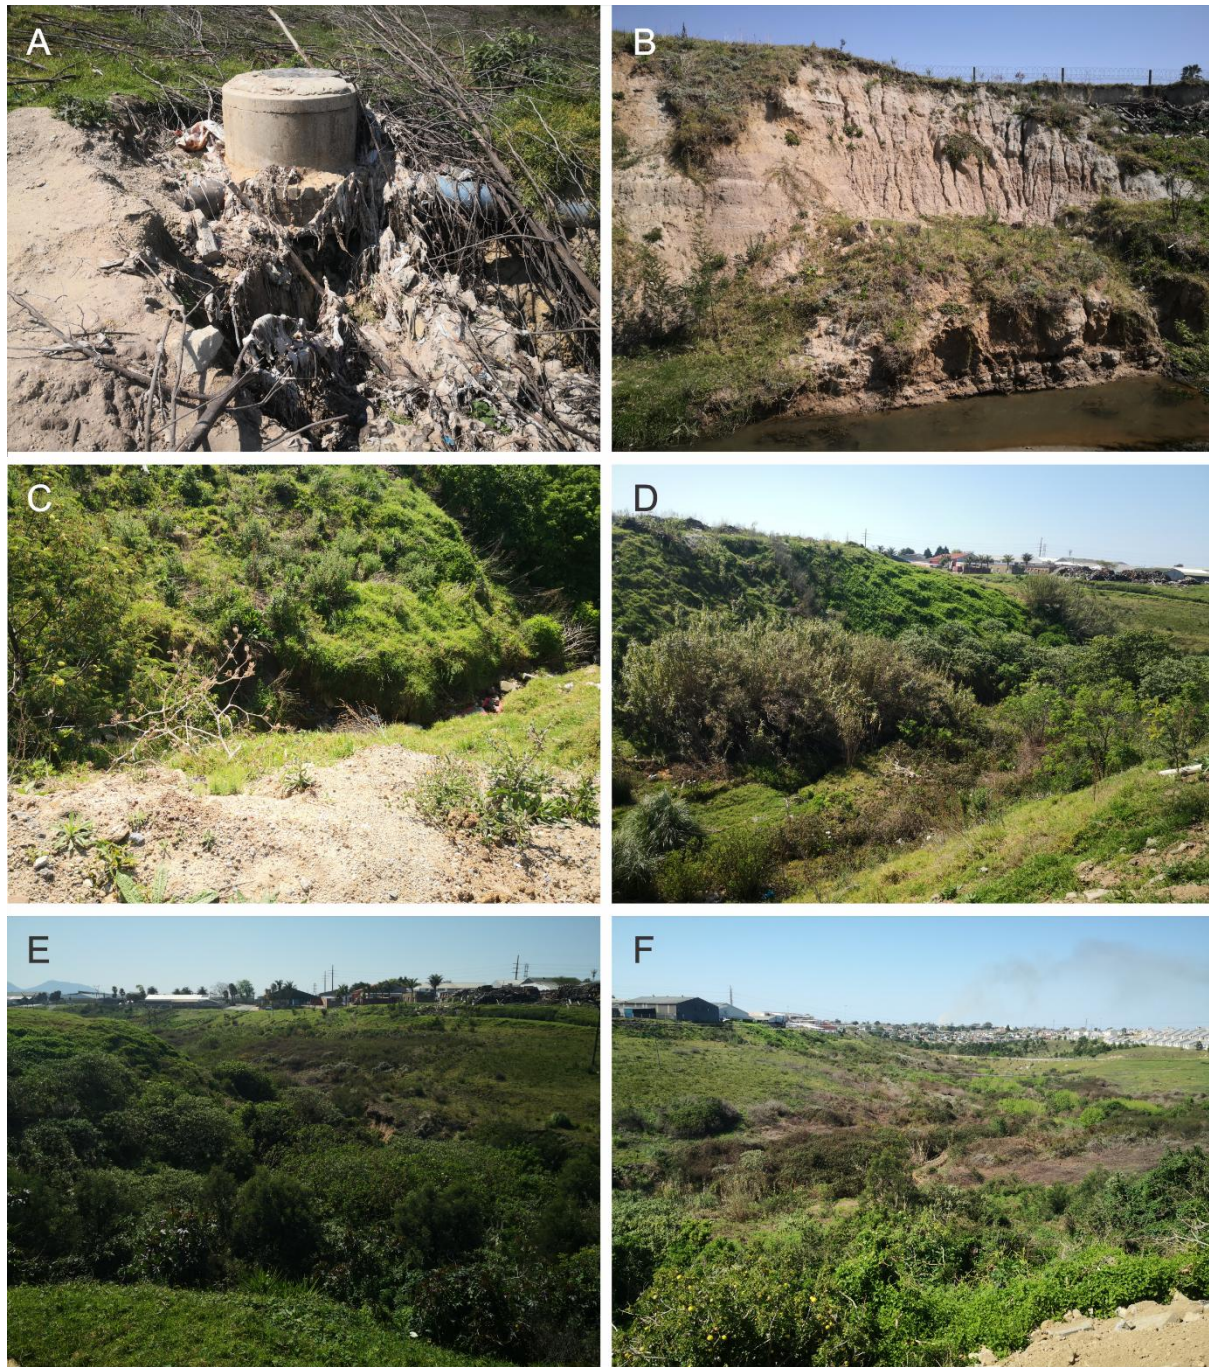
The mapped wetland associated with the upper reach of the Skaapkop River was not confirmed on site. The Skaapkop River is classified as a perennial stream characterised by a heavily incised channel, clear bed and banks, and continuous water flow (Figure 13). The Skaapkop River has been heavily impacted by sewage, solid waste pollution, and erosion of the channel caused by high stormwater inputs. At the time of the site visit evidence was observed that sewage had been spilling into the river from two manholes (located approximately 10 m east of the Skaapkop River), and were not only polluting the river but also eroding the banks of the river (Figure 12: A and B).

HGM1 is a small non-perennial stream that grades into a small, channelled valley-bottom wetland. The stream is characterised by a distinct channel, prominent bed, and banks with intermittent flow following rainfall events (Figure 13). The valley bottom adjacent to the channel is primarily dominated by Kikuyu grass and Bugweed as well as *Nidorella ivifolia*, *Arundo donax*, and *Cortaderia selloana* with erosion evident along the banks (Figure 12: D). At the time of the site visit there was visible evidence of building rubble falling down the steep slope into the active channel of HGM1 (Figure 12: C).

HGM2 is a small non-perennial stream (similar to HGM1) that grades into a small channelled valley-bottom wetland (Figure 13). The vegetation along HMG2 includes, but is not limited to; Kikuyu grass, Black wattle, Bugweed, *Nidorella ivifolia*, *Arundo donax* and *Cortaderia selloana* (Figure 12: E and F).

*Figure 12: A – Leaking sewer infrastructure 10 m 10 m east of the Skaapkop River, B – Skaapkop River with eroding banks on the West, C – General vegetation present at HGM1 with the channel of HGM1 filled with building rubble, D – CVB at the lower reach of HGM1, E – CBV at the confluence of HGM1 and HGM2 looking in a north-westerly direction, F – CBV at the confluence of HGM2 and the Skaapkop River looking in a southern direction.*

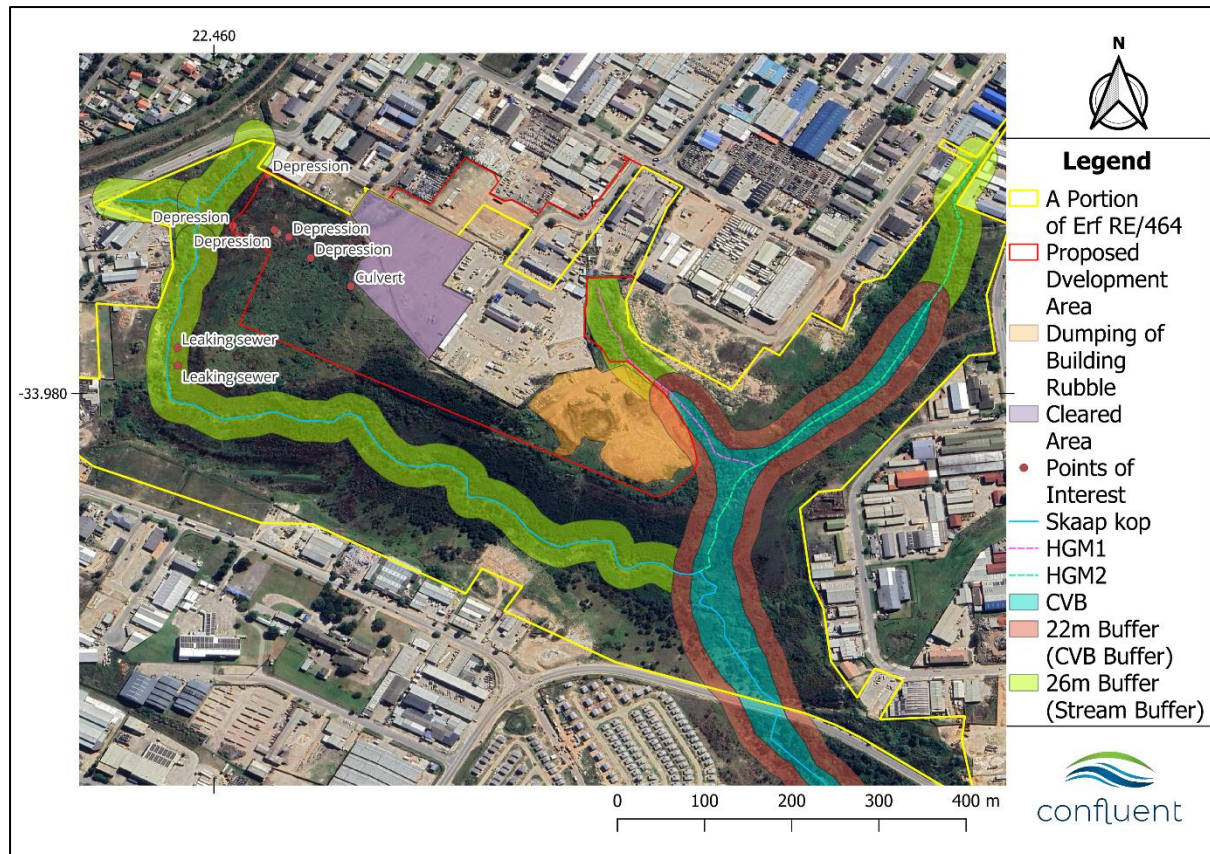
Based on these inputs the buffer for the CVB wetland is set to 22 m (Figure 15).

Figure 15: Map showing buffers associated with watercourses.

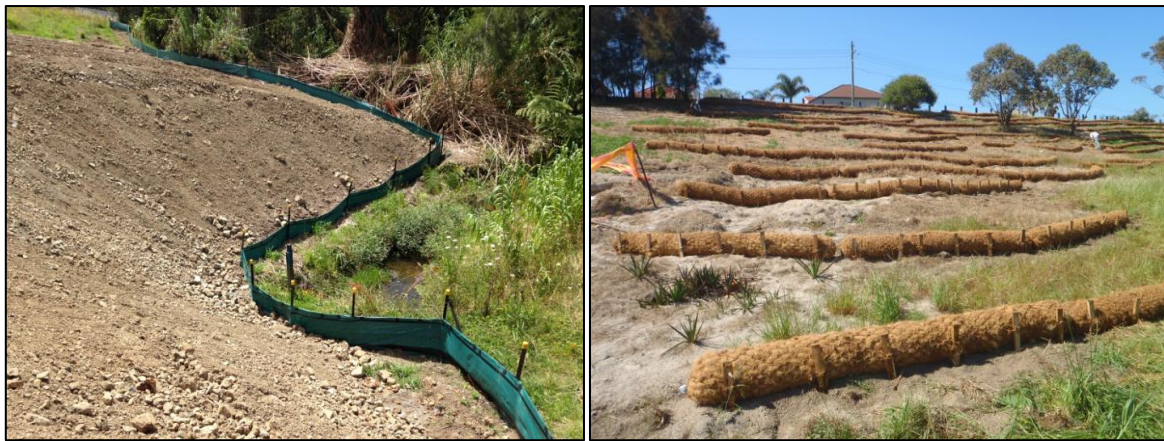
Figure 16: Examples of silt fences (left) and coir logs (right) used to trap sediment mobilised from steep slopes.

- Check weather reports ahead and prepare the site when rainfall is predicted. Discontinue any on the site during rainfall.
- Construct check dams or sediment basins for flooded construction areas to be drained into if need be, to trap sediment, and facilitate sediment settlement before runoff reaches the non-perennial drainage line.
