# Impact Assessment for Retrospective and Proposed development of a Municipal Water Depot on the Remainder of Erf 464, George, Western Cape

Terrestrial and Plant Species Theme Specialist Assessment:  
Site Sensitivity Verification, Impact Assessment, and 24G Rectification Process

**Date:** November 2024

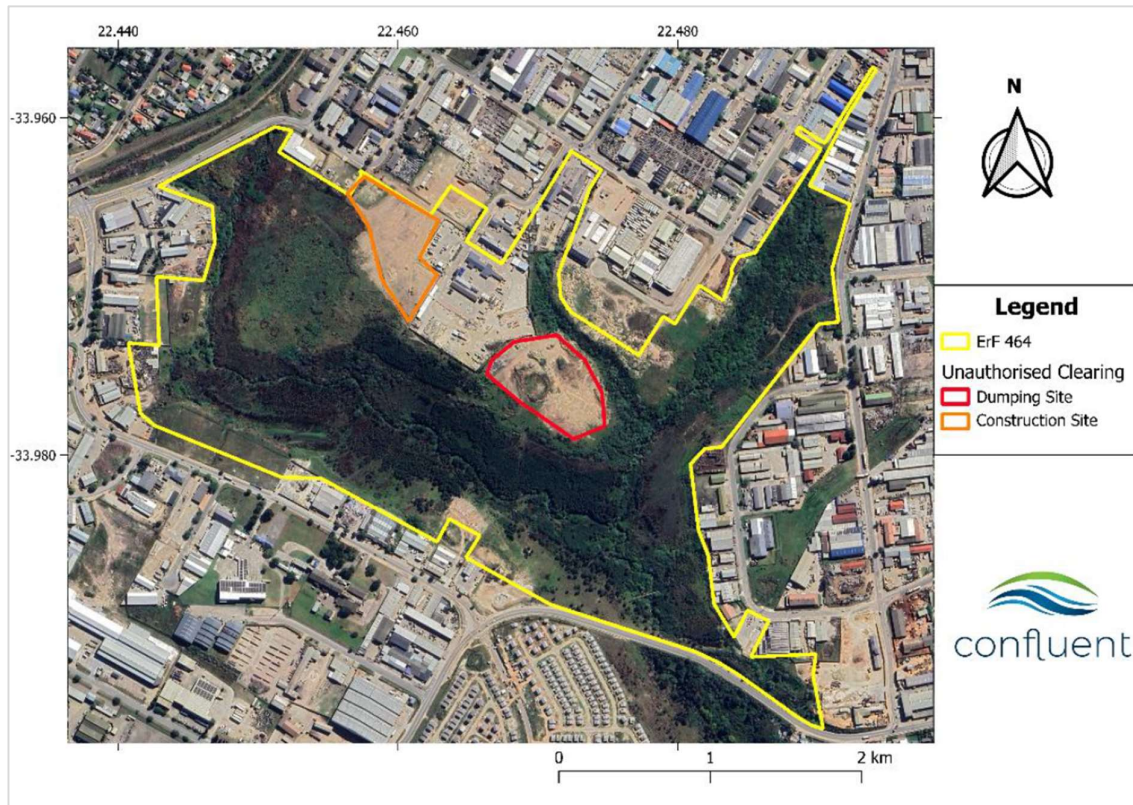
The unauthorized clearing of vegetation on Erf 464 (Orange outline, Figure 2), intended for the expansion of the George Municipality Water Depot, has potentially caused significant ecological and environmental degradation. Of particular concern is the potential removal of the critically endangered Garden Route Fynbos vegetation which is mapped to occur with the property boundaries. Furthermore, the site is located within a highly sensitive ecological zone that includes an unchanneled valley-bottom wetland and a non-perennial river, all of which provide essential ecosystem services.

The municipality cleared additional indigenous vegetation outside the depot's current fence line, establishing an unauthorised dumping site on the cleared land (outlined in red, Figure. 2). This area is included in the Section 24G application.

*Figure 2. Map showing the unauthorized clearing of indigenous vegetation on Erf 464*

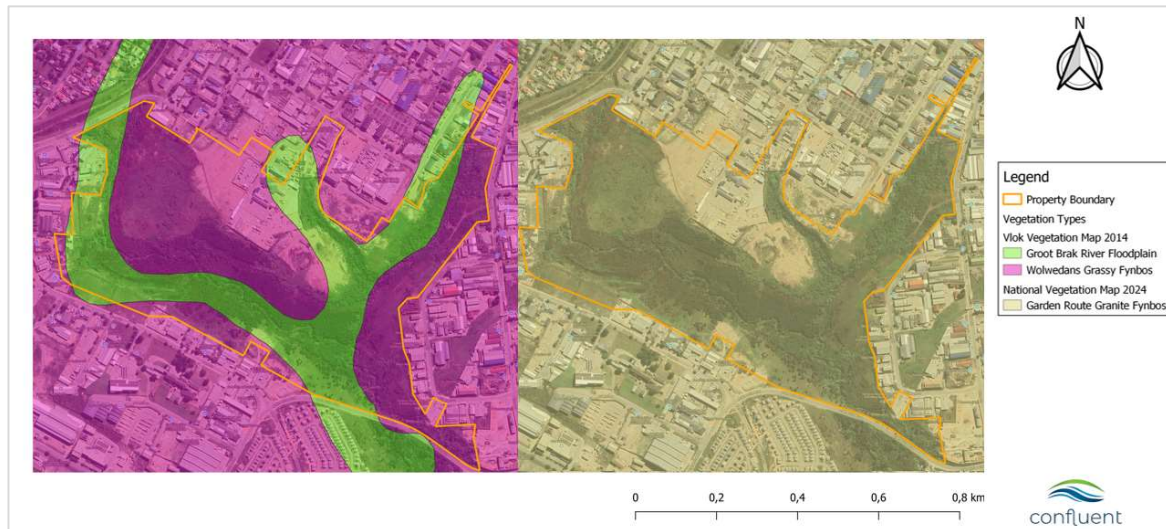
Figure 8. The national and more local Vlok vegetation map layers for RE/464, George.

The vegetation of the property is mapped as **critically endangered (CR) Garden Route Granite Fynbos (FFg 5)** (Figure. 8; Dayaram et al., 2019; Mucina & Rutherford, 2006).

The Vlok vegetation map which has a higher resolution outlines the Groot Brak River floodplain as extending into the property with the rest of the site being comprised of Wolvedans grassy fynbos (Figure. 8).

The Biodiversity Spatial Plan for the Western Cape (WCBSP) contains several conservation planning layers that are used to set priority areas for conserving biodiversity. The definition and objectives of the WCBSP layer mapped on Erf RE/464 is given in Table 2. Most of the property is mapped as a CBA 1 area for the aquatic theme (See Table 2; Figure. 7). The rest is mapped as CBA 2 for the terrestrial theme with small areas of ESA 2 and classified as “Climate Corridor, River, Wetland” (Figure. 8).

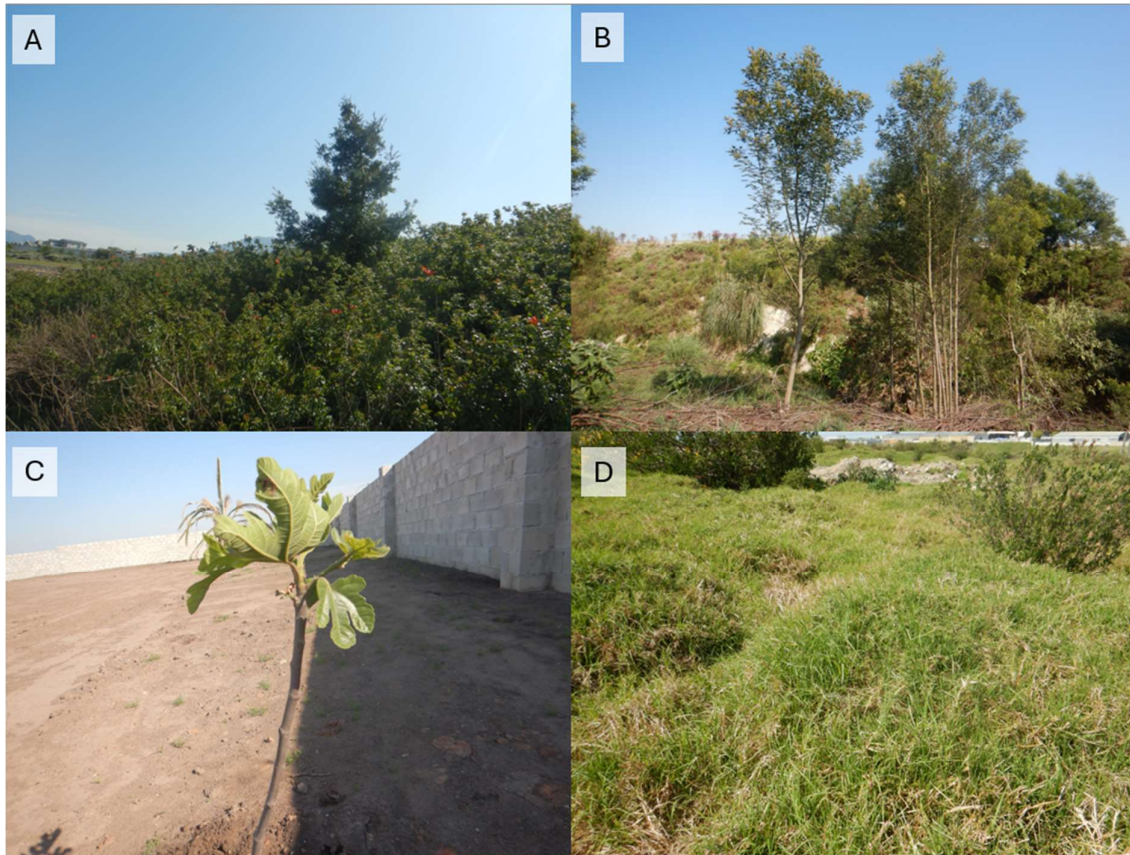
Figure 12. Some vegetation categories determined during the site visit. (A.) Heavily invaded vegetation with an Outeniqua yellowwood (*Afrocarpus falcatus*) in the background and Cape honeysuckle (*Tecomaria capensis*) in the foreground, (B.) Black wattles (*Acacia mearnsii*) in heavily invaded vegetation with evidence of clearing in the foreground, (C.) An example of the areas labelled as 'cleared vegetation' with a planting of *Ficus sp.* (further details in Section 3.2 of this report), (D.) Most of the transformed area is dominated with disturbance-loving grasses such as Kikuyu grass (*Cenchrus clandestinus*).

No SCC were observed on the site, but individuals of a protected tree species was observed (Figure. 11, Figure 12), namely Outeniqua Yellowwood (*Afrocarpus falcatus*, Protected tree 16). Some endemic species were found at the site, predominantly in the area designated as Invaded Fynbos (Figure. 11; some of these species are shown in Figure. 13). Invasive species occur throughout the site with Blackwood Wattles (*Acacia melanoxylon*), Black wattles (*Acacia mearnsii*) (in 'Heavily Invaded areas'), and Kikuyu Grass (*Cenchrus clandestinus*) (in 'Transformed areas') being the most common (Figure. 12; See Table. 7 for the full list of invasive species).

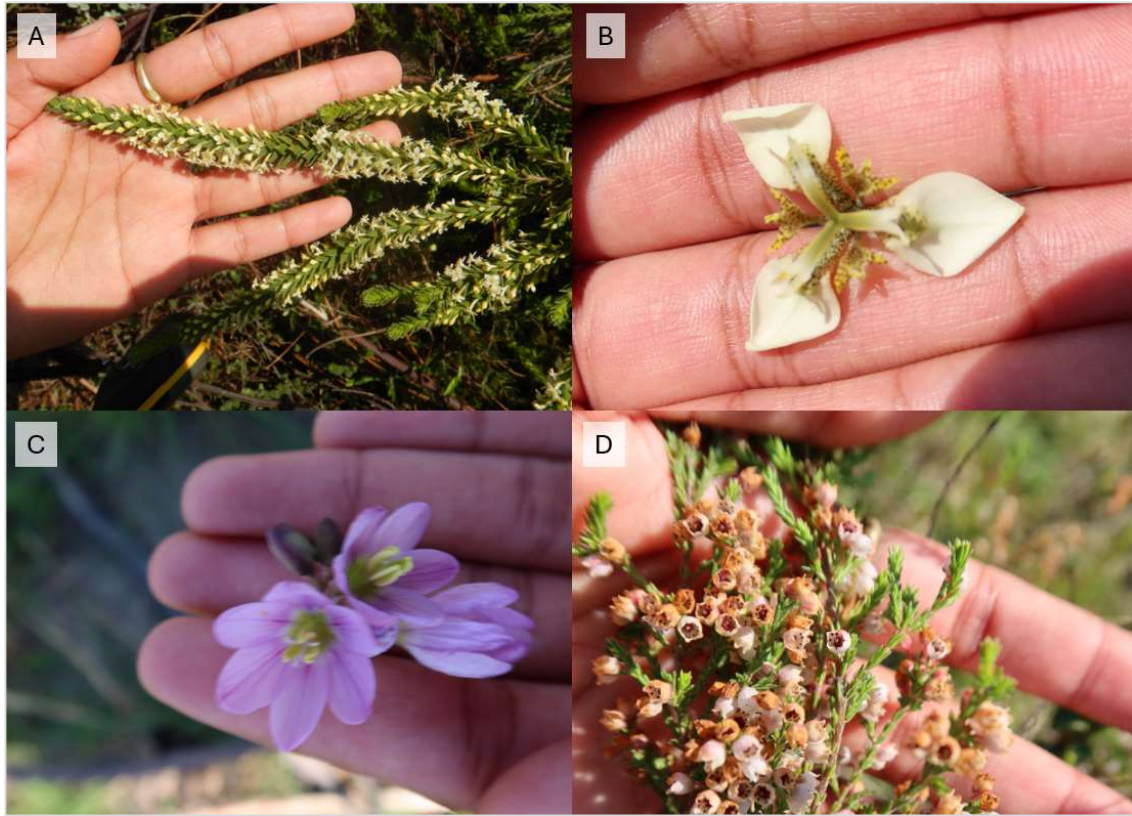
Figure 13. South African endemic species found in the invaded fynbos area. (A.) *Struthiola hirsuta*, (B.) *Moraea unguiculata*, (C.) *Ixia orientalis*, and (D.) *Erica quadrangularis*.

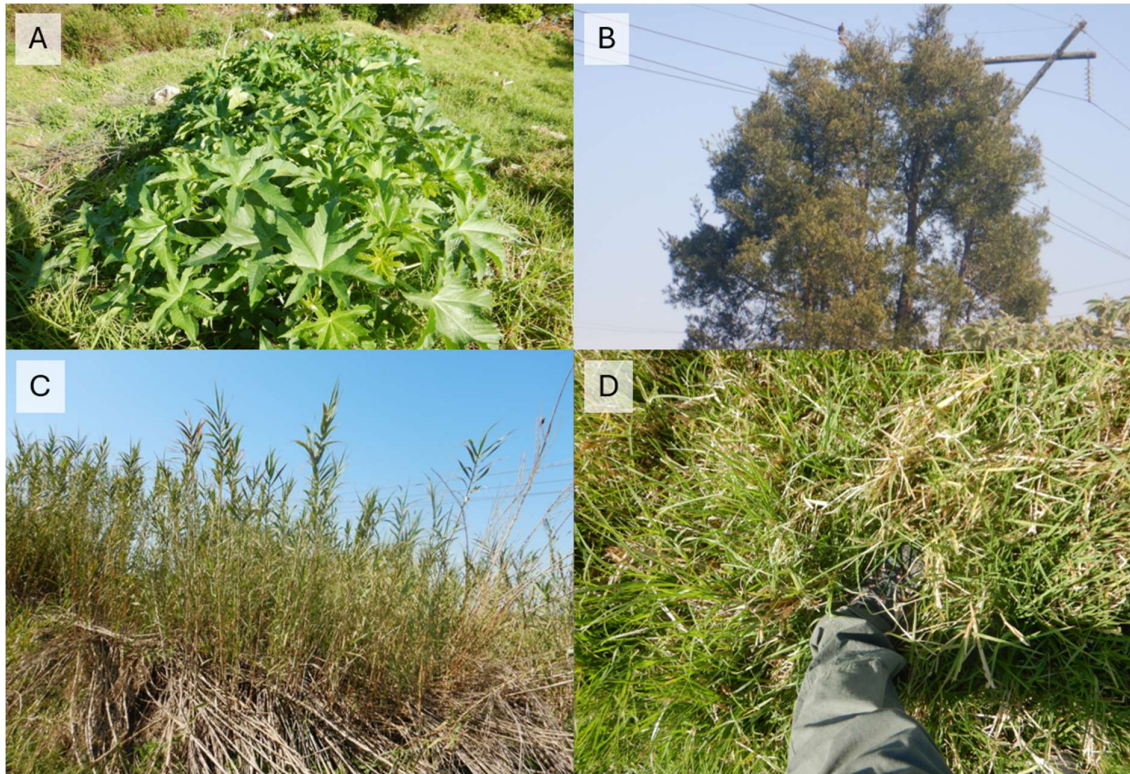
Figure 14. Some invasive Species observed during the Site Assessment and found throughout the site. (A.) Ricinus communis, (B.) Acacia mearnsii, (C.) Arundo donax and, (D.) Cenchrus clandestinus.

Most of the property is heavily invaded by Kikuyu grass, Black wattle, and other species. It is noted that a small patch of invaded fynbos was found in an area where clearing of woody invasive species had happened before (as evidenced by slash found in the area). This shows some capacity for recovery of this fynbos. The invaded fynbos patch extends over CBA 1 and CBA 2 areas at the site.

The vegetation at the site is heavily transformed and invaded by the species listed in Table 7. The most widespread species present at the site is varying age classes of Blackwood wattle. It is highly recommended that the current impacts are addressed, and that an alien plant management plan be developed and implemented concurrent with (preferred), or after development at the site.

Currently, the greatest impact on biodiversity at the site is invasive species. Most of the property is heavily invaded by Kikuyu grass, Black wattle, and other species. It is highly recommended that all alien invasive plant species on the site be actively managed through the development and implementation of alien invasive plant management plan, as this will limit current negative impacts on the property and the surrounding areas and increase natural fynbos habitat.

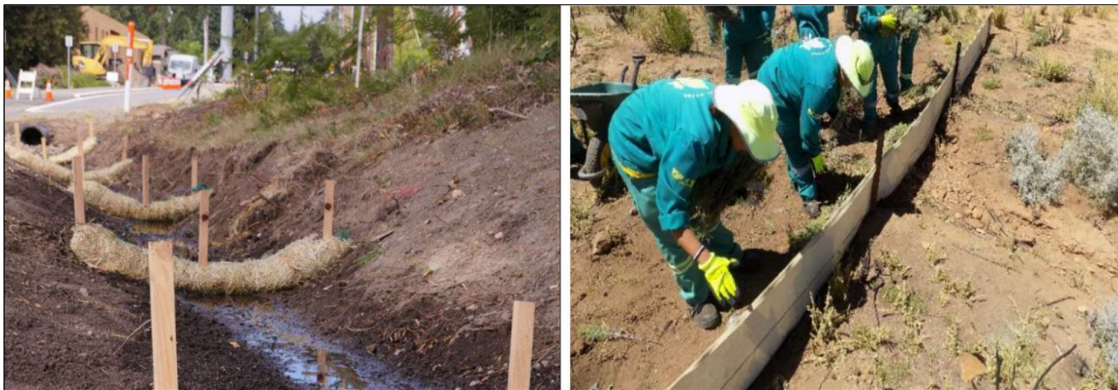
*Figure 17. Examples of silt socks (left) and a silt fence (right) placed perpendicular to the flow of water. These methods reduce the force of water flow, erosion and can prevent unwanted sedimentation at the site.*

4. Where vegetation will be cleared to make way for construction, filled sandbags, silt socks, or a silt fence must be used to reduce the intensity of water runoff and flow over the site and thereby reduce erosion potential (Figure. 17). This should be placed around the perimeter of the downslope disturbance footprint and needs regular inspection and adaptive management to ensure the integrity of the system for reducing erosion.
