# Engineering Geological Report

New Steel Structure  
George Depot – George  
Western Cape

| <b>Project No:</b> | TG-24-040 |

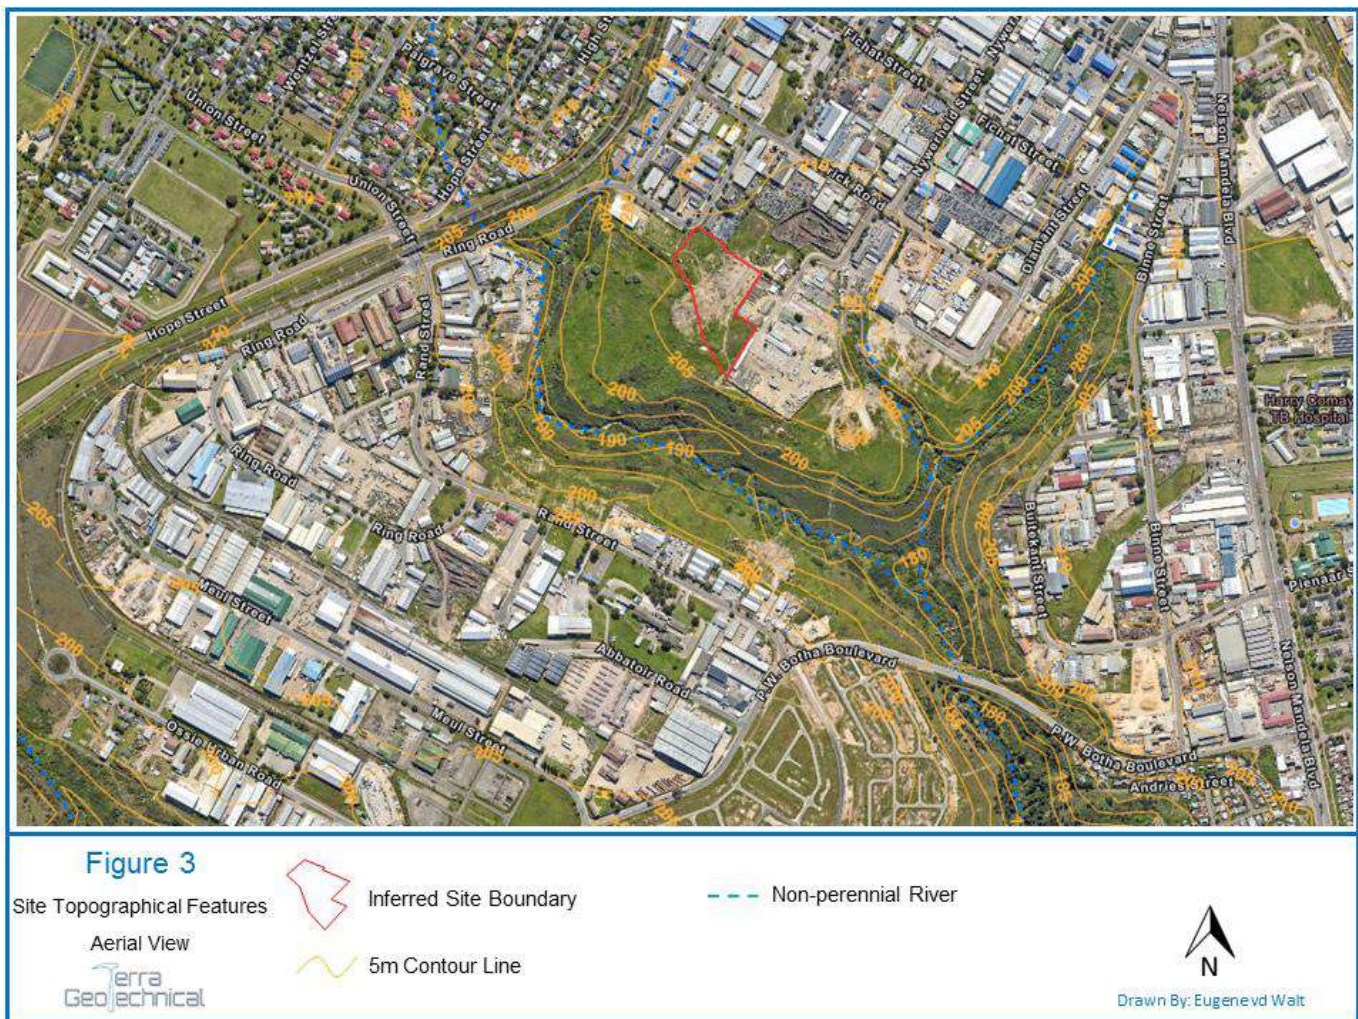
Figure 3: Topographical Features

Figure 3 below depicts the topographical features of the study area. Various valley type structures are identified by closely spaced contour lines and the presence of a drainage (non-perennial and perennial). The image depicts that no known drainage channels traverse the site.

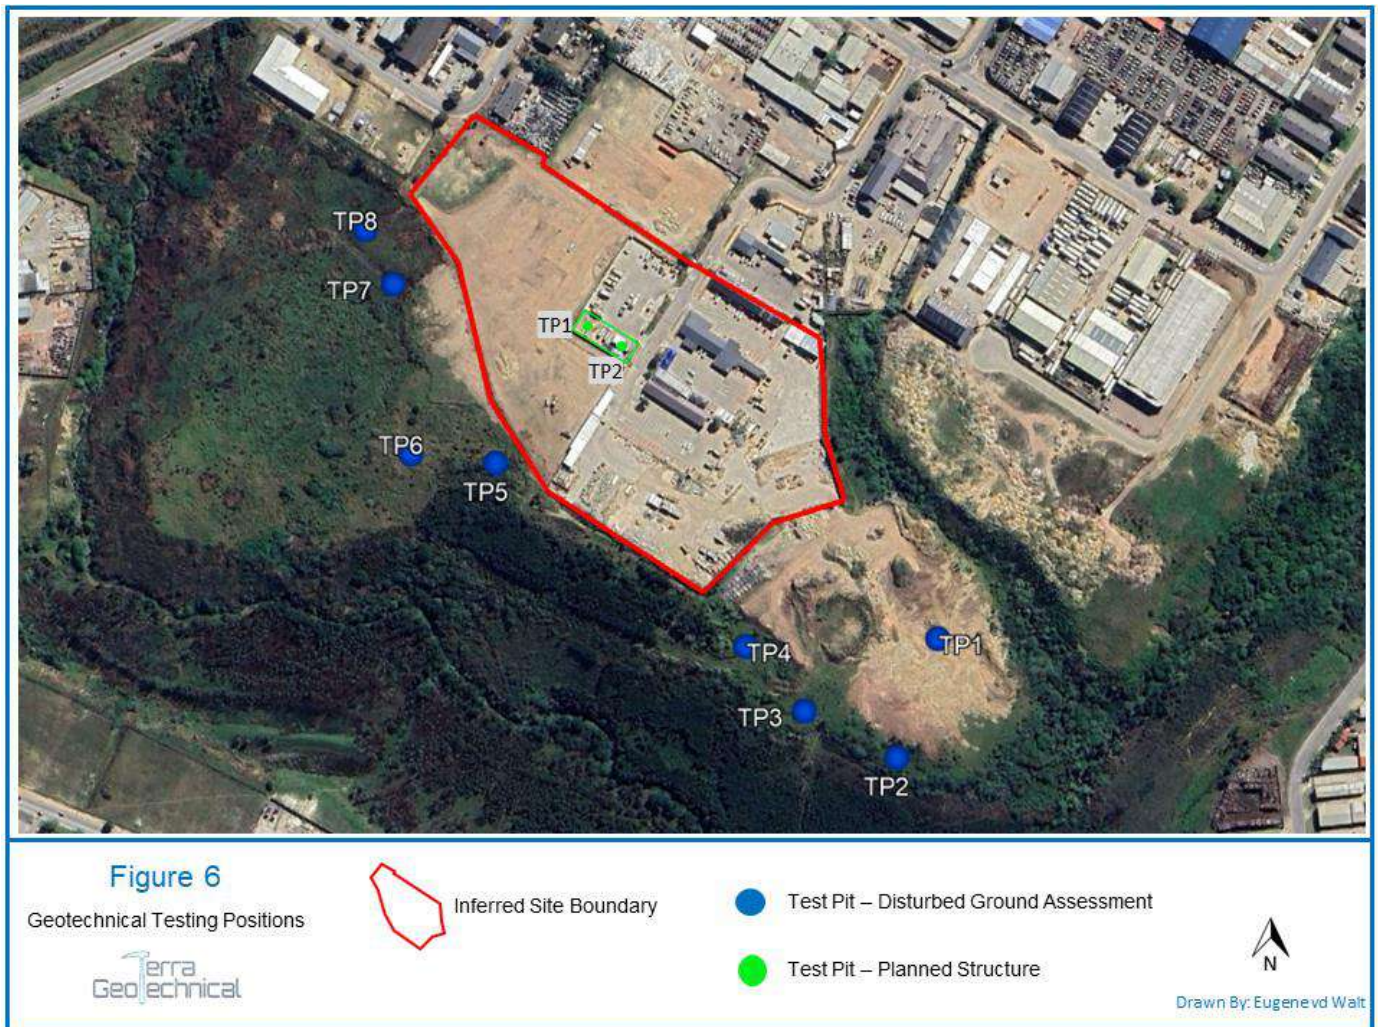
Two additional test pits were excavated at the area earmarked for an additional structure. The location of these test pits was determined by the Consultant, after which test pits were excavated, profiled and closed.

Figure 6 below depicts the location of these eight test pits.

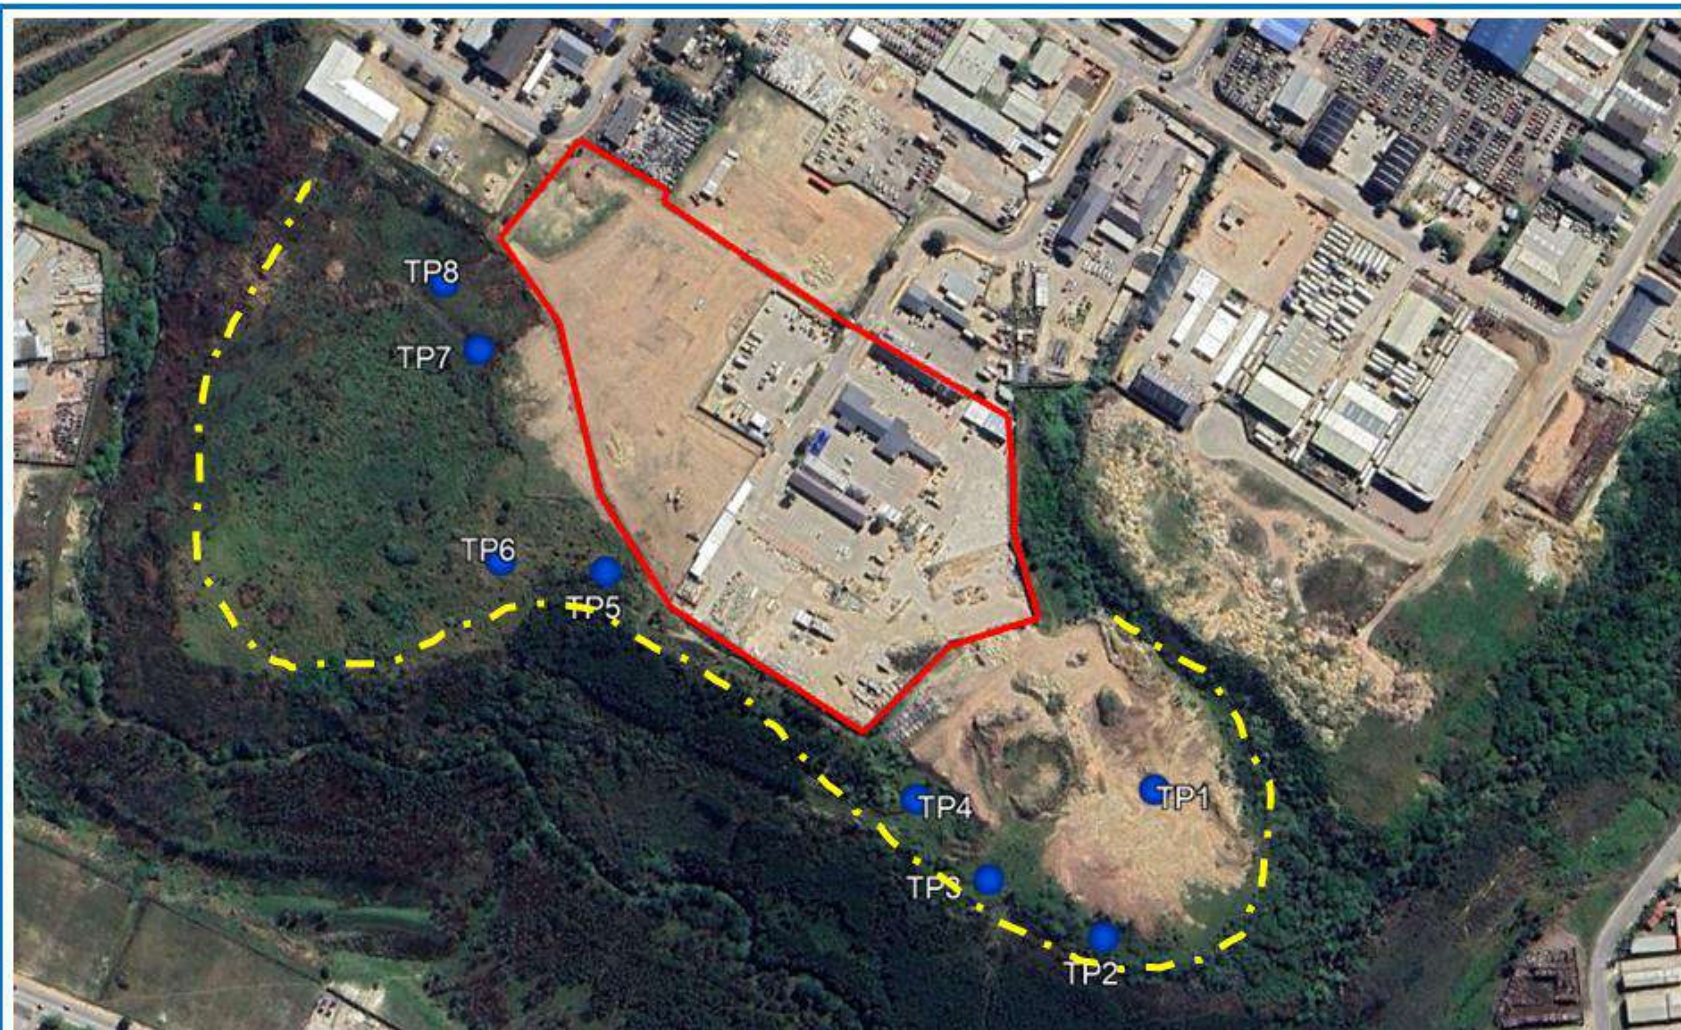
**Figure 7**  
Disturbed Ground

From the test pitting, it can be noted that the surface of the original landscape had been drastically altered from the natural, as a prominent uncontrolled fill horizon, generally covers the majority of the site.

Observations of the surface features across the landscape indicate that ground disturbance is more widespread than in the tested area. Figure 7 on the following page depicts the site surface and inferred extent of the altered/disturbed ground.

It is recommended that a follow-up investigation be conducted to establish founding conditions for deep foundations (piles) in the areas with excessive uncontrolled fill.

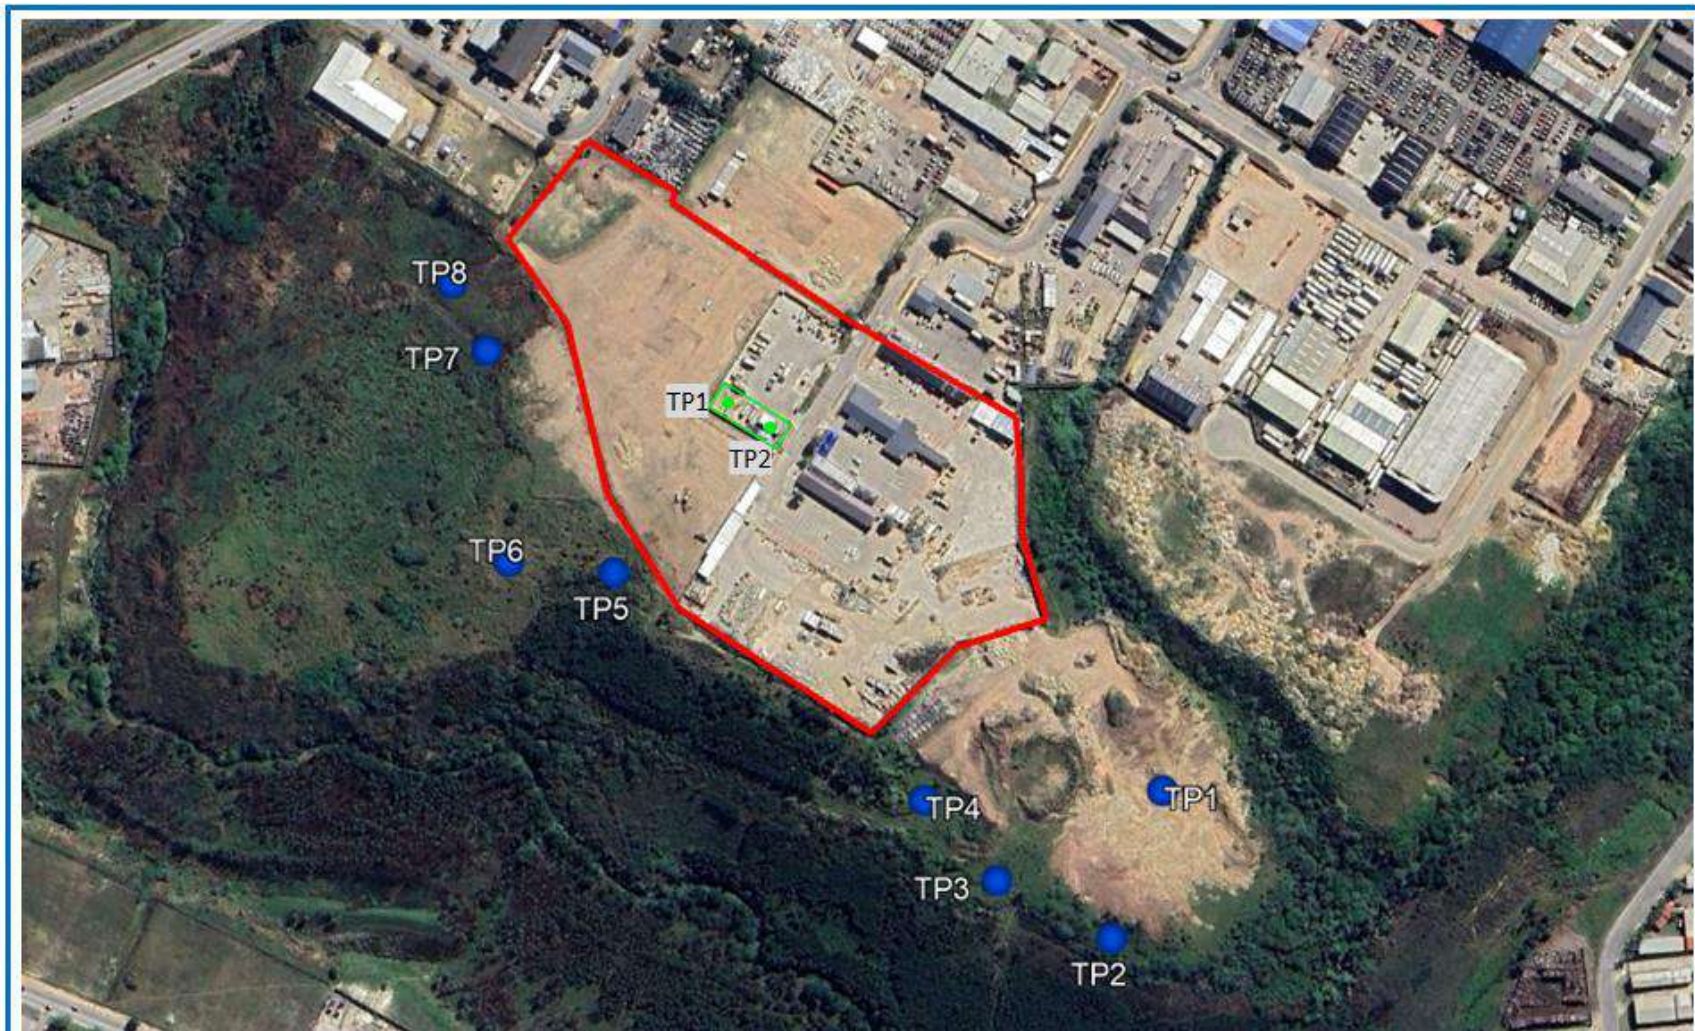
**Figure 6**  
Geotechnical Testing Positions

Two test pits were excavated across the footprint of the proposed structure (as indicated by Figure 6).

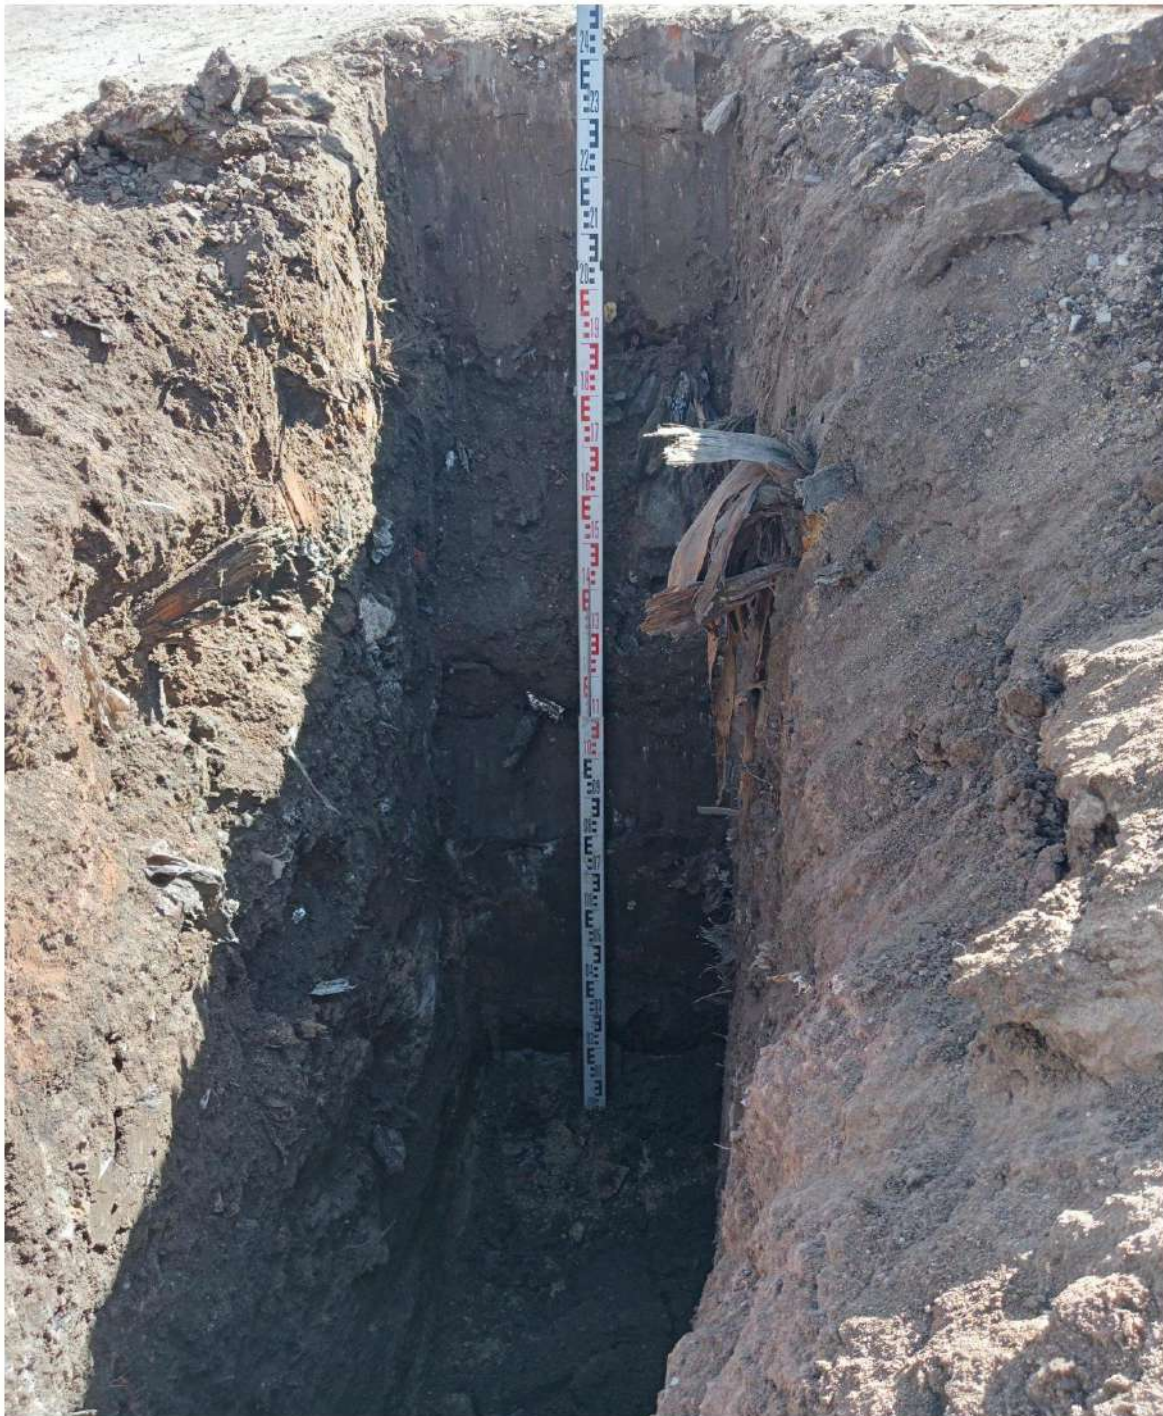
Soil Profile Photo of Test Pit TP1

slightly moist; dark brown; medium dense; intact; silty sand; Fill; Dump site materials with dead plants and tree branches; Not Sampled.

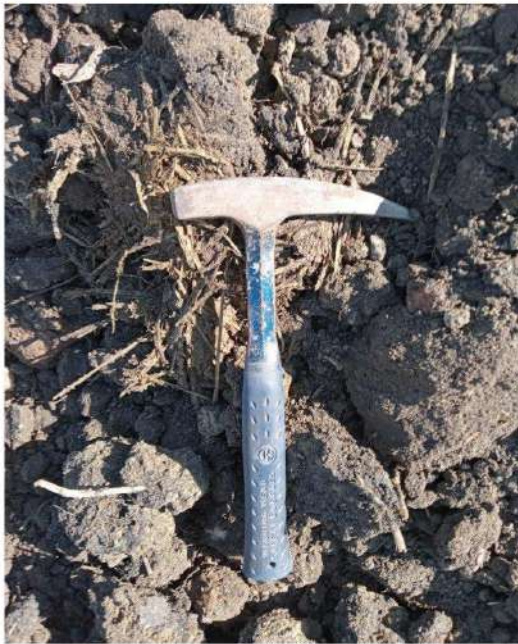
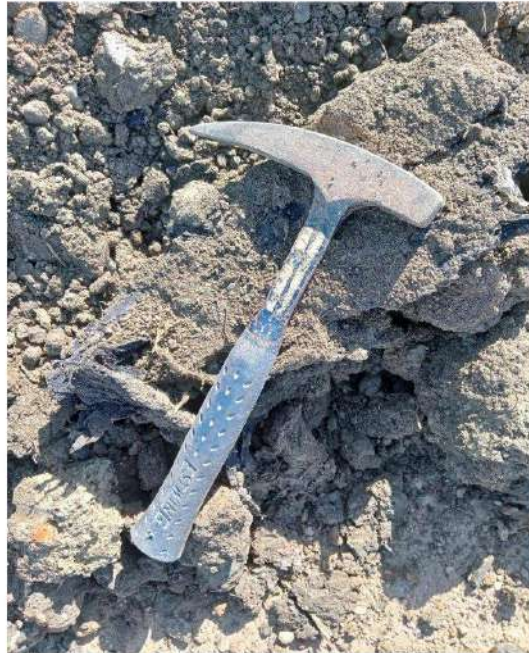
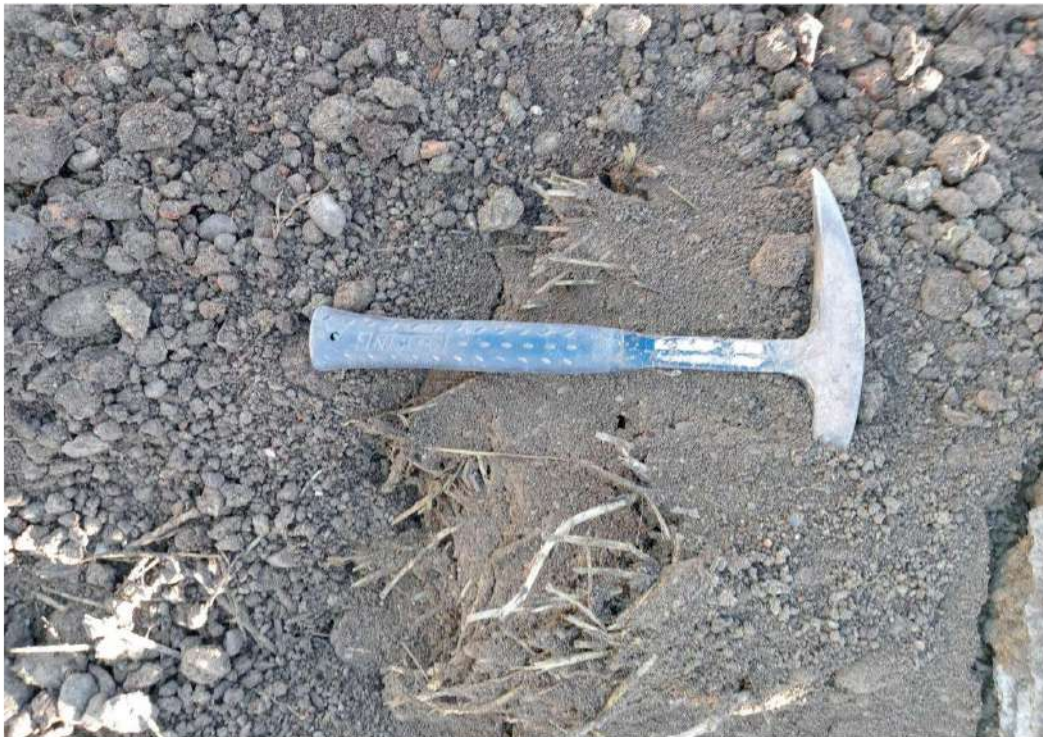
Material Present in Test Pit TP4

slightly moist; dark brown; loose; intact; silty sand; Fill; Refuse materials; Not Sampled.

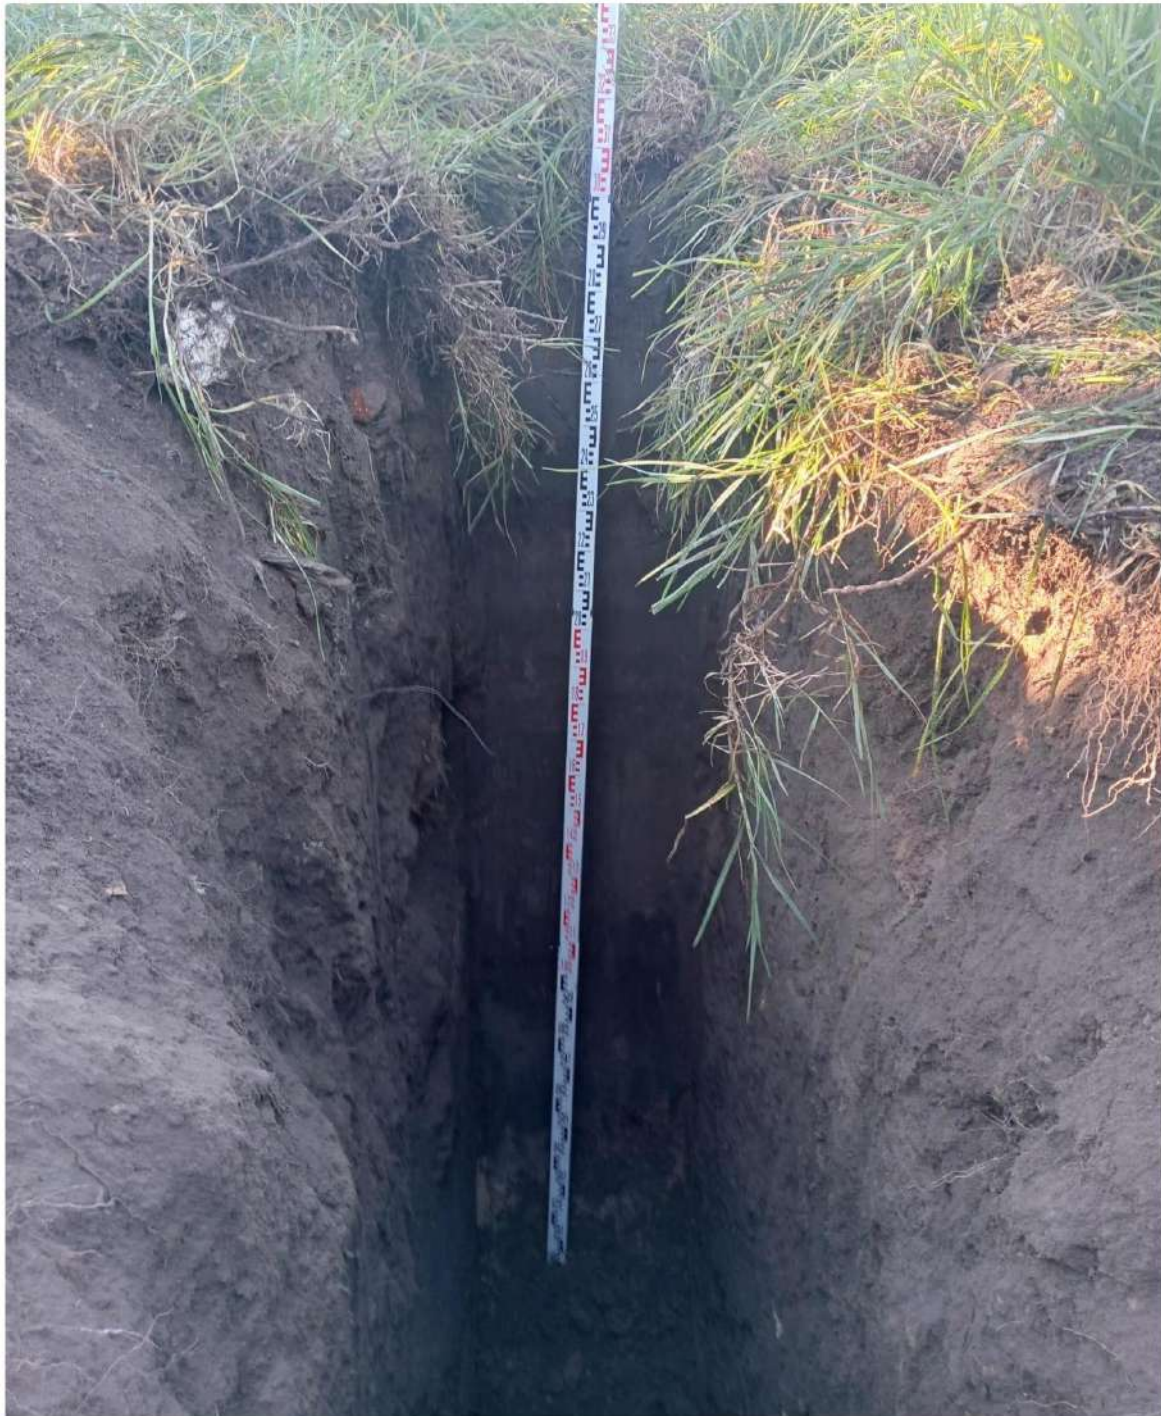
Soil Profile Photo of Test Pit TP2

slightly moist; dark brown; loose; intact; silty sand; Fill; Refuse materials; Not Sampled.

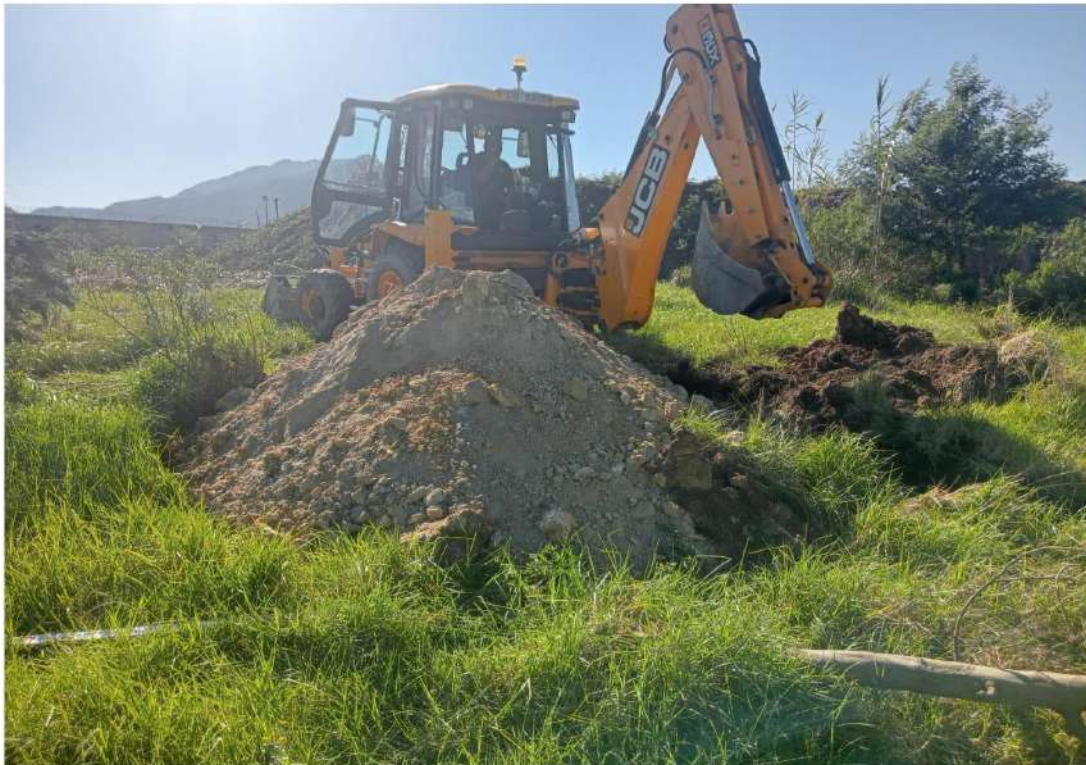
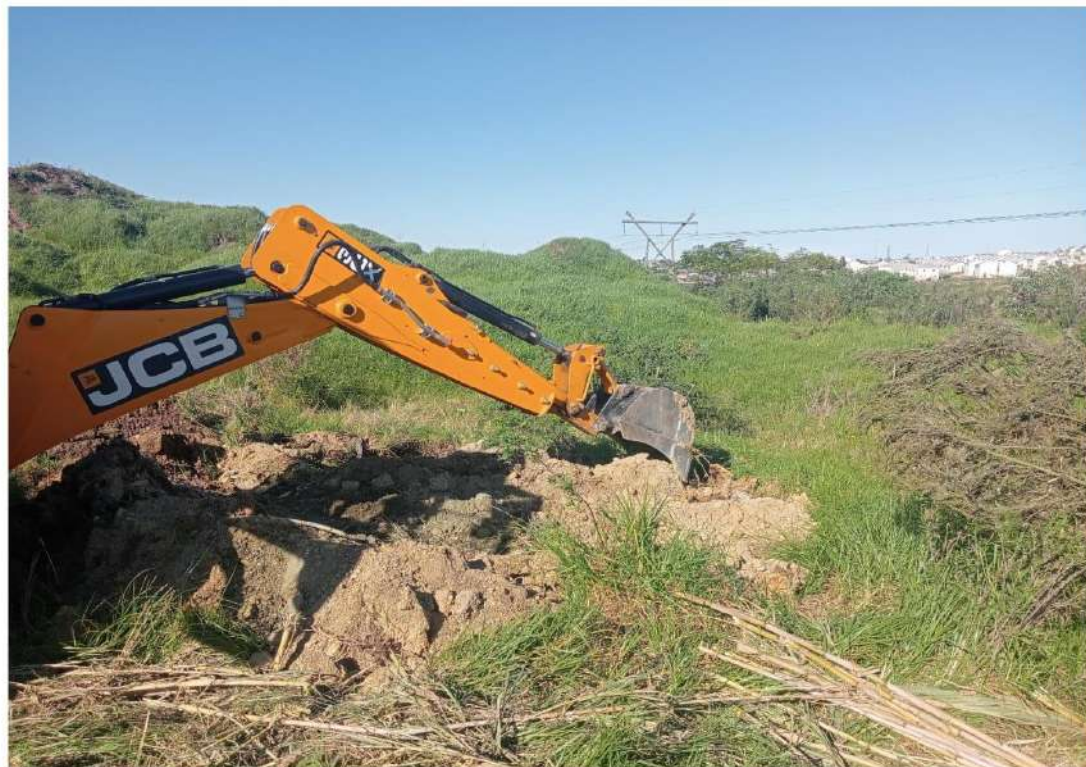
Surroundings of Test Pit TP4

slightly moist; dark brown; loose; intact; silty sand; Fill; Refuse materials; Not Sampled.

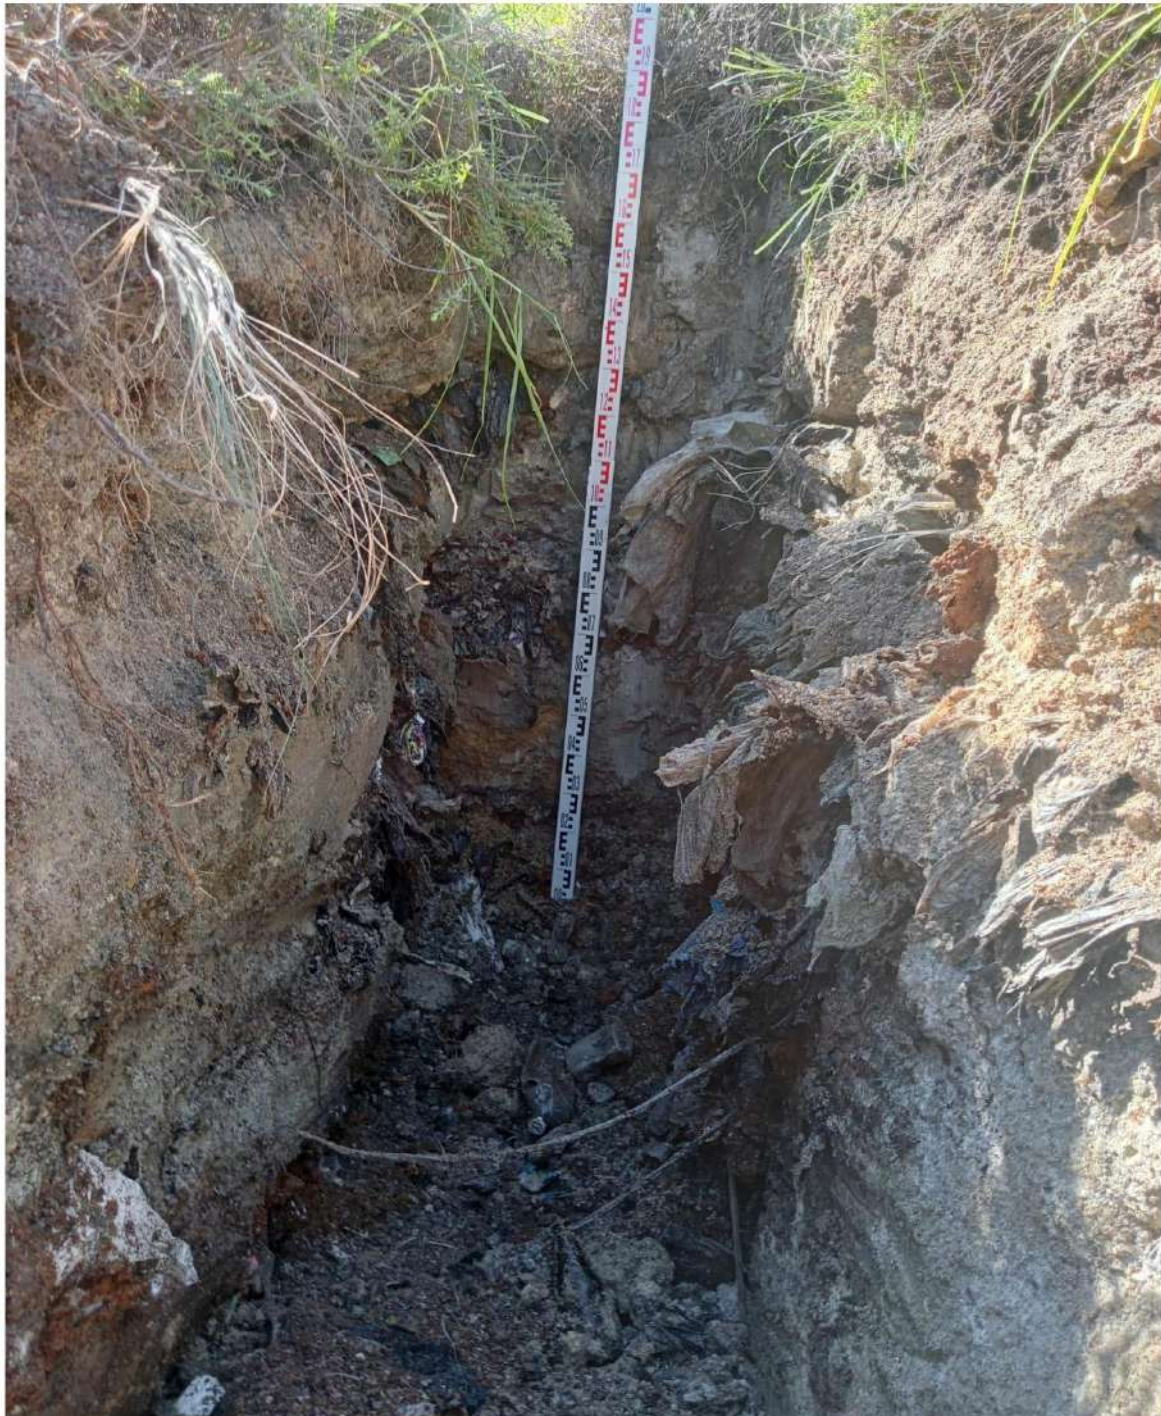
Soil Profile Photo of Test Pit TP5

slightly moist; dark brown; loose; intact; silty sand; Fill; Refuse materials; Not Sampled.

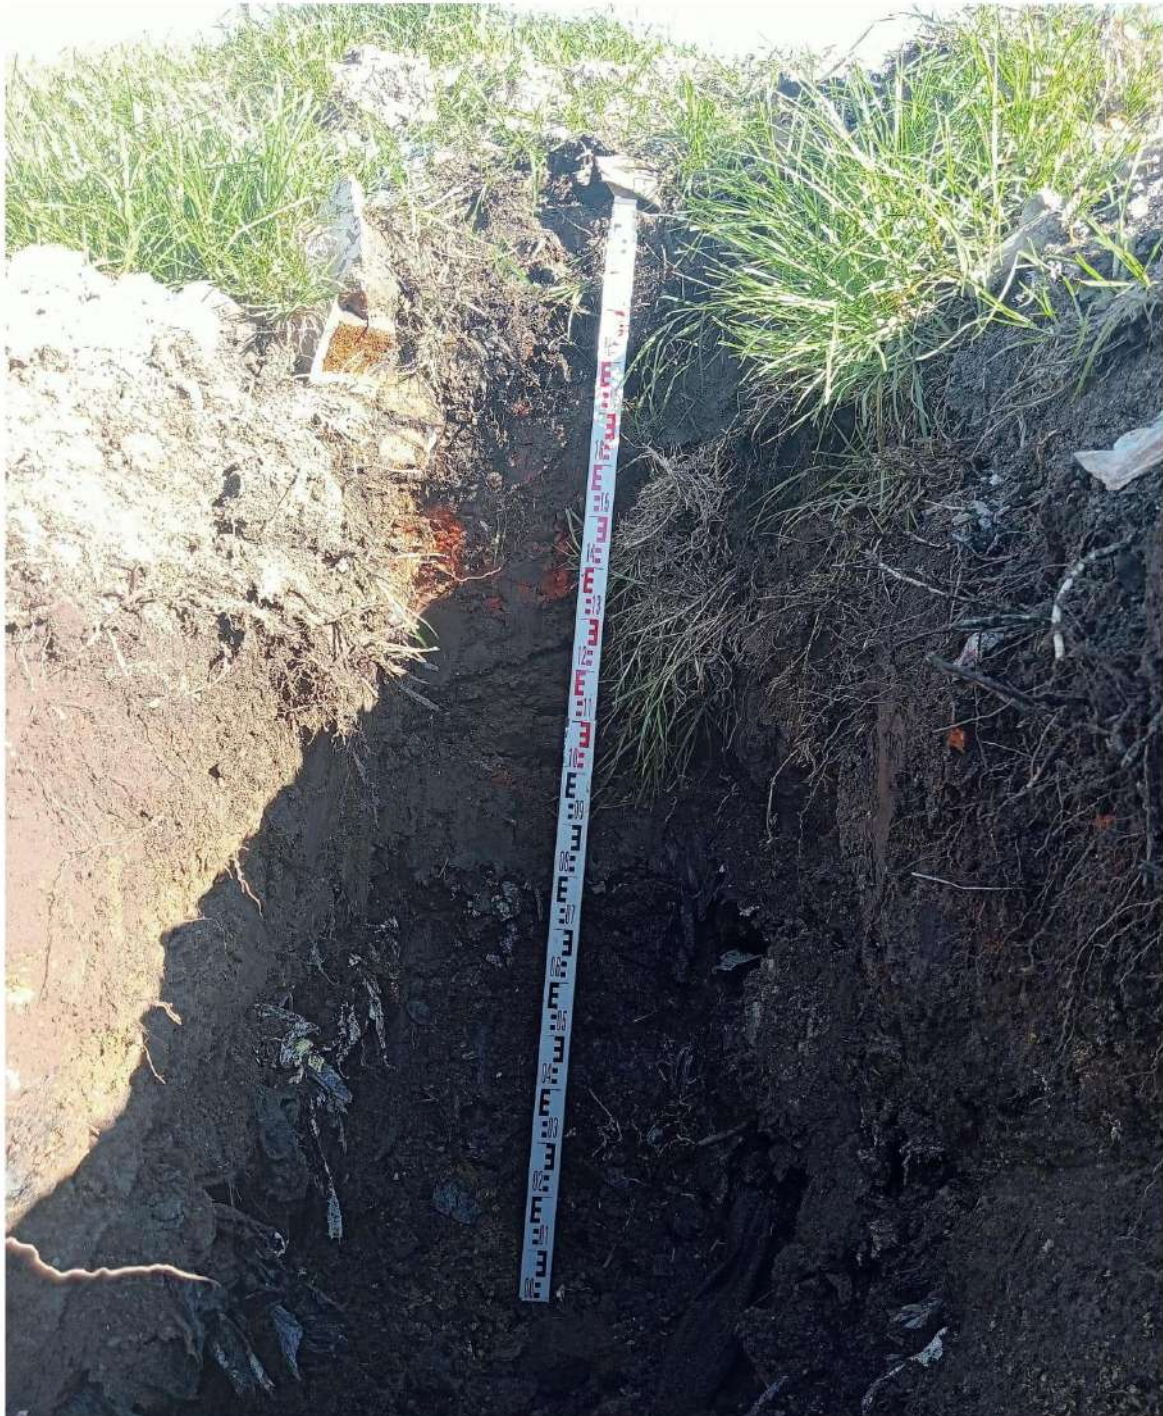
Soil Profile Photo of Test Pit TP6

slightly moist; orange patched grey mottled black; firm; voided; clayey/silty sand with highly weathered gravels; completely weathered granite; Not Sampled.

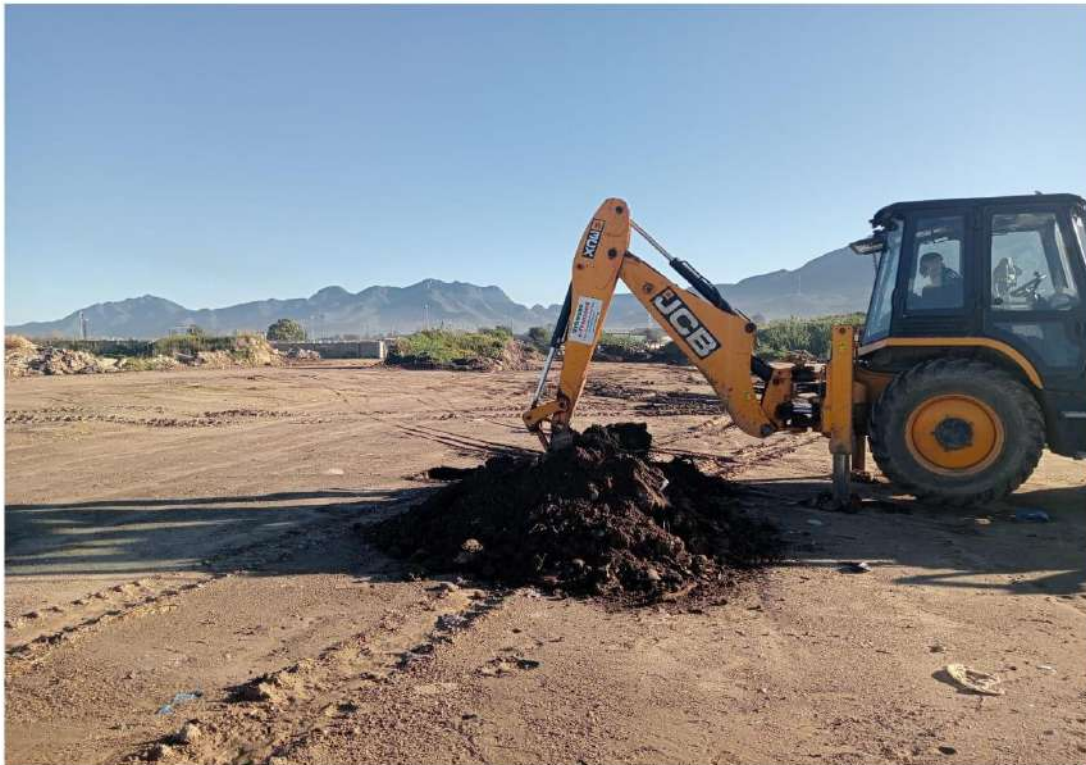
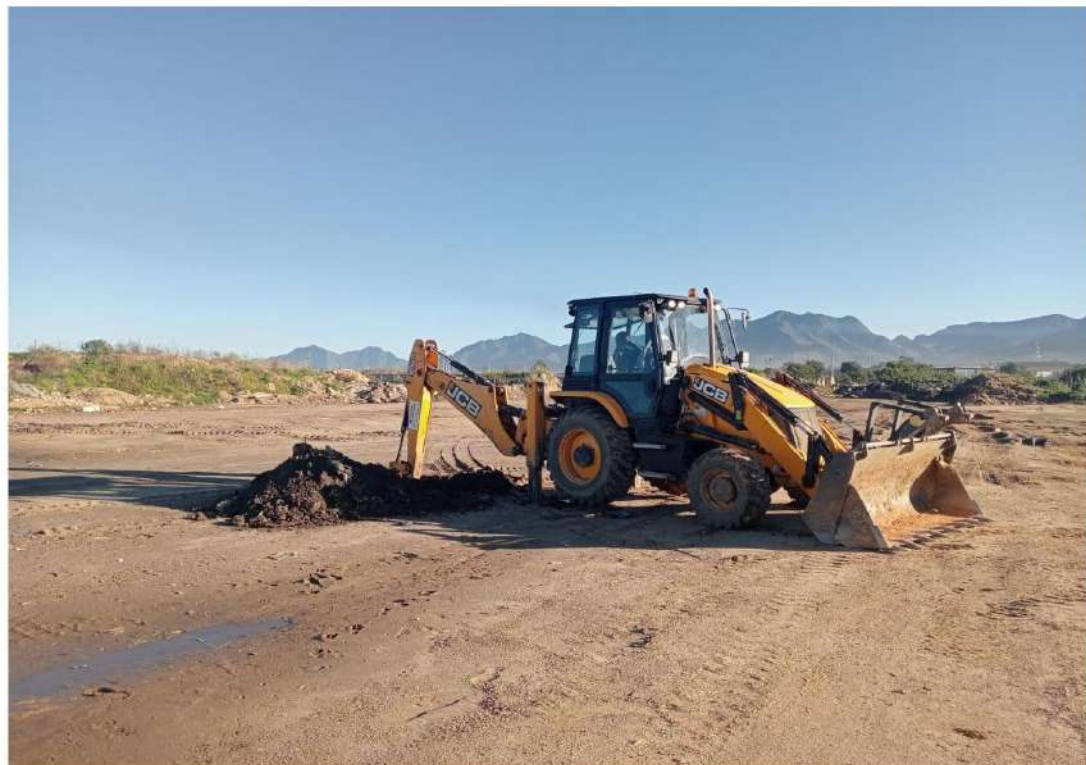
Surroundings of Test Pit TP1

slightly moist; dark brown; loose; intact; silty sand with scattered boulders; Fill; Refuse materials; Not Sampled.

Moist; orange patched grey mottled black; firm; Slickensided; clayey/silty sand with frequent gravels; Reworked residual; Not Sampled.
